Route U.S. 1 & 9 (Pulaski Skyway)

Contract No. 051183160

Town of Jersey City, Hudson County
City of Newark, Essex County

PRE-BID MEETING

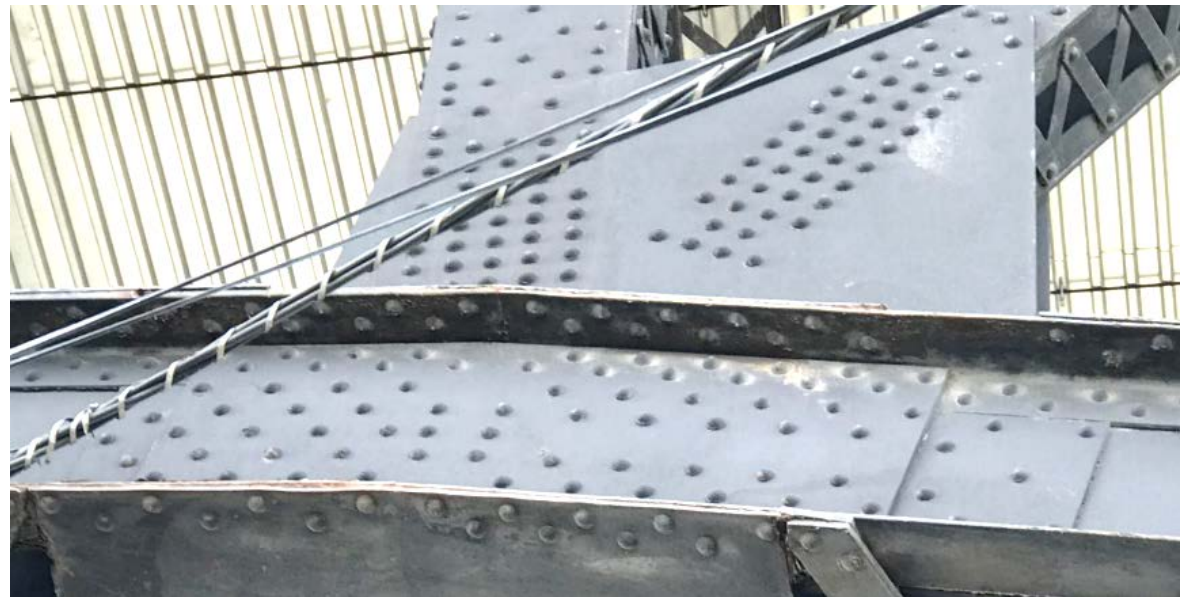
1. Replace existing rivets with tension control bolts with rounded heads.
 - RB47: See Structural Steel Note #3.
 - RB97: See General Note #6C.

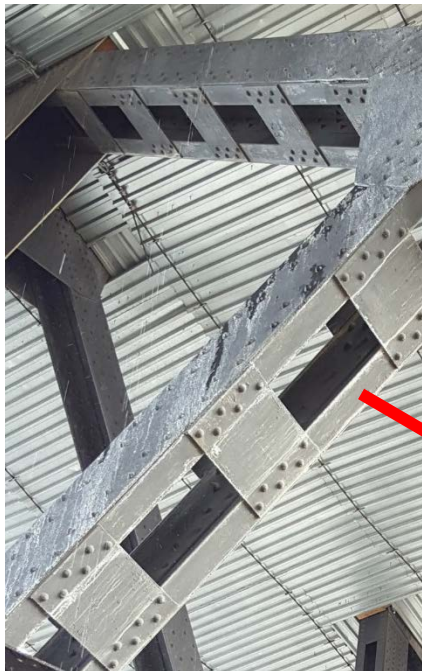
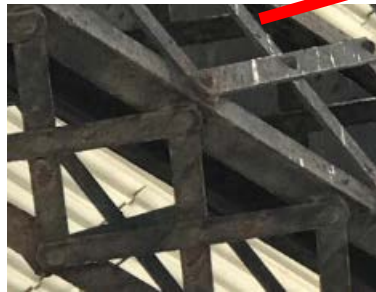
2. Replace existing lacing bars and batten plates with lacing plates

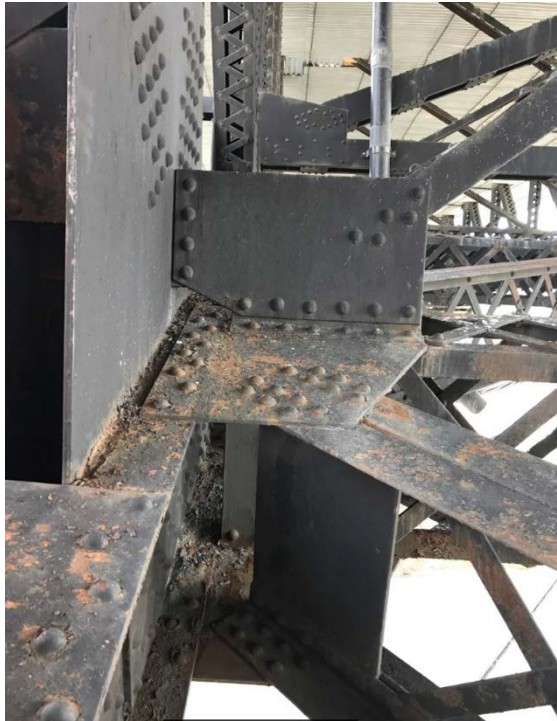
RB47 Bottom Connection Corrosion

Severe Corrosion, Pack Rust, Section Loss, Frozen Pins

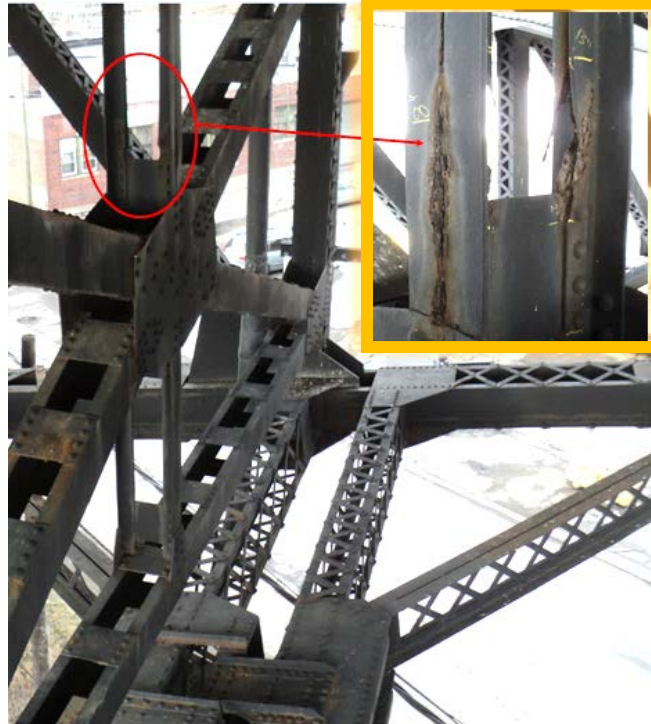
RB47 Sway Brace with Severe Section Loss

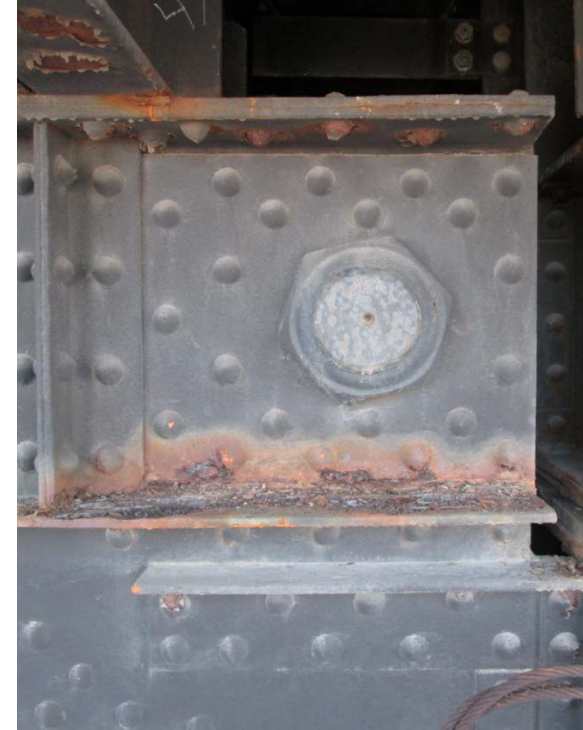
RB47 Frozen Top Pin

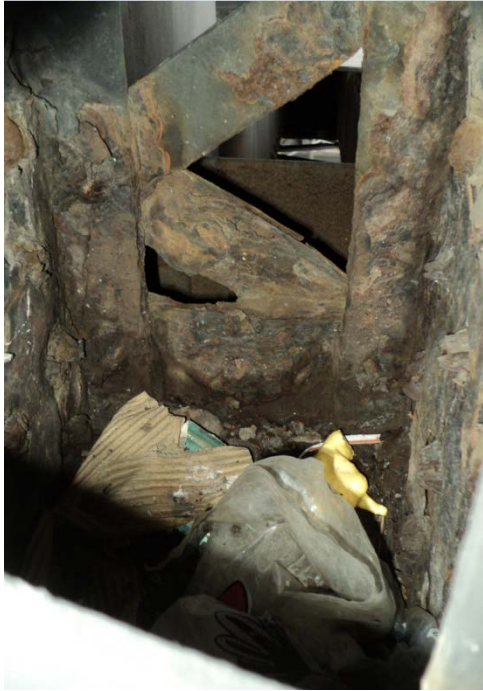
RB47 Vertical
Chord Corrosion

Severe Corrosion, Pack Rust, Section Loss, Frozen Pins

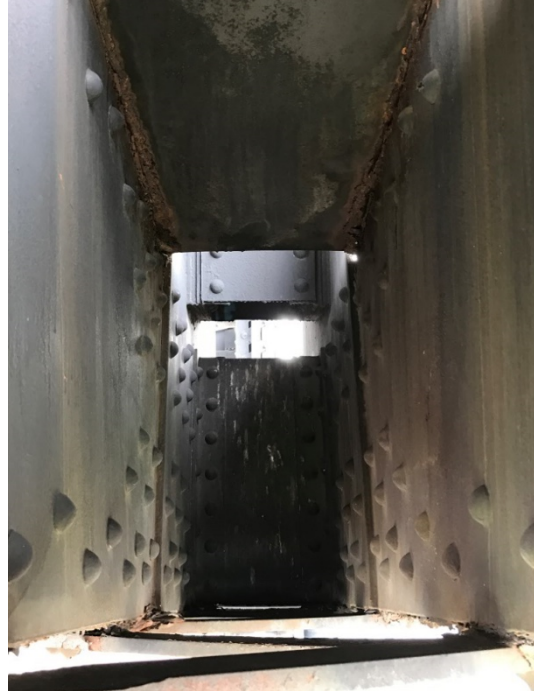
Span 47 Bottom Chord
Pack Rust

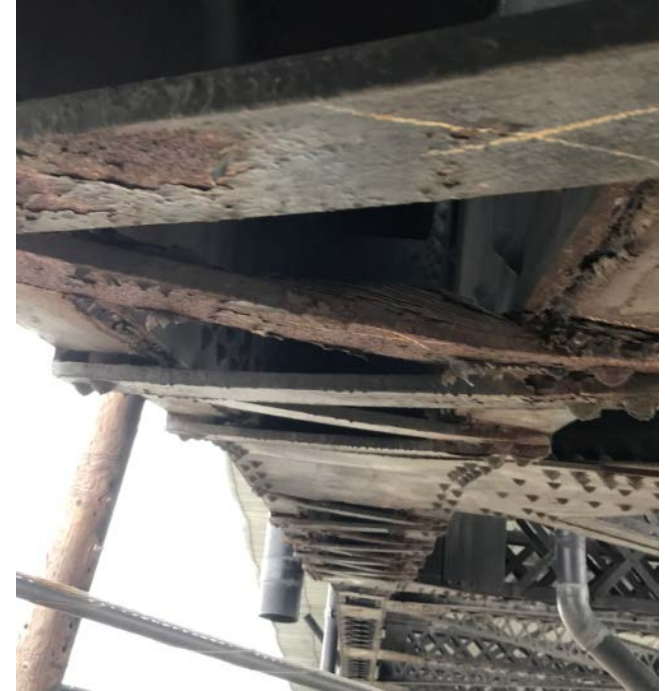
Span 47 Lacing Bars

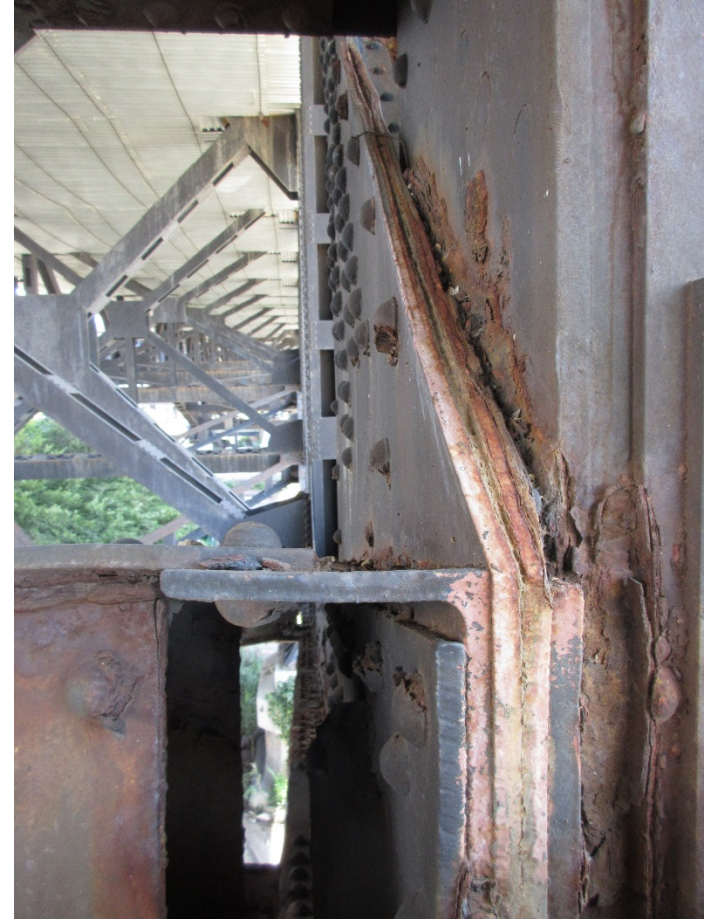
Corroded Slip Surface

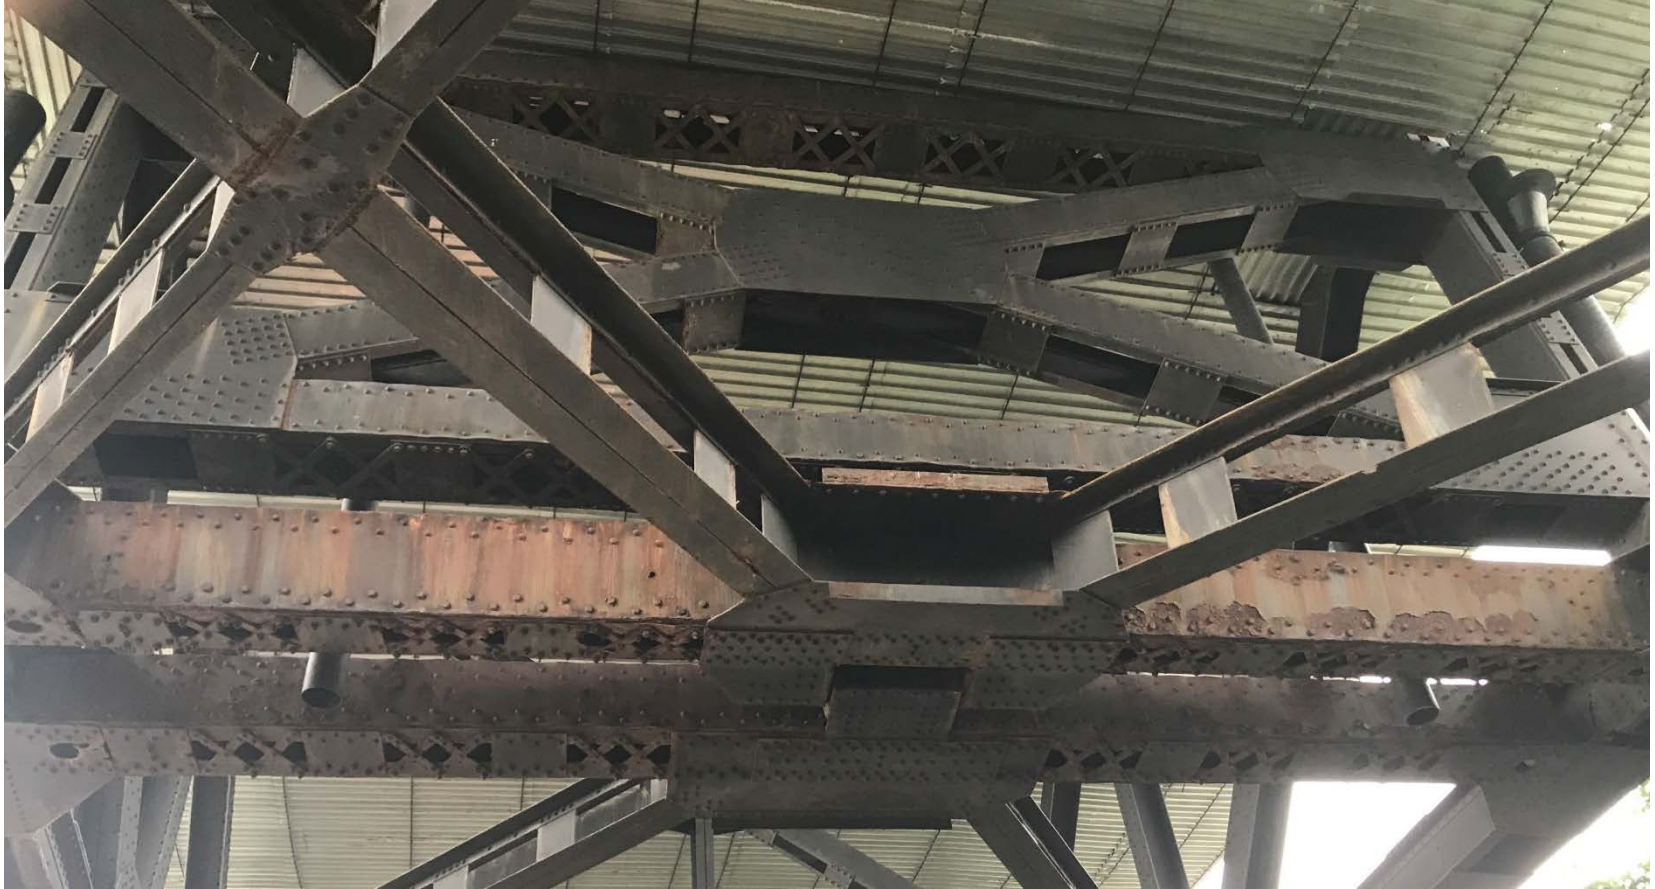
Widespread Corrosion
