**Route 22 over Liberty Avenue and Conrail Hillside Township, Union
County, Monitoring of Tensar MSE Walls**

FINAL REPORT
December 2011

16. Abstract This report discusses the application of Tensar geogrids as the reinforcement elements in the construction of mechanically stabilized earth (MSE) walls on the Route 22 over Conrail and Liberty Avenue bridge replacement project in Hillside, NJ. As this is a relatively new product to the New Jersey Department of Transportation, the geogrids were instrumented with strain gages and tiltmeters to allow performance monitoring of the MSE walls during and after construction. This report documents the results and findings of the monitoring data at the end of construction and after six months, as well as an optical surveying of the MSE wall faces to determine post-construction wall movement. The monitoring effort is in collaboration with the Federal Highway Administration's Long Term Bridge Performance Program.		13. Type of Report and Period Covered Final Report 10/01/2010 – 11/30/2011

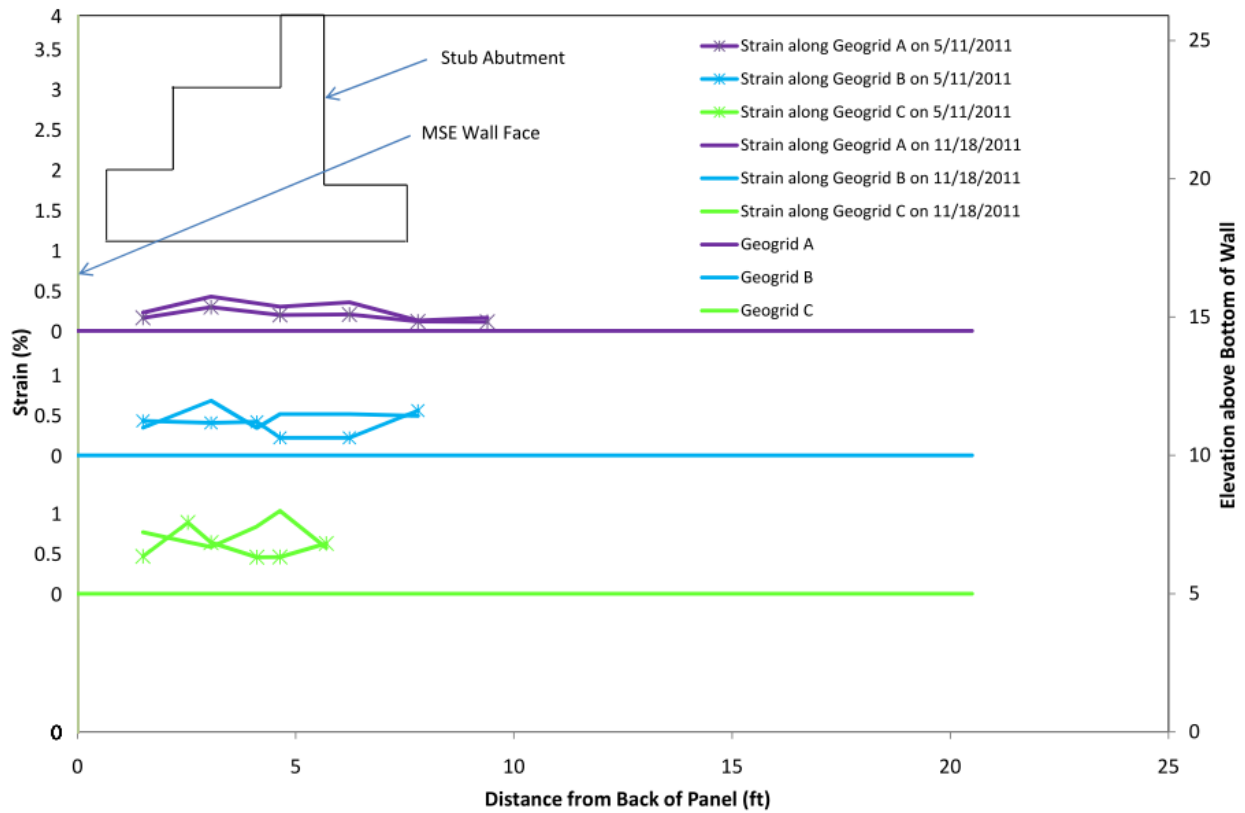
Figure 3. Variation of strain along geogrid at wall 3

Plots showing the variation of geogrid strain during construction since the time of installation are provided in Appendix E for all geogrids. Figures 2 and 3 provide the variation of strain along the instrumented geogrids for Walls 1 and Wall 3 respectively at the time of preparation of the Interim Report and the time of preparation of this Final Report. It can be seen that the maximum tension was captured by the strain gages. The data in Figures 2 and 3 indicate that the geogrids experienced some relatively small creep within the five month duration between the two sets of readings for both Walls.

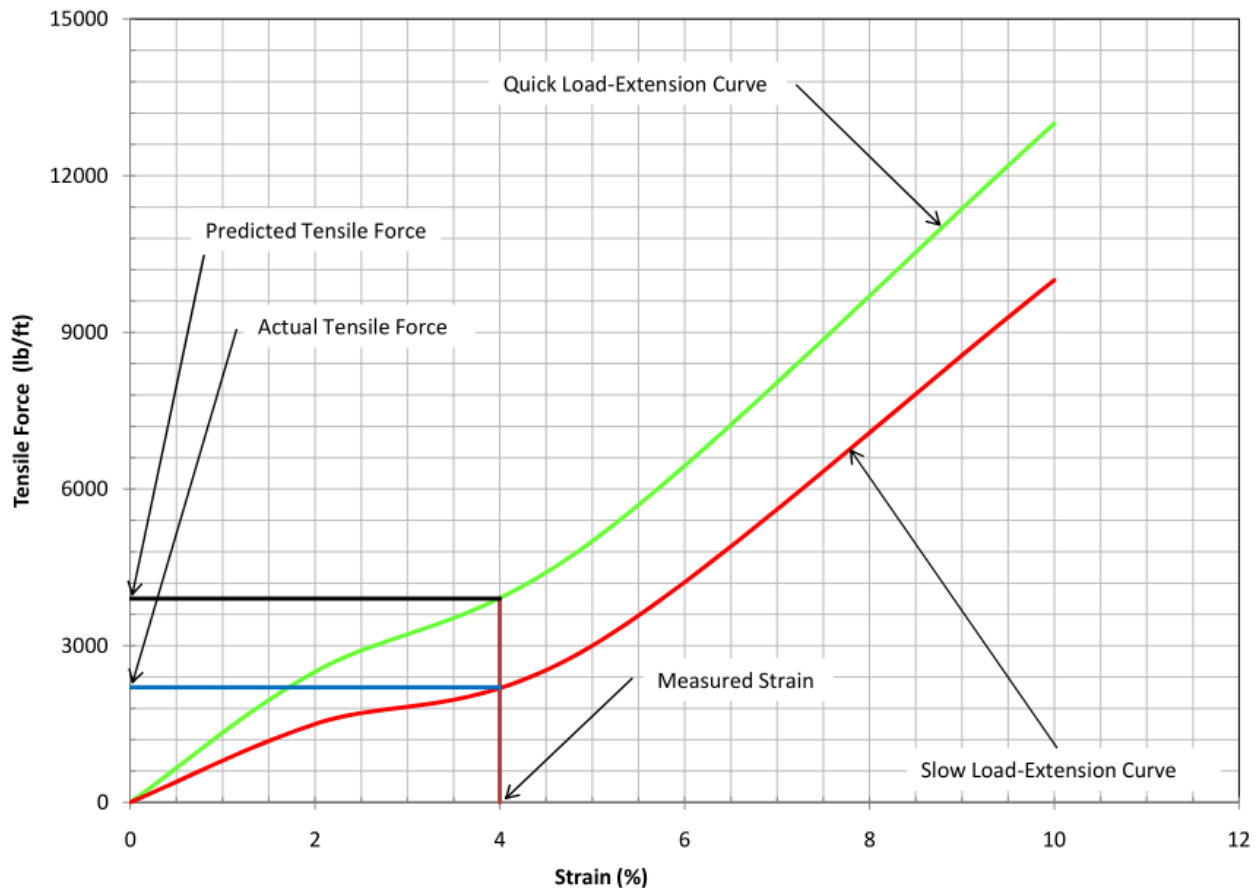
Figure 4. Conservatism in estimating geogrid tension force

The maximum tension deduced from strains and based on quick load-extension tests (Column 5 in Table 2) are compared with the allowable tension (column 8), which is equal to the long term design strength (LTDS, Column 7) divided by a factor of safety of 1.5 as typically assumed in the allowable stress design (ASD) method. It can be seen that in all cases, the maximum estimated tension is less than the maximum allowable tension. This, in addition to the fact that the tension is conservatively estimated from the strains, as already discussed, indicates that there is sufficient safety factor against tension failure for all the instrumented geogrids. For completeness, the maximum tension forces in the geogrids as obtained using the software MSEW V.3 developed by Adama Engineering, Inc. and based on limit equilibrium method are provided in Column 6. By comparison with Column 8, it can be seen that the design tension forces are less than the maximum allowable tension indicating that some conservatism was used in design.

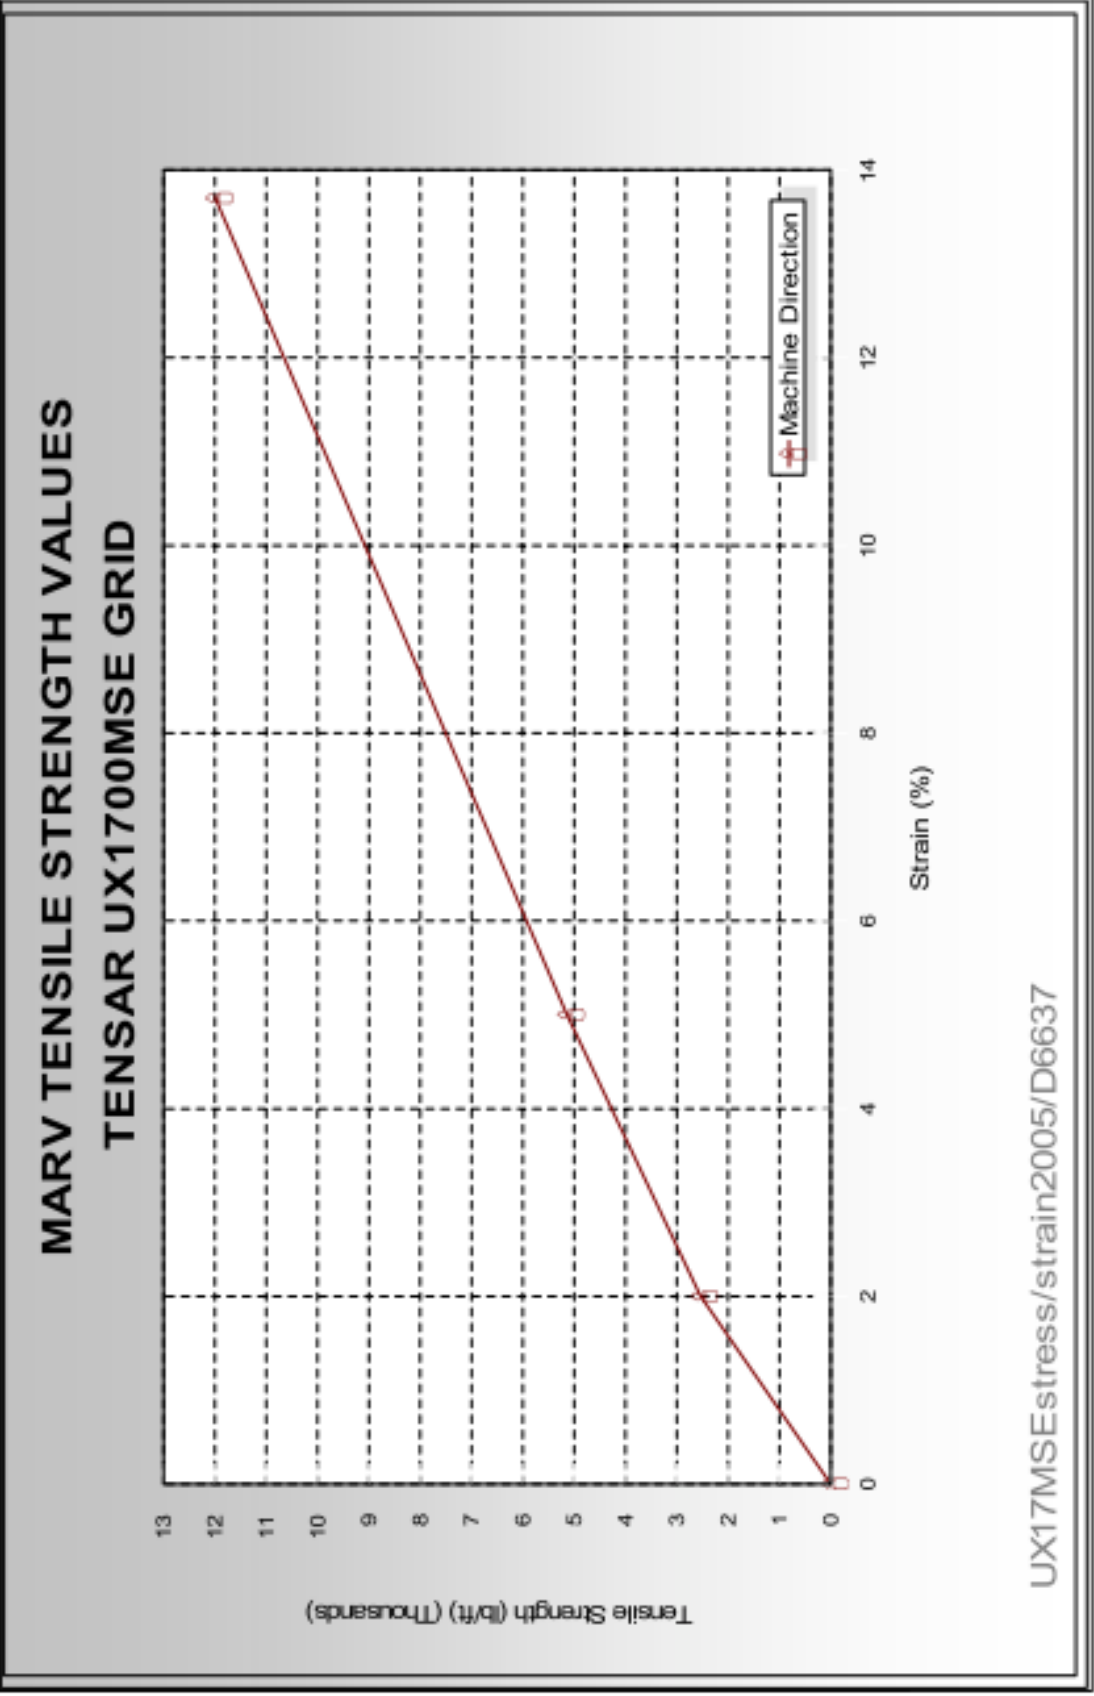
Figure 9. Marv Tensile Strength Values, Tensar UX1700MSE Grid

As shown in Table 1, a coverage ratio of 89% was used in the instrumented walls. The load-extension curves measured according to ASTM D6637 for the four geogrid types are included in Appendix A. The tests were conducted at a strain rate of about 10% per minute.

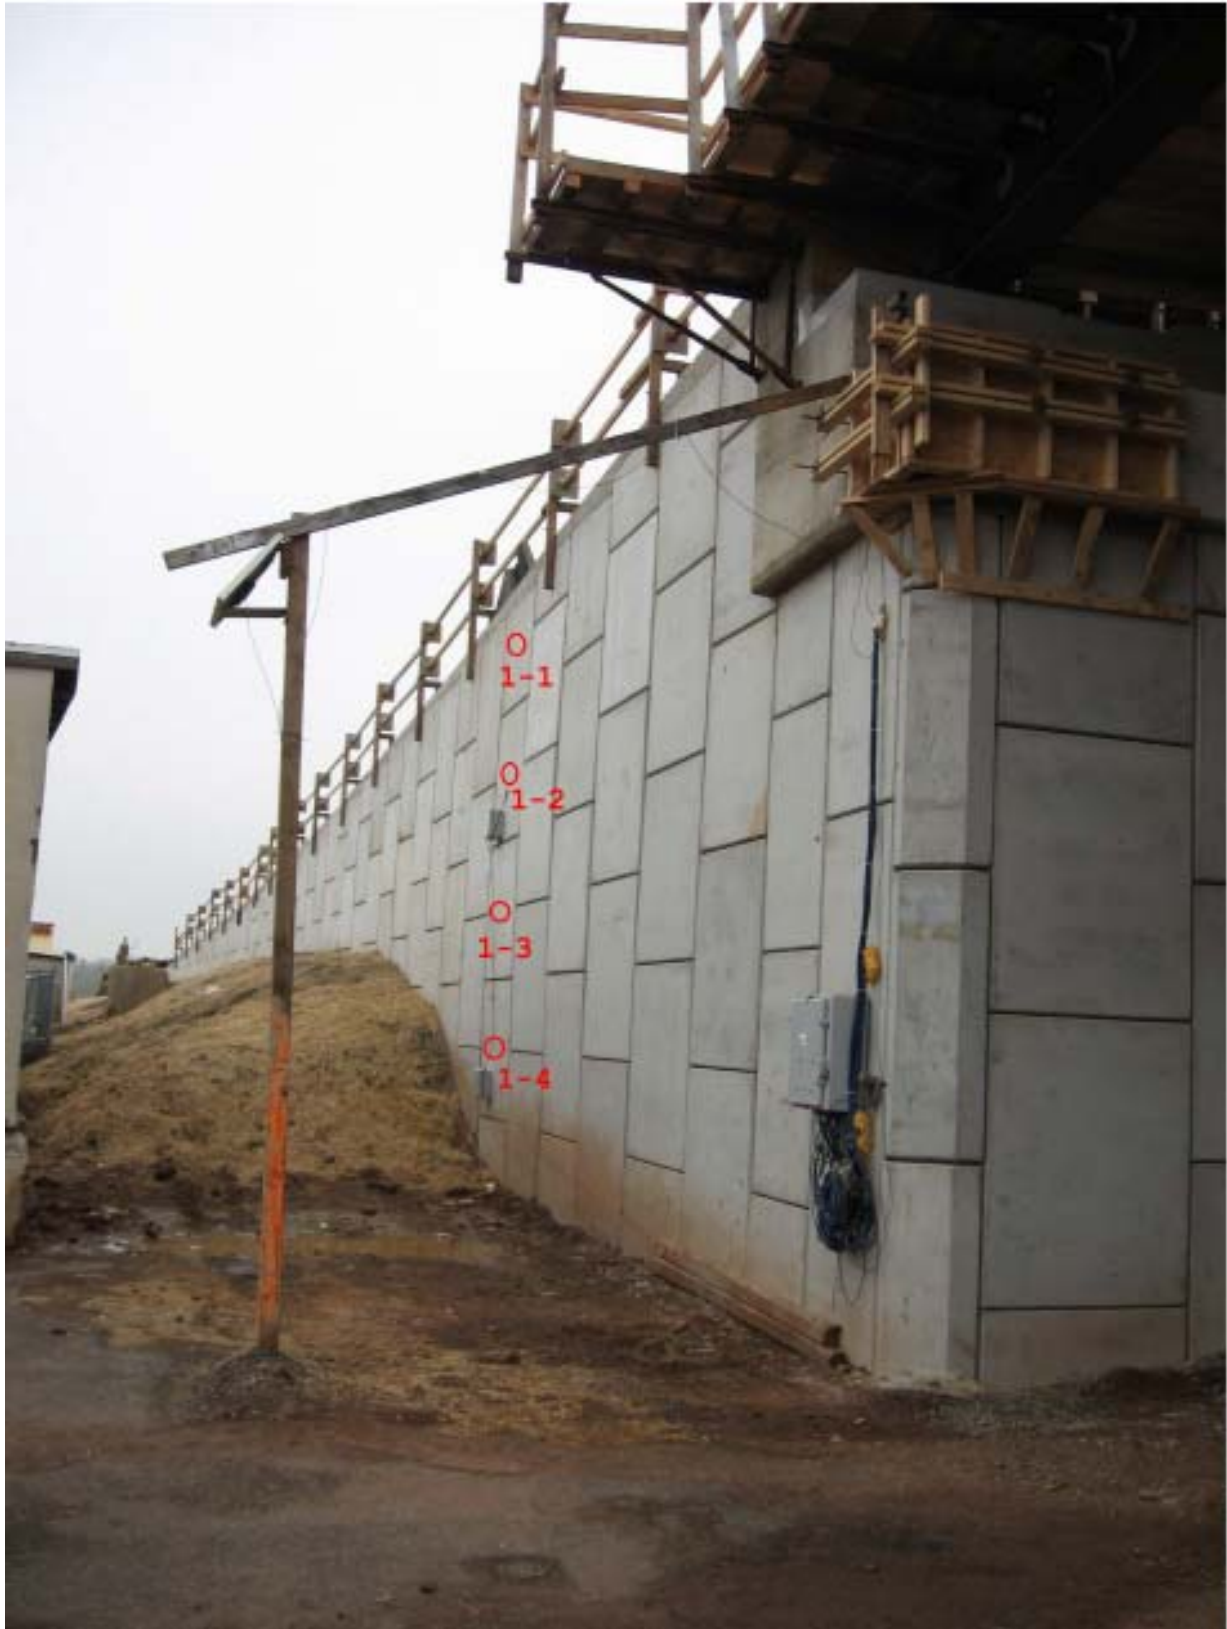
Figure 14. Optical Prism Locations at Wall 1

Five sets of survey readings were taken by Geocomp on June 30, 2011 to establish the average and standard deviation for the northing, easting, and elevation for each optical prism. Another survey was performed October 28, 2011 to determine the changes in northing, easting, and elevation between the two dates (about four months). Inspection of the data which are included in Appendix F indicates that in almost all cases the final values of the northing and easting fall within the range between the minimum and maximum of the corresponding initial values indicating that the measured displacements in the north and east directions are within the range of accuracy of the initial survey data and hence could not be accurately evaluated. This, in addition to the fact that the deduced out of plane displacements of the wall at several prisms were toward the inside of the wall which is not practically possible, leads to the conclusion that the wall face displacements are too small to be accurately evaluated with the survey equipment.

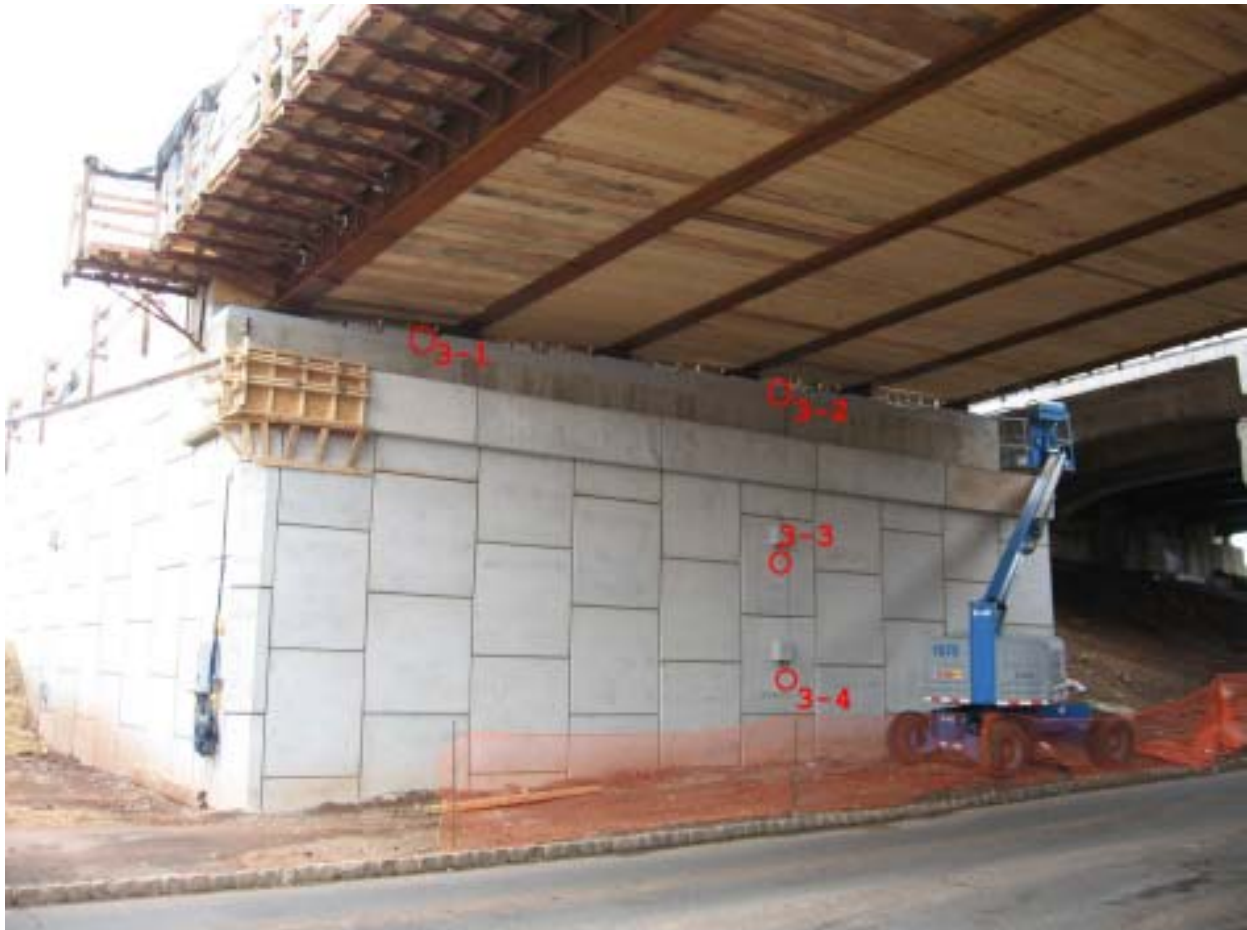
Figure 15. Optical Prism Locations at Wall 3

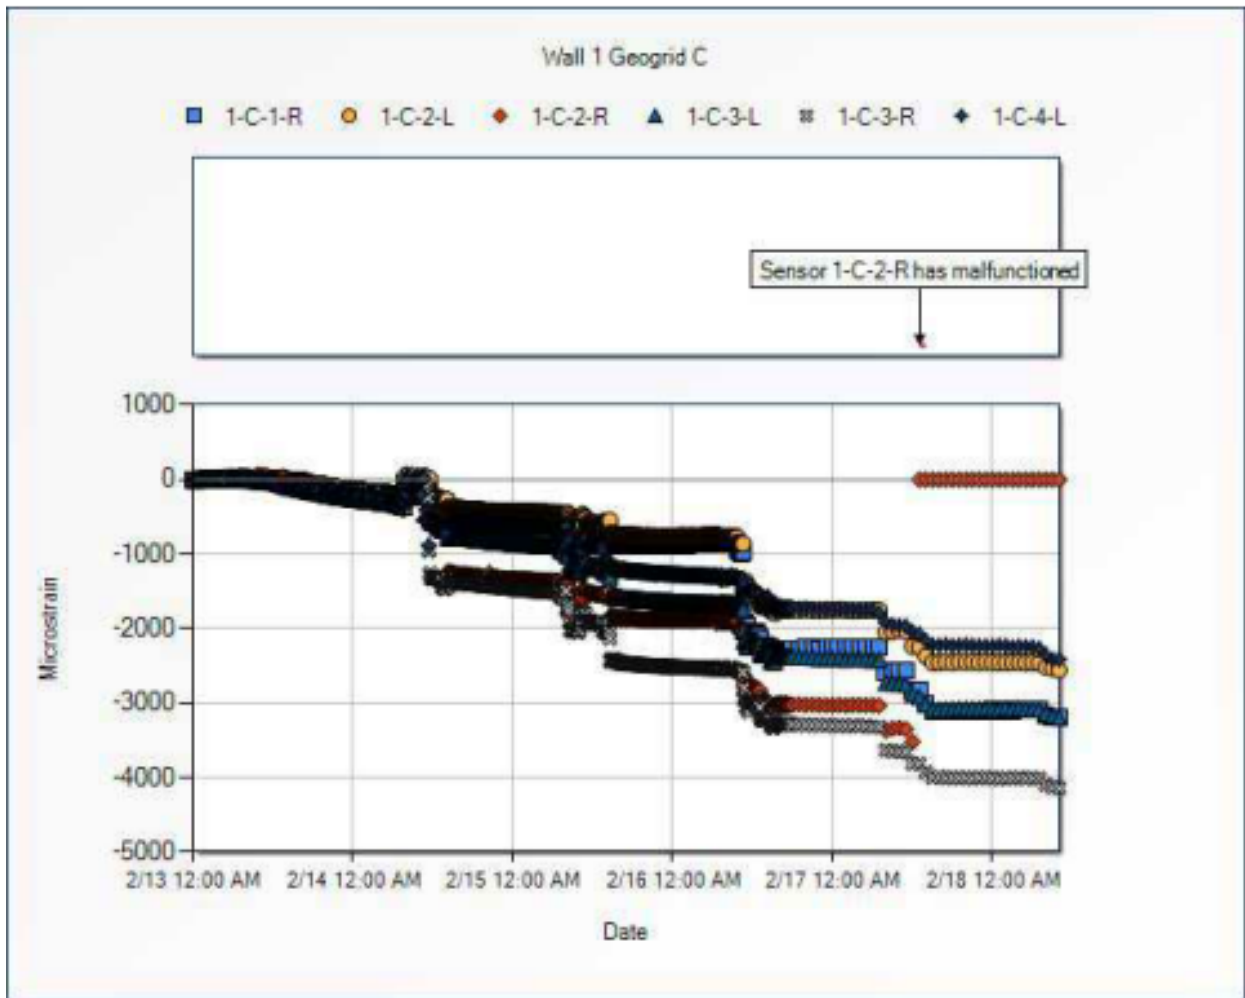
Figure 16. Microstrain over time for Wall 1 Geogrid C

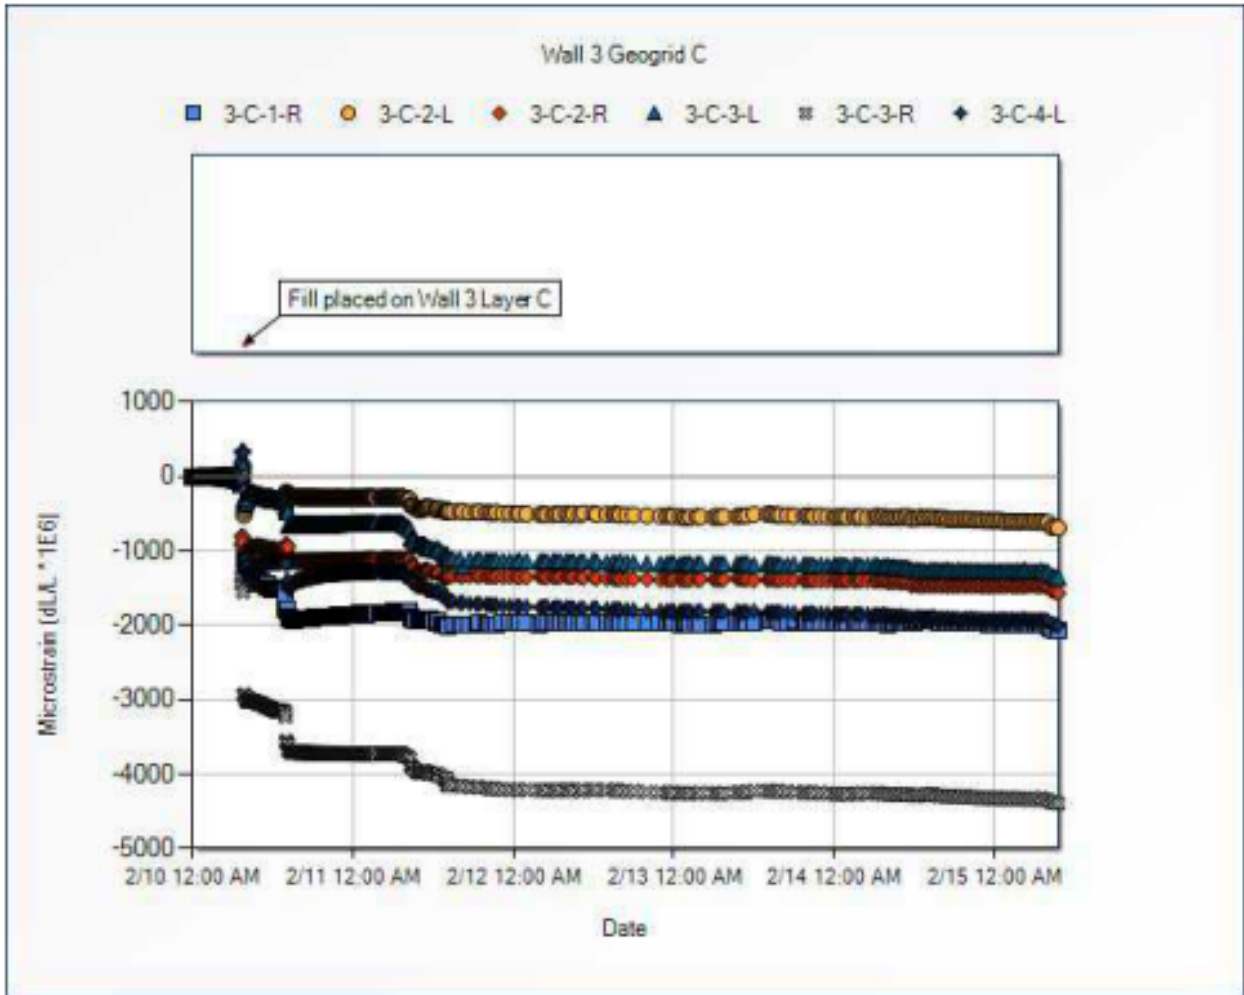
Figure 17. Microstrain over time for Wall 3 Geogrid C

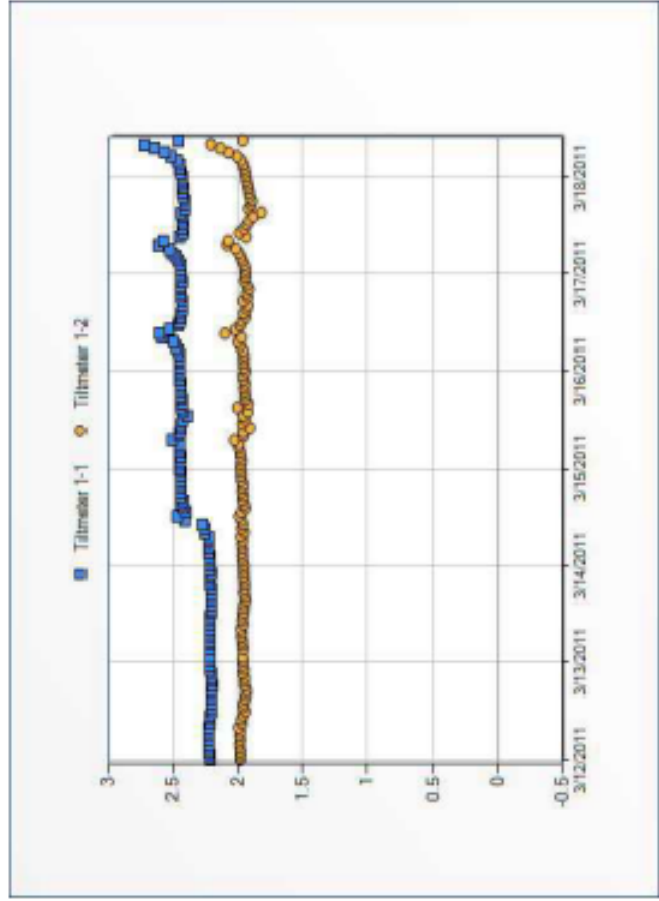
WALL 1 TILTMETER PLOT

Figure 18. Installation Log for Tiltmeter 1-1 and 1-2

Two tiltmeters were installed on each of the instrumented walls during wall construction. In order to be able to correlate the tiltmeter and strain gage data, the tiltmeters were mounted on the column of panels to which the instrumented geogrids were attached. The installation logs of the tiltmeters are provided in Appendix D.

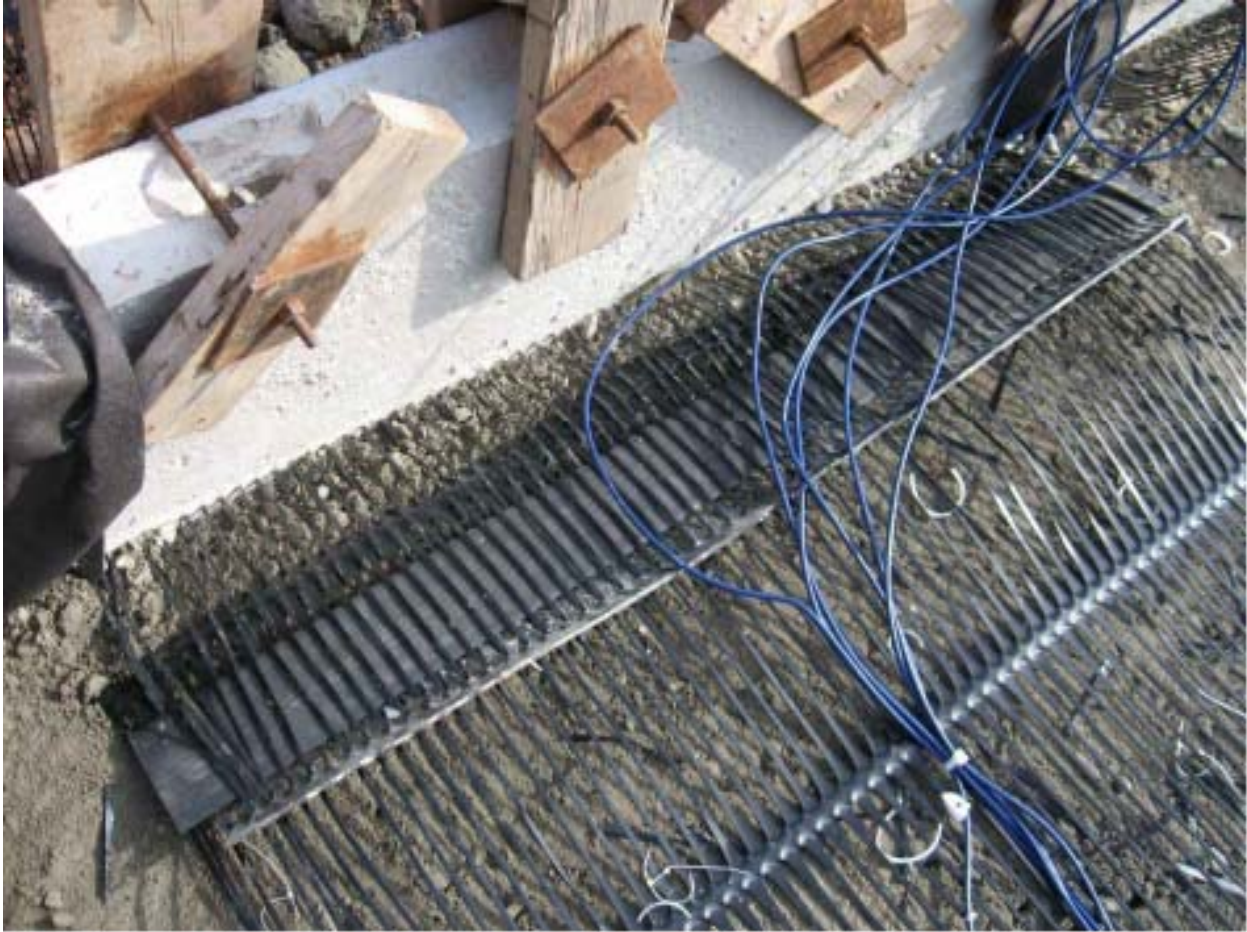
Figure 20. Bodkin Joint

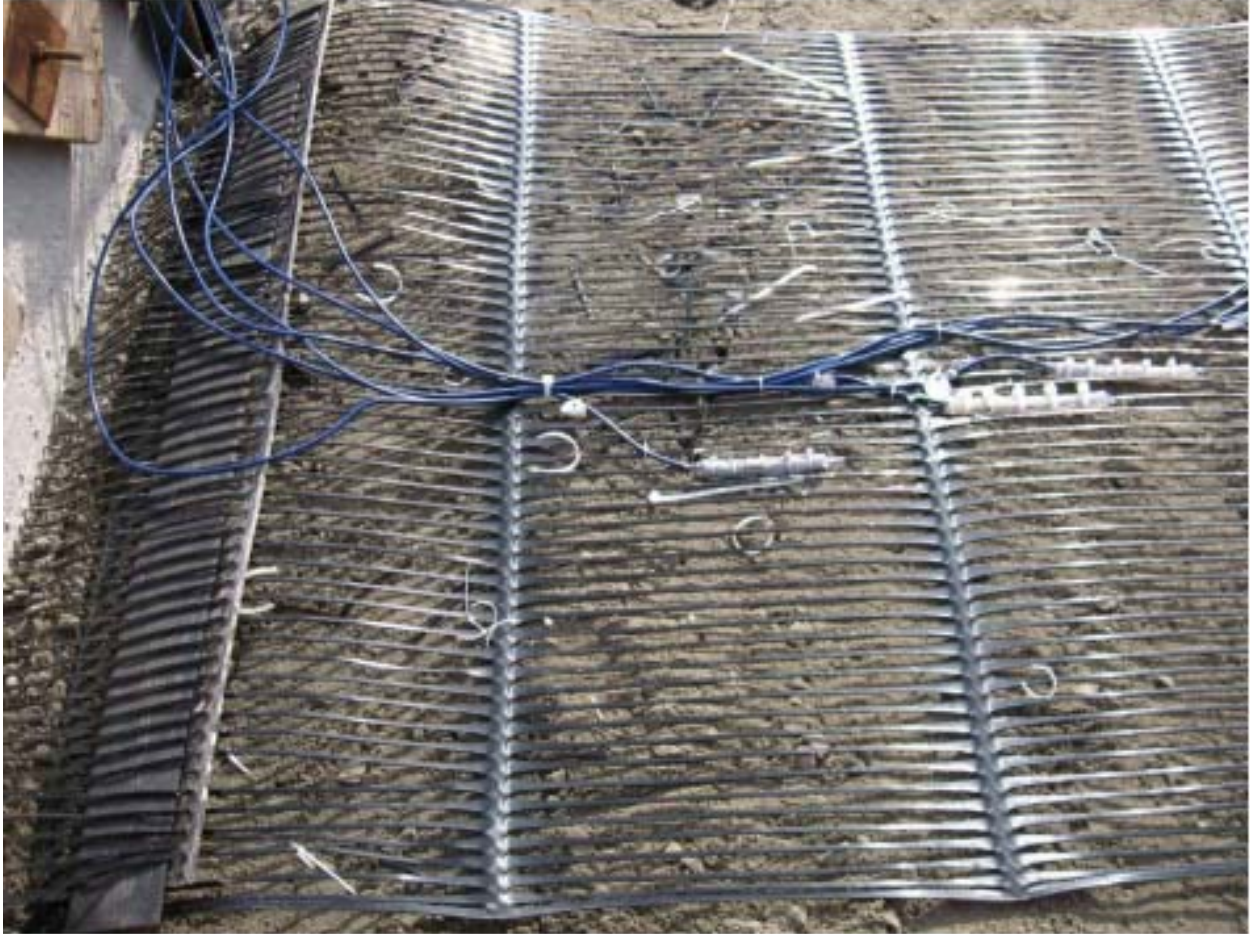
Figure 21. Instrumented Geogrid with Strain Gages

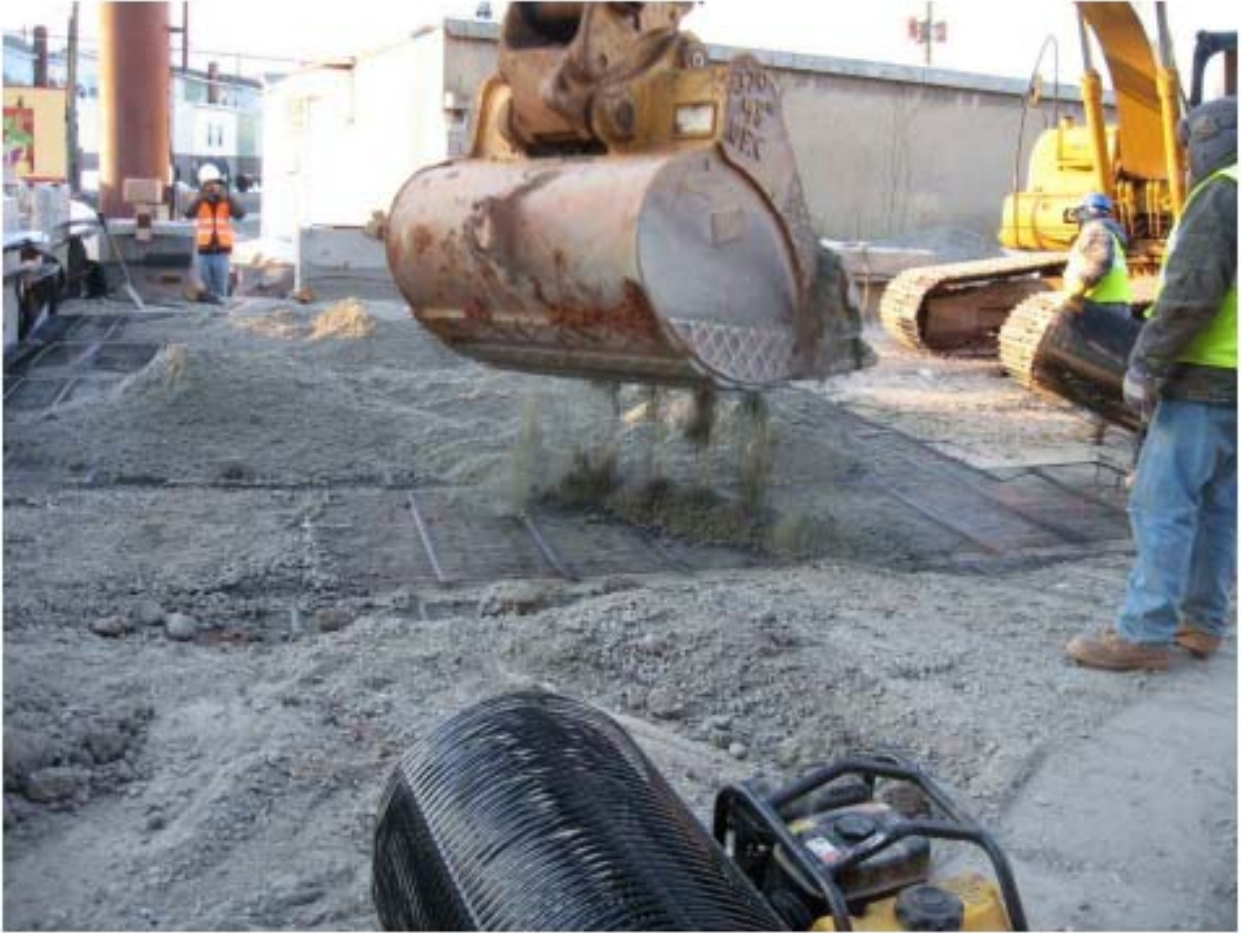
Figure 22. Place Select Fill on Top of Geogrid

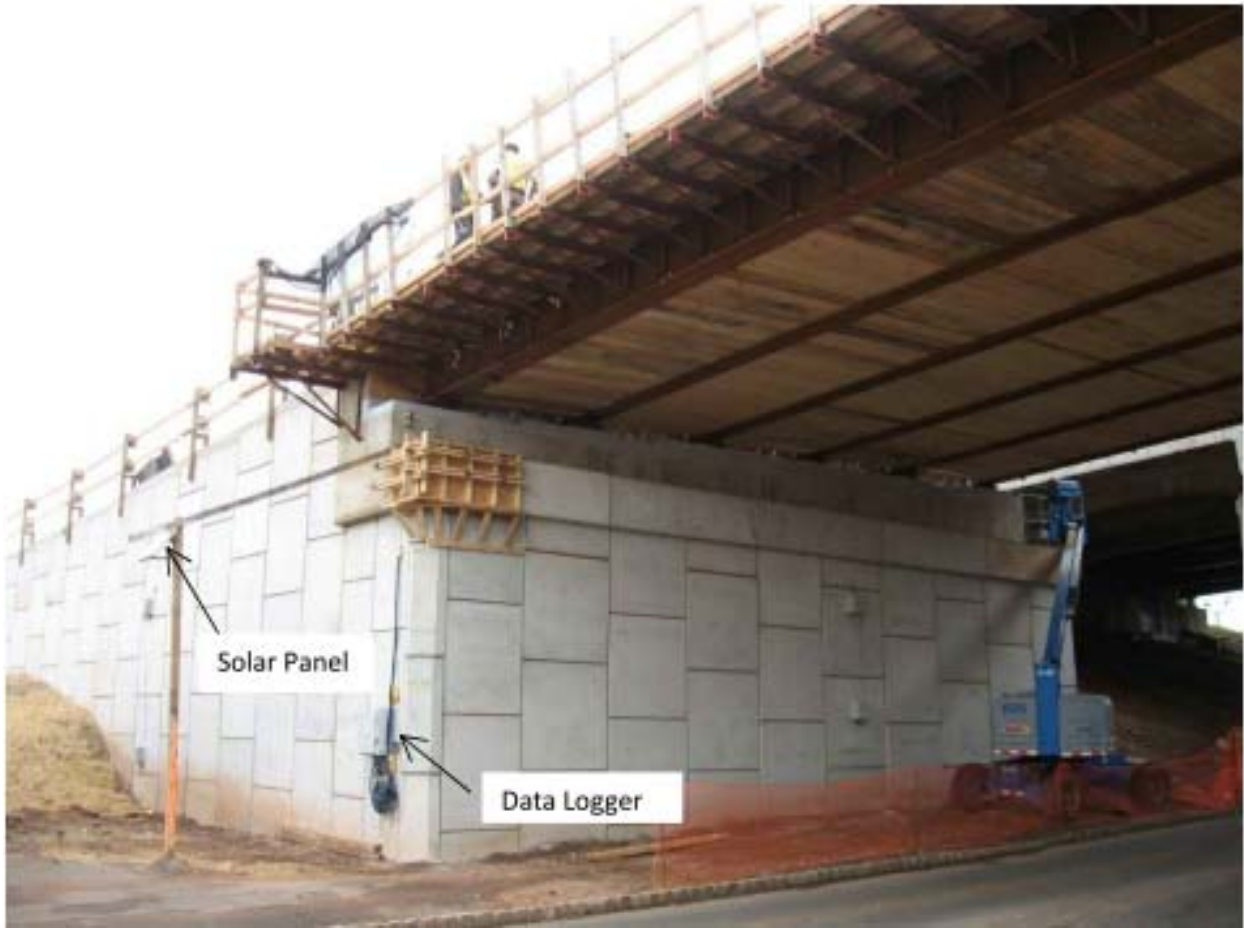
Figure 23. Wall 1 and Wall 3 at End of Construction

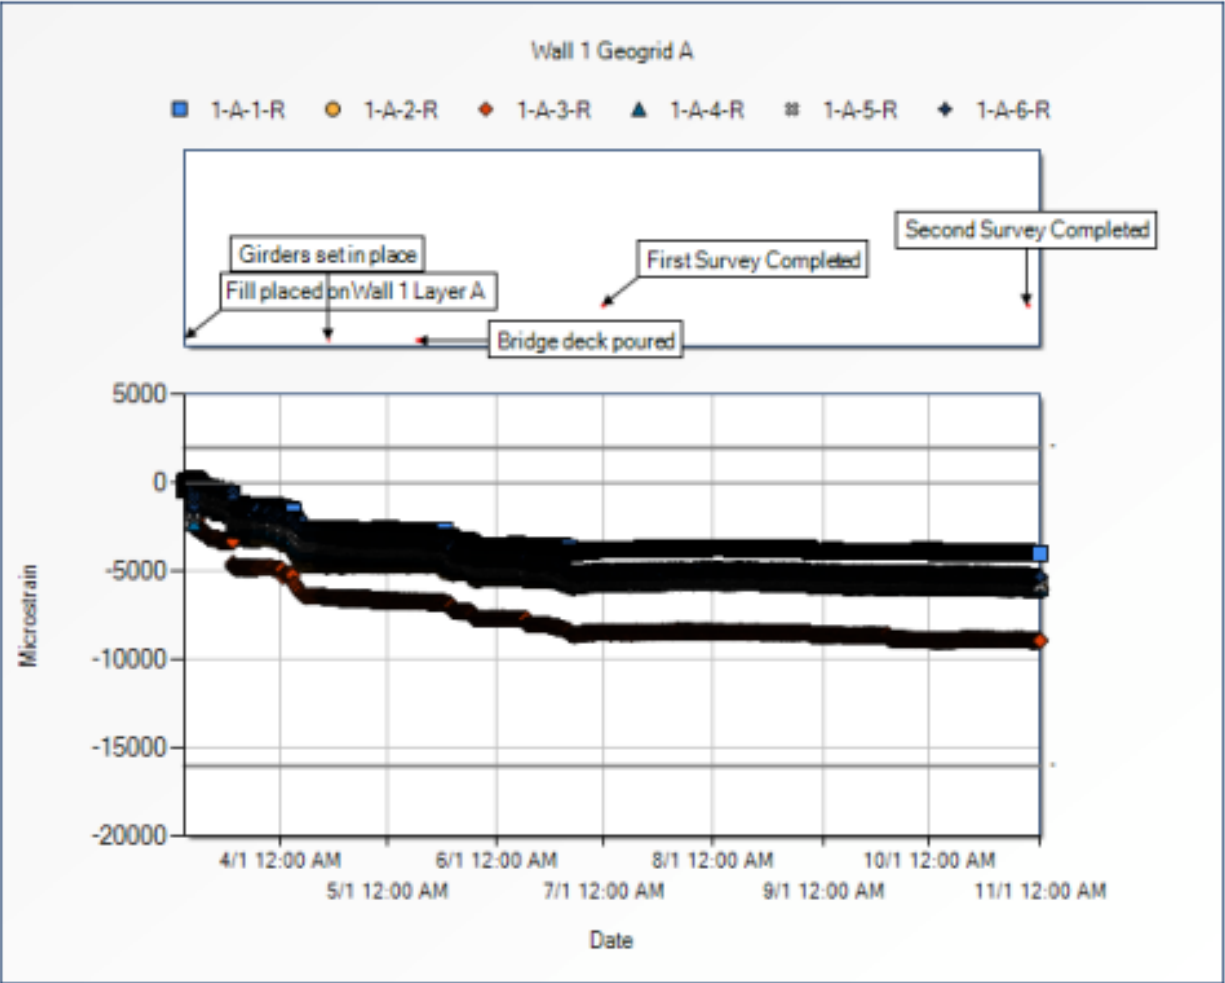
Figure 25. Microstrain over time for Wall 1 Geogrid A

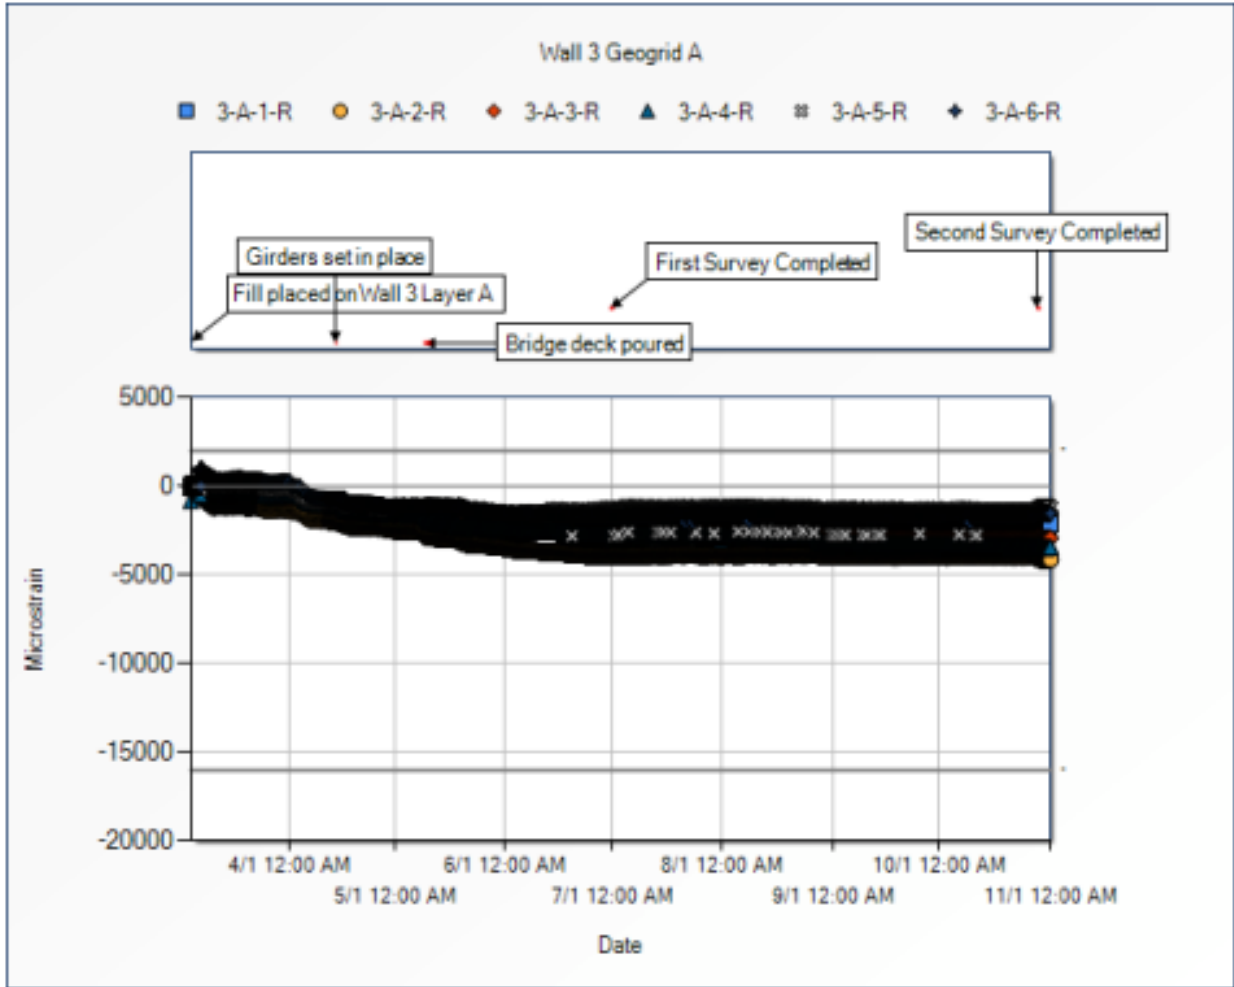
Figure 29. Microstrain over time for Wall 3 Geogrid A

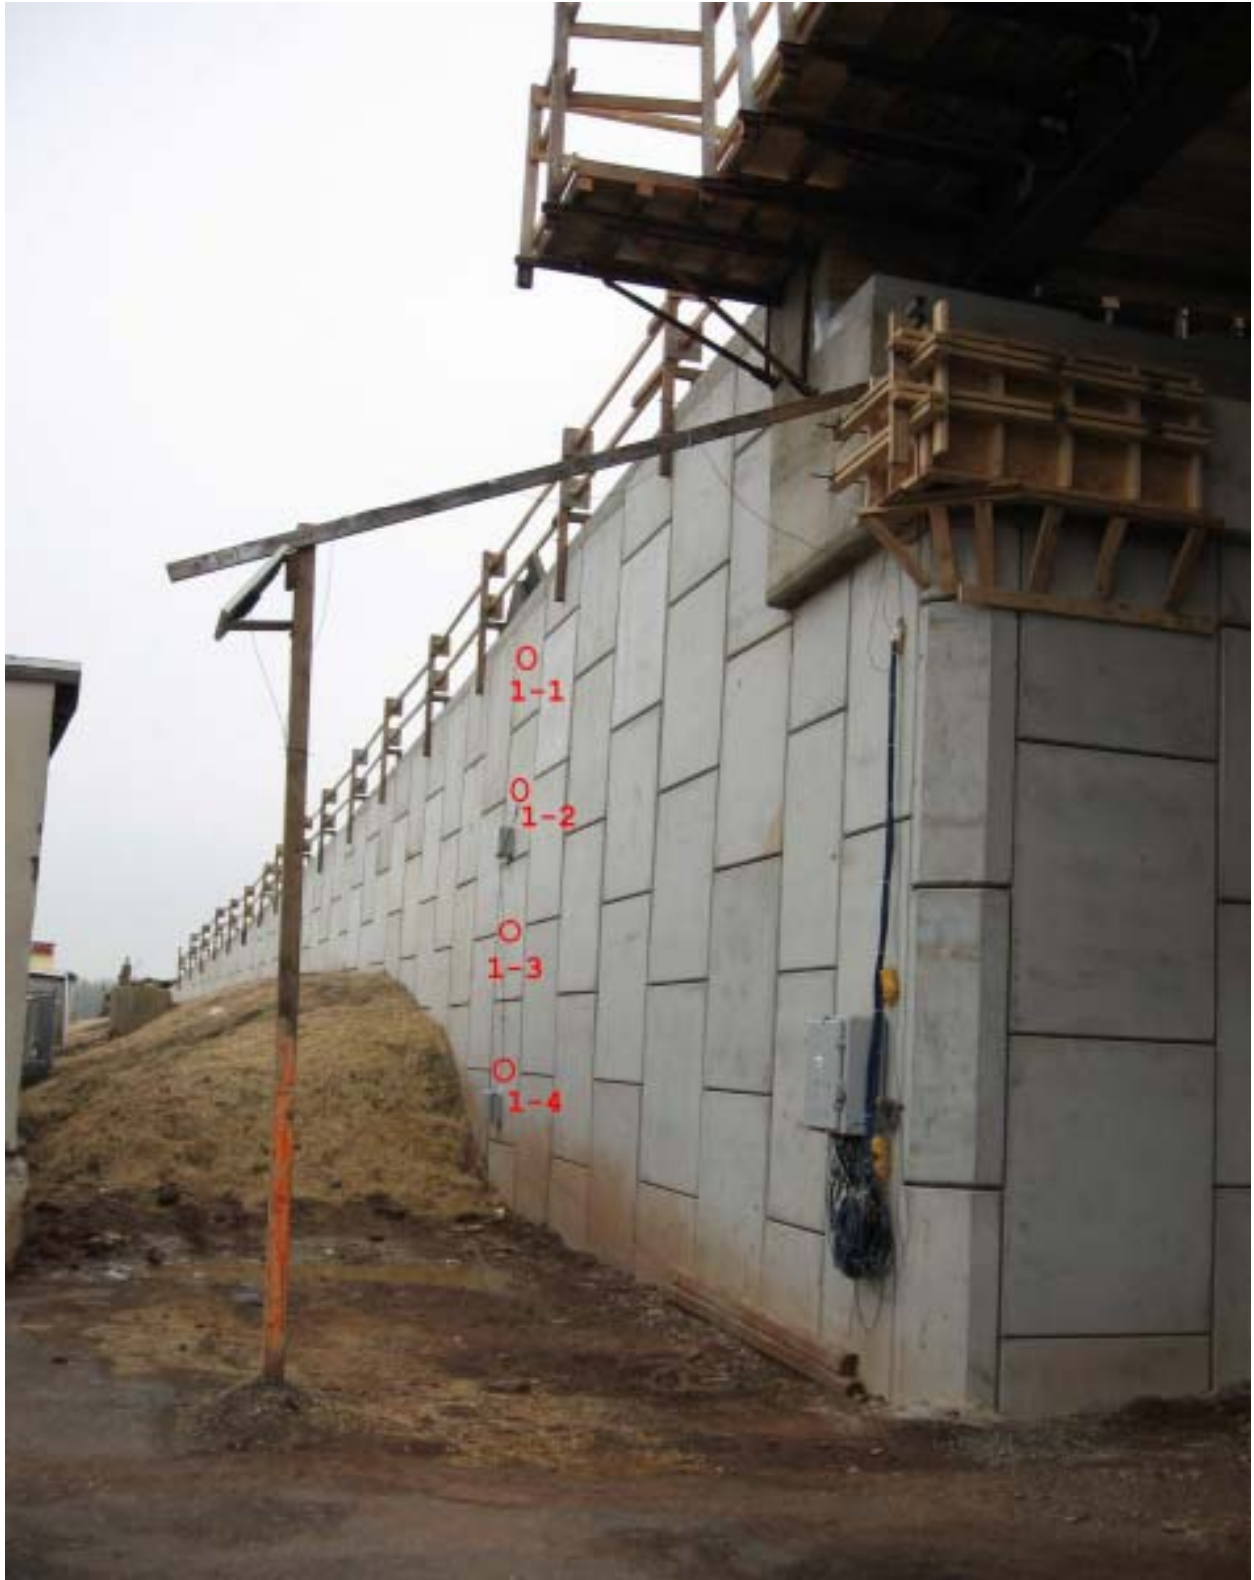
Figure 35. Wall 1 Survey Point Locations

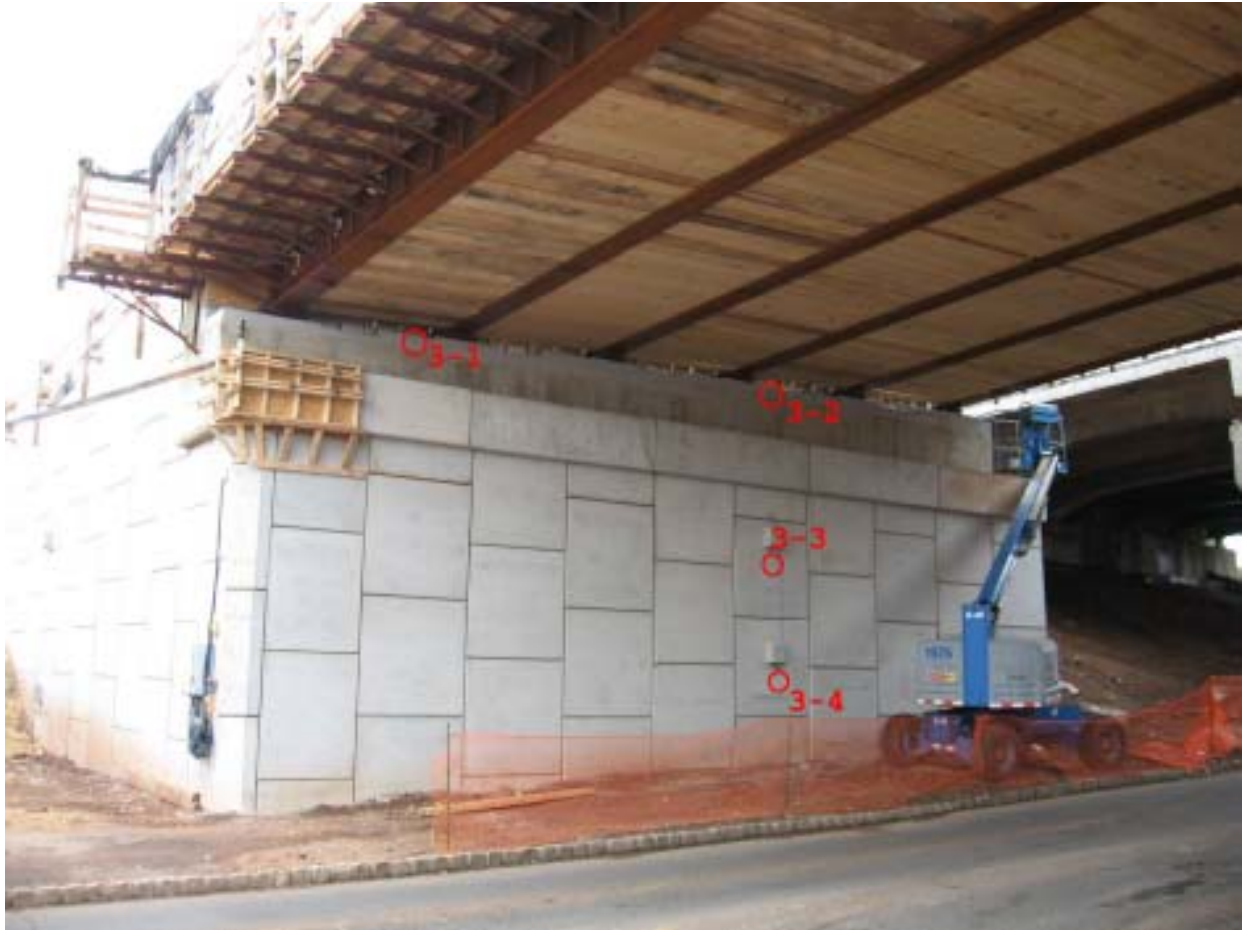
Figure 36. Wall 3 Survey Point Locations
