STATE OF NEW JERSEY
DEPARTMENT OF TRANSPORTATION

Scoping & Design – Project Level Data Collection & Analysis

By Robert J. Blight

Pavement Management & Technology

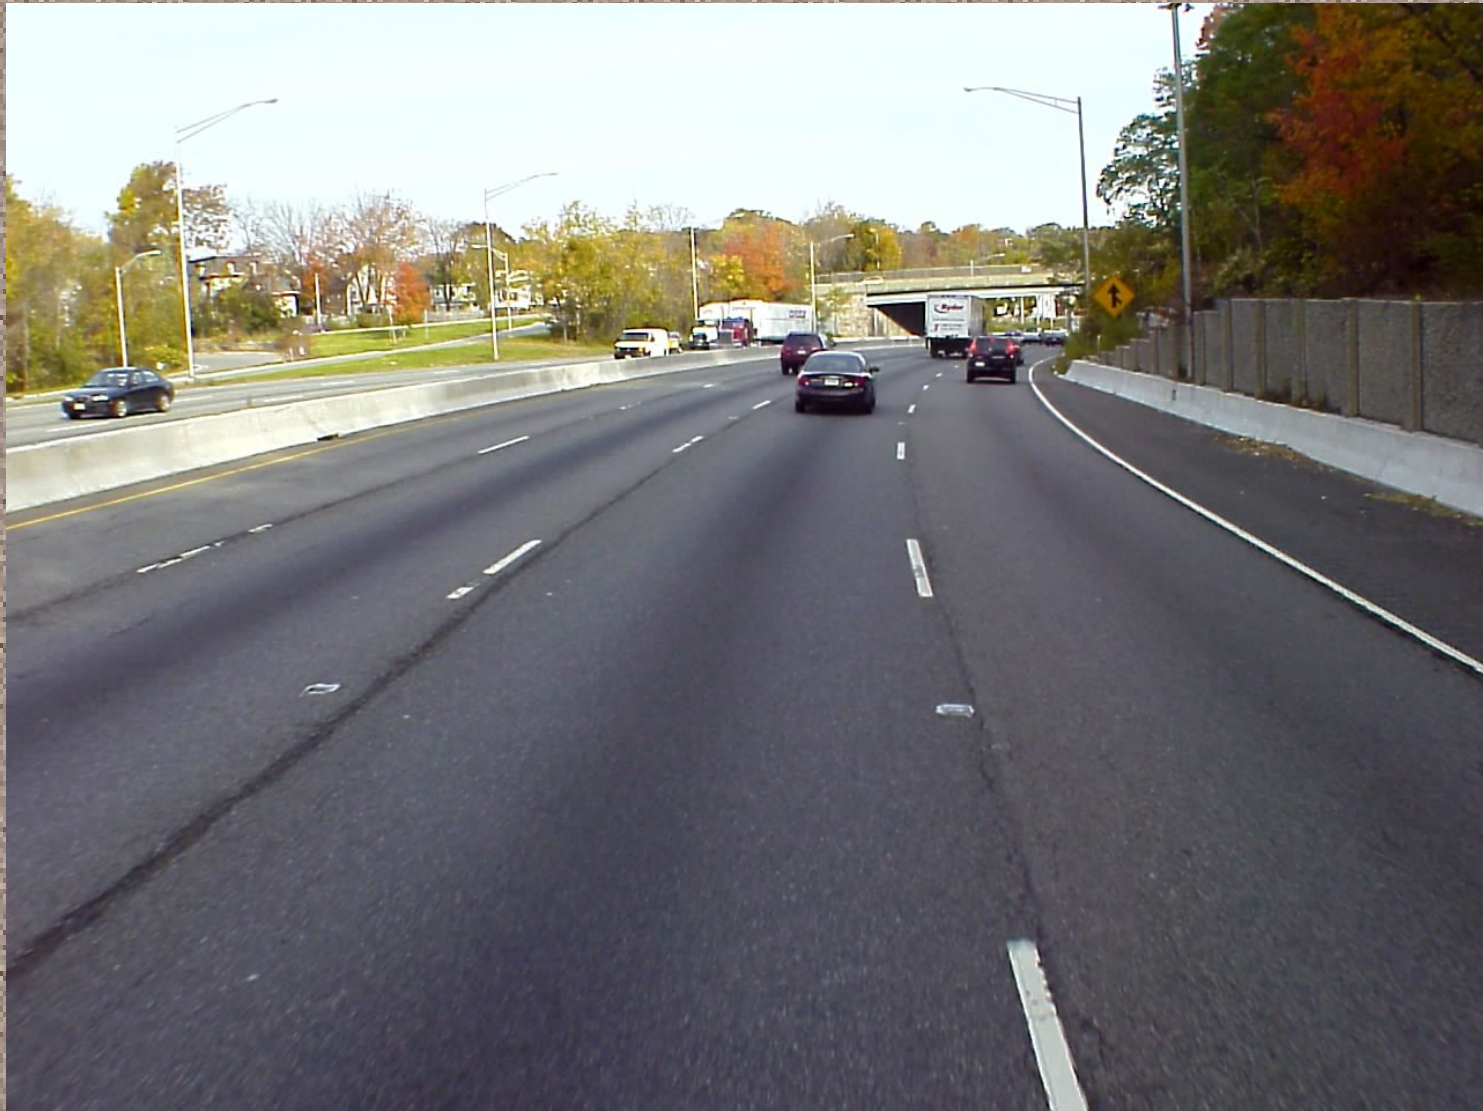
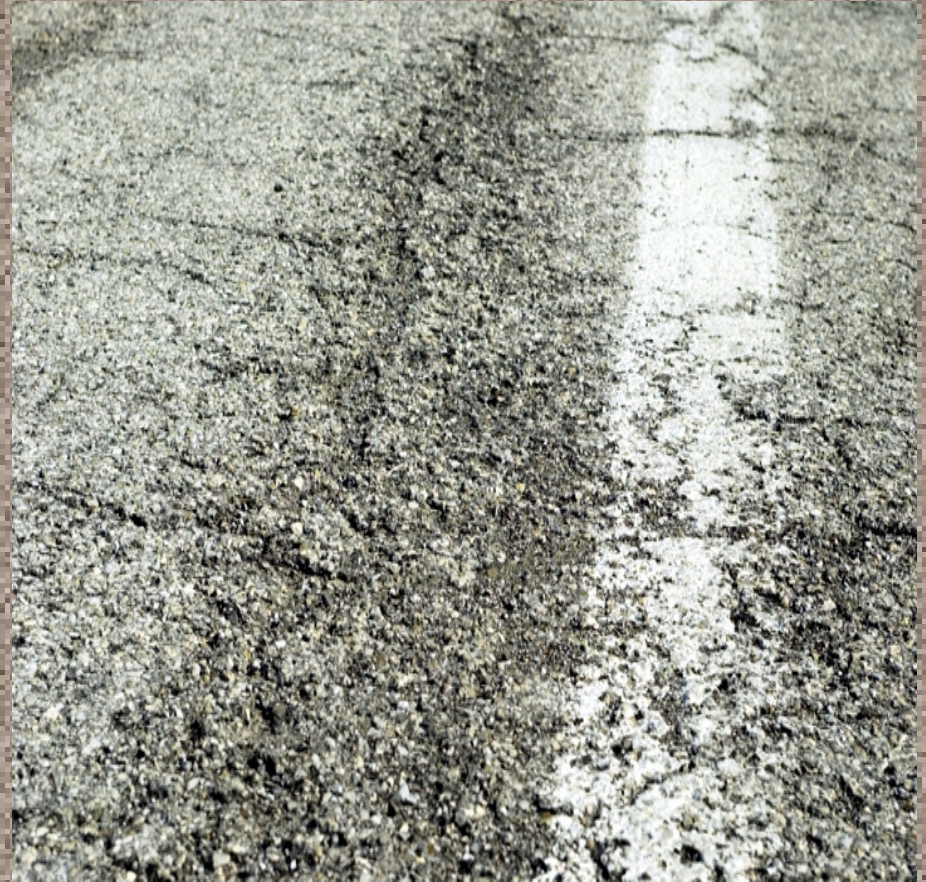
Raveling

- Improper compaction
- Lack of density
- High fines in mix
- Low asphalt content
- Oxidized asphalt

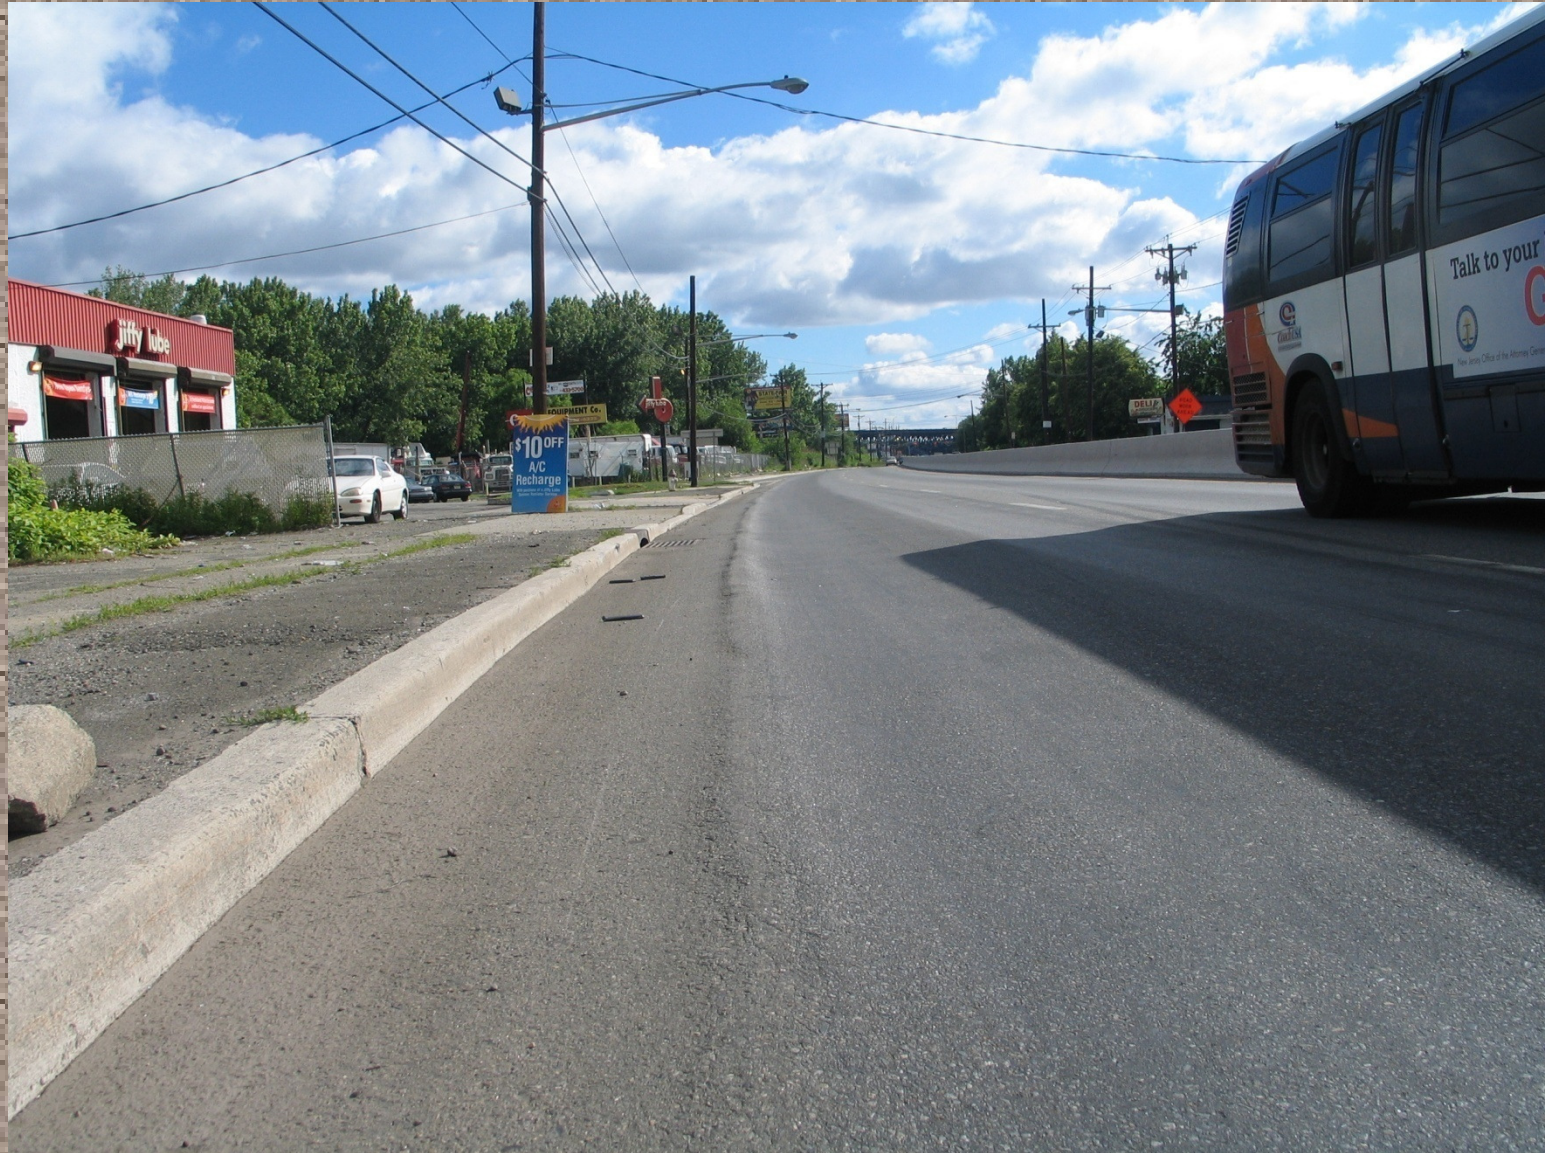
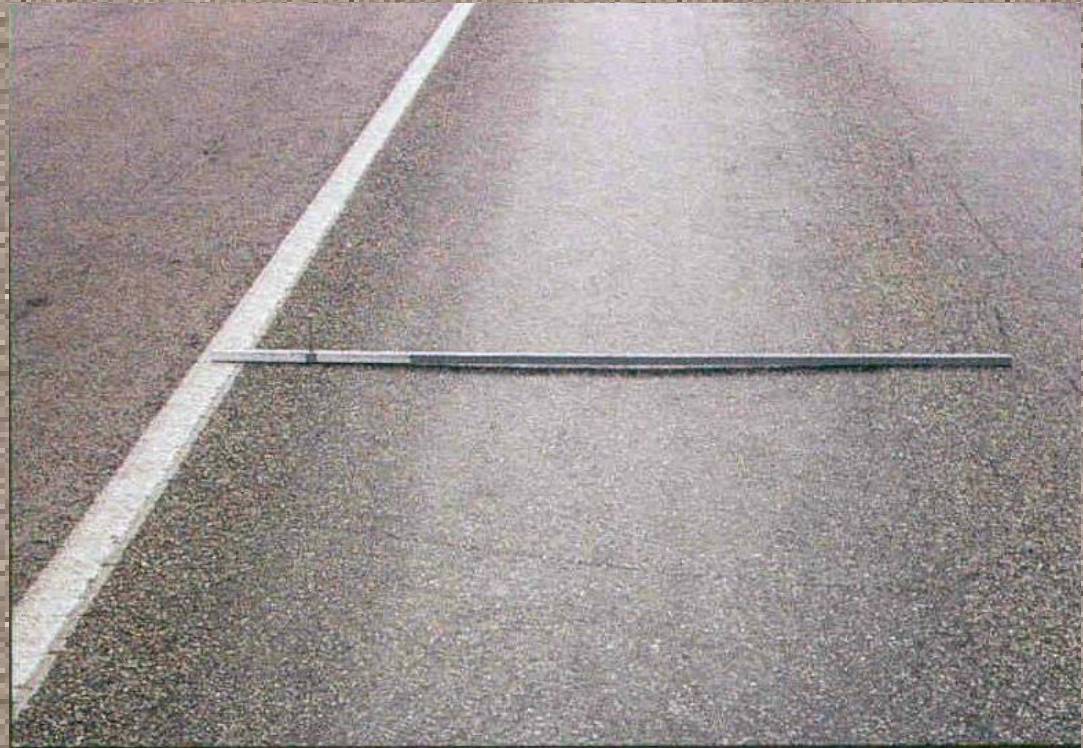
Rutting

- Poor compaction
- Improper density
- Lateral movement of the asphalt layers
- Weak subgrade

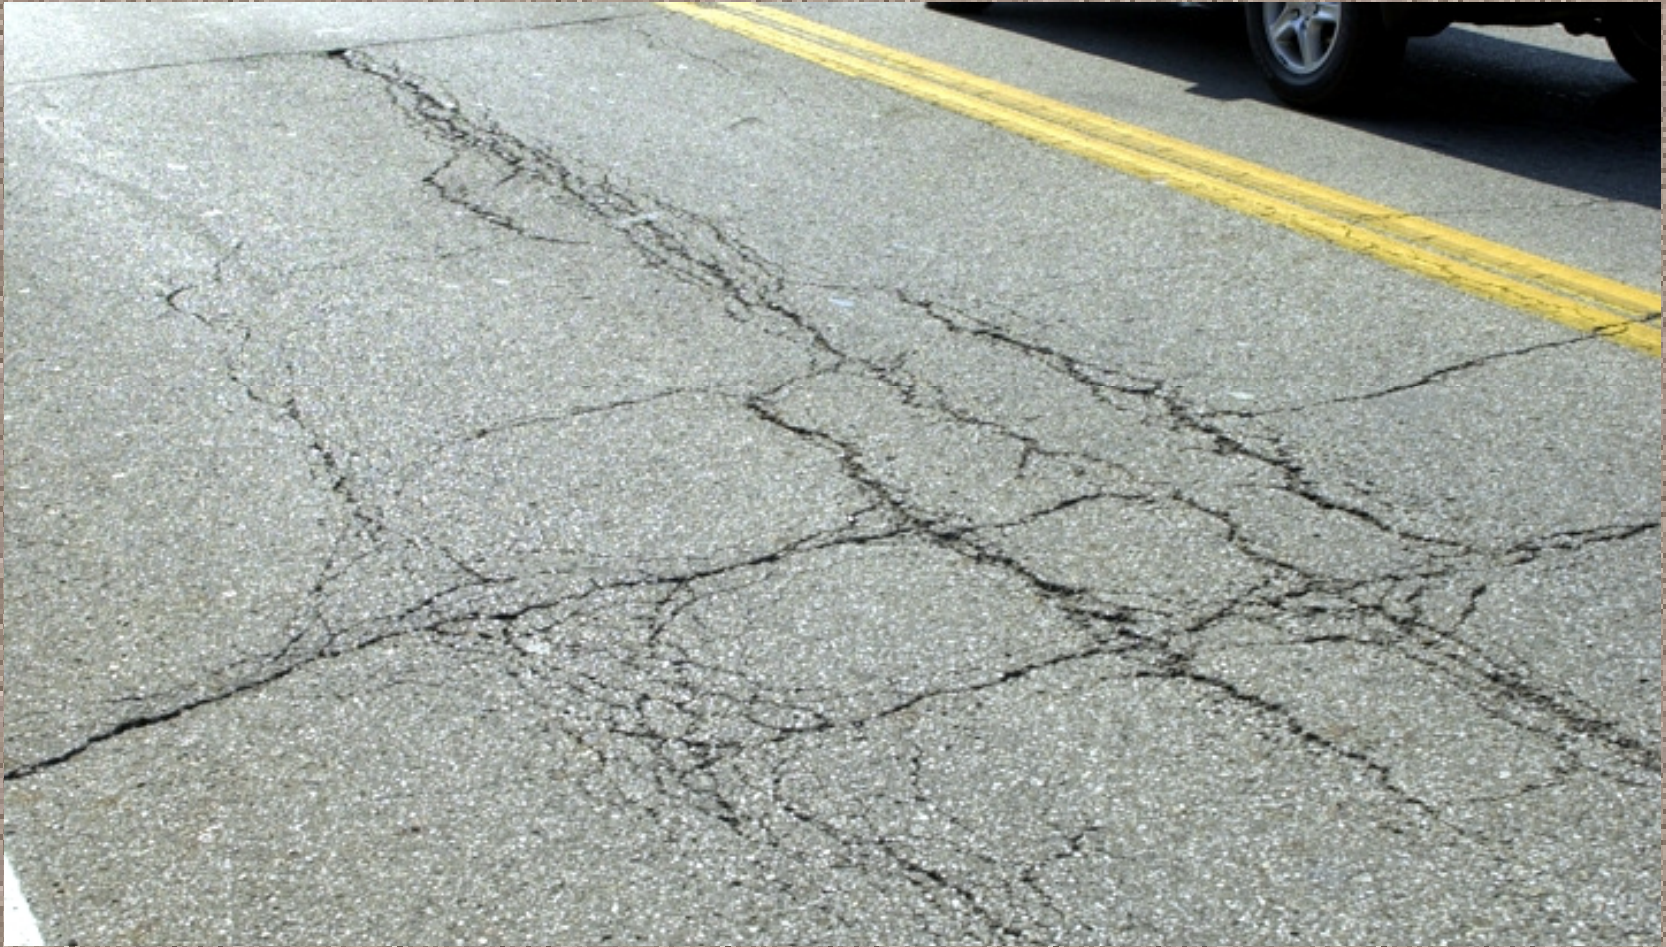
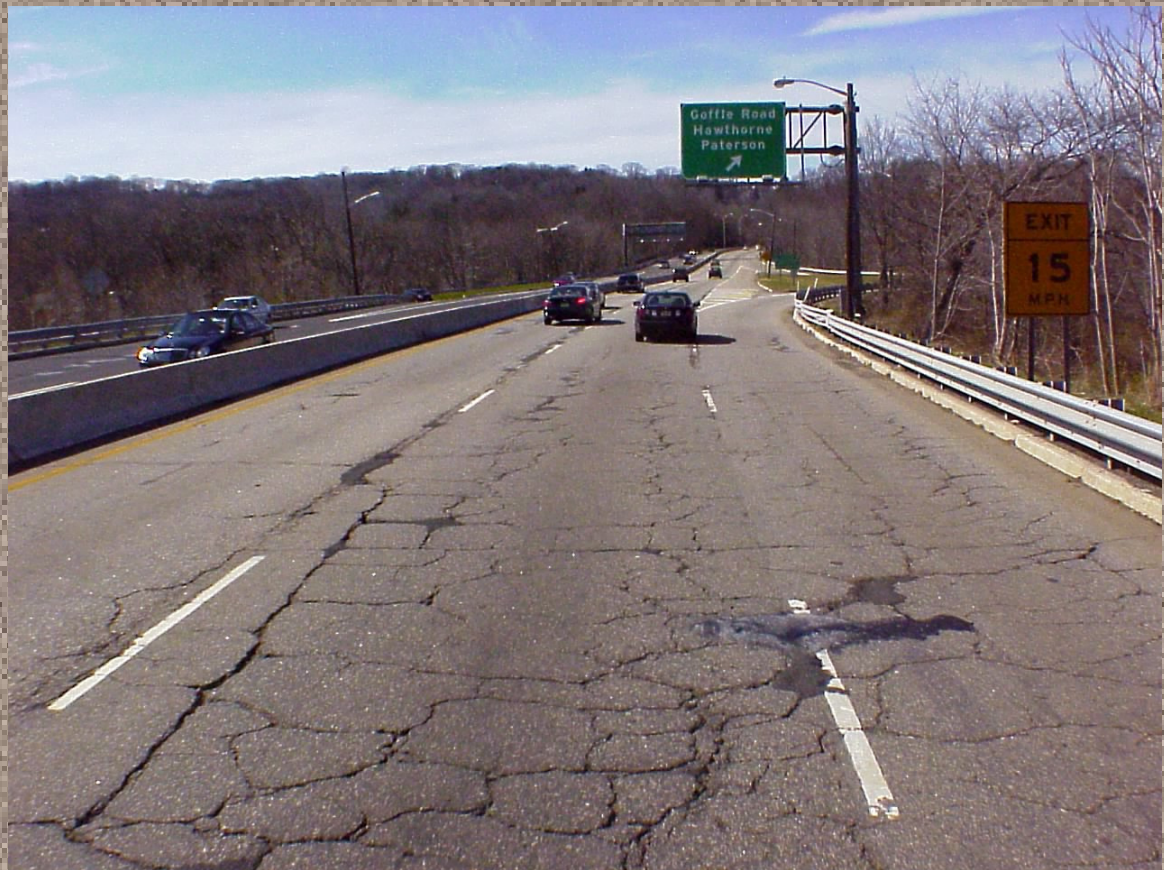
Block Cracking

- Materials (PG grade of binder)
- Climate (frost action)
- Construction (poor subbase or embankment)
- Traffic load (heavy trucks)

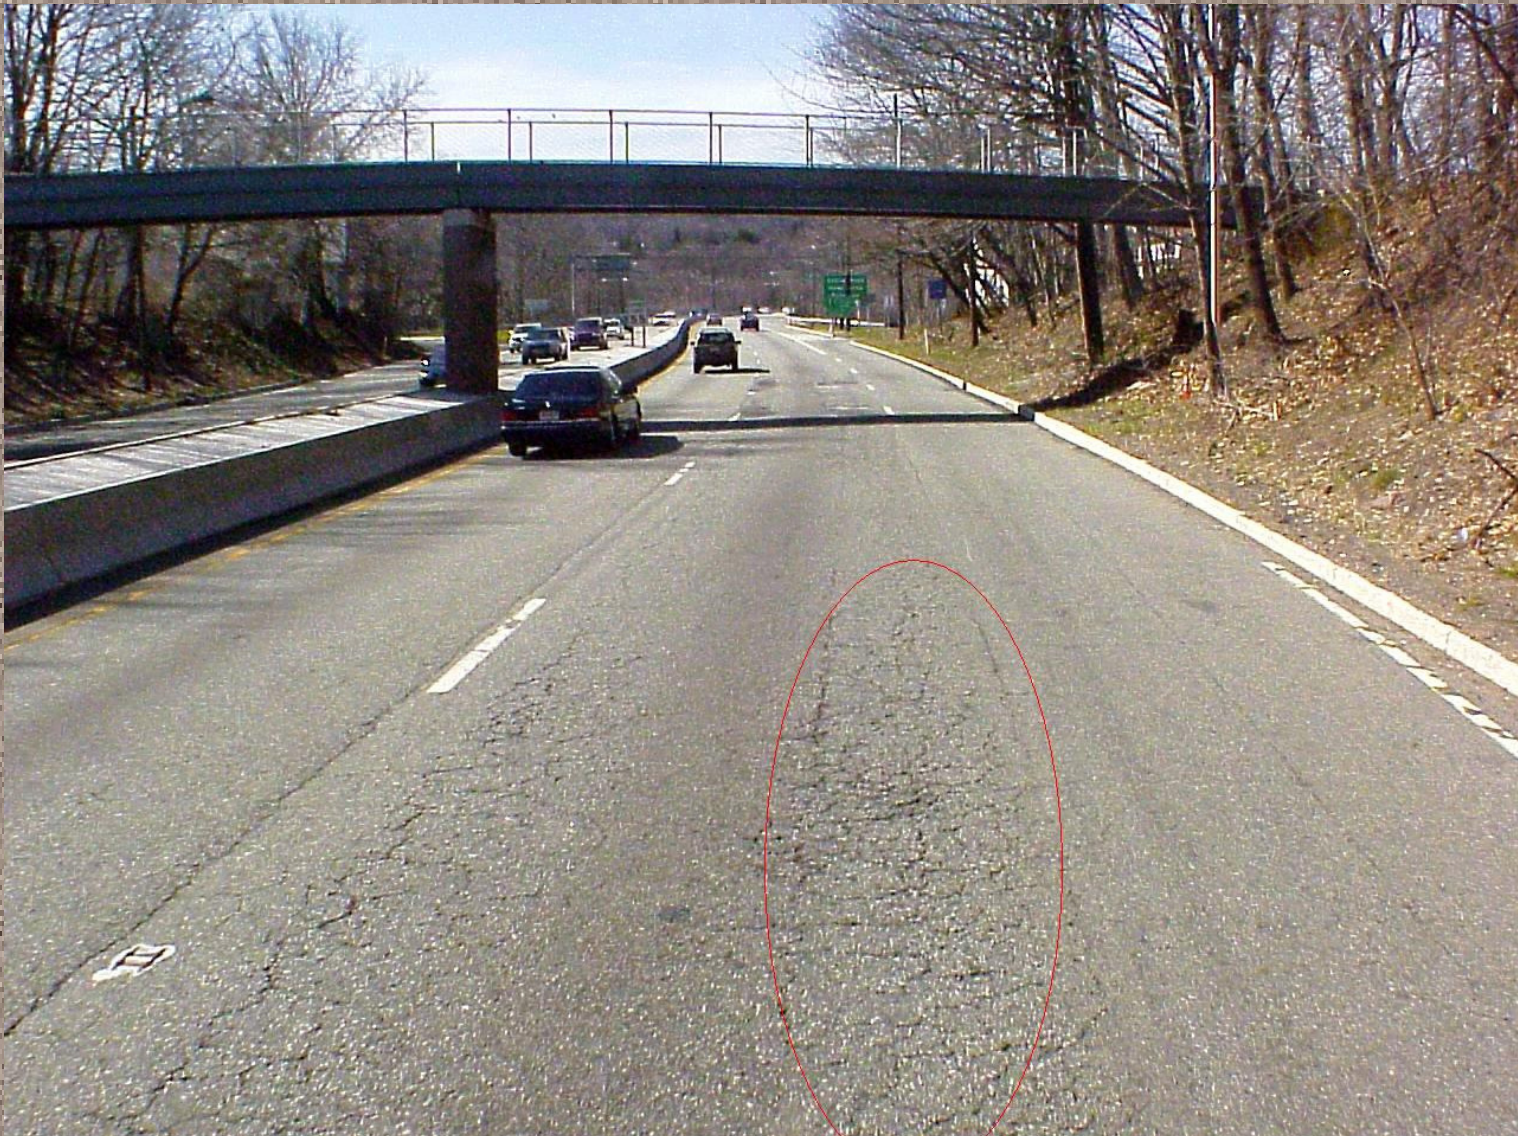
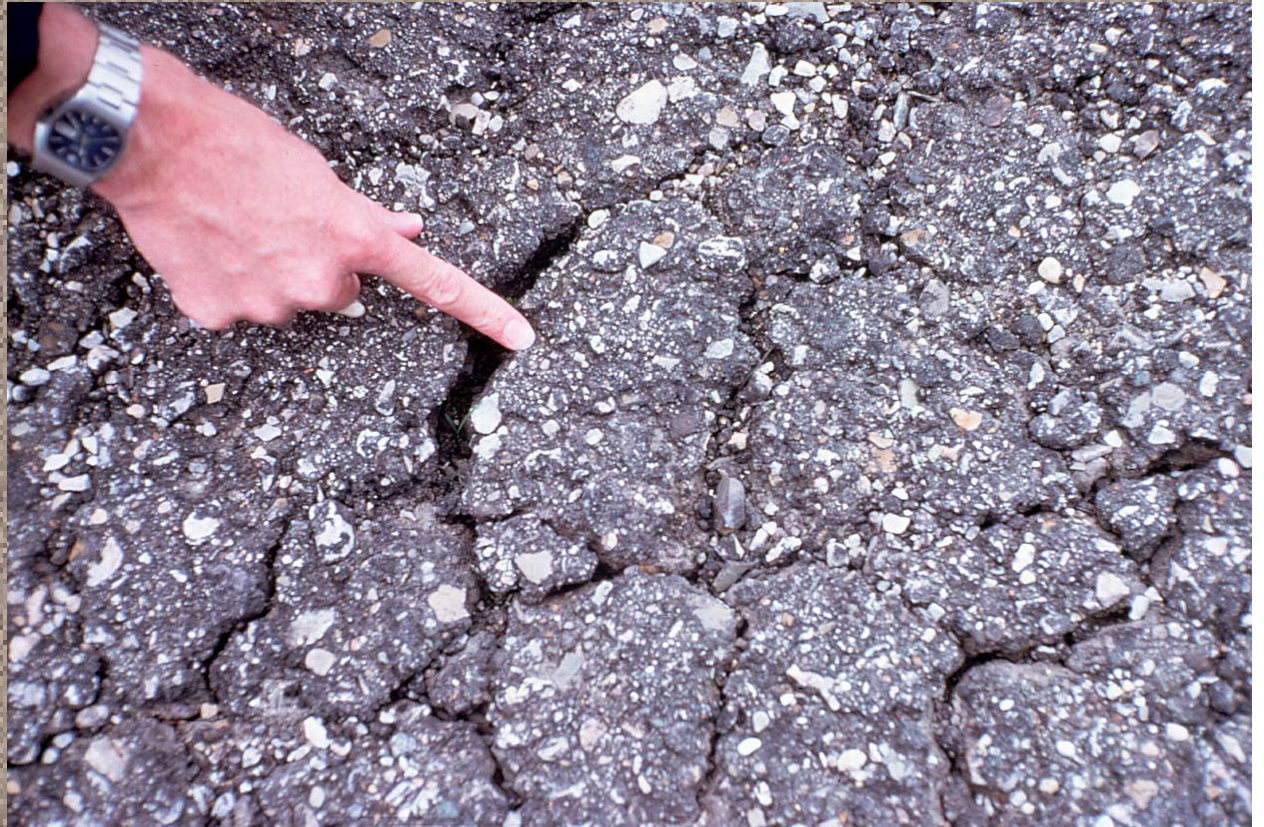
Wheel Path Fatigue Cracking

- Traffic Load
- Structurally deficient

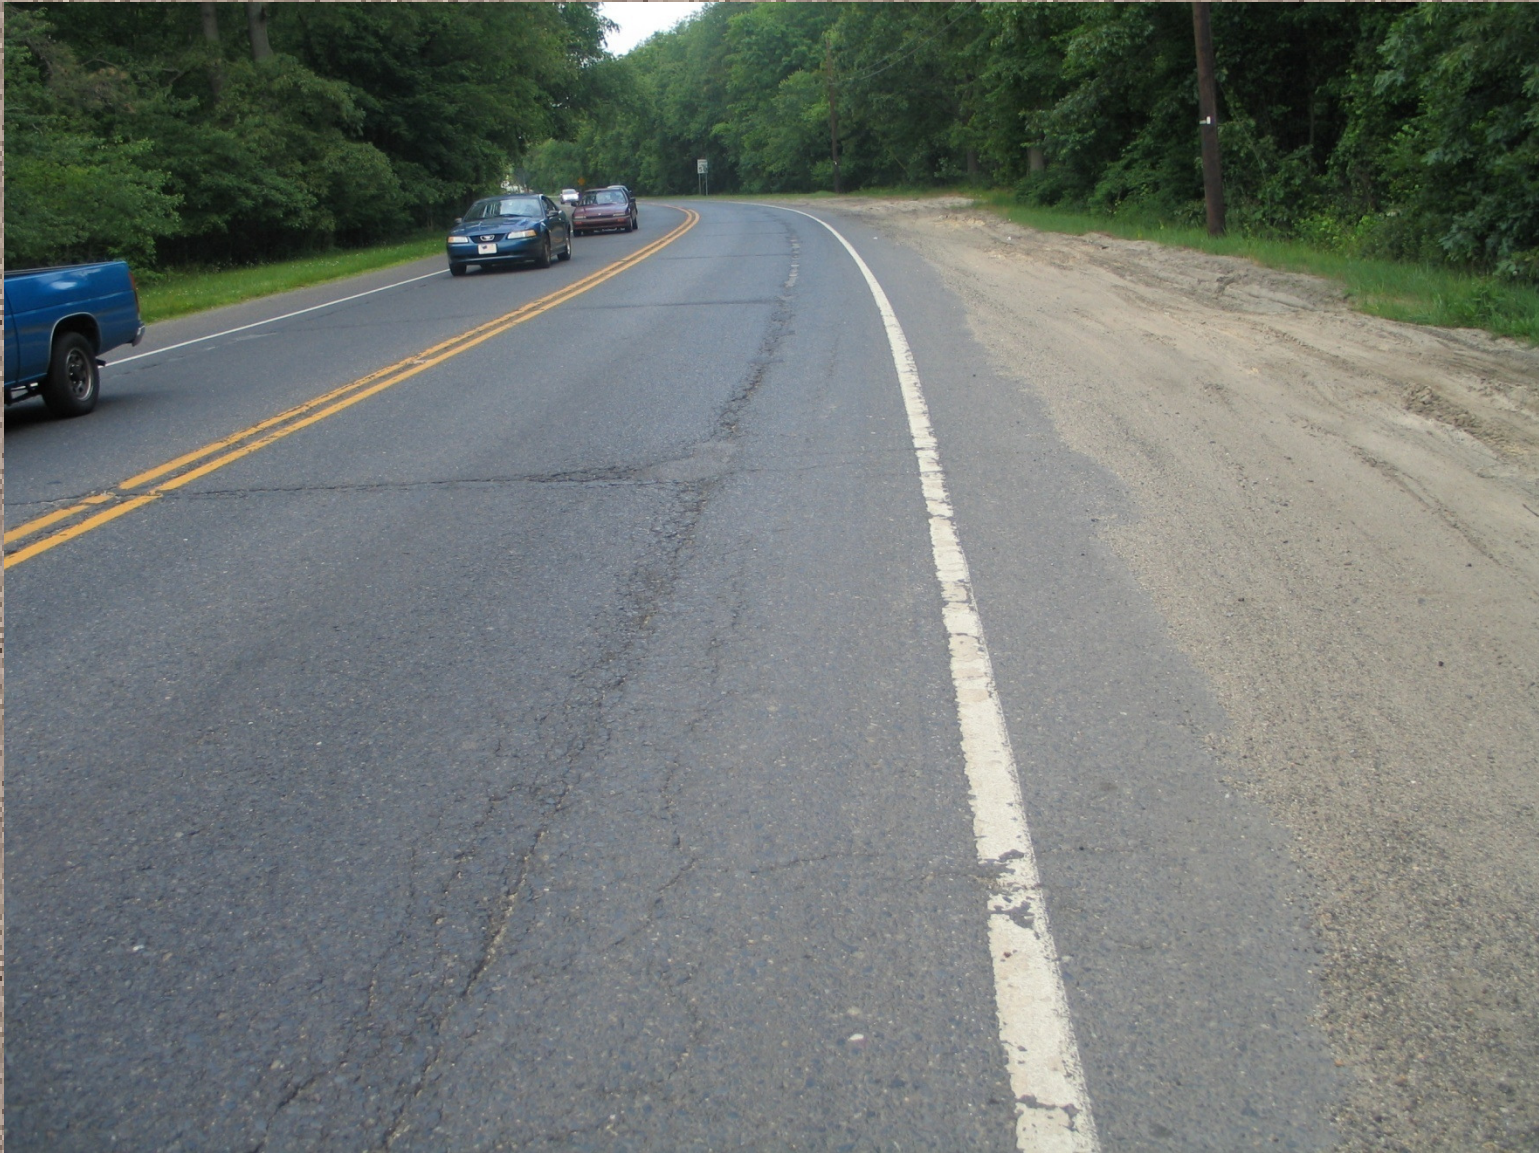
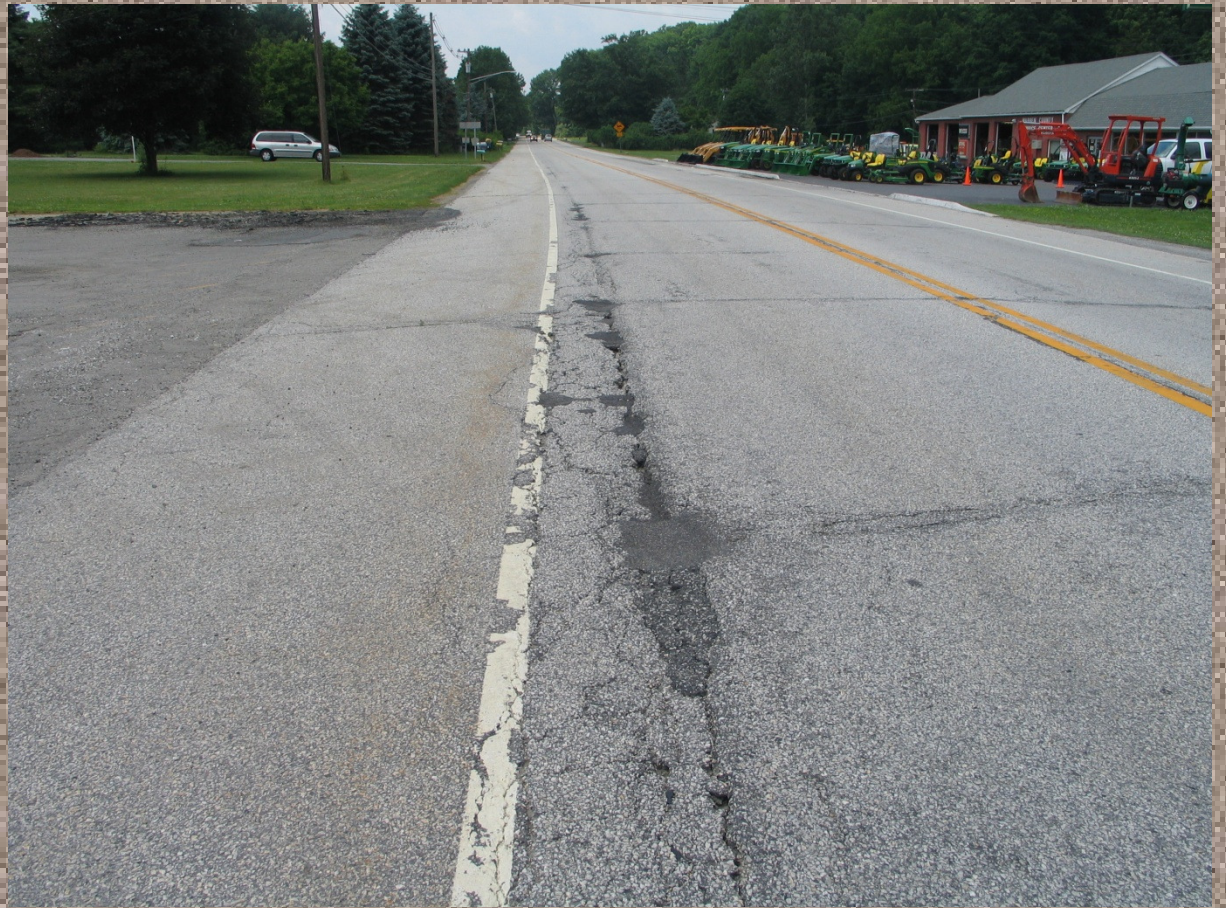
Reflective Cracking

- Load
- Materials
- Climate
- Construction

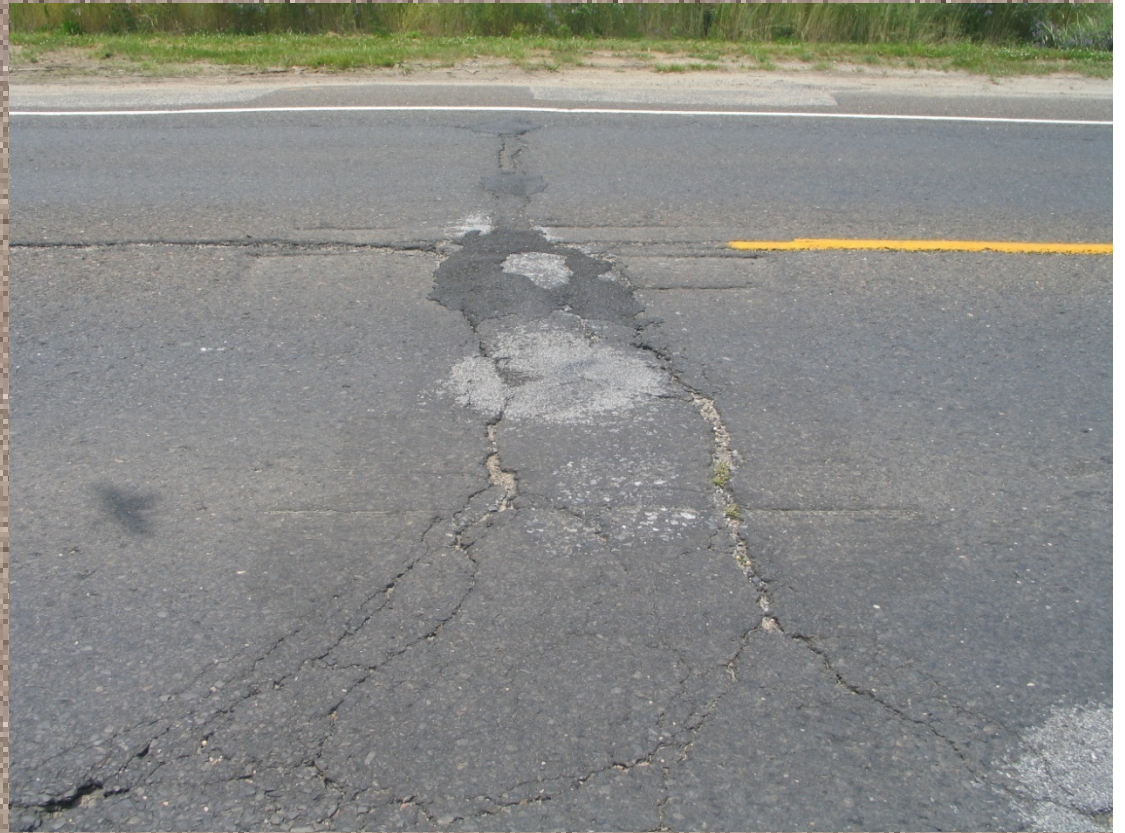
Reflective Cracking

- Joint Repair

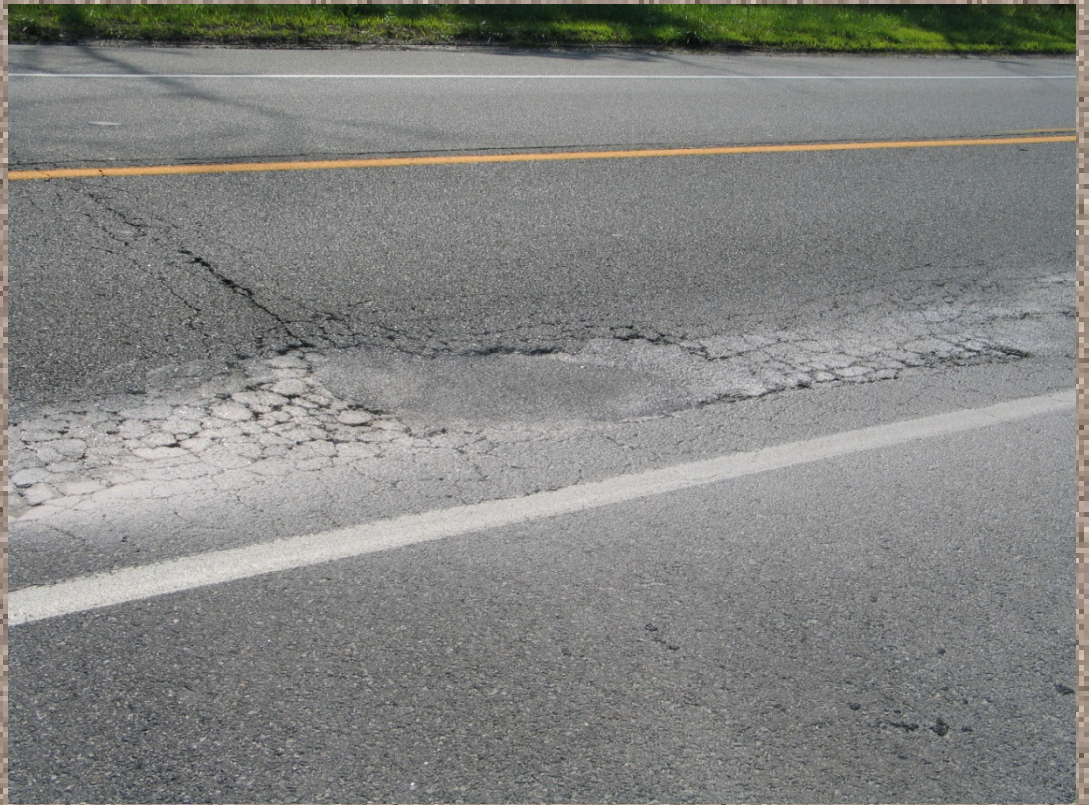
Disintegrating Concrete

- Poorly compacted asphalt
- High voids (not enough AC binder)
- Water intrusion (cracks or pores)
- Deicing chemicals
- Traffic load

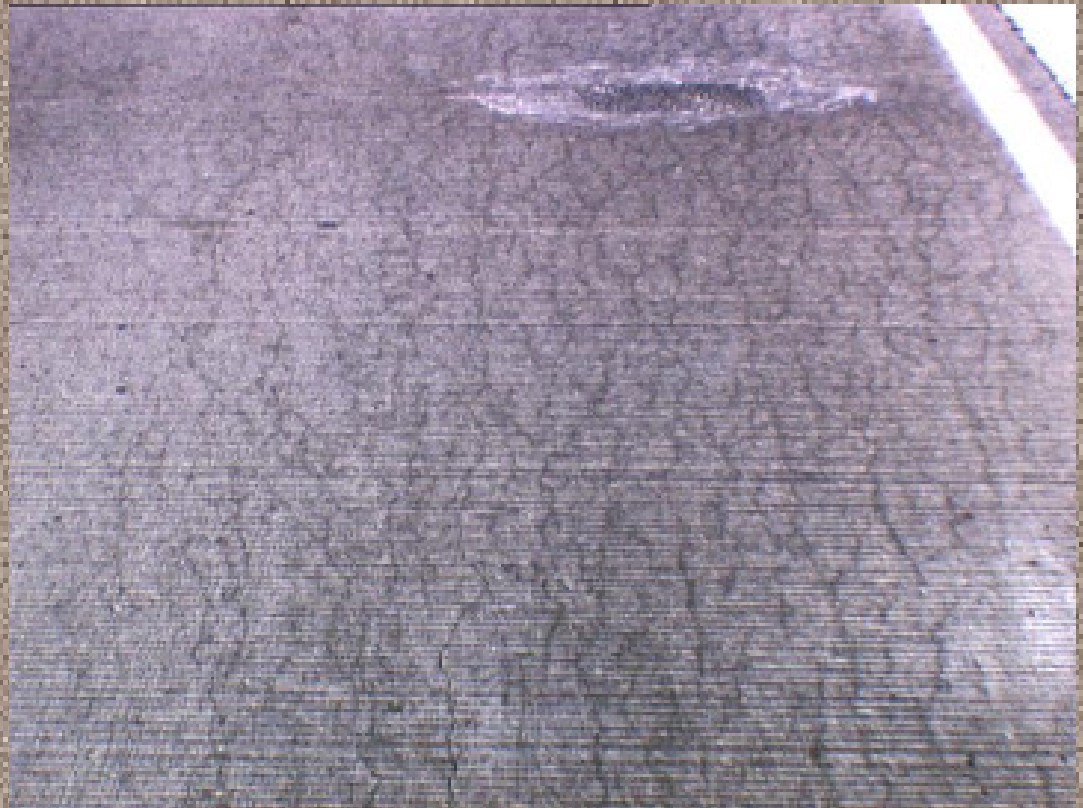
Alkali-Silica Reacting Concrete

- Disintegrating Concrete
- Caused by reaction between aggregate, cement paste and water

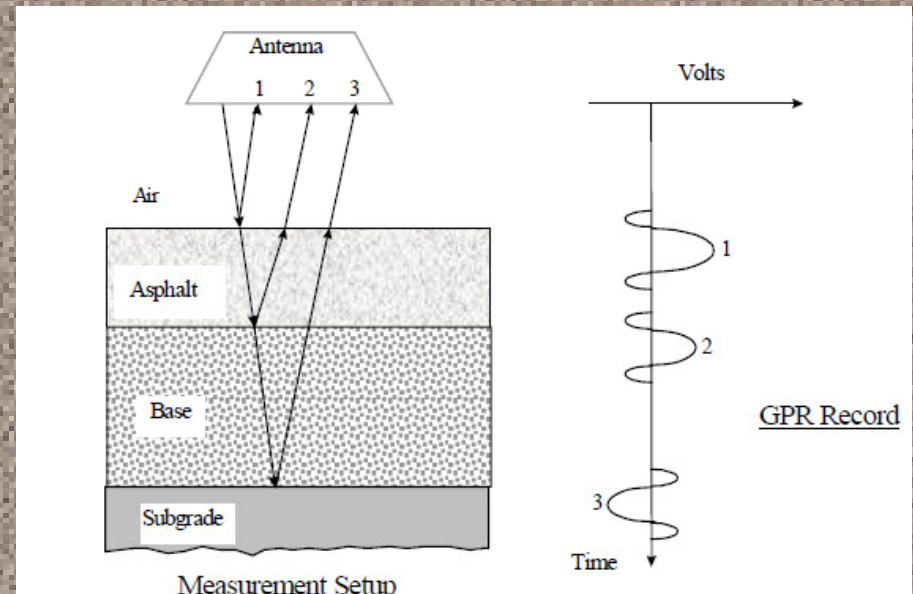
How GPR Works

- Antenna sends electromagnetic pulses
- Pulses reflect back with amplitudes and arrival times
- Measured data relates to dielectric constants
- Verified /calibrated with core samples

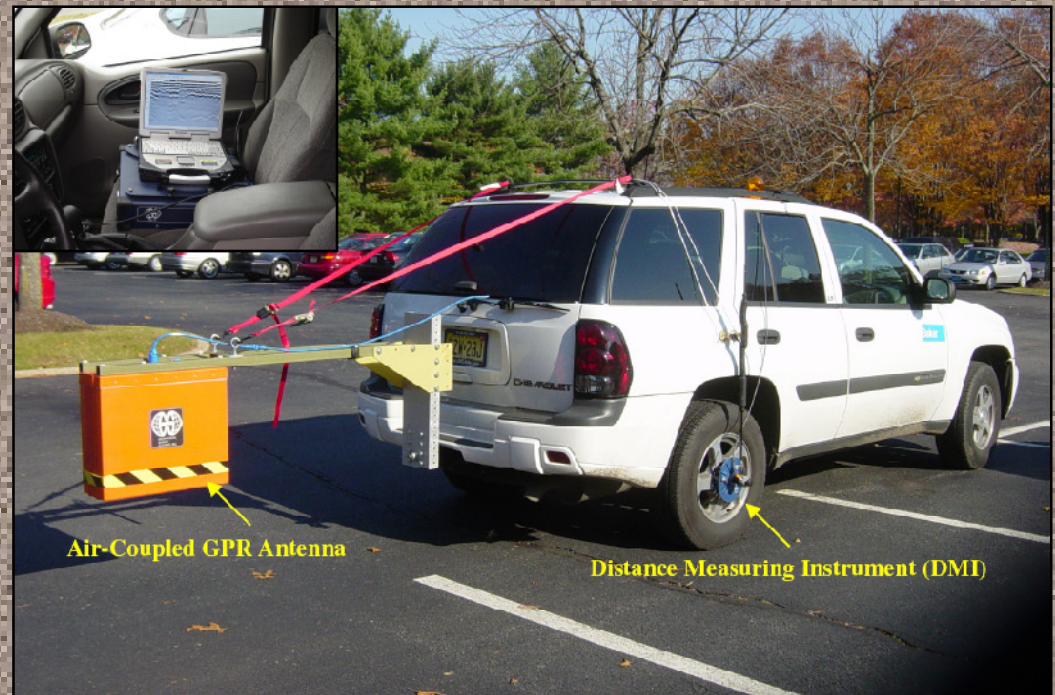
What GPR gives you

- Layer Material
- Continuous Layer Thickness
- Void detection (large)
- Anomalies that need further investigation

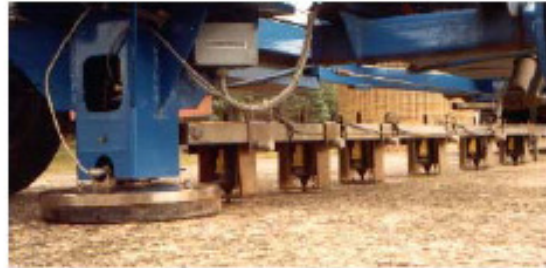
Figure 9.22: FWD Impulse Loading Mechanism (foreground) and Sensors (background)

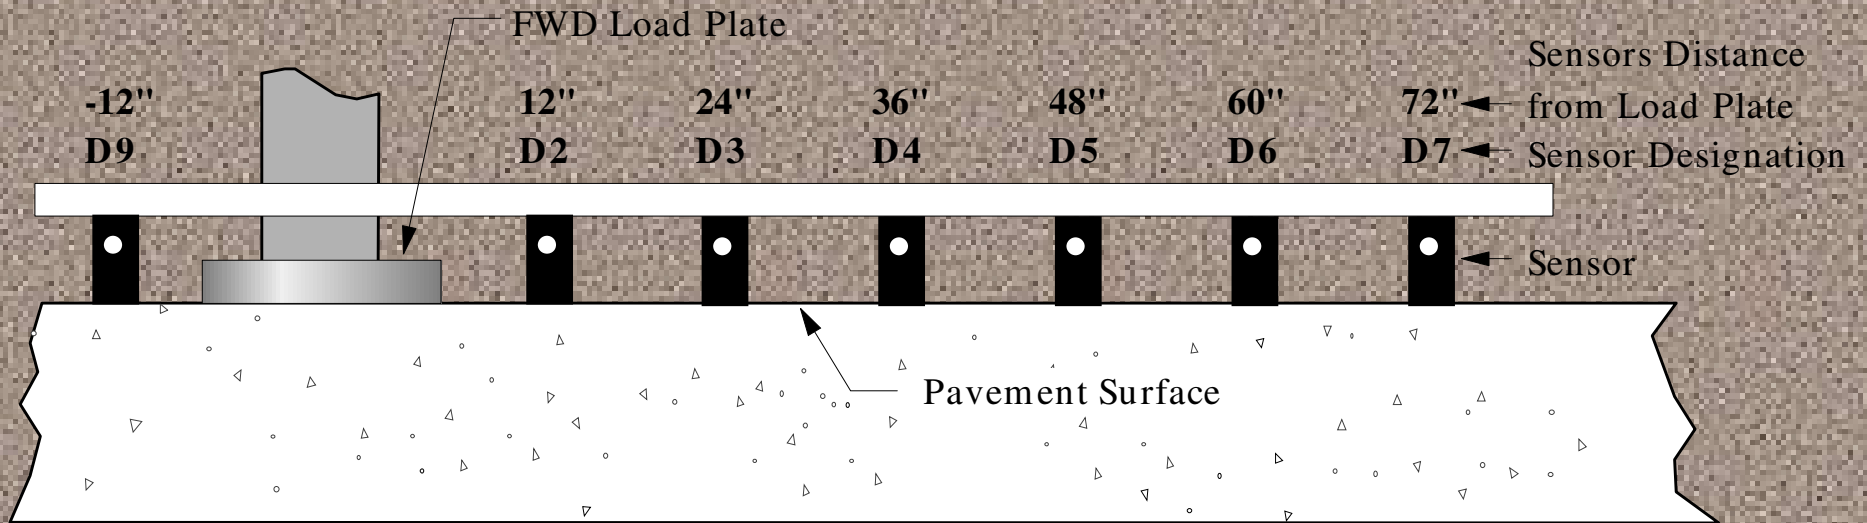
Typical FWD Load Plate and Geophone(s) Set-up

Note: Sensor D8 is located 12 inches to the right of the load plate.

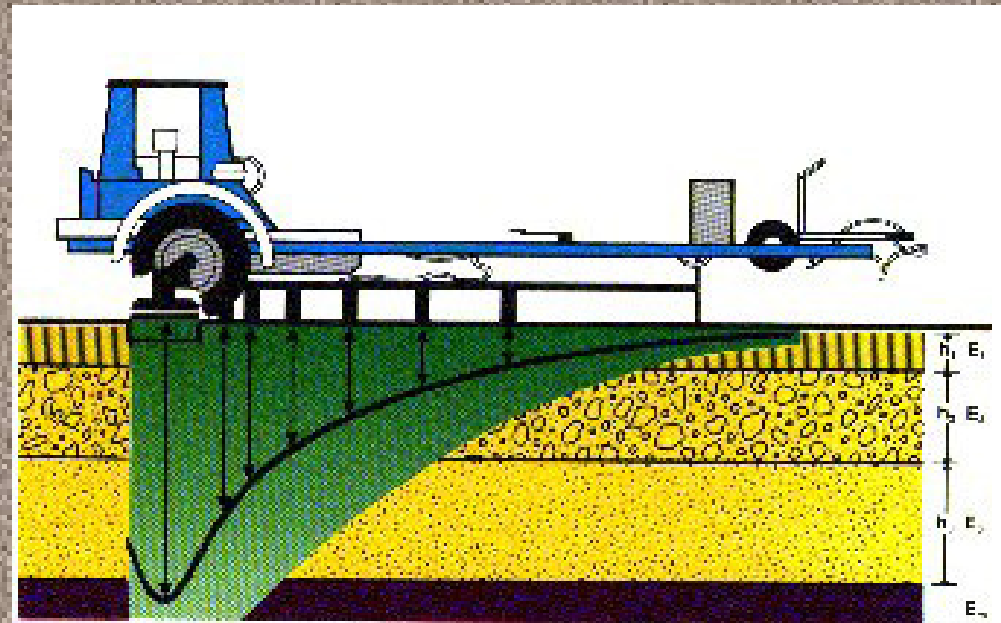
How FWD Works

- FWD is an impulse deflection device
- Lift weight to given height and drops
- Weight strikes specially designed plate and transmits impulse force to the pavement
- Pavement deflections are measured

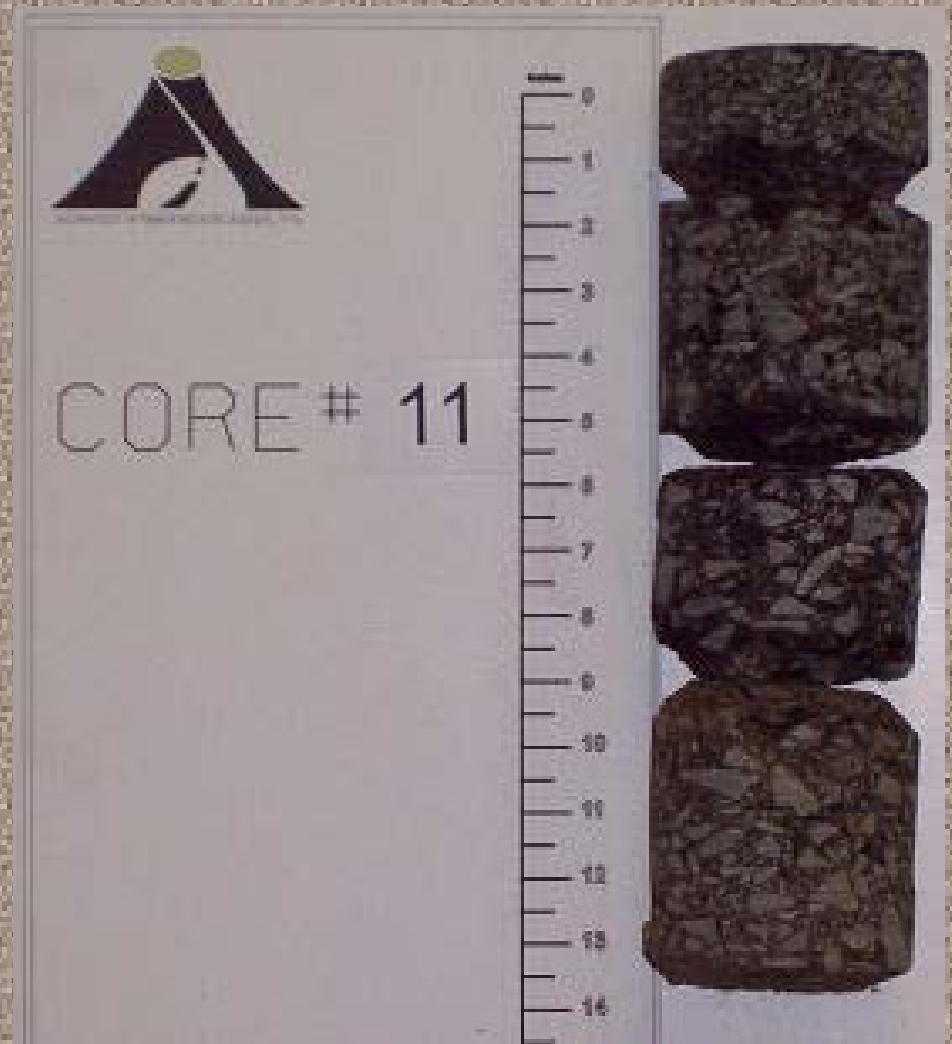
Coring

- Thickness
- Material determination
- Crack depth
- Debonding of layers
- Stripping
- Rutting
- Samples for testing

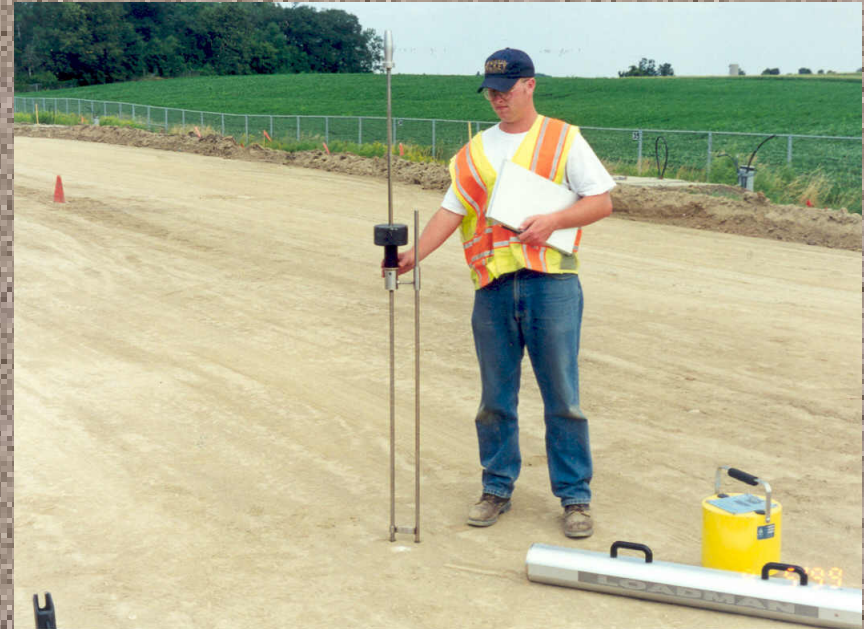
DCP

- Unbound layer strength
- Changes in unbound layers
