IN THE MATTER OF THE JUNE 23, 2015 BOW ECHO)	ORDER ACCEPTING
WEATHER EVENT: REVIEW OF THE RESPONSE)	STAFF'S REPORT
AND RESTORATION OF ELECTRIC UTILITY)	REQUIRING ELECTRIC
OUTAGES)	UTILITIES TO IMPLEMENT
)	RECOMMENDATIONS
)	
)	DOCKET NO. EO15080984

**June 23, 2015 “Bow Echo” Weather Event:
Report and Recommendations on the Response and
Restoration of Electric Utility Outages**

Division of Reliability and Security
August 26, 2015

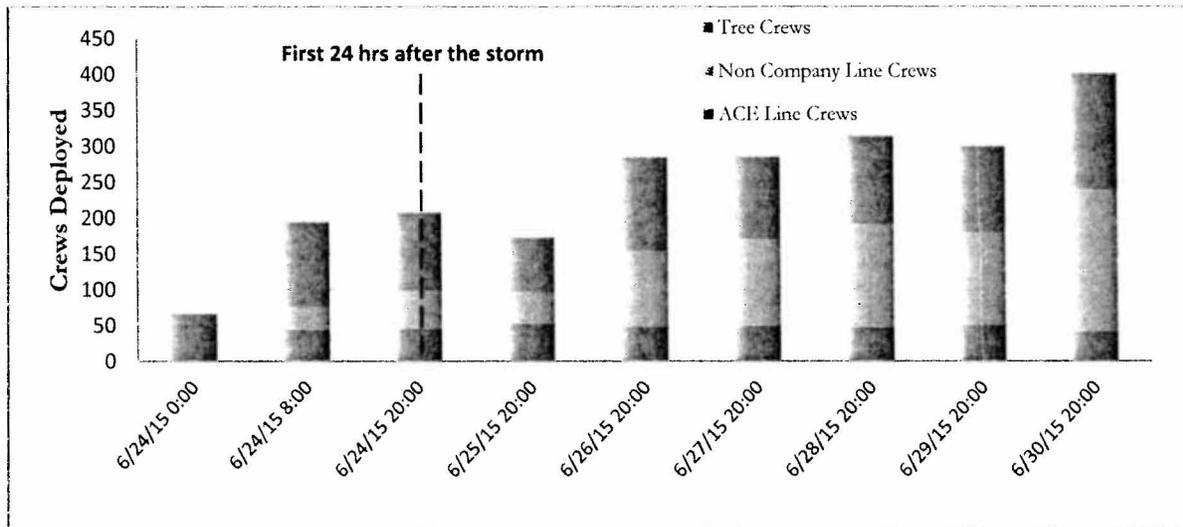
Figure 1: Workforce Deployment – total crews deployed through 6/30/15

ACE's service territory is divided into four separate operating districts: Cape May, Glassboro, Pleasantville and Winslow. While Cape May experienced minimal damage from the storm, each district was impacted by the weather event. ACE began deploying additional company crews to each of the four districts at 12:00 a.m. on June 24, 2015. Within 24 hours after the storm passed, the workforce deployed by ACE increased from 125 FTEs (Full Time Equivalent) to over 800 FTEs⁴. That number eventually grew to over 1,600 FTEs by Sunday June 28th.

The following graph illustrates the workforce deployment throughout the restoration process.

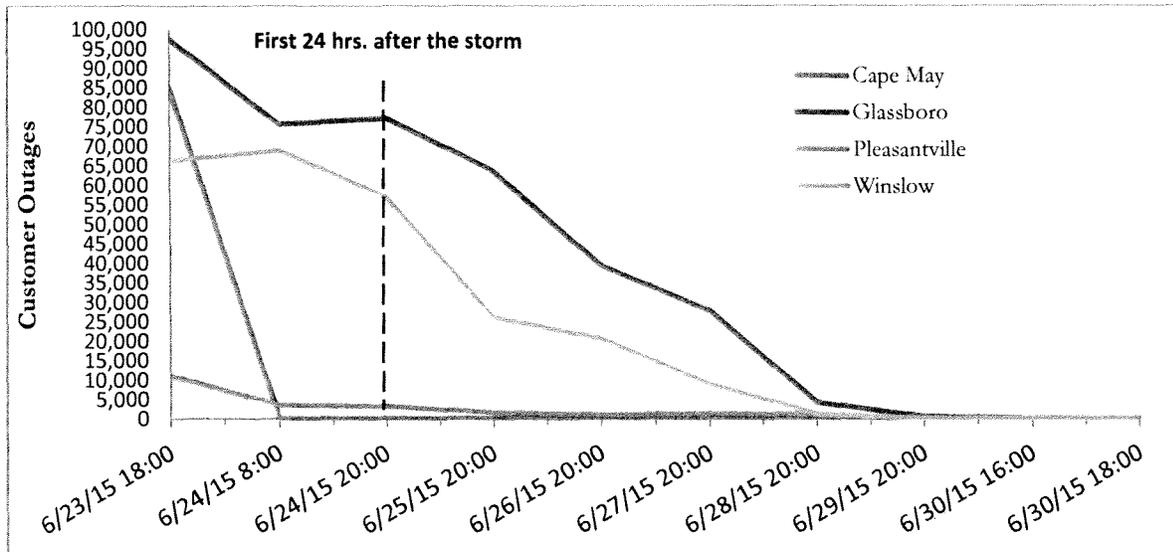
Figure 2: Restoration Timeline through 6:00 PM on 6/30/15

Soon after the storm passed, ACE was able to deploy significant resources quickly and effectively, reducing the number of outages in the first 4 days of restoration from a peak of over 259,000 to fewer than 40,000. However, on Saturday June 27th, heavy rains and high winds hampered the restoration process, knocking out power to an additional 16,000 customer. Full restoration of all customers was completed on Tuesday afternoon June 30th.

The following graph illustrates ACE's restoration timeline throughout the restoration process.

At peak, the total number of ACE customers out of service reached 259,372, with the hardest hit areas in the Glassboro and Winslow districts. Within 24 hours after the storm passed, nearly all of the 80,000 plus customer outages in the Cape May district were fully restored. Most of the customers in Cape May lost service initially not because of physical damage to the infrastructure, but as a result of a load shedding condition caused by the instability of the transmission system damaged by the storm. The load shedding was an action directed by PJM Interconnection (PJM) to control for real time transmission overloads. Many of these customers were quickly restored; however, when the system was stabilized and switching could occur.

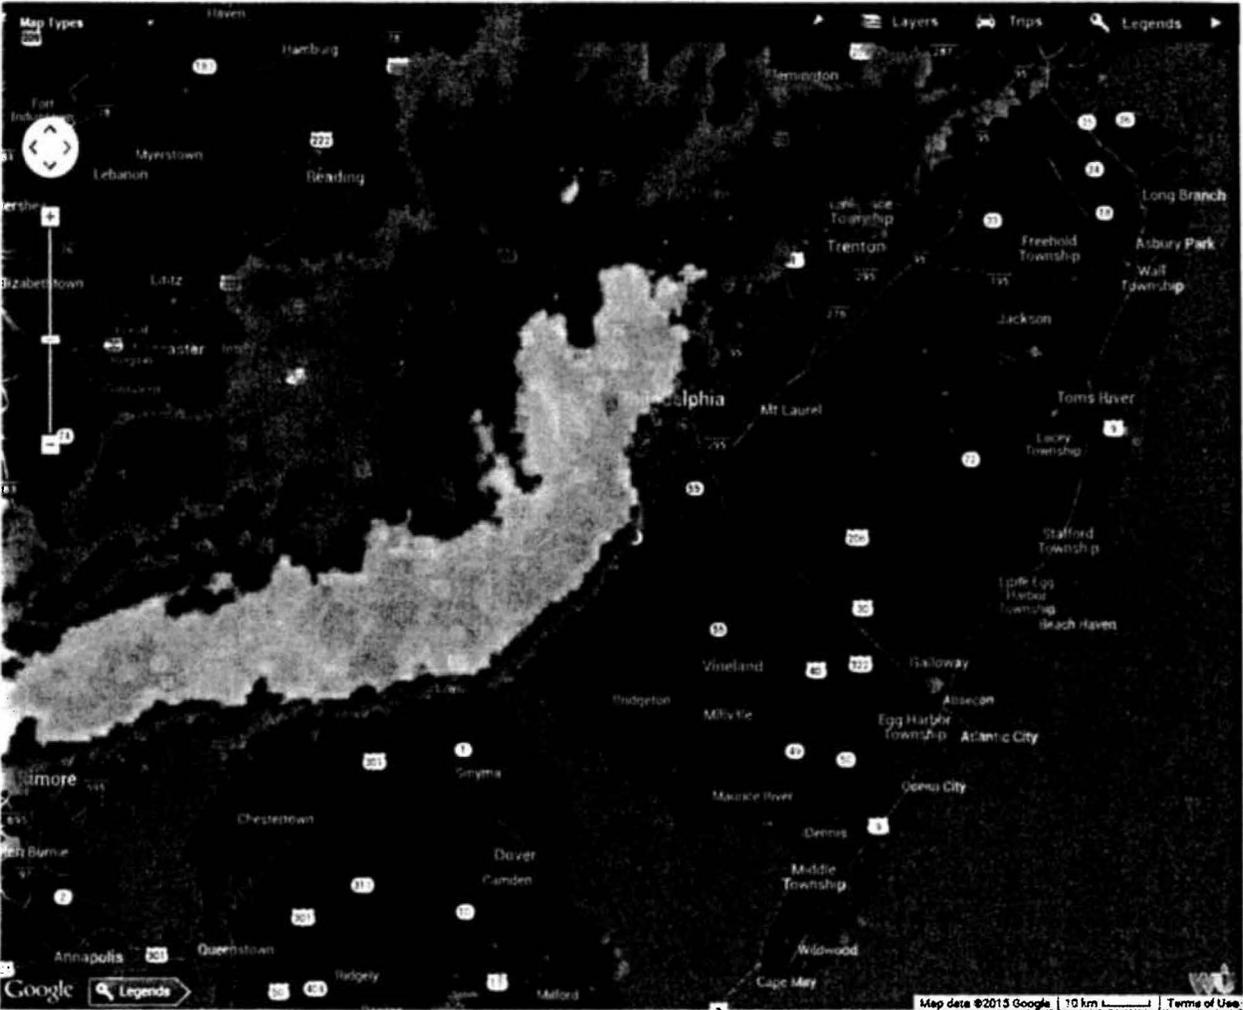
Radar Image: Tuesday, June 23, 2015 6:00 PM (Weather Underground)⁶

Bow Echo Event Radar Imagery

The storm system initially started in Pennsylvania and strengthened as it moved eastward and crossed over the Delaware River. As the storm strength continued to increase a “bow echo” developed, defined by the National Weather Service Office as “a radar echo which is linear but bent outward in a bow shape. Damaging straight-line winds often occur near the “crest” or center of a bow echo.” The center/crest of the bow in this system passed over parts of Gloucester County where the brunt of the storm was felt. The hardest hit areas included East Greenwich, Greenwich, and Wenonah.
