# State of New Jersey

## New Jersey Board of Public Utilities

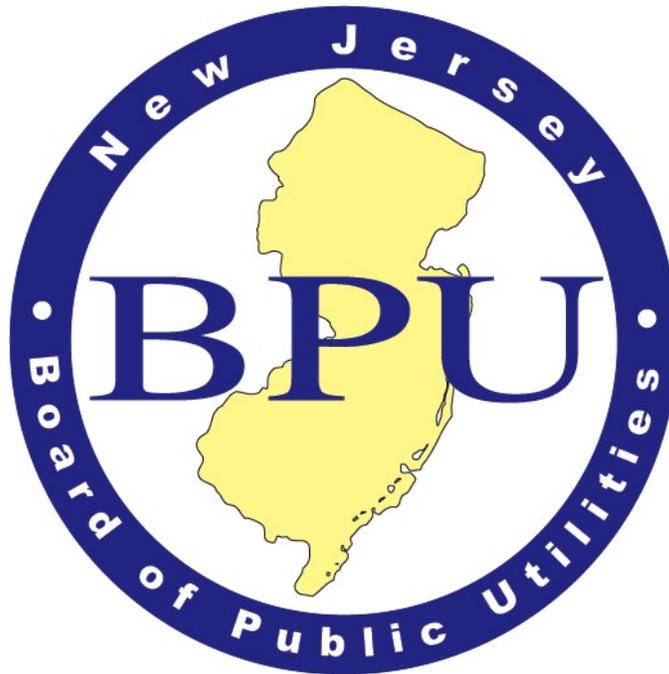
**Staff Report and Recommendations  
on Utility Response and Restoration to Power Outages  
During the Winter Storms of March 2018**

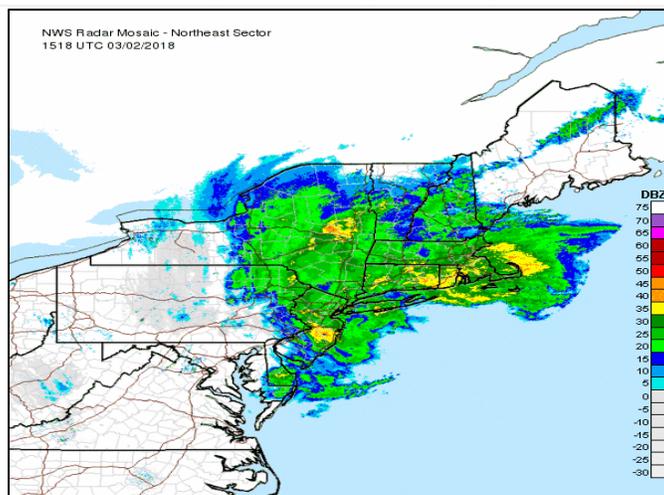
Source: National Weather Service (NWS)

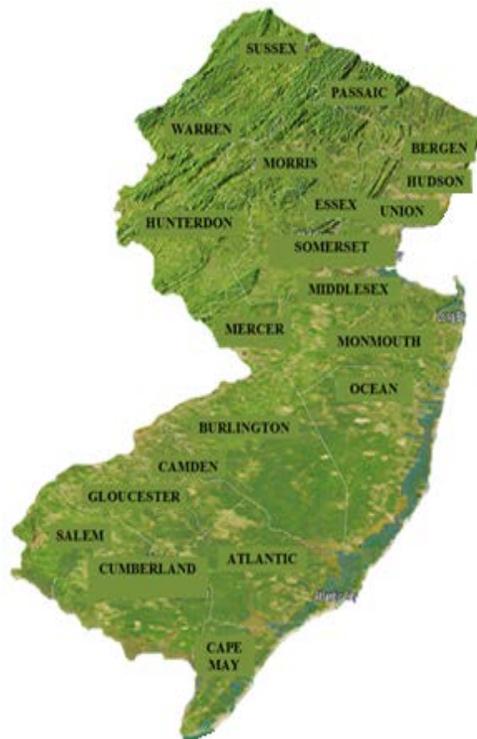
Source: [www.maphill.com](http://www.maphill.com)

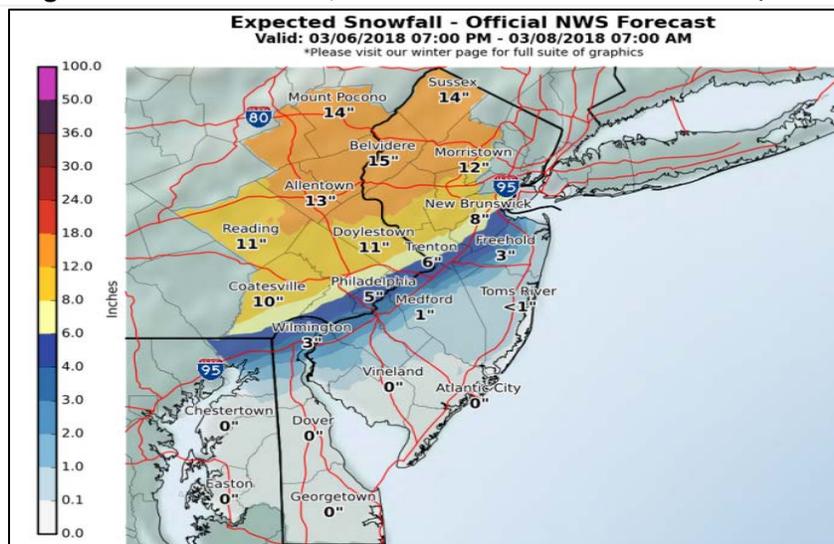
Source: National Weather Service (NWS)

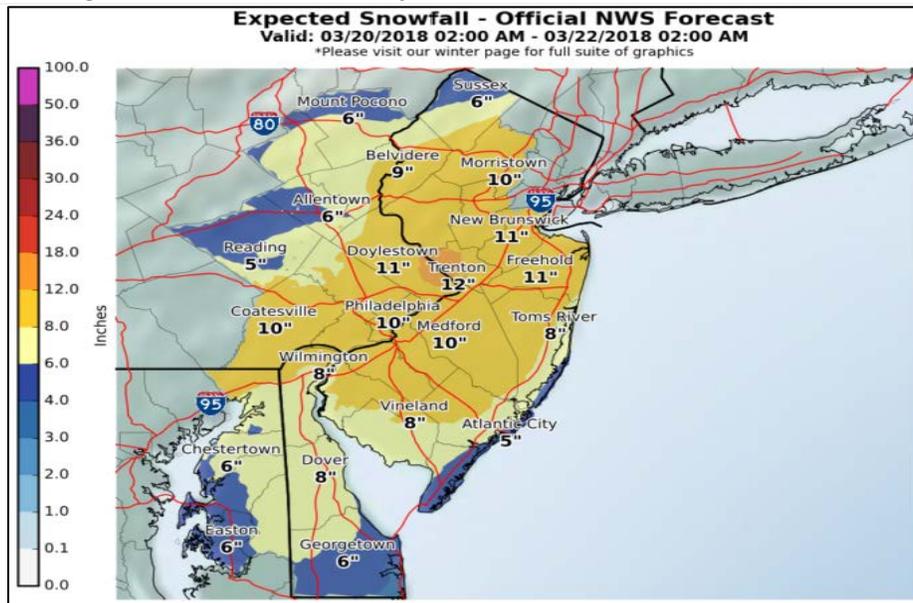
Source: National Weather Service (NWS)

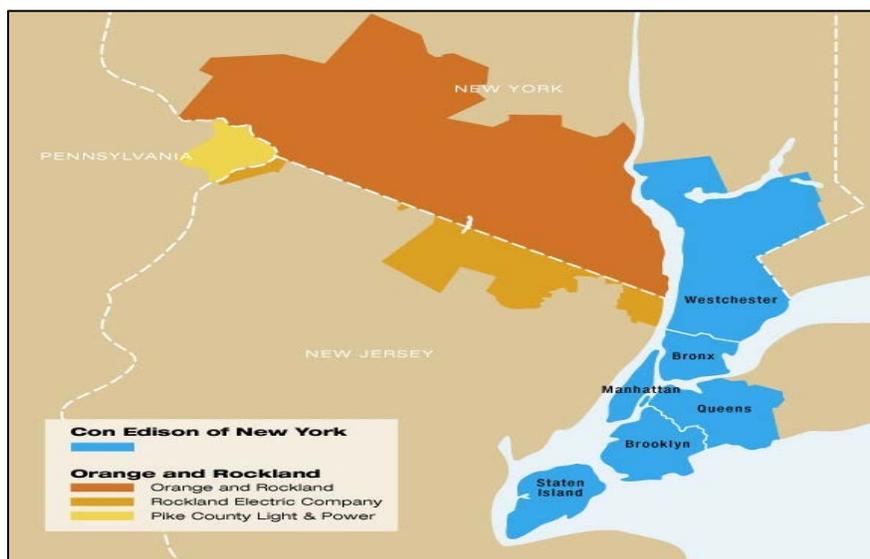
## 2.2. Weather Forecasting and Outage Predictions

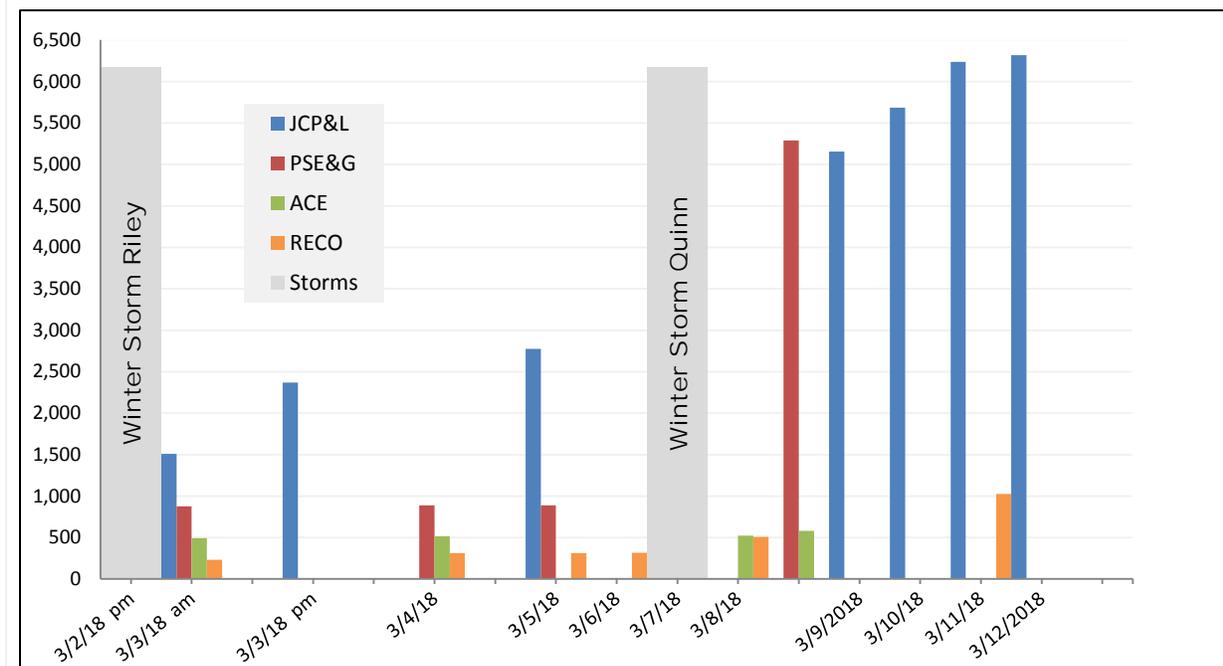
Between the morning of March 2 and the evening of March 13, crews worked in shifts around the clock to restore service to more than 1.2 million electric utility customers.<sup>17</sup> As the restoration progressed, EDCs re-deployed its crews between their own divisions or districts as necessary to accomplish repairs in a timely manner. As PSE&G and ACE completed their restorations, they sent personnel and contractors crews to JCP&L. On March 5 and March 6, PSE&G supplied 120 line FTEs and 132 contractors to JCP&L. Between March 6 and March 10 ACE released FTEs it had acquired from its Exelon sisters to JCP&L. In some instances, this sharing of resources occurred at the behest of the Board. As recommended in Section 2.5, EDCs should formalize this practice.

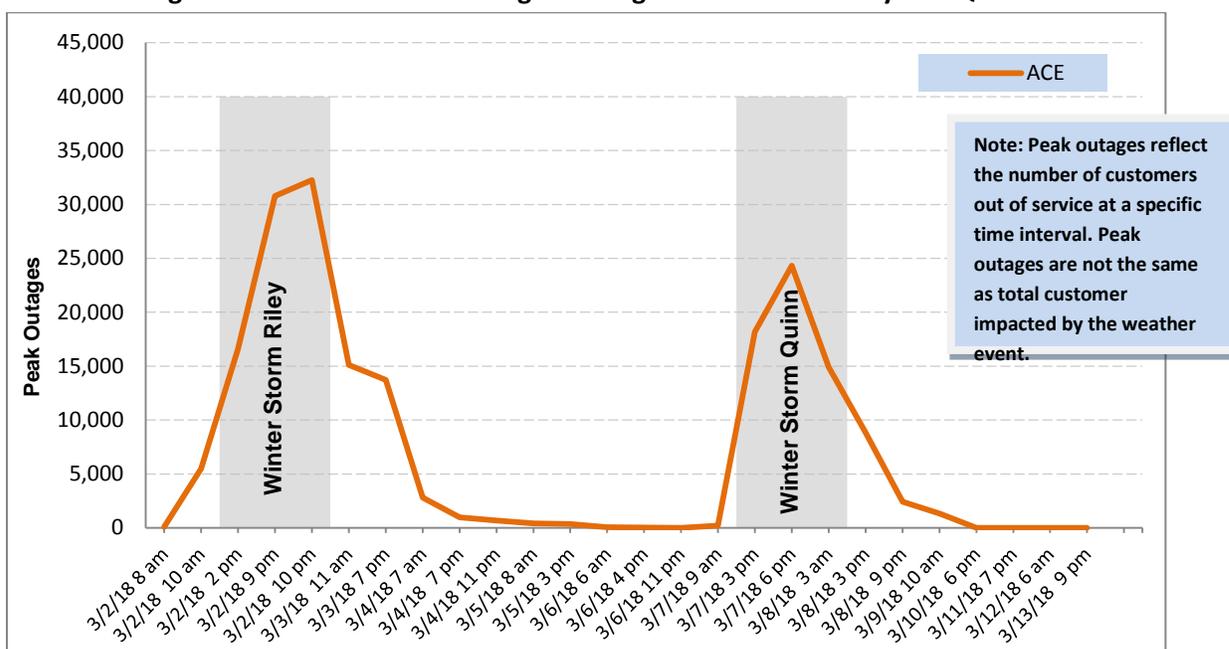
More than 129,000 ACE customers were impacted by the two storms. Figure 13 shows the number of customer outages over time. It also depicts peak outages—the point in time when the highest number of simultaneous customer outages was reached during each nor’easter. The reduction in customer outages post-peak reflects ACE’s restoration activities.

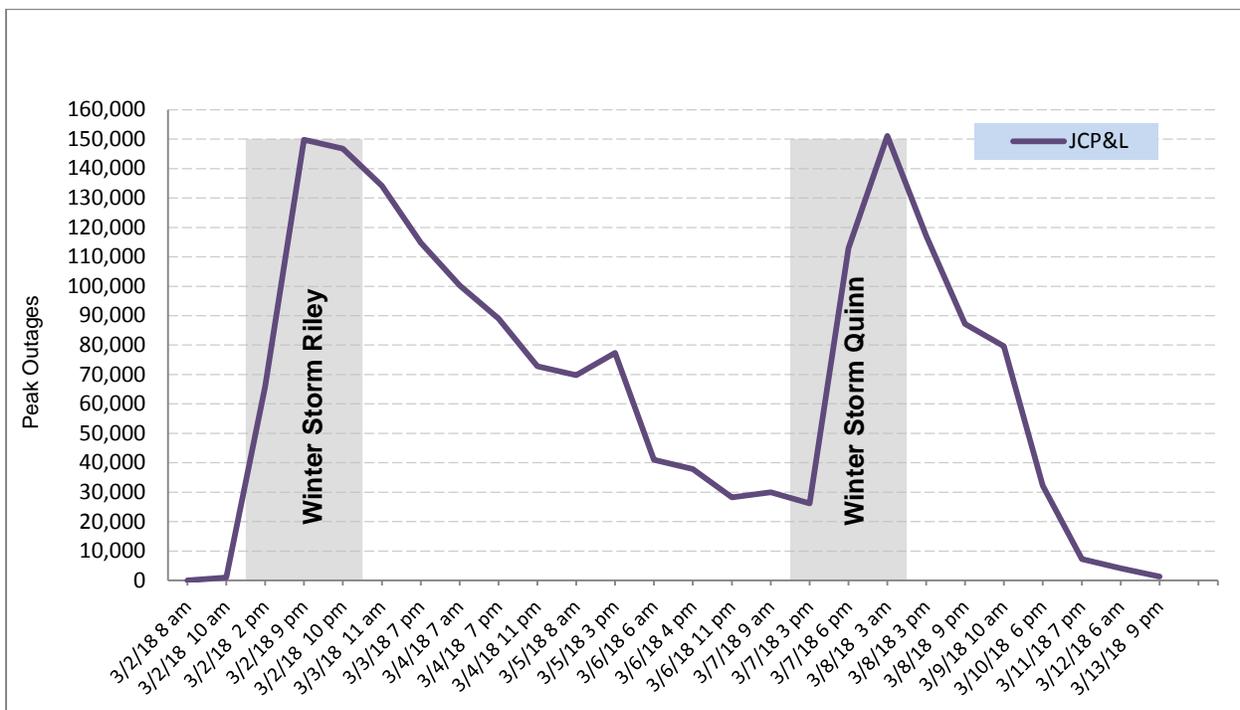
More than 526,000 customers were impacted by the two storms. The majority (77%) of these customers were in JCP&L’s Northern Region. Figure 14 depicts customer outages by storm and reflects the overall restoration timeline. Customer outages from Riley peaked at 150,000 on the afternoon of March 2. Customer outages from Quinn peaked at slightly more than 150,000 during the evening of March 7. Despite eventually mobilizing a workforce of more than 6,300 FTEs, JCP&L was unable to complete its storm restoration until March 13; a full 11

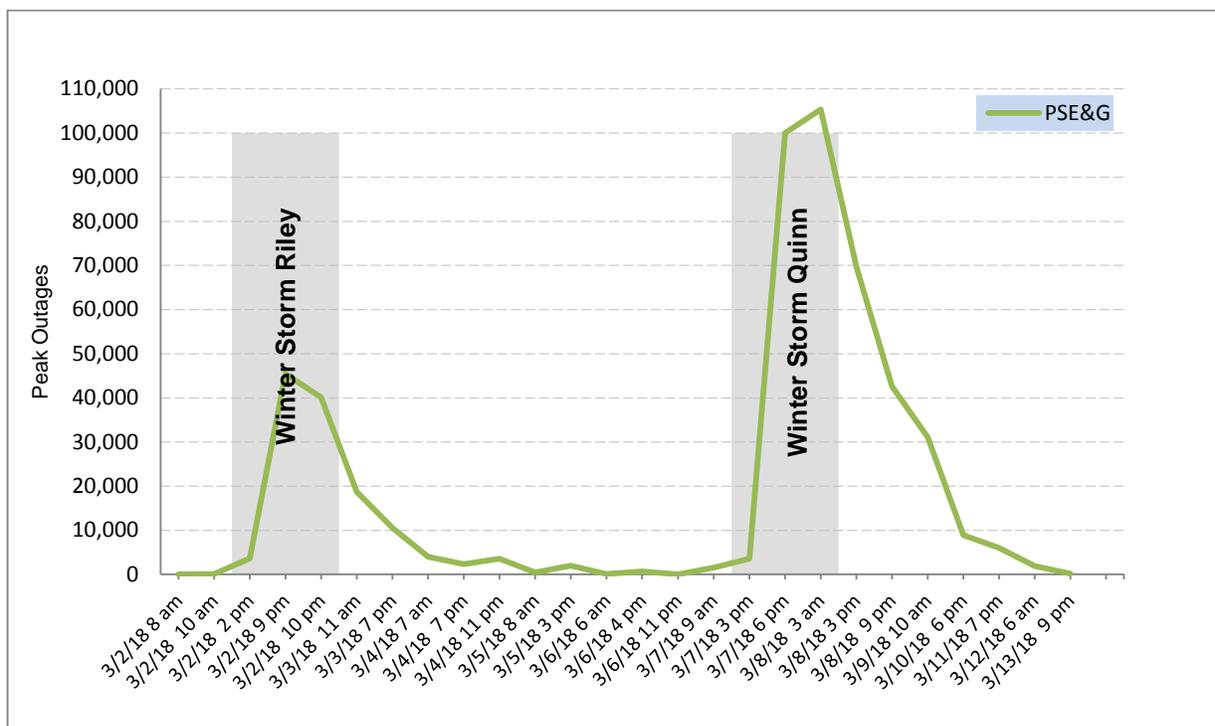
Storm Quinn. Despite mobilizing a workforce of more than 5,200 FTEs, PSE&G did not complete restoration until March 13, approximately 6 days after Quinn arrived.

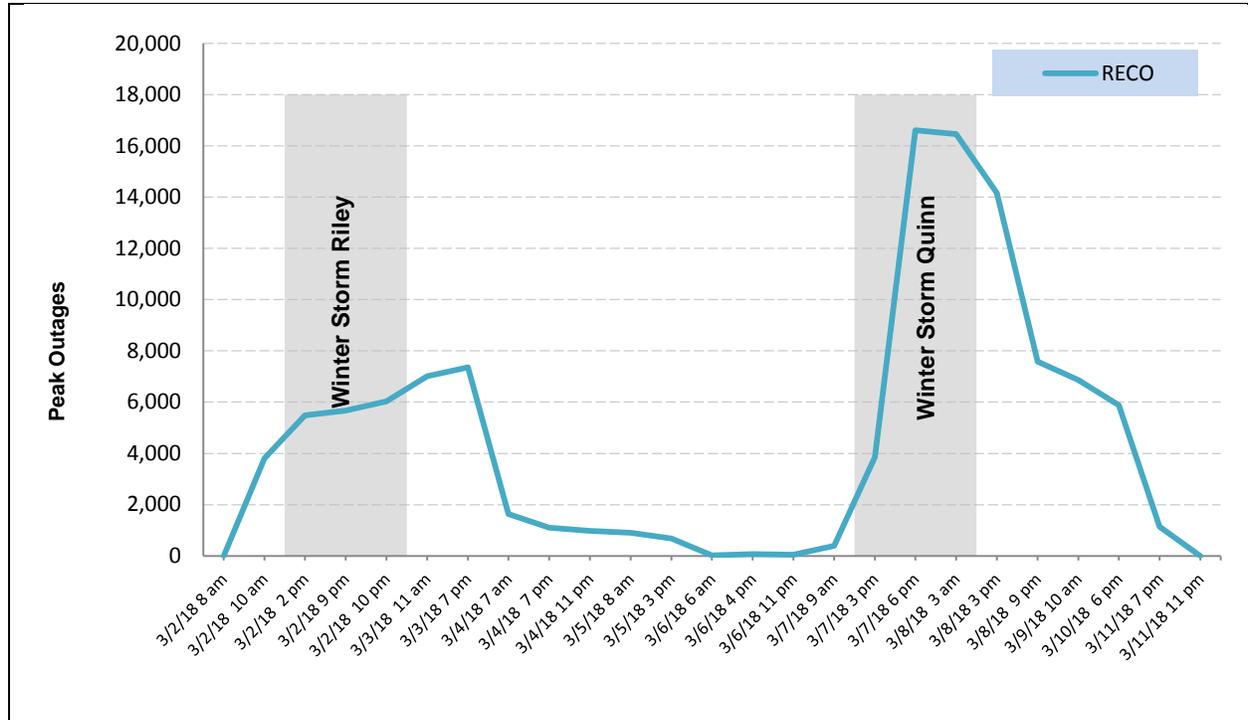
customers peaked at roughly 7,400 the evening of March 3. This was due to the combination of strong winds, saturated soil, and the weight of the heavy snow causing mature trees to uproot and tree limbs to fall even after the storm had left the area. Outages for Quinn peaked at slightly more than 16,000 on the evening of March 7. Restoration was completed on March 11.

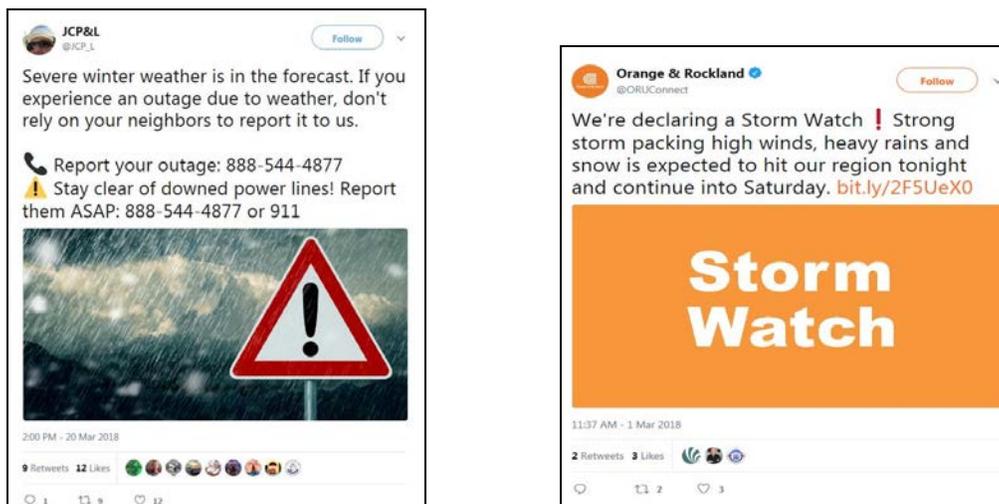
Alerts were first issued beginning on March 1 advising customers to be prepared for potential power outages and providing information as to how to report an outage (see Figure 17). Notifications and updates continued throughout the restoration process for Winter Storms Riley and Quinn.

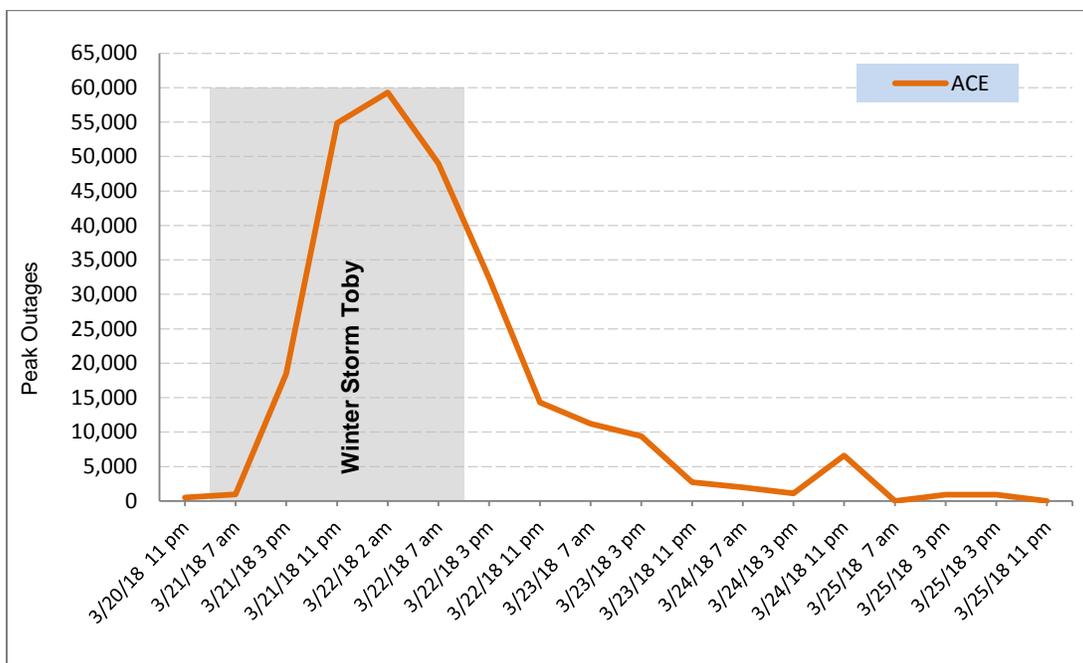
- **Communication and Outreach**

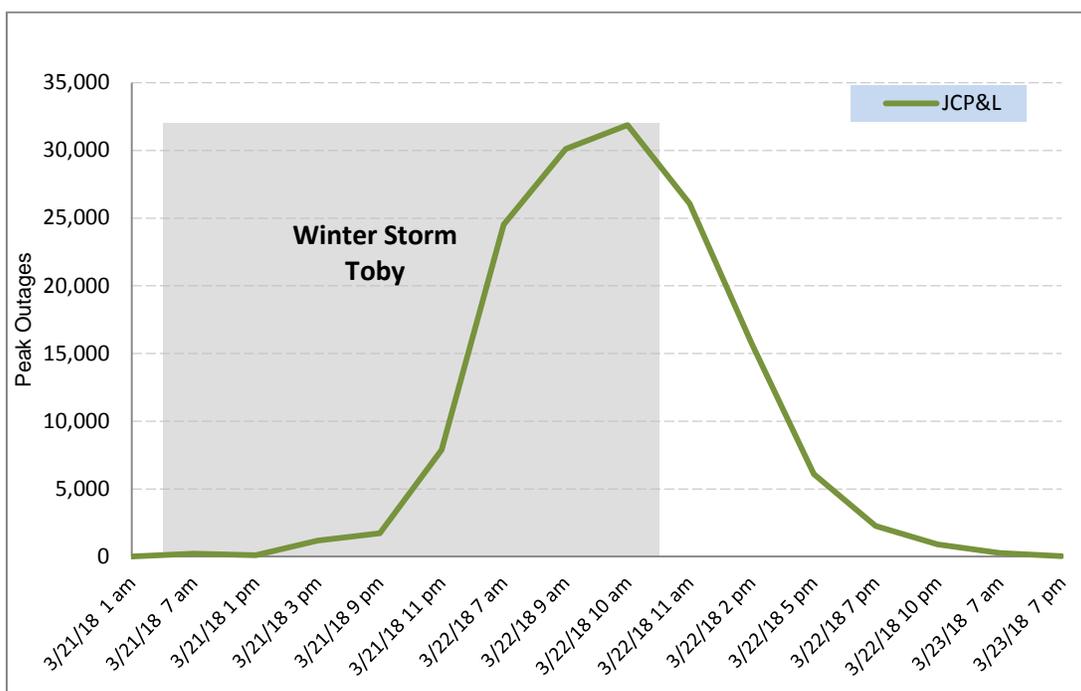
- Communication and Outreach**
