NEW JERSEY DIVISION OF FIRE SAFETY

Firefighter Fatality and Serious Injury Report Series

Seven Firefighters Injured When a Tractor Trailer On Fire Explodes

**Mansfield Township, New Jersey
May 31, 2012**

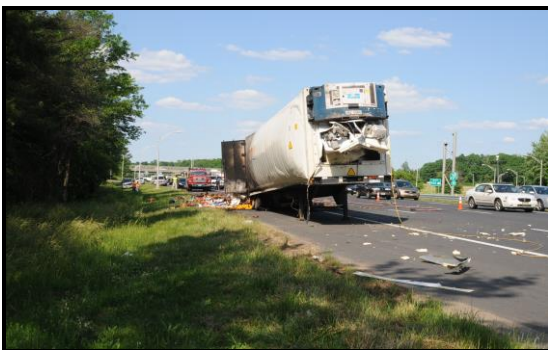
Figure 1 - Front of trailer damage to Refrigeration Unit

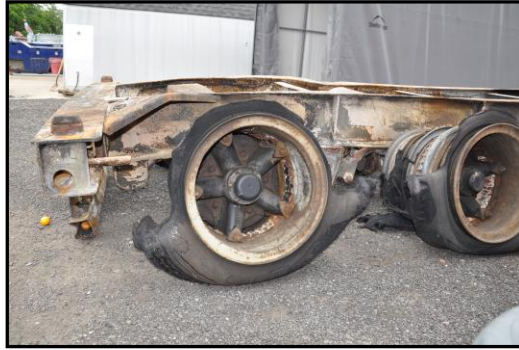
The area of origin was determined to be the passenger side rear wheels. The fire was determined to be accidental in nature. The exact cause of the fire is undetermined due to the fact that the investigation team was unable to identify the first material ignited as well as a possible mechanical failure.

Figure 6 - Area of origin
