## **NEW JERSEY DIVISION OF FIRE SAFETY**

### Firefighter Fatality and Serious Injury Report Series

# A North Bergen Firefighter is injured after falling from a fire escape ladder at an apartment building fire

**Union City, New Jersey**

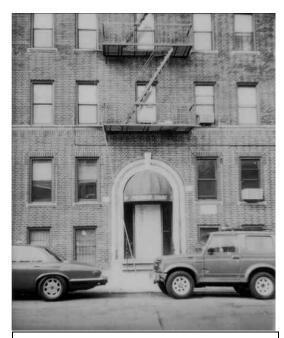
Figure 2 - View of 1625 Palisade Ave. shown from Division "A"

The building was a five story of unprotected, Type 3, ordinary construction consisting of brick exterior bearing walls and wood joists on the interior. It was utilized as a multi-occupancy apartment building. It was classified as a non-life hazard use by the NJ Uniform Fire Code and as a use group R-2 by the NJ Uniform Construction Code.

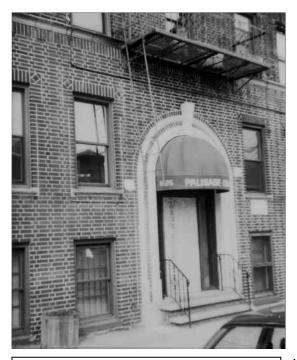
Figure 3 - View showing fire escape ladder on Division "A" where FF Velez fell

began to climb down the ladder, which was a vertical drop-down type suspended by a cable over a pulley and counterbalanced with a weight on the end of a cable. This type of ladder is not secured tightly to the fire escape frame, rather it moves vertically through a set of guides at the fire escape landing and is not secured at all at the bottom of the ladder. At about the point when Velez was two rungs down from the top of the ladder, his weight caused the heel of the ladder to suddenly shift horizontally across the doorway of the front entrance below. Velez lost his grip on the ladder and began to fall backward. Still holding the child inside his coat, he hit his head on an adjacent second floor windowsill and fell to the sidewalk fifteen feet below. It was at this point that FF Viscardo was crossing the street to help Velez with the rescue effort and he witnessed Velez falling from the ladder. As Velez landed on his back, on top of his SCBA cylinder, the child was dislodged from his coat due to the impact of the fall and landed on the sidewalk approximately

While it is understandable that firefighters will need to improvise or use climbing equipment such as fire escape ladders or non-fire service ladders that may be present at incident scenes, these practices should be viewed as the exception rather than the norm. In this case Firefighter Velez's decision to use a non-fire service ladder was based on his attempting to ensure the safety of the victims on the fire escape.

It should be remembered however, that fire service ladders should be the preferred devices for operations above grade under normal circumstances. Properly tested, maintained, and trained on; fire service ladders offer reliable use and greater safety for firefighters working in elevated positions.

The injuries sustained at this incident can be directly attributed to the use of a fire escape ladder that was not designed to be used for fire department rescue operations. However, it would be simplistic to formulate a conclusion based on that fact alone.
