National Register of Historic Places Registration Form

historic name Thatcher house
other names/site number _____

street & number 255 Ridge Road not for publication
city or town Kingwood Township vicinity
state New Jersey code NJ County Hunterdon zip code _____

Traditional Patterned Brickwork Buildings in NJ MPS

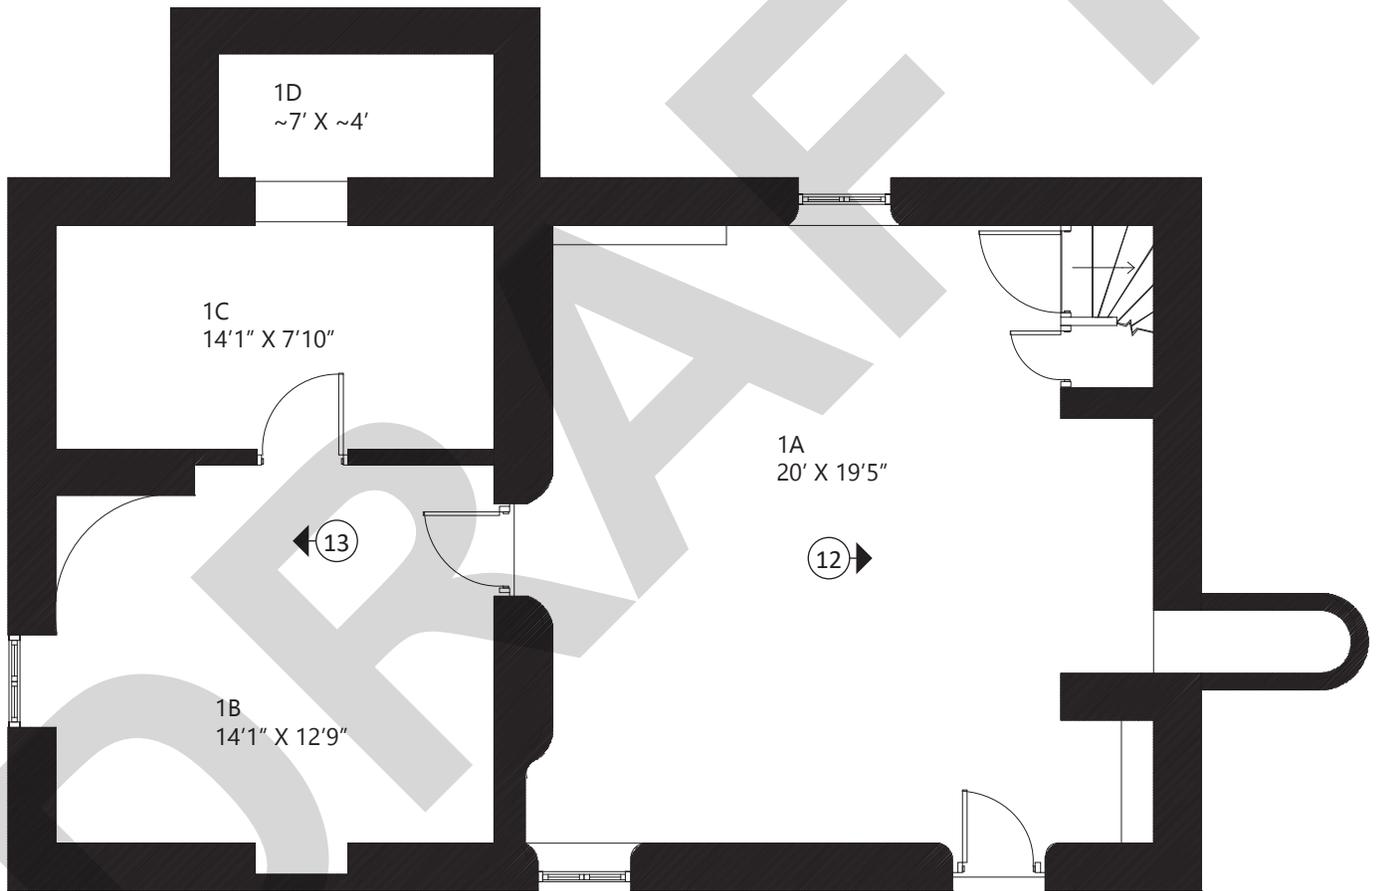
Floor Plan: Cellar

The one entrance to the cellar from outside, through the south wall, opens into a large, finished space (01A) on the east half of the floor, the full depth of the house. (For the sizes of rooms, please refer to the floor plans.) This space was originally the kitchen and features the largest hearth in the house, complete with an oven for baking (Photo 12; see beehive oven, mentioned above). A closet and winder stair occupy the northeast corner

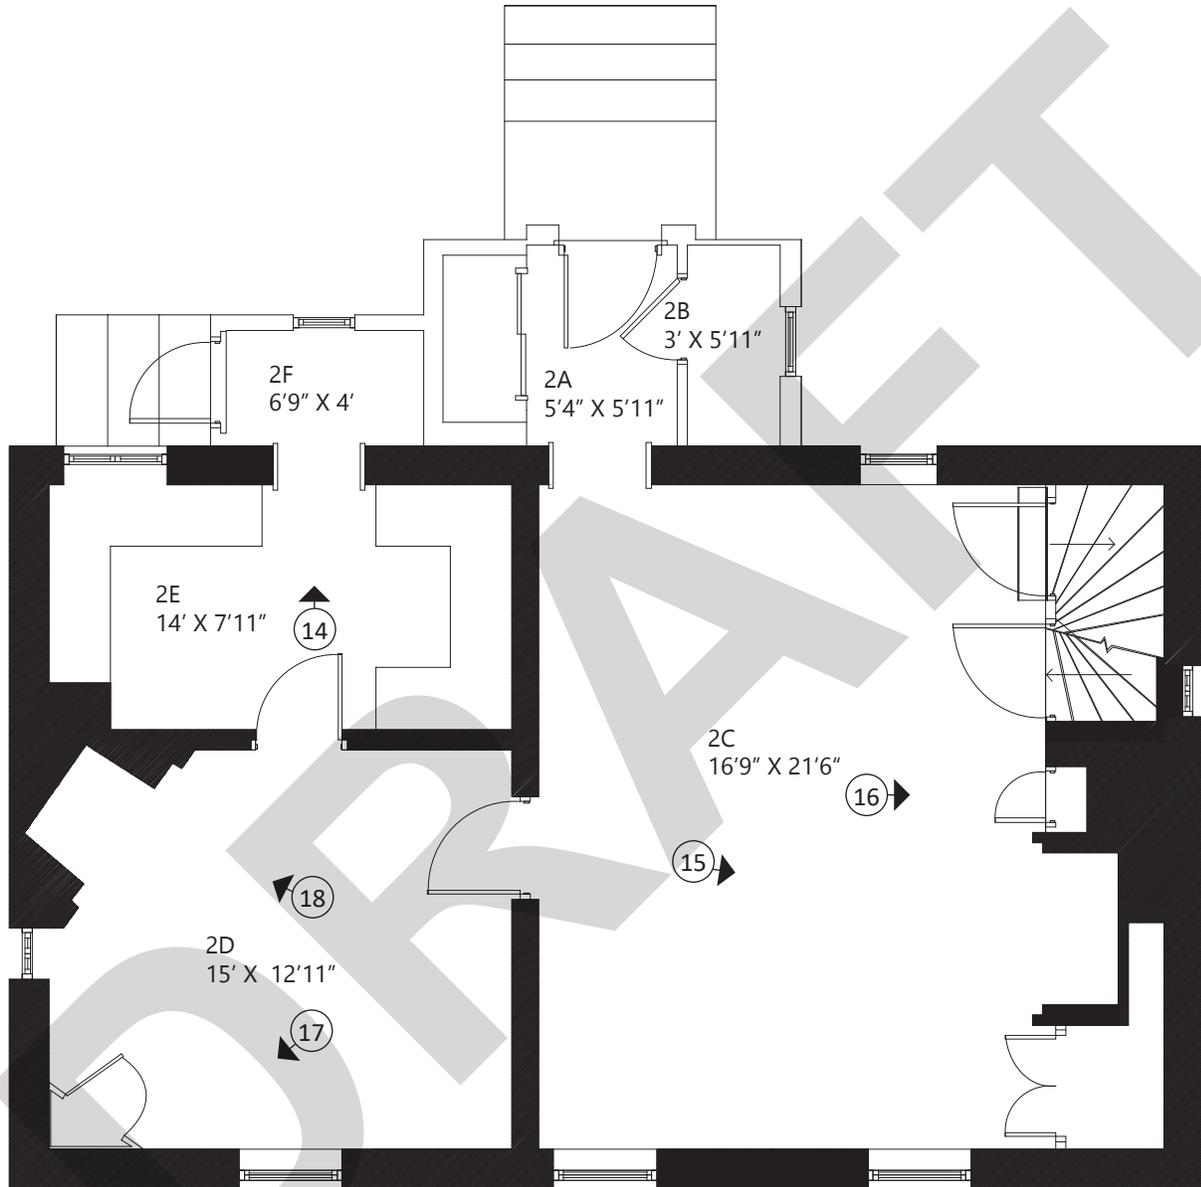
Floor Plan: First Floor

The double-pile form¹ of the Thatcher house is not as pronounced as many examples of this form, and the principal space in both the cellar and the first story display a three-room plan, with a large space extending the full depth of the house on one side and two smaller rooms on the other side, the third, in the rear corner, entered from the second (see Cellar and First Floor plans). The second story, on the other hand, is a more conspicuously double-pile space, with a more complex arrangement of bedchambers on both sides of a corridor. The house has evidently always relied on the winder stair in the northeast corner of the plan, and has never had a central stair, nor a stairhall such as was popular in the era during which this house was constructed.

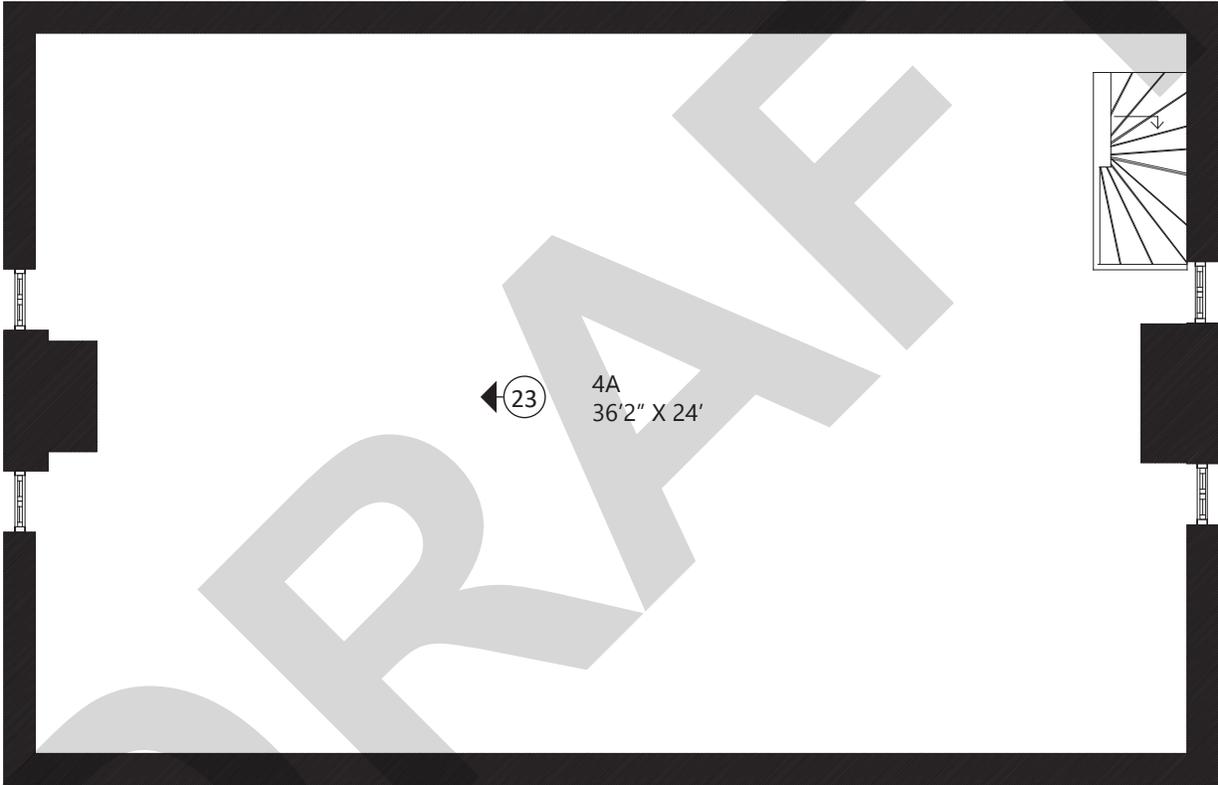
Floor Plan: Second Floor

The second story contains three bedrooms, a full bathroom, and a corridor that links them from the winder stair in the northeast corner of the floor (Second floor plan). Wide, probably original boards comprise the flooring through the entire second floor. The vocabulary in each bedroom includes chair rails and baseboards; whether they are original to the house has not been determined. The principal (or master) bedroom (3A) occupies the southeast corner of the second floor. It features closets along the east wall (Photo 22). The doors enclosing

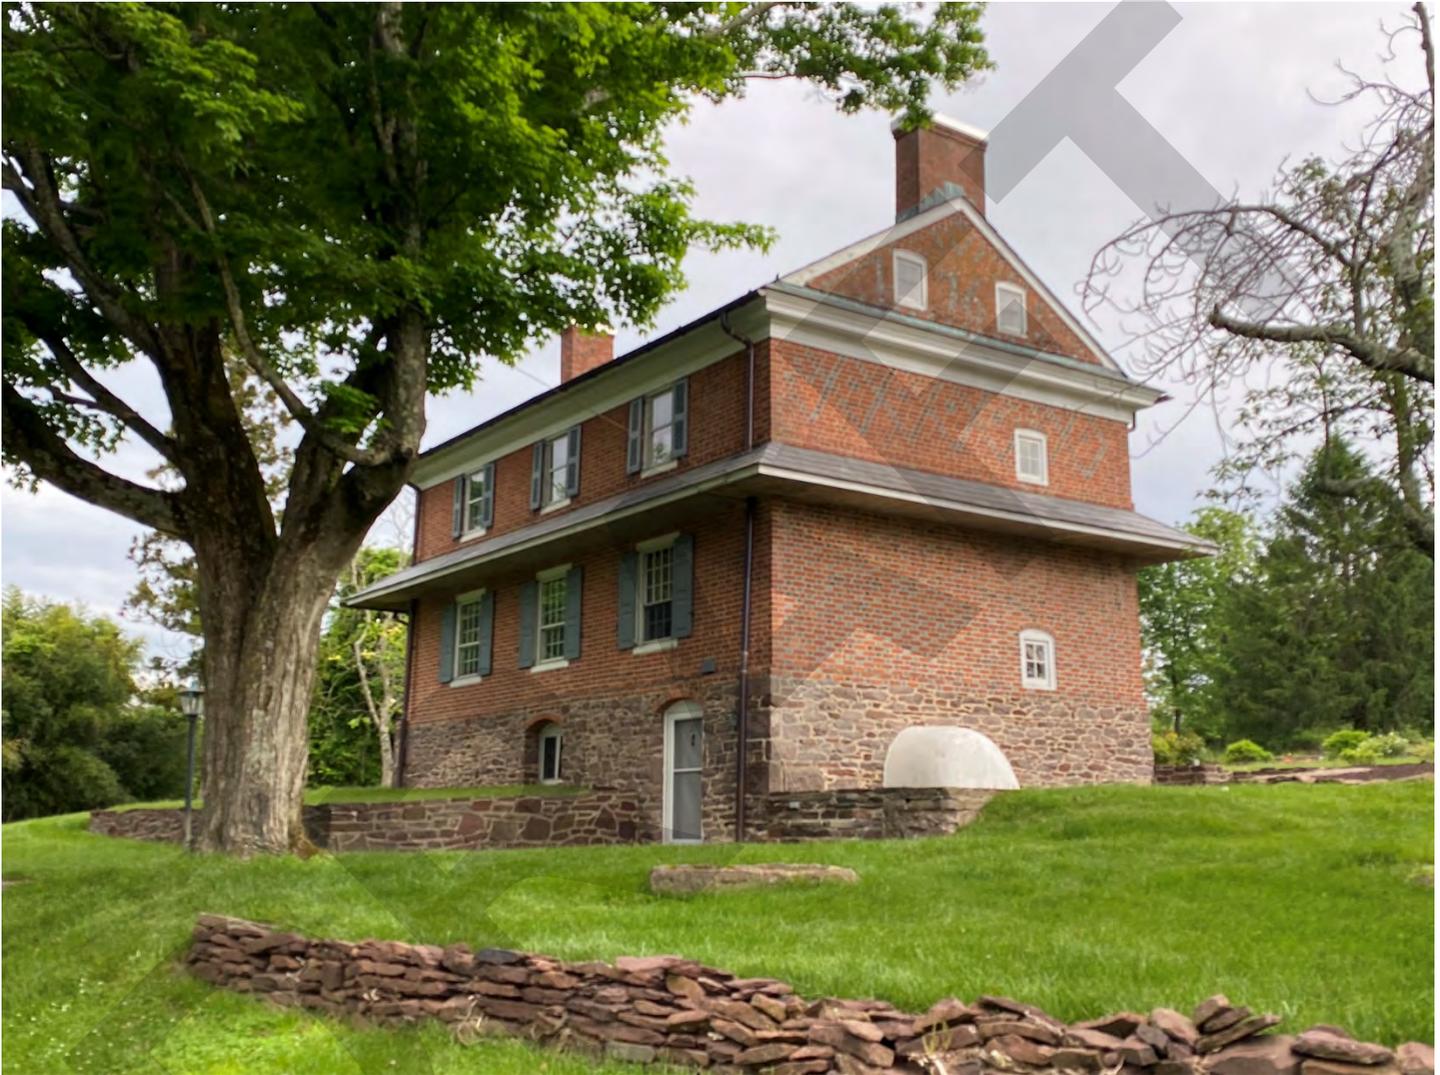
Photo 1

The Thatcher house is a two-story, three-bay, brick house, plus a full cellar, built in 1765, at 255 Ridge Road on a hillside location in Kingwood Township, Hunterdon County, about two miles northeast of Frenchtown Borough (Photo 1). It exhibits notable patterned brickwork, for which it is significant (see below and Section 8). The house stands embanked on a sloping site, with the terrain falling away to the south. The house is set back about 25 to 45 feet from the north side of Ridge Road, with its rear elevation toward the road. The house stands on a fieldstone foundation and has a cellar accessible at grade. The house faces northerly. It possesses a large pent roof between the first and second stories that fully surrounds the house, and smaller pent roofs in the gable ends at the level of the eaves. A small, north-side vestibule and kitchen addition was added in the 20th century. The house was re-shingled in slate in the early 20th century. Other minor alterations were also made in the 20th century. The property includes two outbuildings that, while they include old construction materials, they do not possess integrity from the period of the house's construction and are therefore non-contributing buildings.

The Thatcher house displays a cellar of locally-obtained fieldstone set in lime mortar (Photo 1). Due to its hillside location, the house is embanked, leaving the cellar on the south side fully exposed. This is a situation that is quite common in Hunterdon County. A water table of beveled brick follows (Photo 2). Two stories of brickwork stand atop the cellar, laid nearly entirely in Flemish bond of reddish brick: plain Flemish bond in the north façade and south elevation and a mix of plain Flemish bond and Flemish checker in the east and west elevations, outside the diamond work (Photos 2, 5, 6, and 8, and see below). The house still retains both a large pent roof, 2'9" deep, between the first and second stories and two much smaller ones in the gable ends above the second story. (Without evidence to the contrary, this nomination assumes that the pent roofs are original to the house.) A stringcourse of plain brickwork surrounds the house at the top of the lower pent roof (see, for example, Photos 4, 5 and 10). This stringcourse visually marks the transition to the second story.

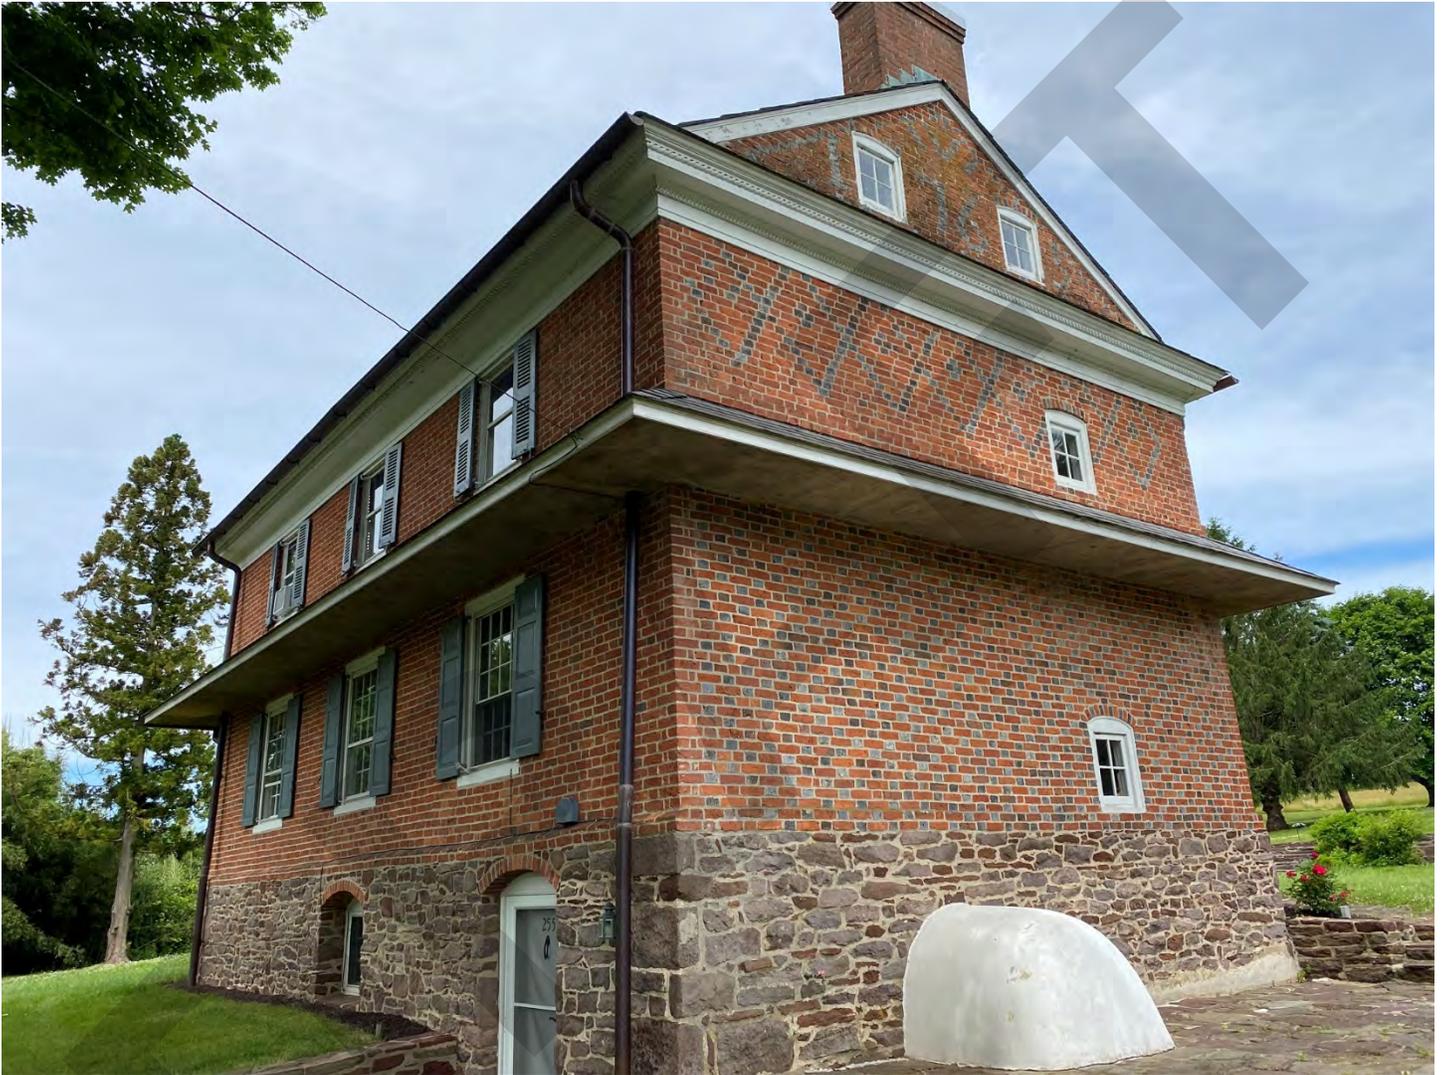
Photo 2

The immediate environs of the house have been improved with hardscape. The front entrance (Photo 5) is accessed by a set of steps in stone meant to match that of the house's foundation, and a stone sidewalk extends to the driveway. The east side of the house (Photos 2 and 3) has been improved with a patio of stone flags enclosed with shallow retaining walls. This feature extends to a stone retaining wall and sidewalk (Photos 1 and 3) that control access to the cellar entrance on the south side of the house.

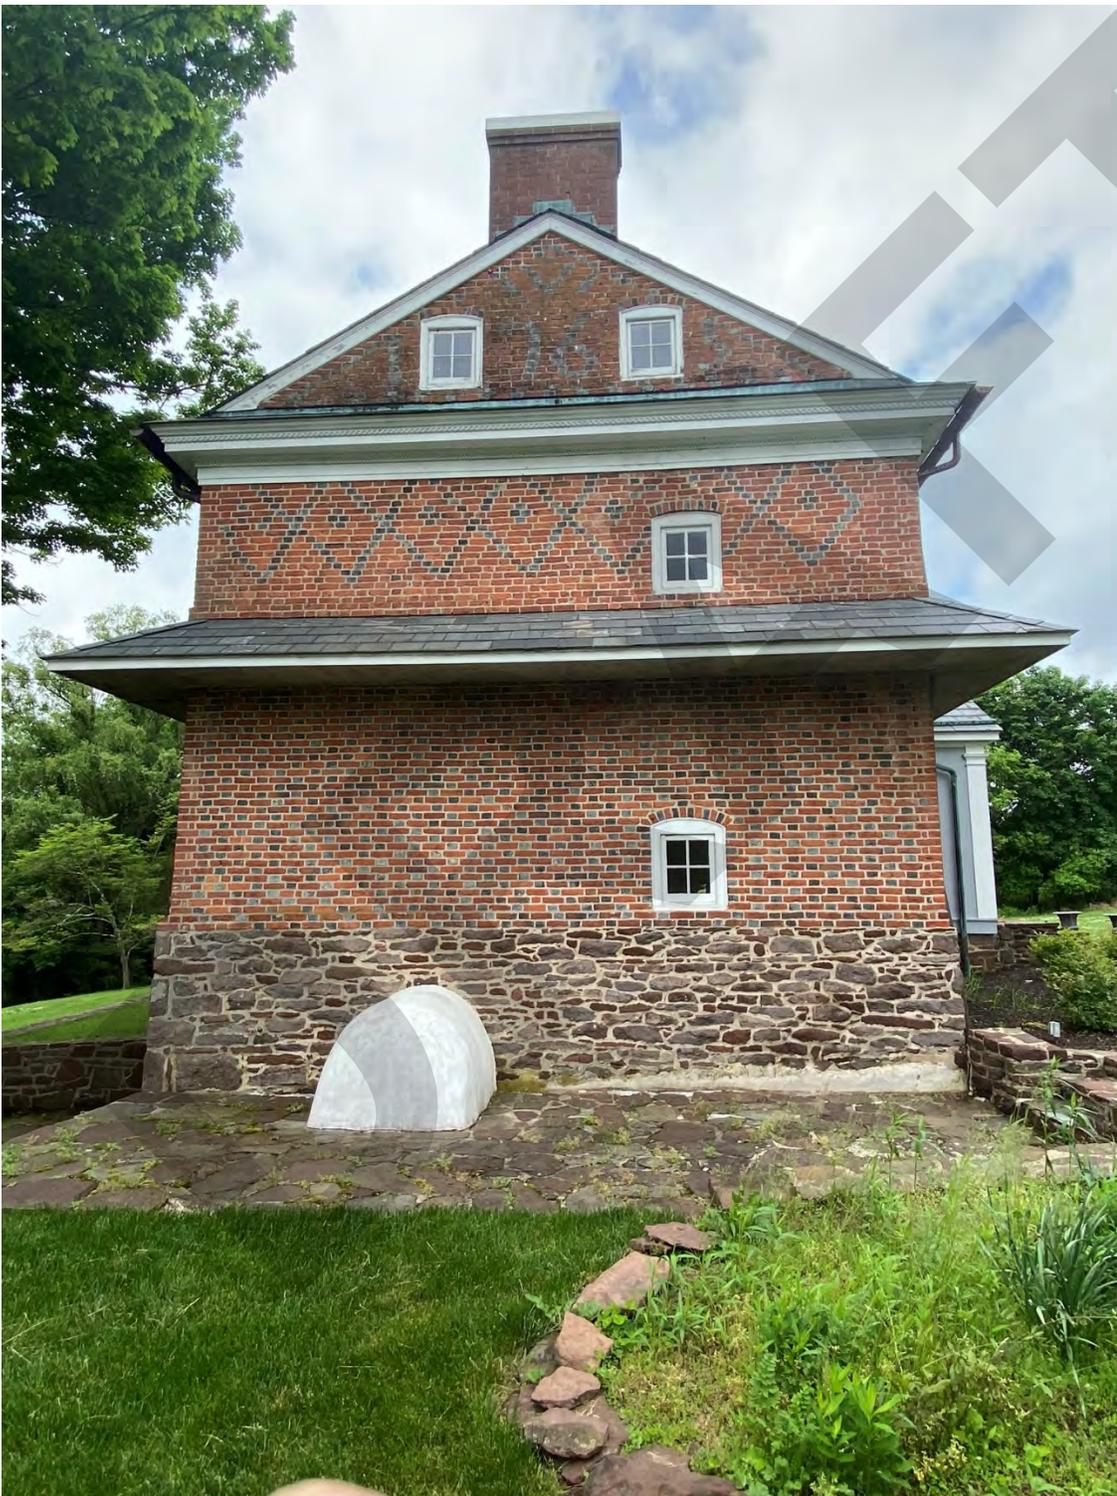
Photo 3

The east end elevation exhibits only the solid mass of the original kitchen's beehive oven, now painted white (Photo 3). What would ordinarily have been an uninterrupted wall is divided by the lower pent roof into upper and lower halves, which are differently decorated with patterned brickwork (see below). The only fenestration in this wall are two, 4-light casement sash windows: one each in the first and second stories to light the stairwells, and two in the gable to light the attic. This elevation also contains the date in brick of the house's construction (more about, below). The west elevation, as one faces it, is nearly identical to the east elevation, with four, 4-light casement windows identically placed (Photo 7). The only notable distinctions lie in the presence of a cellar window like that in the south elevation, and the different brickwork. In the west elevation, the 1st- and 2nd-story casement windows illuminate a dining room and a bedroom.

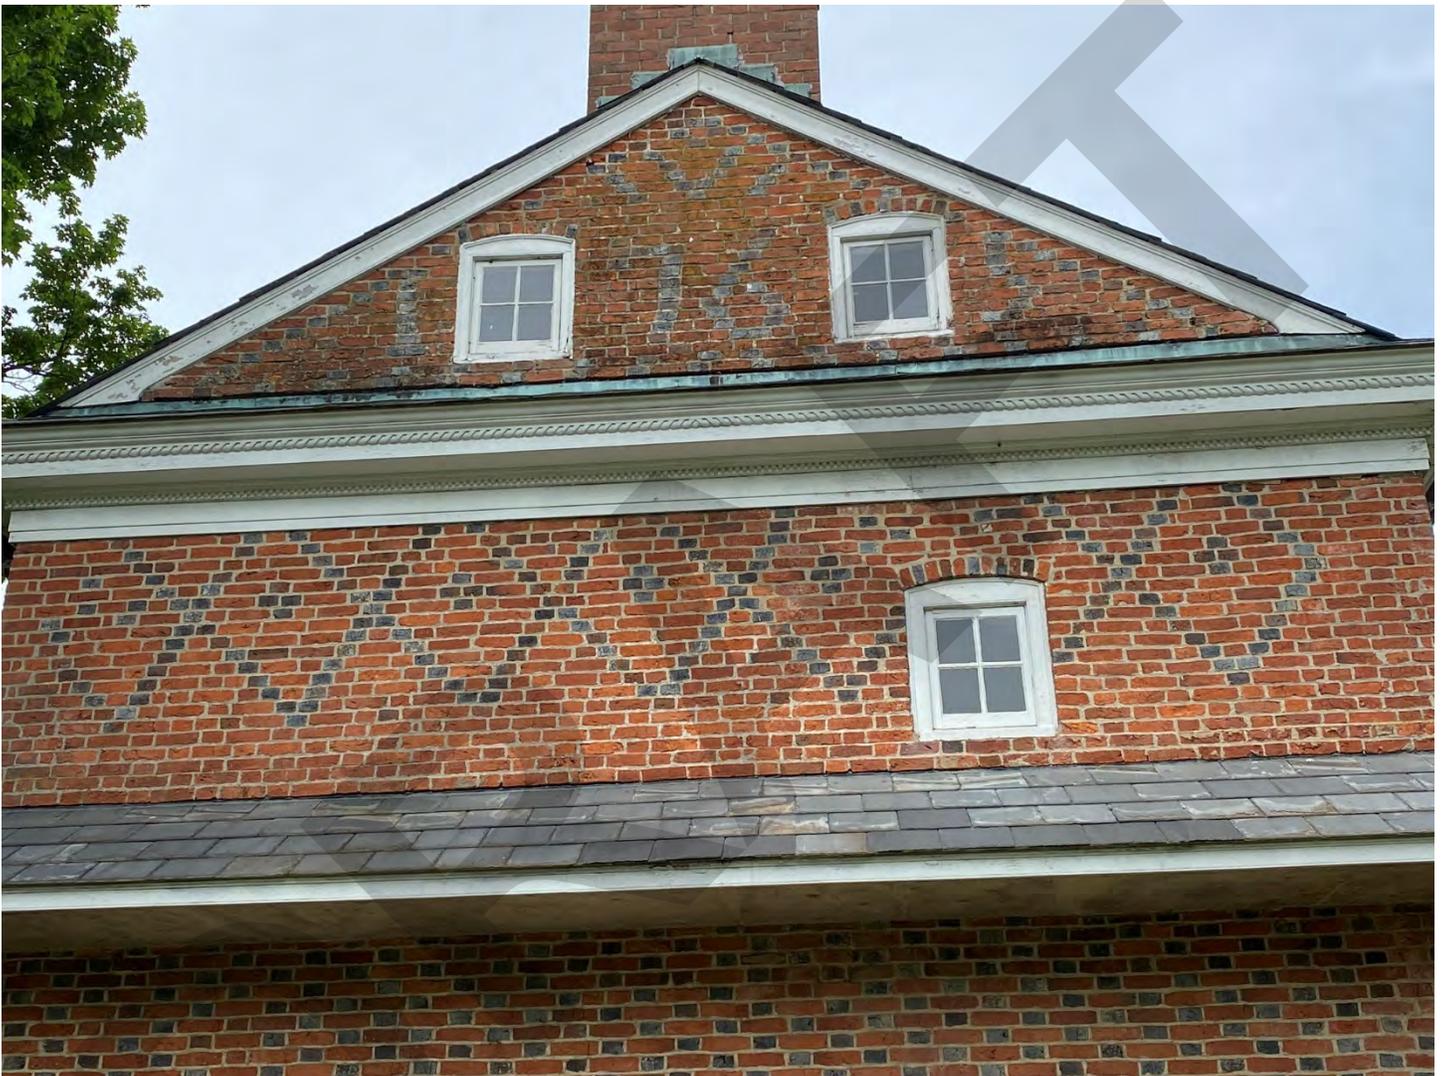
Photo 4

Larger and more complex diamonds, 17 courses high, occupy the second story of both the east and west elevations, in each elevation as a single horizontal row. Like the smaller diamonds described above, these are “hollow,” meaning they are filled with plain brick. These larger diamonds have at least one characteristic of diamond diapers⁴ in that the rows stretch from nearly one side of the wall to the other. In the east elevation (Photos 3 and 4), the bricklayer attempted to complete eight diamonds in the row, but he failed to center the work horizontally, leaving too much blank space on the right (as one faces the wall) and failing to close the end diamond on the left. He failed to properly account for the size of the window in the spacing of the headers, so that the right end of the wall does not look like it belongs with the middle and left side. Here, too, he also failed to center the decoration vertically, so it looks cramped⁵ at the top and disconnected at the bottom. He also failed to center the decoration vertically, so that in both dimensions a coarse effect is the result (Photo 4). The bricklayer also failed to lay the diamonds symmetrically, giving a leftward tilt to the diamonds that became progressively worse on the left side (as one faces the wall). He further attempted to finish the decoration by placing a small, 3-course diamond in the center of the larger diamonds. The bricklayer added a second course of two vitrified headers, and then a third course of a single vitrified header to complete the three-course diamond, but in doing so, the combination was thrown off-center. Off-center in diamonds already tilting to the left (Photo 4).

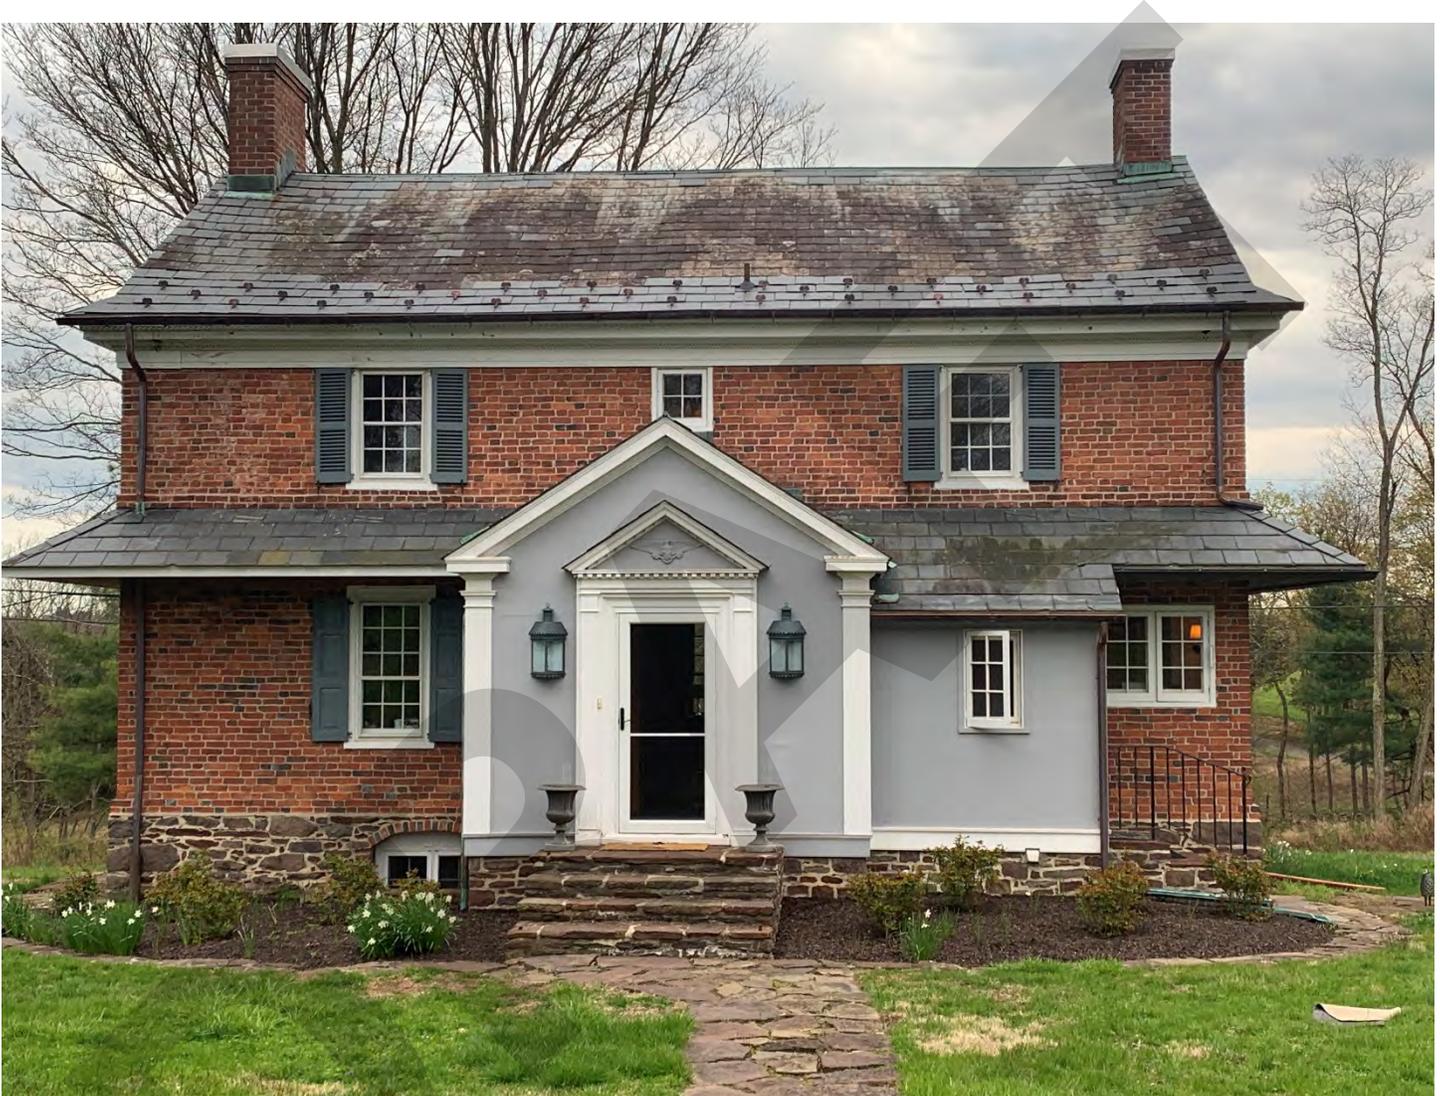
Photo 5

The house faces north, away from Ridge Road. The north elevation features the first-story entrance, centrally located within a nearly symmetrical façade. The elevation features a large, 1-bay-wide, vestibule addition, with a Colonial Revival doorway framed with a pediment and inside a tabernacle supported on pilasters (Photo 5).

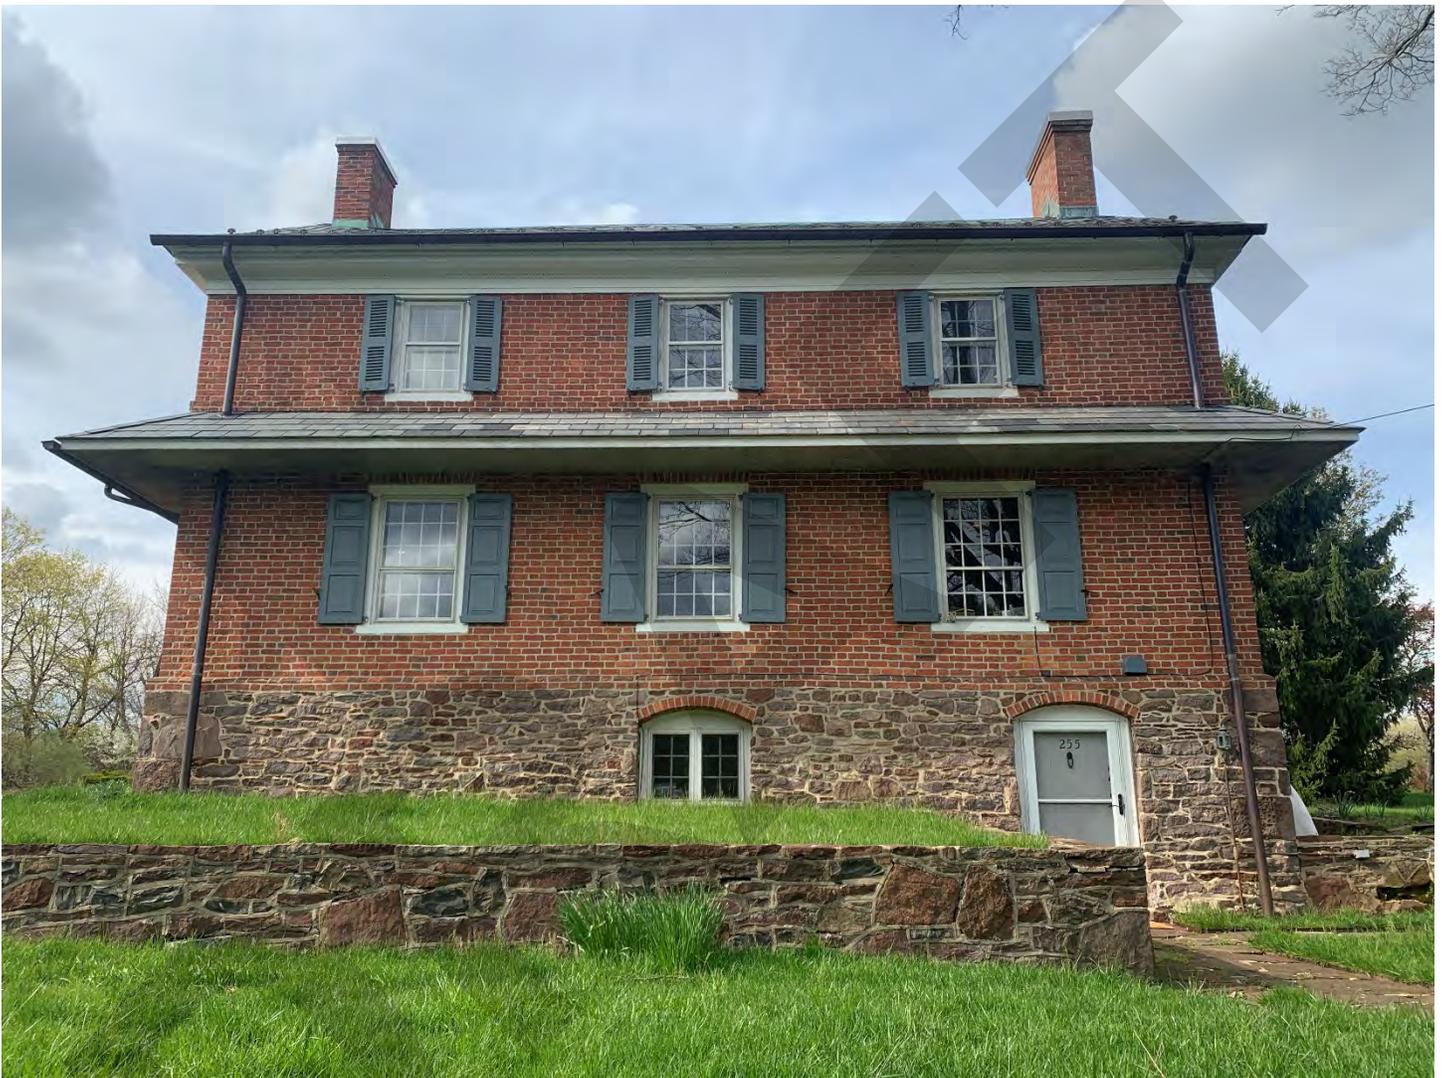
Photo 6

The south, or rear, elevation exposes the cellar below the first story (Photo 6). This elevation is without a porch, so the only entrance accesses the cellar, in the east bay. This opening is capped by a simple relieving arch of one row of plain headers. The cellar wall is otherwise broken by one cellar window, with a similar relieving arch of plain headers. These two openings break the symmetry otherwise imposed by the first and second stories, each of which has three double-hung sash windows, 12-over-eight in the first story and 6-over-six in the second. These, also, are flanked by replacement shutters, though hinged and held in place by reproduction shutter dogs. (Photo 6)

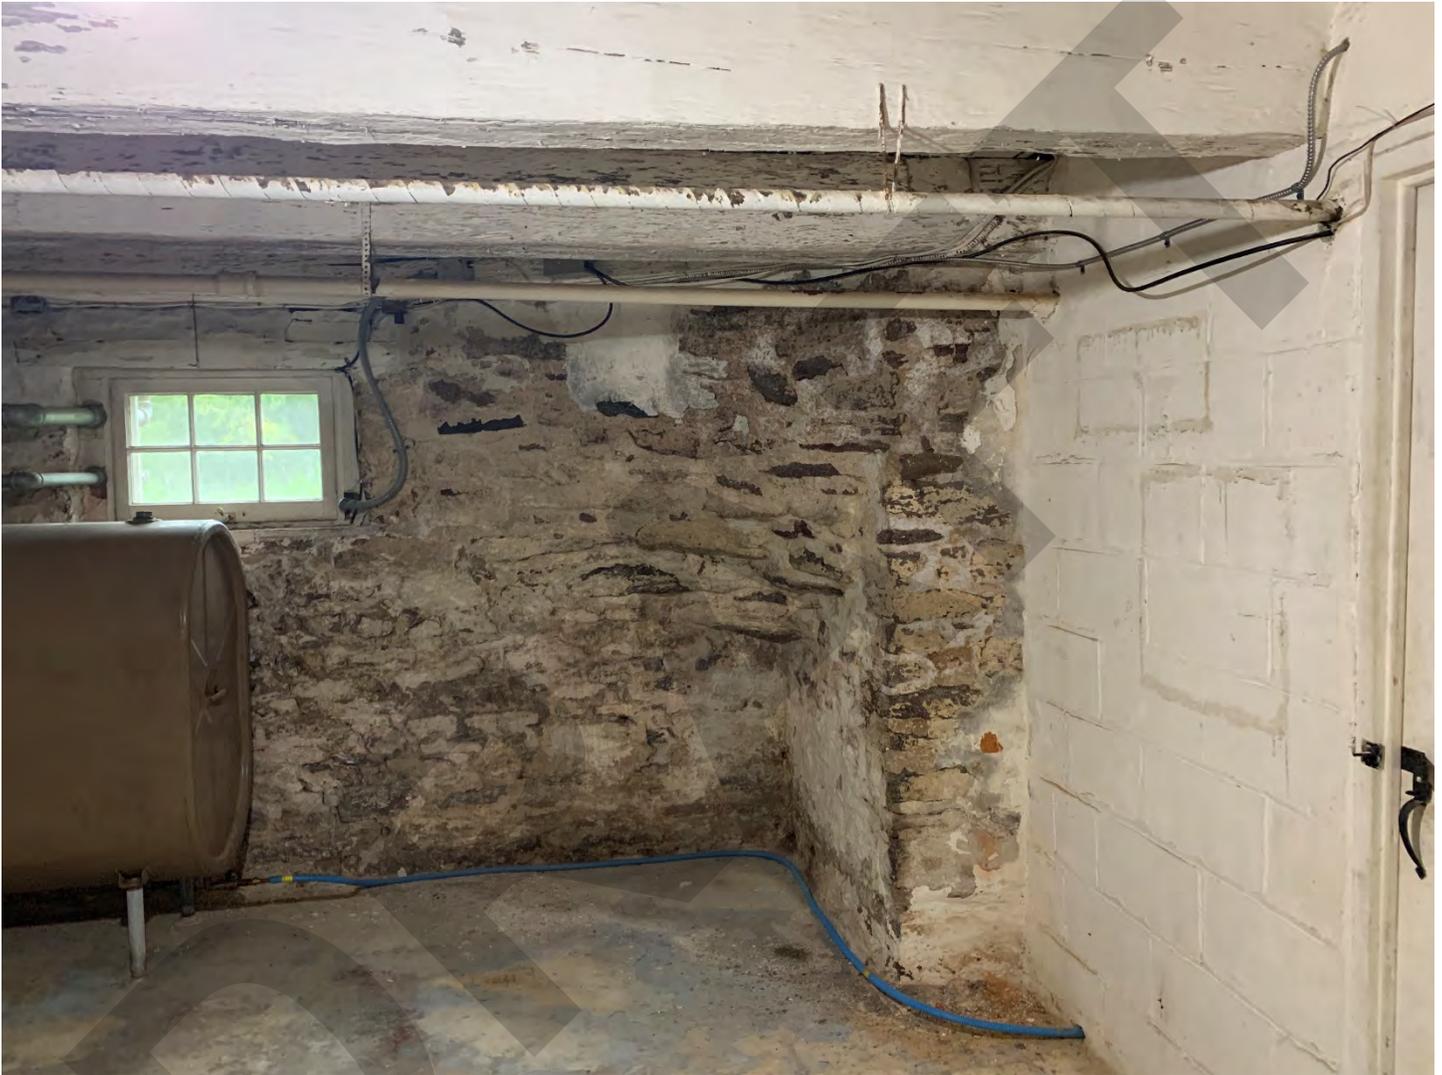
Photo 13

- 13 Interior, east end of cellar, emphasizing the stone foundation for the corner chimney
- 14 Interior, 1st story, modern kitchen
- 15 1st story, east end paneled chimney wall

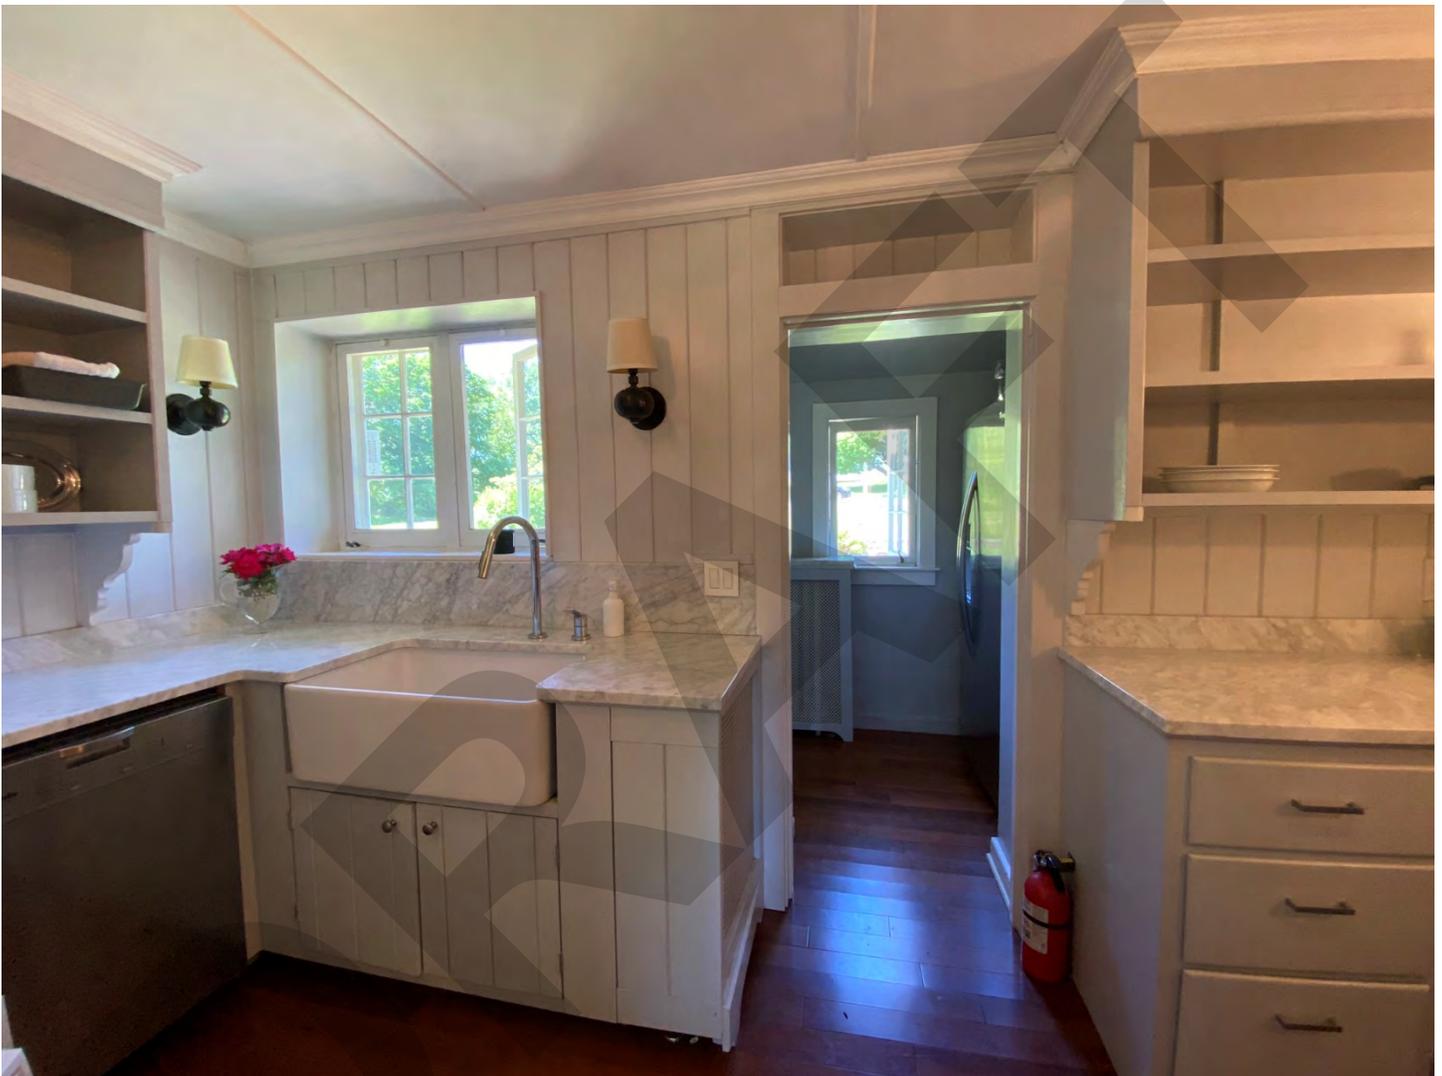
Photo 14

The dining room connects with the modern kitchen (2E), a narrow space dominated by its counters and cabinets (Photo 14). A small addition (2F) was made to the front of the house, attached to the kitchen and the west side of the vestibule. This addition provides a primary, additional access to the kitchen (without going through the living room and dining room) through the modification of what was originally a window opening (Photo 14). A casement window was added to the west of this opening to help better illuminate the kitchen. The addition has its own entrance from the outside, accessed by a small stone porch (Photo 5).

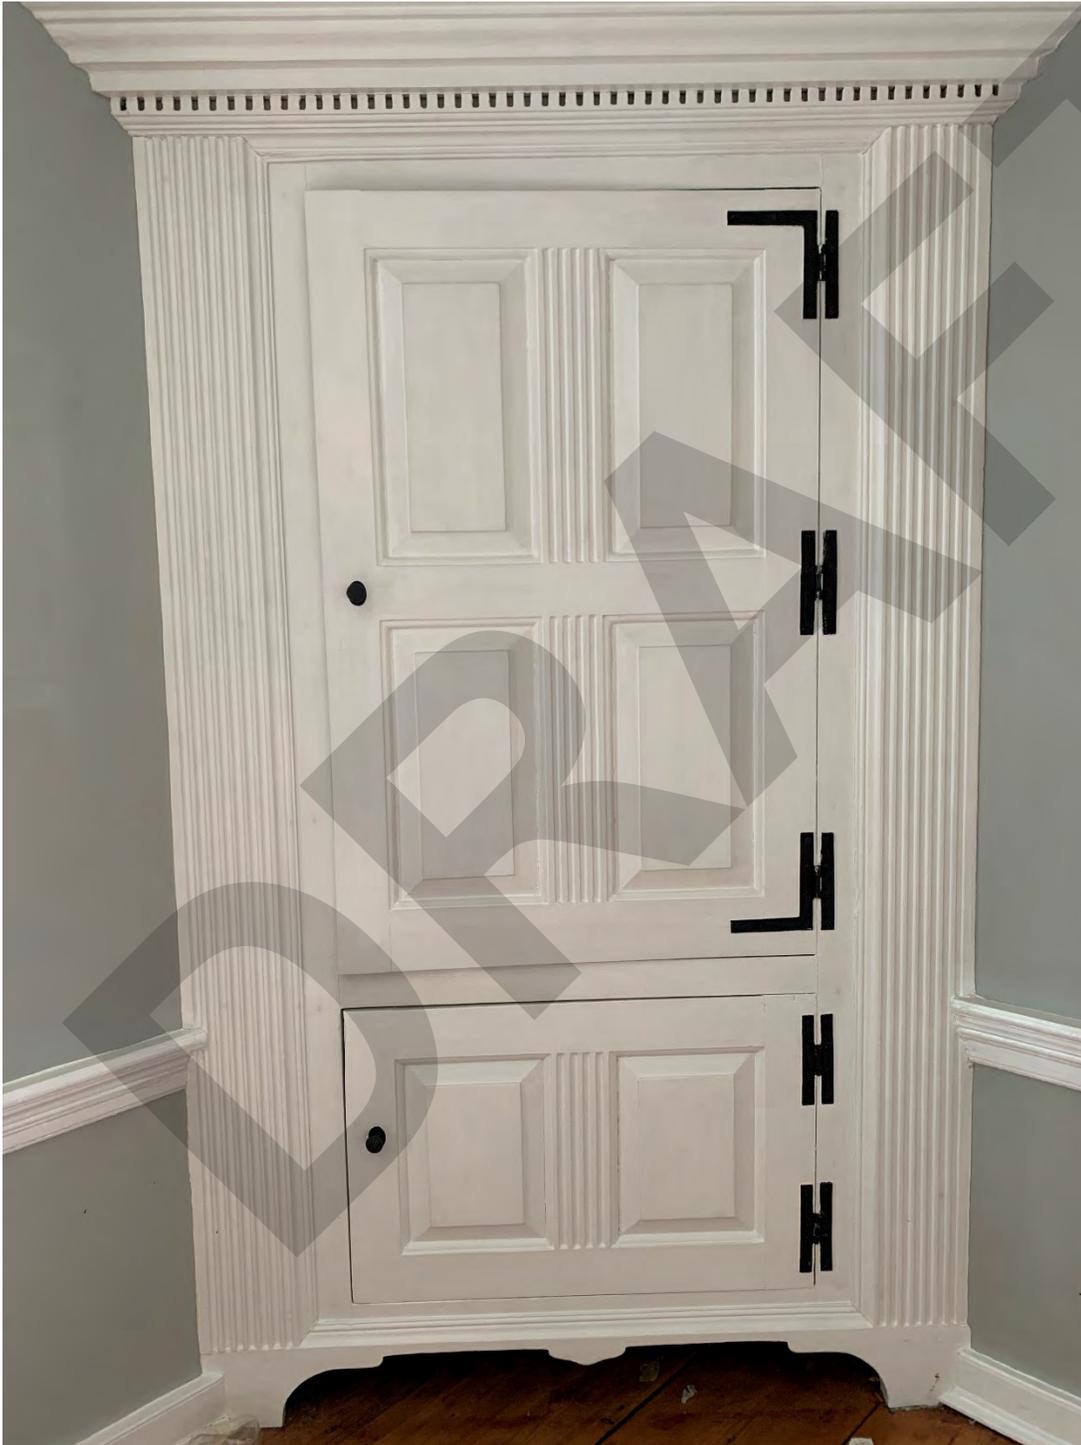
Photo 17

The dining room (2D) is highlighted by a corner cupboard in the southwest corner of the room (Photo 17). This cupboard is of Colonial Revival design, which is further enhanced by the chair rail and baseboard that help fix its lower half in place, and the cornice that connects its upper half to the ceiling. The cupboard's face exhibits vertical fluting in its stiles that is not consistent with 1760s corner cabinetry, and the molding profiles and dentil course in the cornice betray an elaboration more in keeping with Colonial Revival work than with genuine colonial-era work. A small casement window in the west wall of the room helps to illuminate the dining room, and the room's northwest corner is occupied by a corner fireplace that is part of the corner chimney (Photo 18).

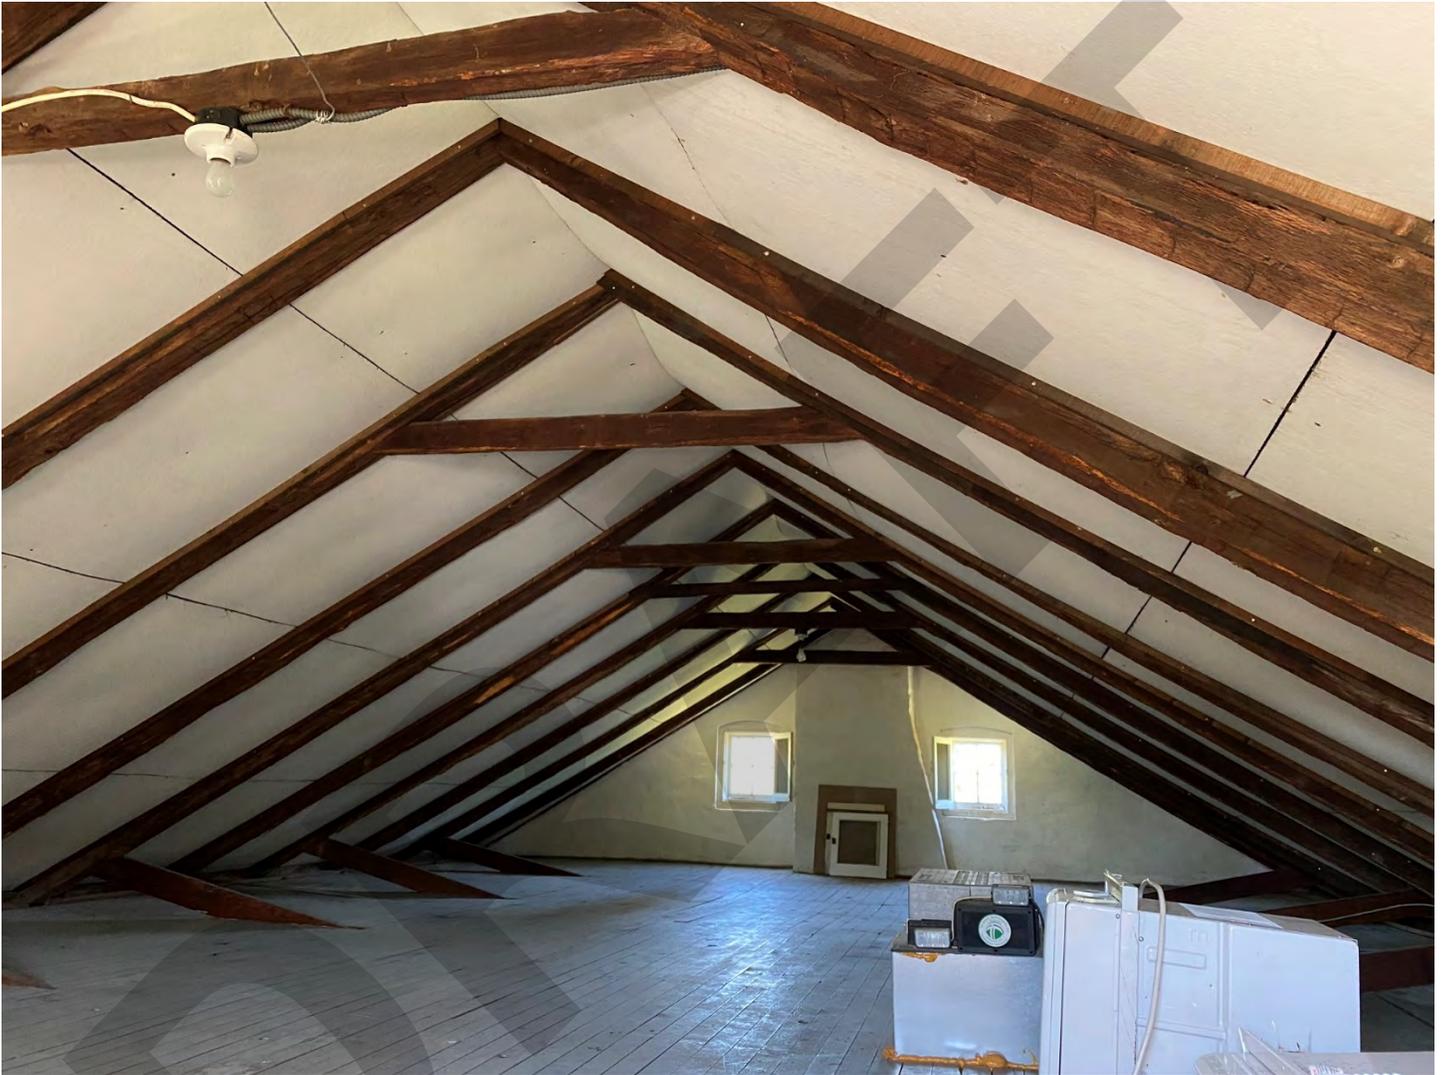
Photo 23

The attic space under the roof is a single, undifferentiated space (Photo 23). It reveals that the structure of the roof is mounted on pairs of common rafters, evidently of oak. High collar ties bind most of the rafter pairs together, and knee braces of a very shallow slope both guard against lateral forces on the front and back walls and help support the attic floor. The attic floor has been replaced. Steel cables were added under the floor for further structural strengthening.
