National Register of Historic Places Registration Form

historic name Thatcher house
other names/site number _____

street & number 255 Ridge Road not for publication
city or town Kingwood Township vicinity
state New Jersey code NJ County Hunterdon zip code _____

Traditional Patterned Brickwork Buildings in NJ MPS

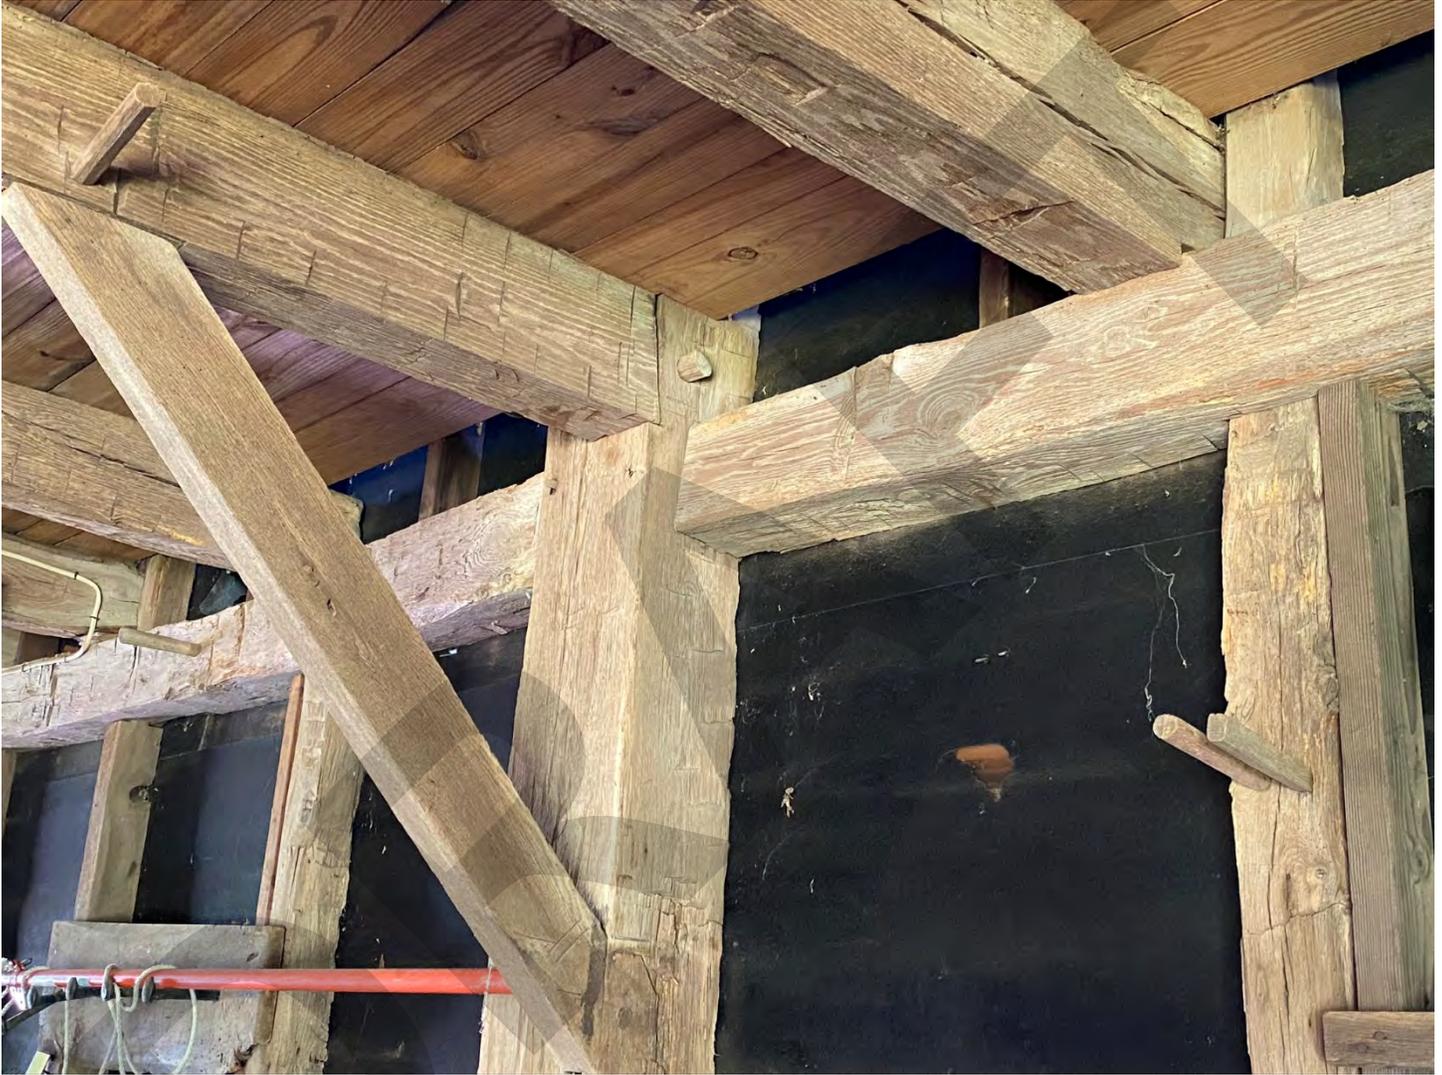
Photo 26

Instead, two small outbuildings, composed of old (likely reused) timber and displaying a variety of framing techniques (Photo 26), stand on the nominated parcel. As buildings they probably date from the second half of the 19th century. The property is accessed by a paved driveway from Ridge Road that swings around the east side of a wagon house that stands about 100 feet to the east of the house (Photo 24). The driveway then swings north toward a small, 1-story barn or shed (Photo 29). The property is largely set out in lawn, with well-spaced deciduous trees, and it is flanked by a private airstrip to the north.

- 25 Wagon house shed
- 26 Wagon house, detail of interior framing
- 27 Wagon house, detail of interior framing
- 28 Wagon house, upper floor
- 29 1-story barn
