NJ/DEP Natural Lands Trust

## Petty's Island Preserve Industrial Heritage Object Survey

April 15, 2015

VITETTA

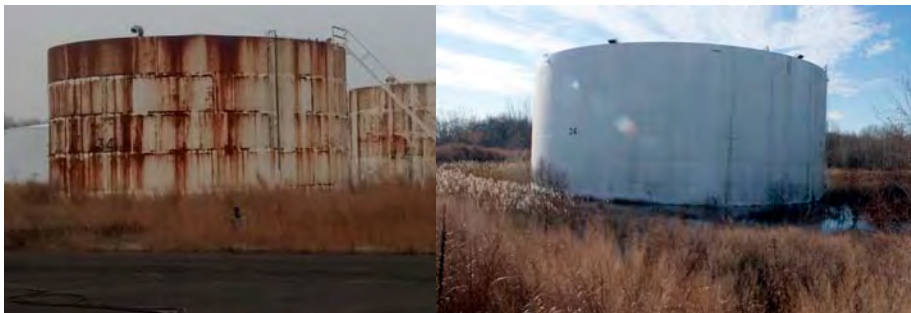
Riveted Tank.

Welded Tank.

Tanks on the site were constructed at various times throughout the history of the site. This can be seen in the aerial photographs as well as the construction methods of the tanks. Large above ground steel storage tanks began being used around the 1880s. At this time they were riveted steel panels. The riveted tanks were used up into the 1920s and 1930s when arc welding was developed. Welded tanks were installed from that point forward. Both riveted and welded tanks are present on site.

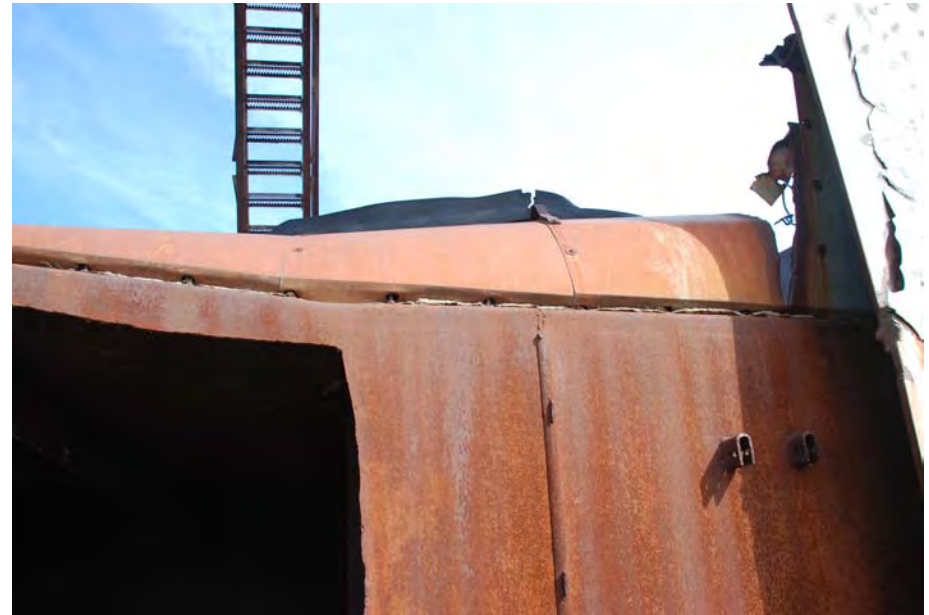
Floating Roof element of tank.

Fixed roof tanks as well as floating roof tanks are also on site. Fixed roof tanks are the early iteration of fuel & oil storage. These kept out rain water, but did not provide for loss of vapor. Fixed roof tanks are used for diesel and kerosene. Floating roof tanks are used for gasoline. They were developed to help prevent loss of gasoline through the loss of vapor. There are also tanks that have been insulated (possibly with asbestos insulation) on site. It is believed that these held either crude oil or asphaltic material.

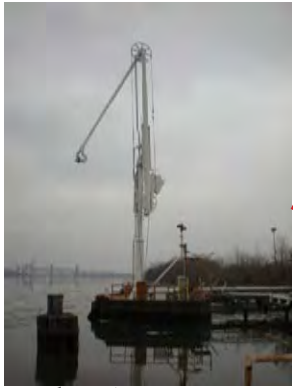
Loading Arm on Breasting Dolphin to load/unload ships.

Between 1970 and 1992 the two story brick building at the north side of the island was removed and the three breasting dolphins were built. The ability to directly load vessels is one of the features of the island that make it unique among many tank farms. Ships were able to dock at the wharf and later on the breasting dolphins and either unload or load fuel/oil. On the center breasting dolphin is a loading arm. This arm was swung out over the river to the ship and either pumped or extracted fuel/oil to the ship. Neither rail lines nor truckers were needed to transport the fuel/oil.

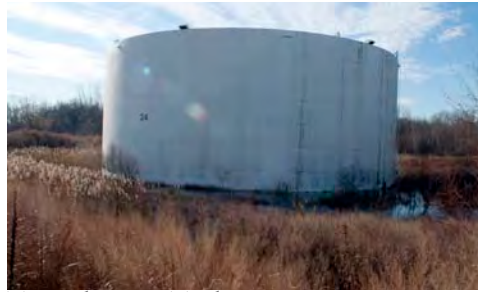
Typical Large Tank

The large tanks on site are approximately 100 feet in diameter and hold approximately 4 million gallons.

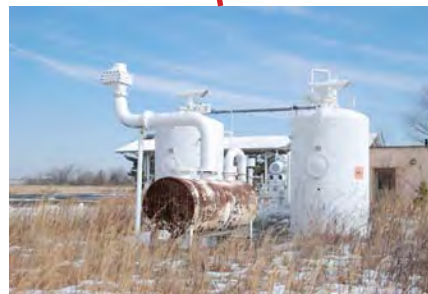
Remediation Equipment

**Object Description:** Used to monitor the amount of contamination that was being removed from the soil. The large tanks to either side is where the contaminated material that had been removed was stored. The controls did not come in contact with the hazardous material and are therefore safe. This is a piece of early remediation equipment from when remediation regulations were first put in place. And while it is no longer functioning, it represents early remediation technology.

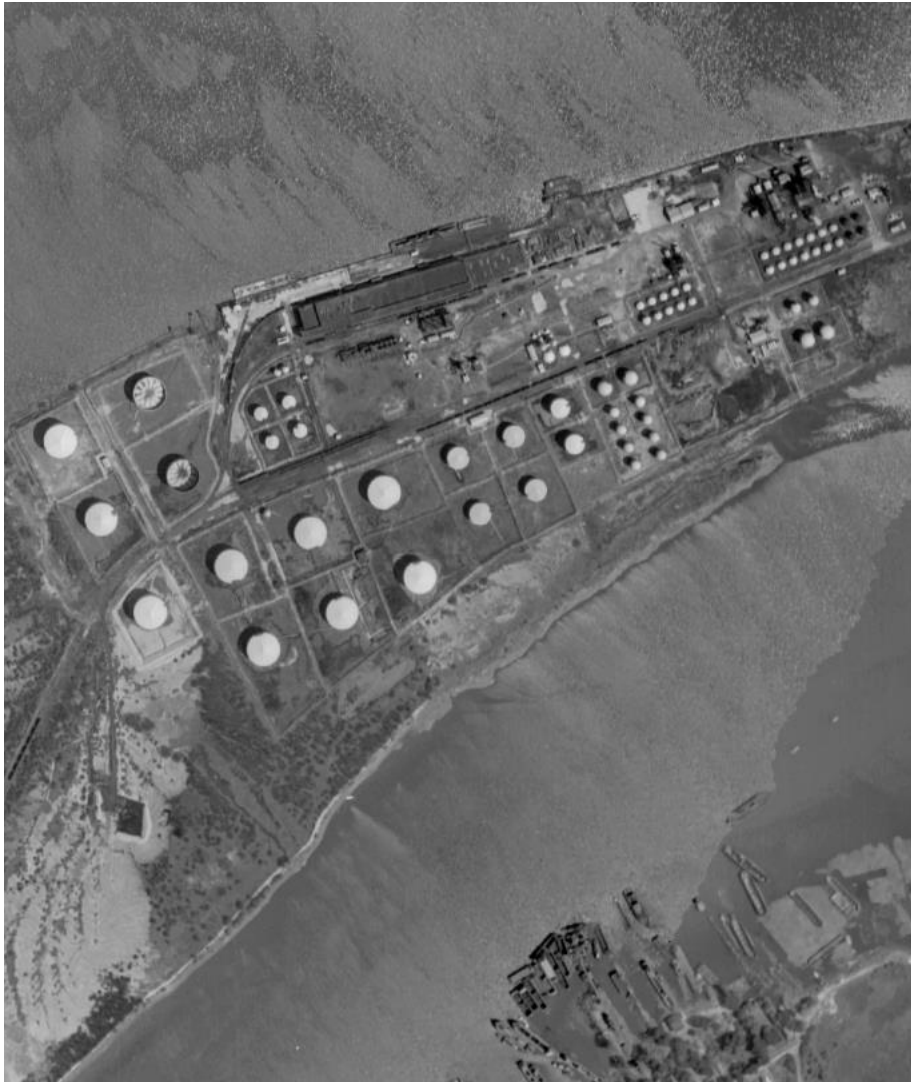
1940

The aerial photograph shows the storage building on the north shore of the island and the extensive number of tanks. The wharf runs along the storage building and is where shipping vessels would dock to be loaded and unloaded.

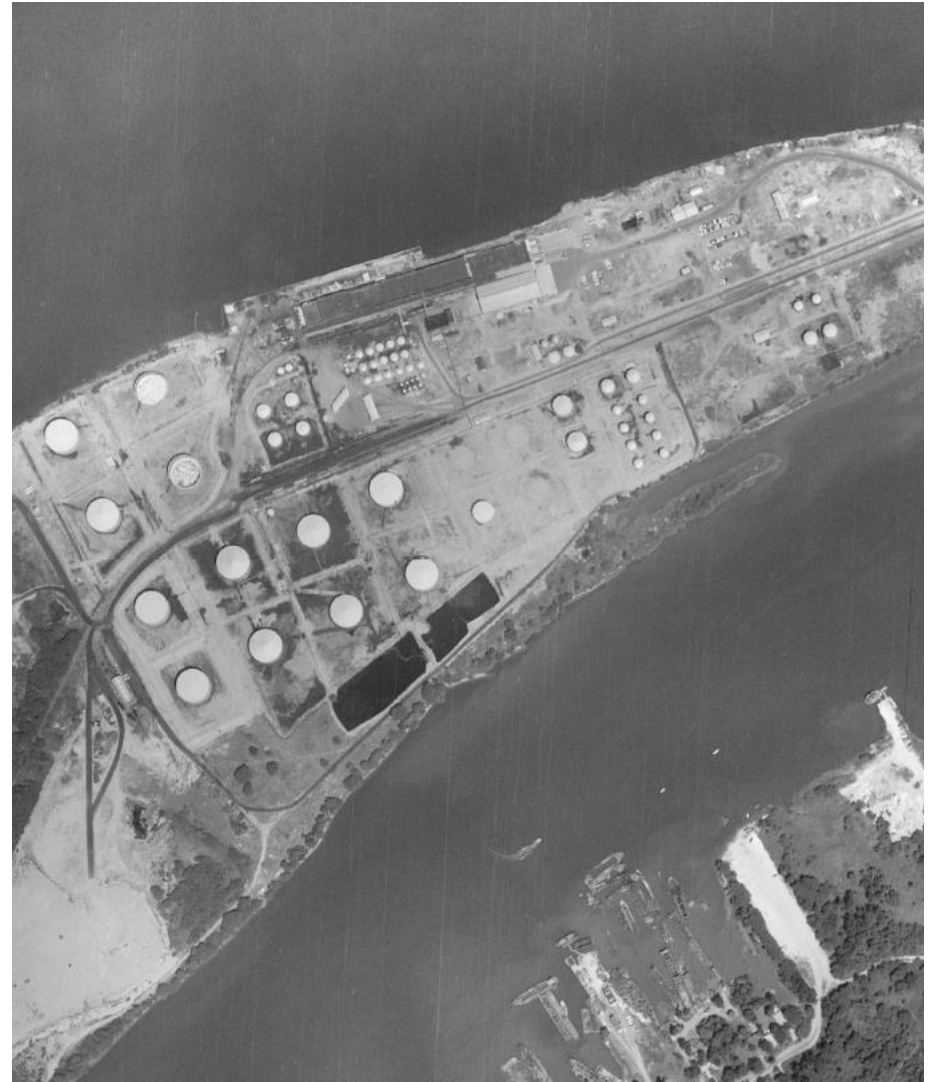
1963 show a decrease in the number of storage tanks and structures on site as well as some new traffic patterns. A new structure was built on the south side of the storage building. The south side of the island has what appears to be new retention areas along the shore line.

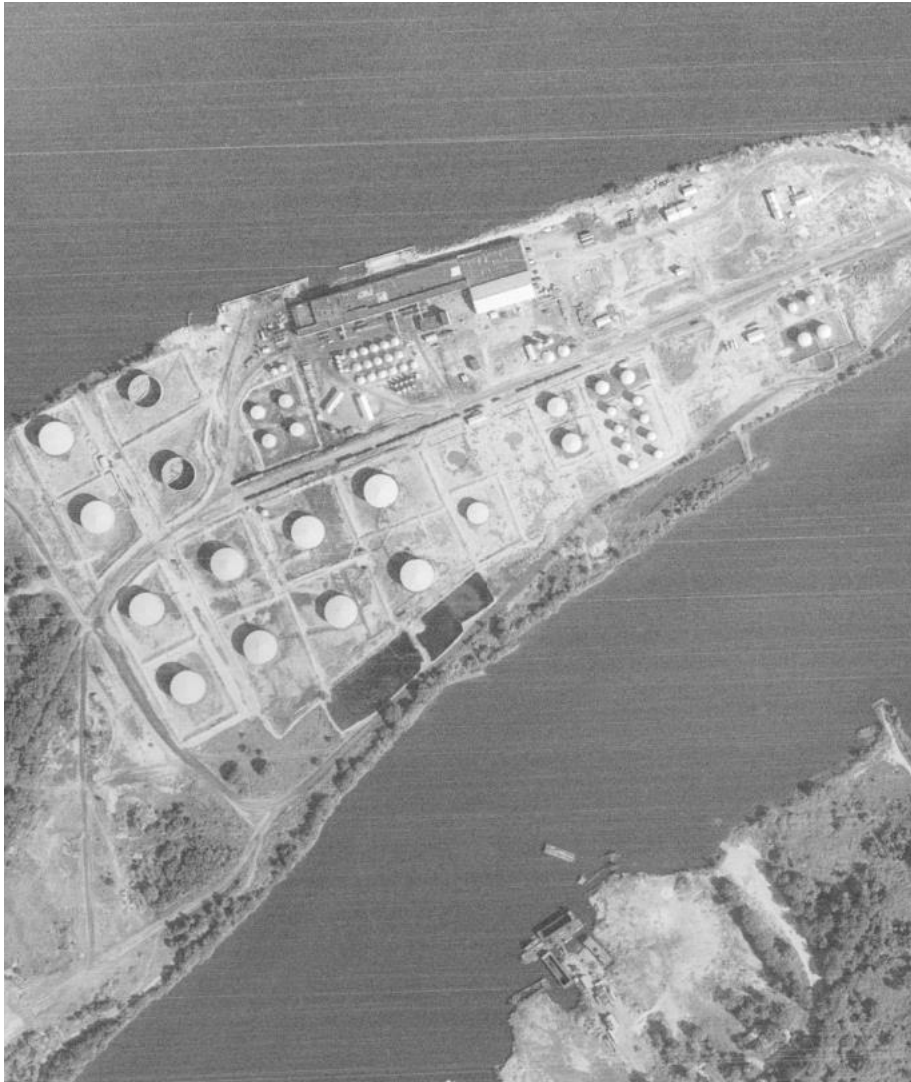
1970

The number of tanks appears to be similar from 1963. The non-industrial section of the island appears to be filling in with plant life.

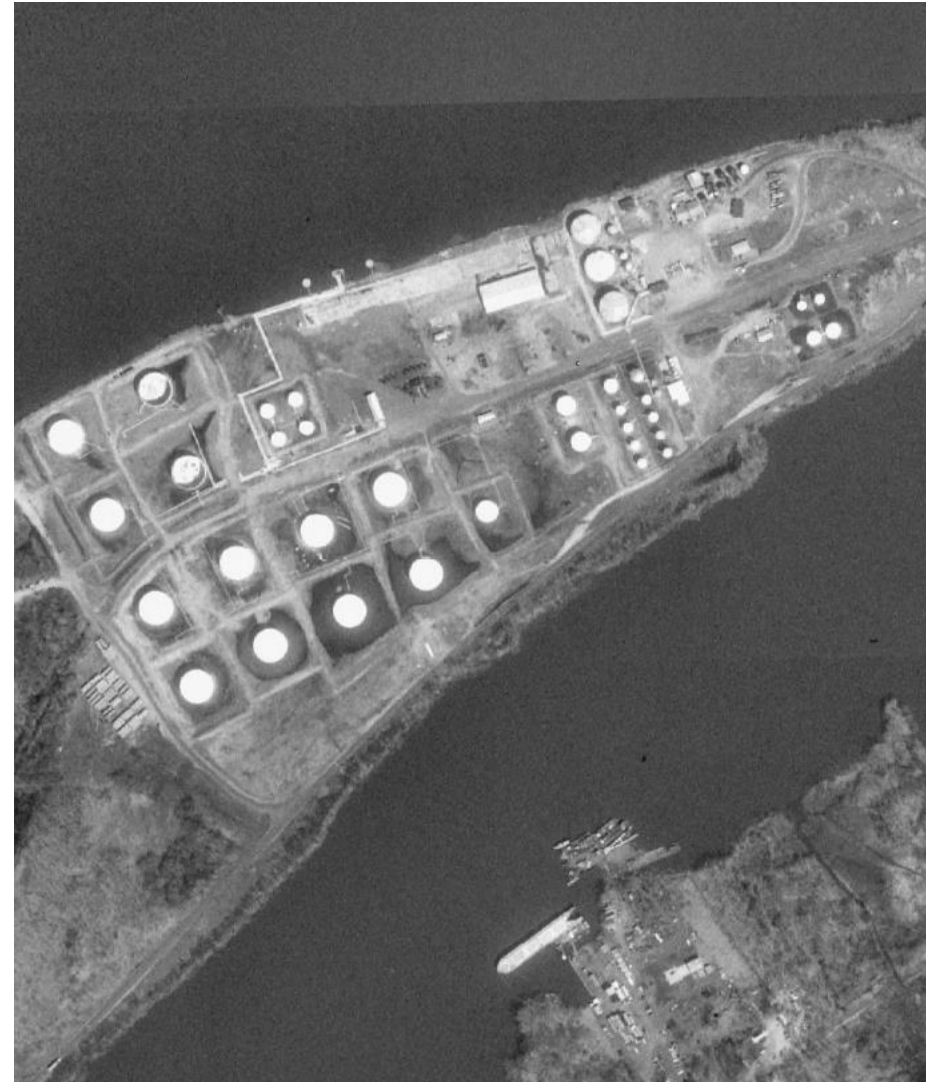
1992

The storage building was removed sometime between 1970 and 1992. The breasting dolphins were constructed during this time as well. Some of the smaller tanks on the north side have been removed and three larger tanks installed to the east of the old storage building. The retention areas on the south side have also been removed.

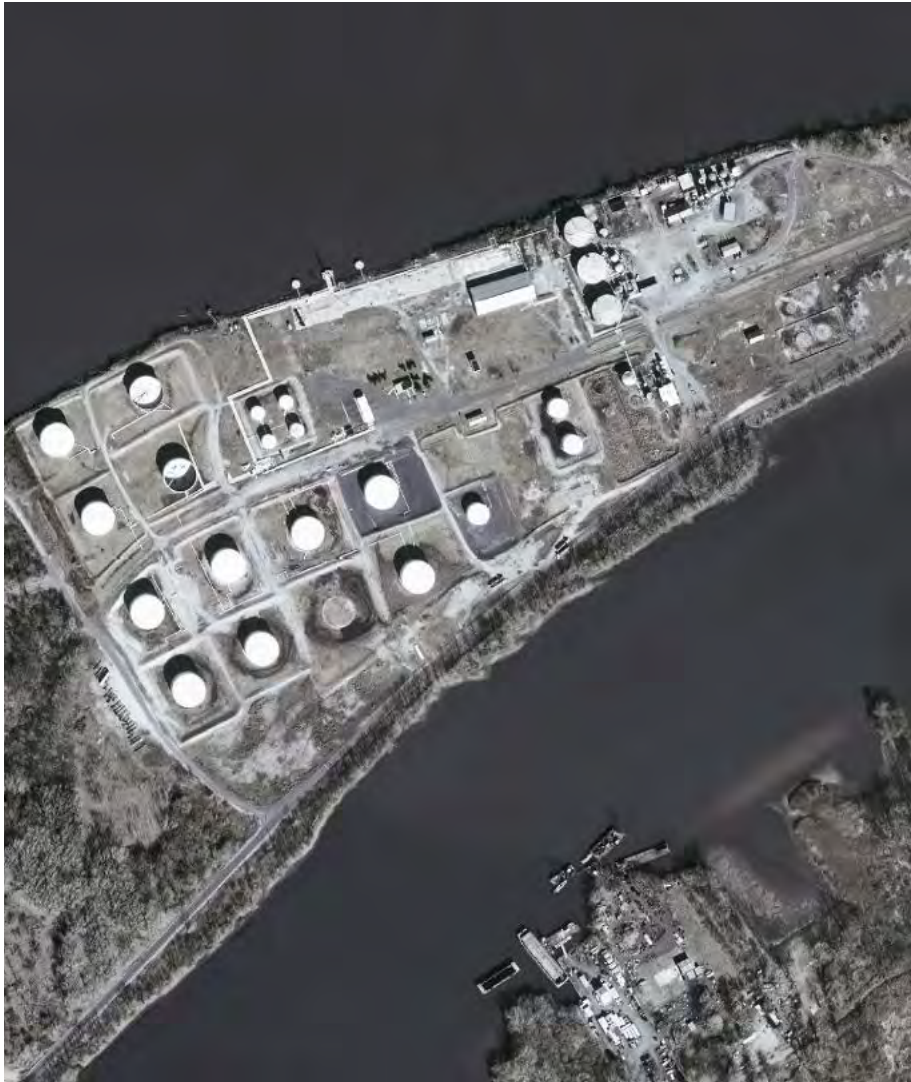
2002 is approximately when CITGO ceased its operations on the island. Buildings and tanks have been removed and the unindustrialized portion of the site becomes more heavily forested.

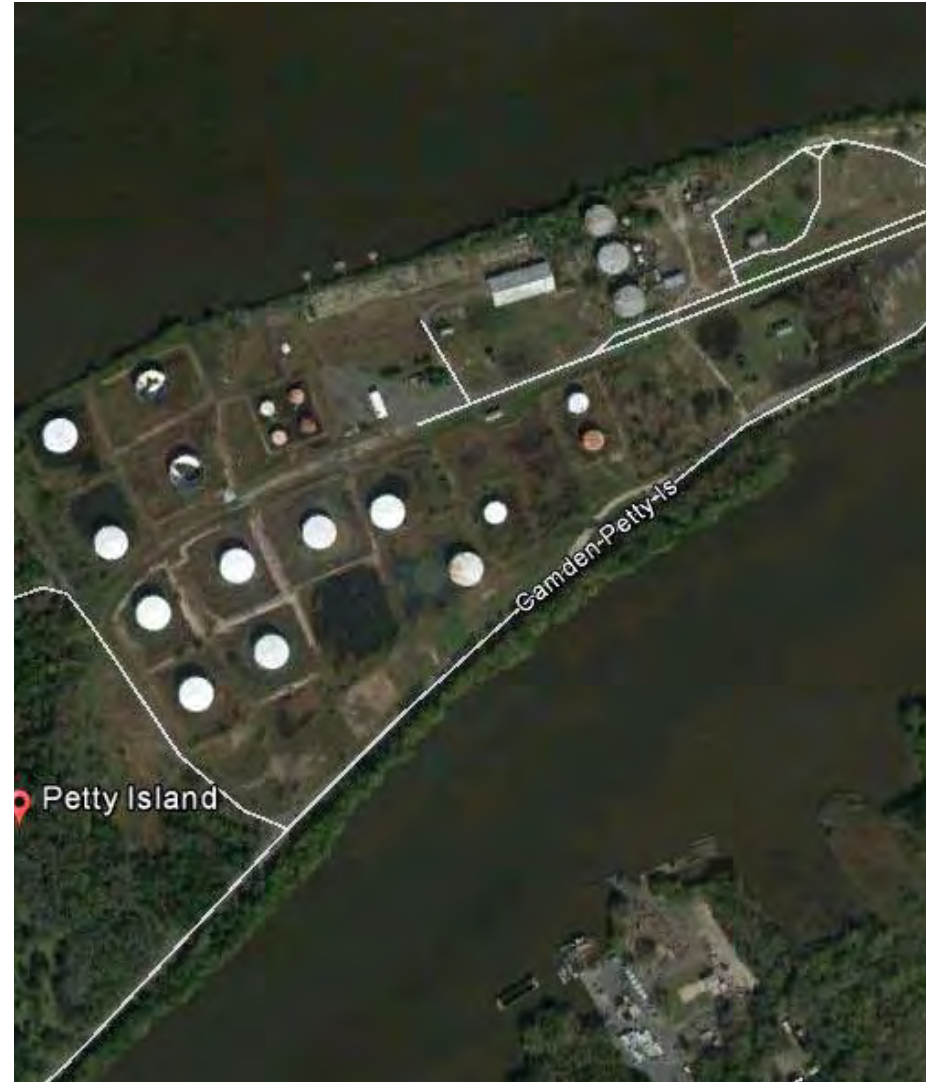
2013

This aerial photograph shows the island as it exists today, a much pared down version of the 1940 site.

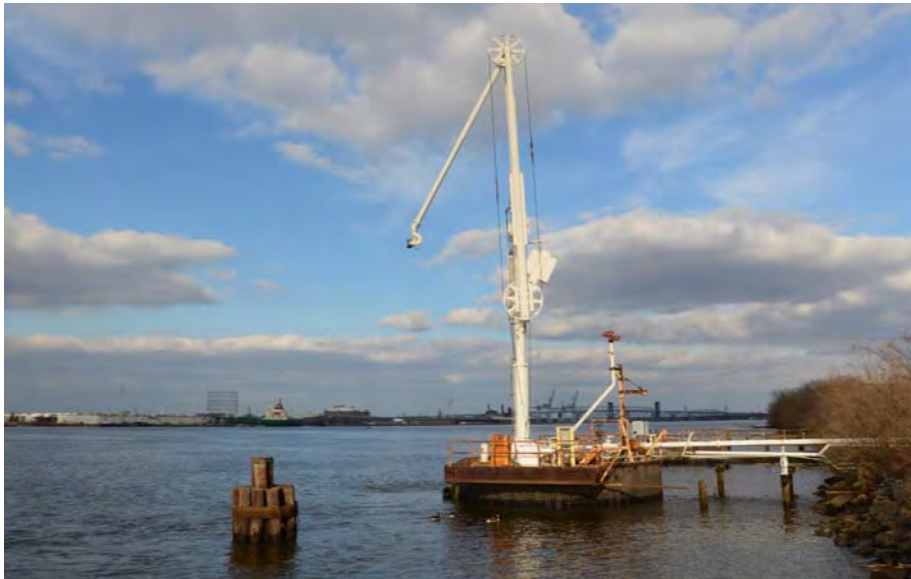
### Breasting Dolphin with Loading Arm

**Object Description:** Under the conservation easement, the Trust agreed that the three breasting dolphins (also called a berthing dolphins or a mooring dolphins) located off the shoreline of Petty's Island can remain in place. With structural improvements, the Trust plans to use the breasting dolphins as river overlooks. The breasting dolphins were used as piers for shipping vessels to dock during loading and unloading. They were also used to display regulatory information for passing ships. A loading arm is located on the center dolphin. This arm would swing out and connect to the ships so fuel/oil could be loaded or unloaded from the ship. Being able to load and unload directly onto shipping vessels was one of the unique elements to Petty's Island as a storage and refinery operation. Under the easement, the loading arm is to be removed by CITGO.

**Potential Use A:** Subject to structural integrity analysis, leave the loading arm in place and interpret it as a sculptural element to explain ship loading.

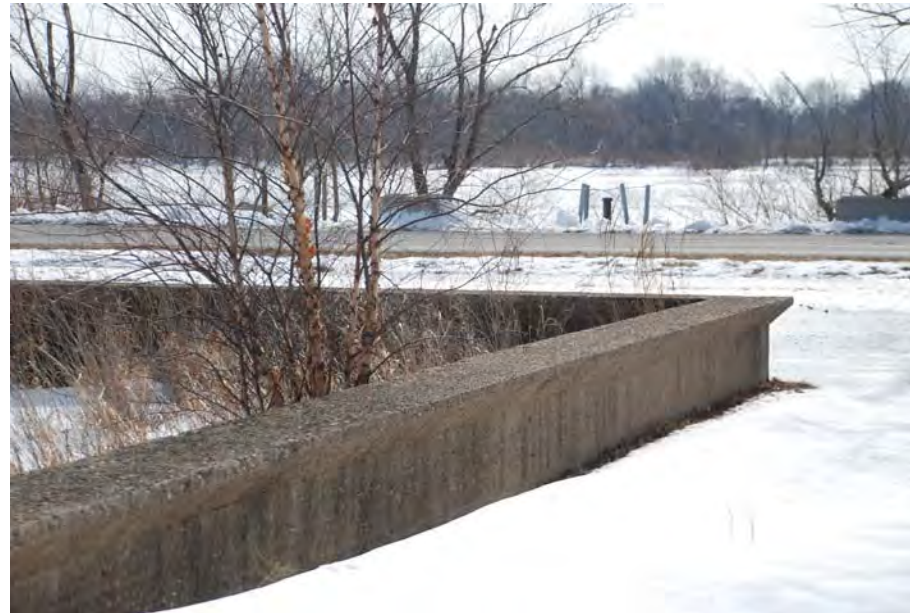
## Concrete Dikes

**Object Description:** Dikes were required around all fuel storage tanks to contain the fuel if the tank leaked. They were designed to hold 110% of the tanks capacity and prevent soil contamination.

**Potential Use A:** Habitat - Currently they surround areas of marshy soil and tall grasses that support wildlife.

**Potential Use B:** Location where native plants can be cultivated before they reach maturity and can be relocated on the site.

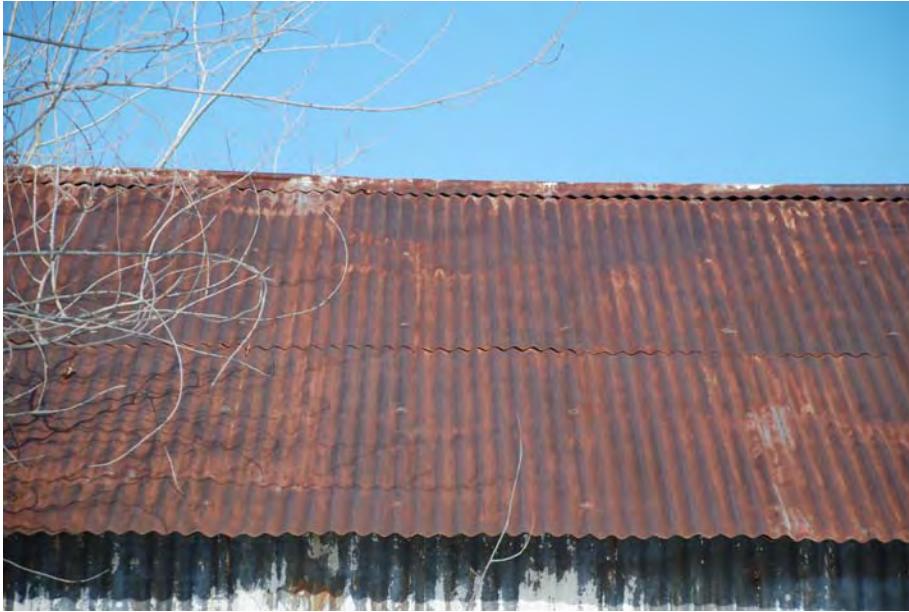
## Corrugated Metal Roofing

**Object Description:** Light-weight metal roofing with a corrugated profile found on the welding and carpenter shop building as well as other buildings on the site.

**Potential Use A:** Wall cladding for composting toilets or other site structures.

**Potential Use B:** Incorporated into site activity space such as a maze or amphitheater area.

**Potential Use C:** Used as signage. Maps and interpretive material could be painted on the metal to serve as information and wayfinding.

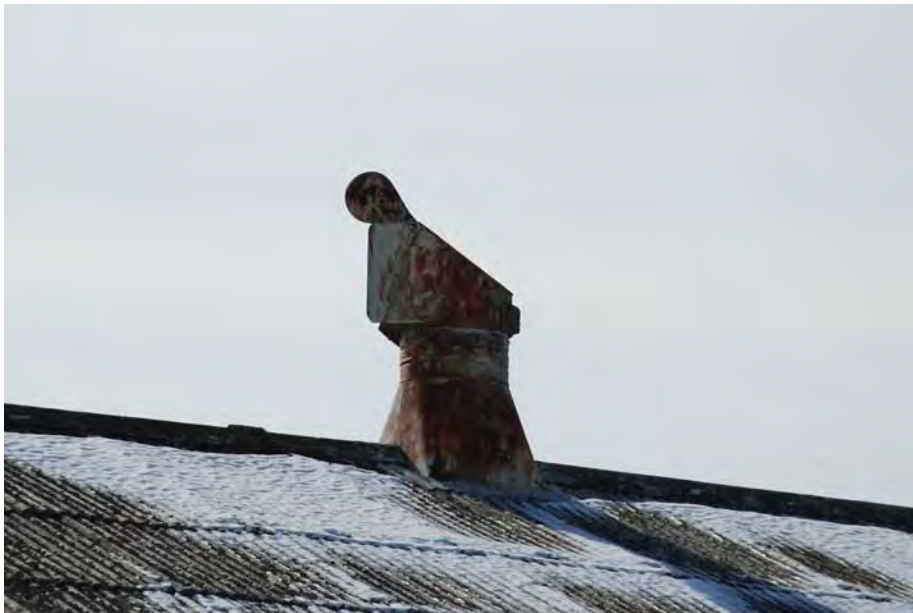
## Exhaust Hoods

**Object Description:** Exhaust hoods were used on top of buildings where people were working with dust and fumes. The hoods usually contained fans that could be used to draw the fumes away from the work below and exhaust them to the outside.

**Potential Use A:** Signage stands. The interpretive material can be inset into the hoods and be sheltered from the elements.

**Potential Use B:** Path lighting.

**Potential Use C:** Sculptural elements to explain how ventilation of buildings was accomplished when working with the strong fumes of refining oil.

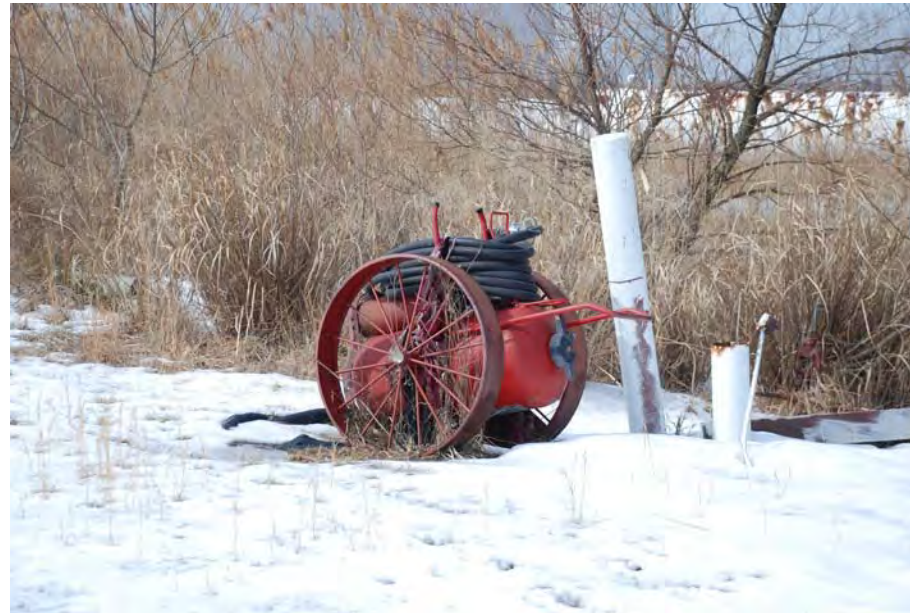
## Fire Cart

**Object Description:** Used to put out fires that occurred in the fuel pipe and occasionally within the tanks. The storage tank below would have been filled with either a chemical or foam material that could be used on gas fires.

**Potential Use A:** Artifact placed on site to explain potential dangers of oil storage/refining and the measures that were taken to prevent them.

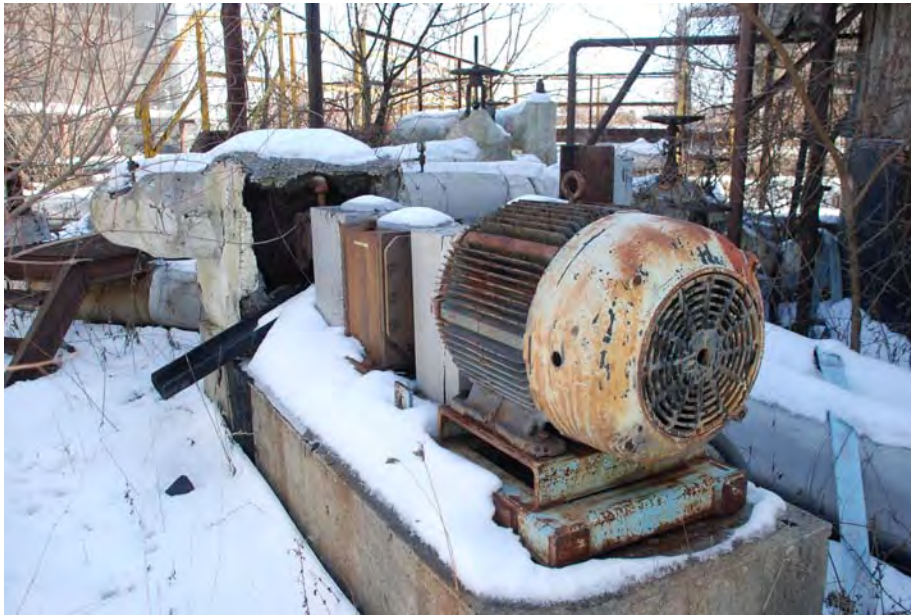
## Fuel Pump

**Object Description:** Fuel pump to move fuel/oil through the pipes around the site.

**Potential Use A:** Artifact placed on site to explain how fuel and oil were moved around the site.

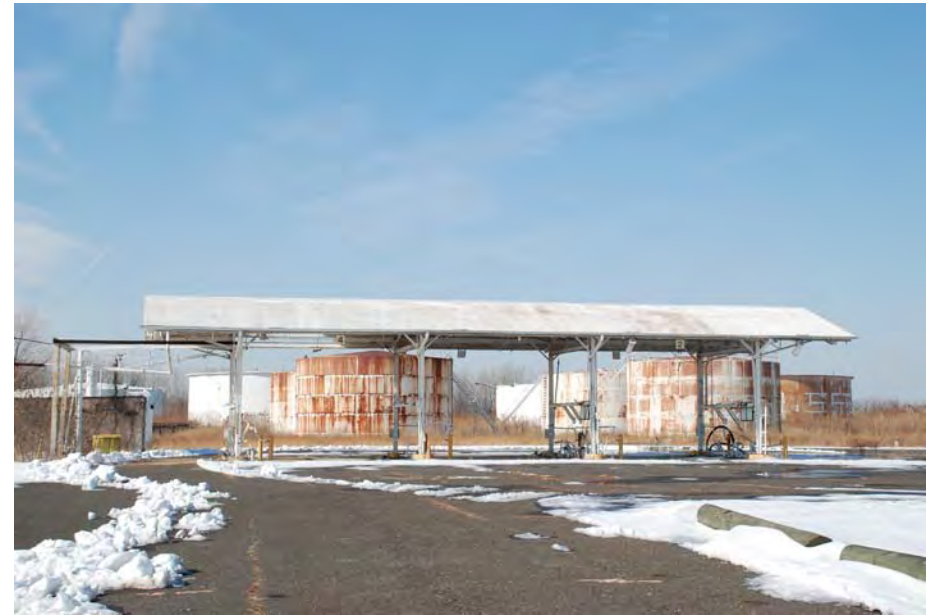
## Fuel Shelter

**Object Description:** Tanker trucks pulled under the shelter and loaded/unloaded for distribution. The structural integrity of the shelter has not been evaluated.

**Potential Use A:** Picnic Shelter for visitors.

**Potential Use B:** Classroom shelter for when students come to do small experiments and learn about the flora/fauna of the island.

**Potential Use C:** Location of a series of small interpretive materials/objects about the industrial heritage of the island.

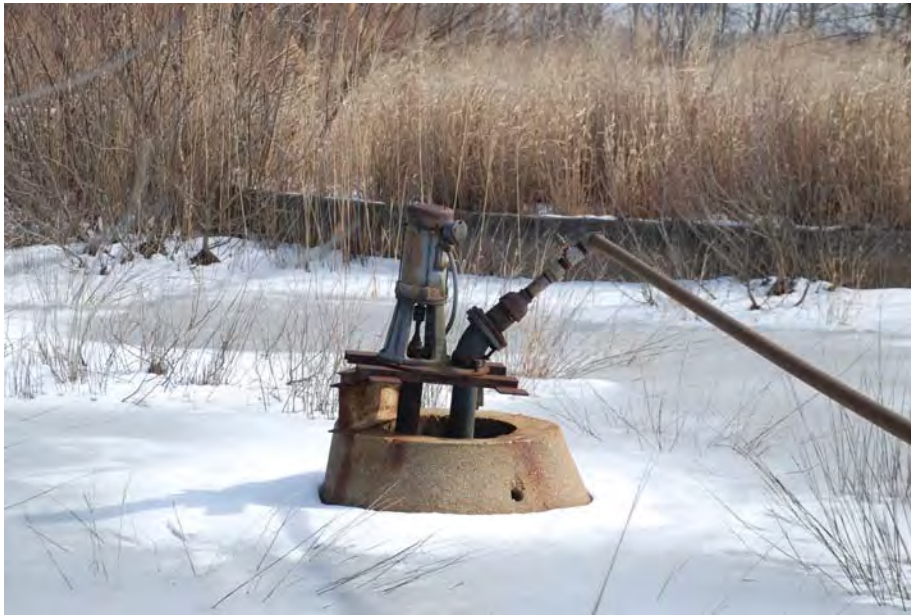
## Pump

**Object Description:** Vertical pump within the dikes used to pump water/fuel out of the reservoir created by the dike. May have been used as part of the site remediation process in the past.

**Potential Use A:** Leave within concrete wall habitats for context.

**Potential Use B:** Sculpture

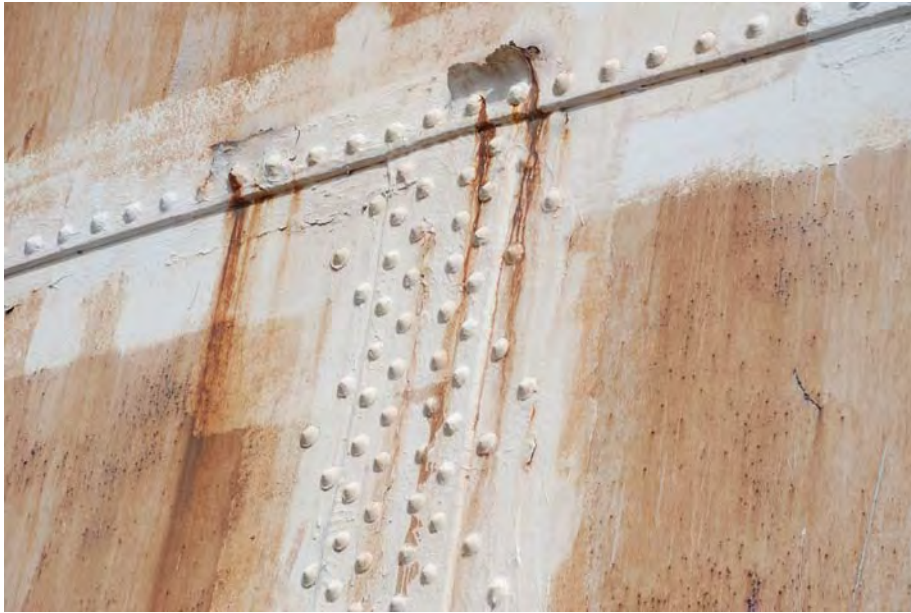
## Rivets

**Object Description:** Prior to the 1920s when welding was developed, storage tanks were constructed using rivets. After the 1930s tank construction was entirely done through welding steel panels together.

**Potential Use A:** Sculpture to describe tank technology through time - the use of rivets then welding.

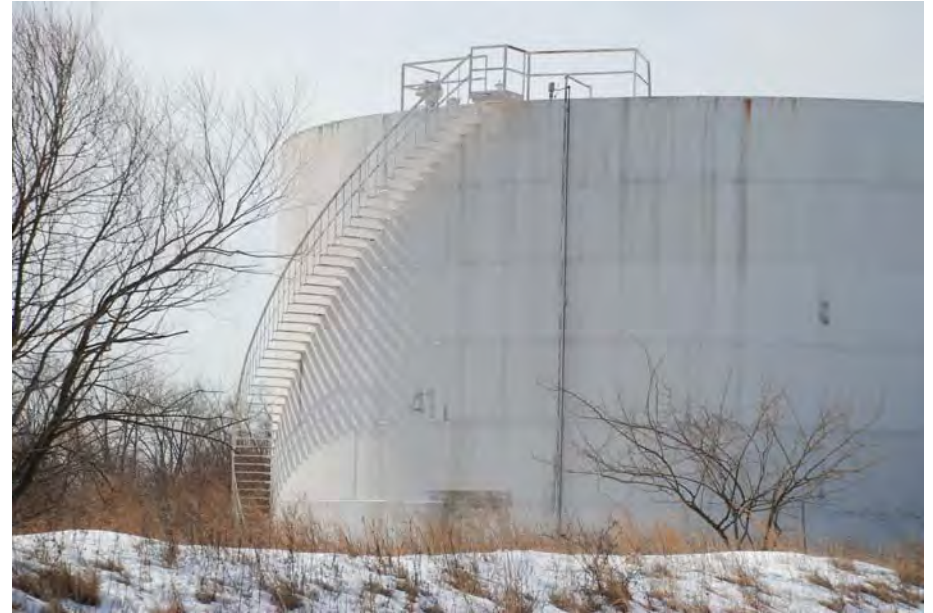
## Stairs

**Object Description:** The stairs provided access to the top of the storage tanks where sample of the fuel were taken to assess quality as well as to measure the amount of fuel that was in the tank. Typically the stairs run up the side of the tanks in a spiral fashion; however, on Petty's Island there are also straight runs of stairs that run in front of the tanks. This fairly unique to typical tank construction.

**Potential Use A:** Treads reads used to create a bridge of wetland habitats to see the flora/fauna of the habitat.

**Potential Use B:** Treads used for paths to provide traction where paths get muddy.

**Potential Use C:** Sculptural element to interpret the height of the fuel storage tanks.

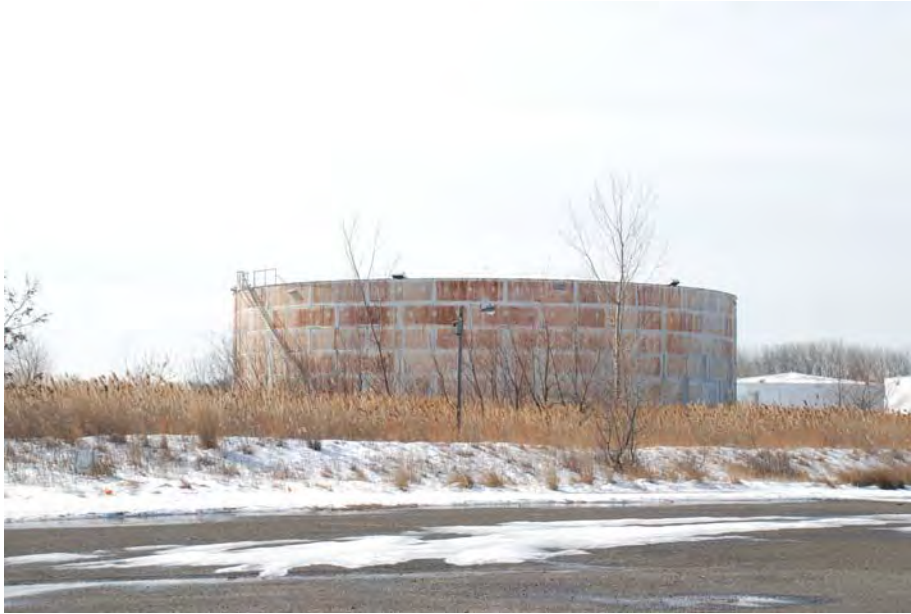
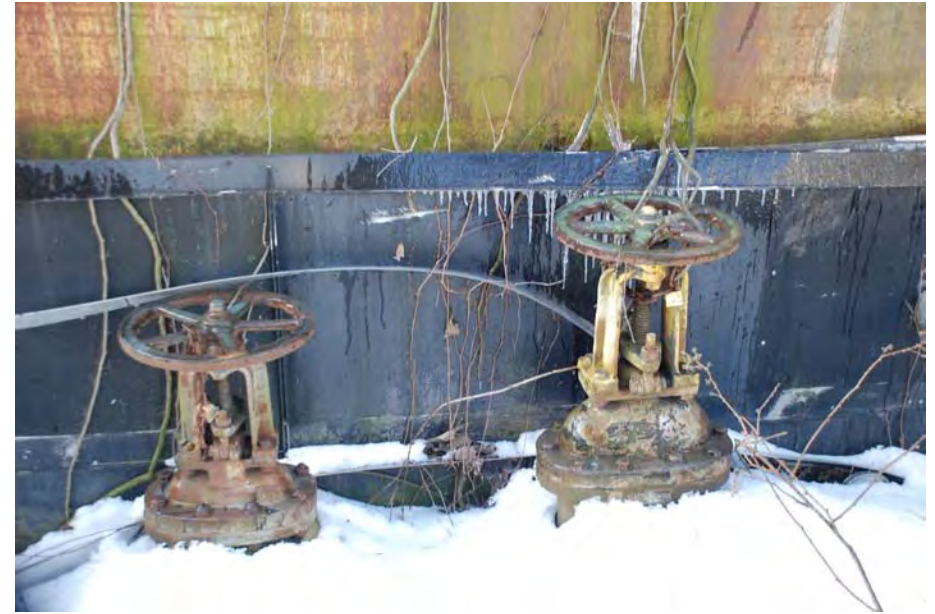
## Tank/Portion of a Tank/ Tank Walls

**Object Description:** Tanks are used to store fuel and oil. They were constructed out of steel panels that were either riveted or welded together. Standard-size tanks are 40 feet high and vary in diameter based on the number of gallons they are meant to hold. The large tanks on the island hold approximately 4 million gallons each.

**Potential Use A:** Use tank elements to form sculptures that interpret the island's industrial heritage in the areas surrounding the visitor's center.

**Potential Use B:** Use tank elements to construct low-tiered amphitheater within a dimensional footprint of an actual tank that could serve as an area to conduct outdoor lectures and classes associated with the center.

**Potential Use C:** Use wall panel of the tank to interpret the overall size of the tanks that were on the site.
