Cedar Grove Brook Watershed Restoration and Protection Plan

New Jersey Department of Environmental Protection

Funded by Section 319(h) Grant ID: RP04-011

July 2011

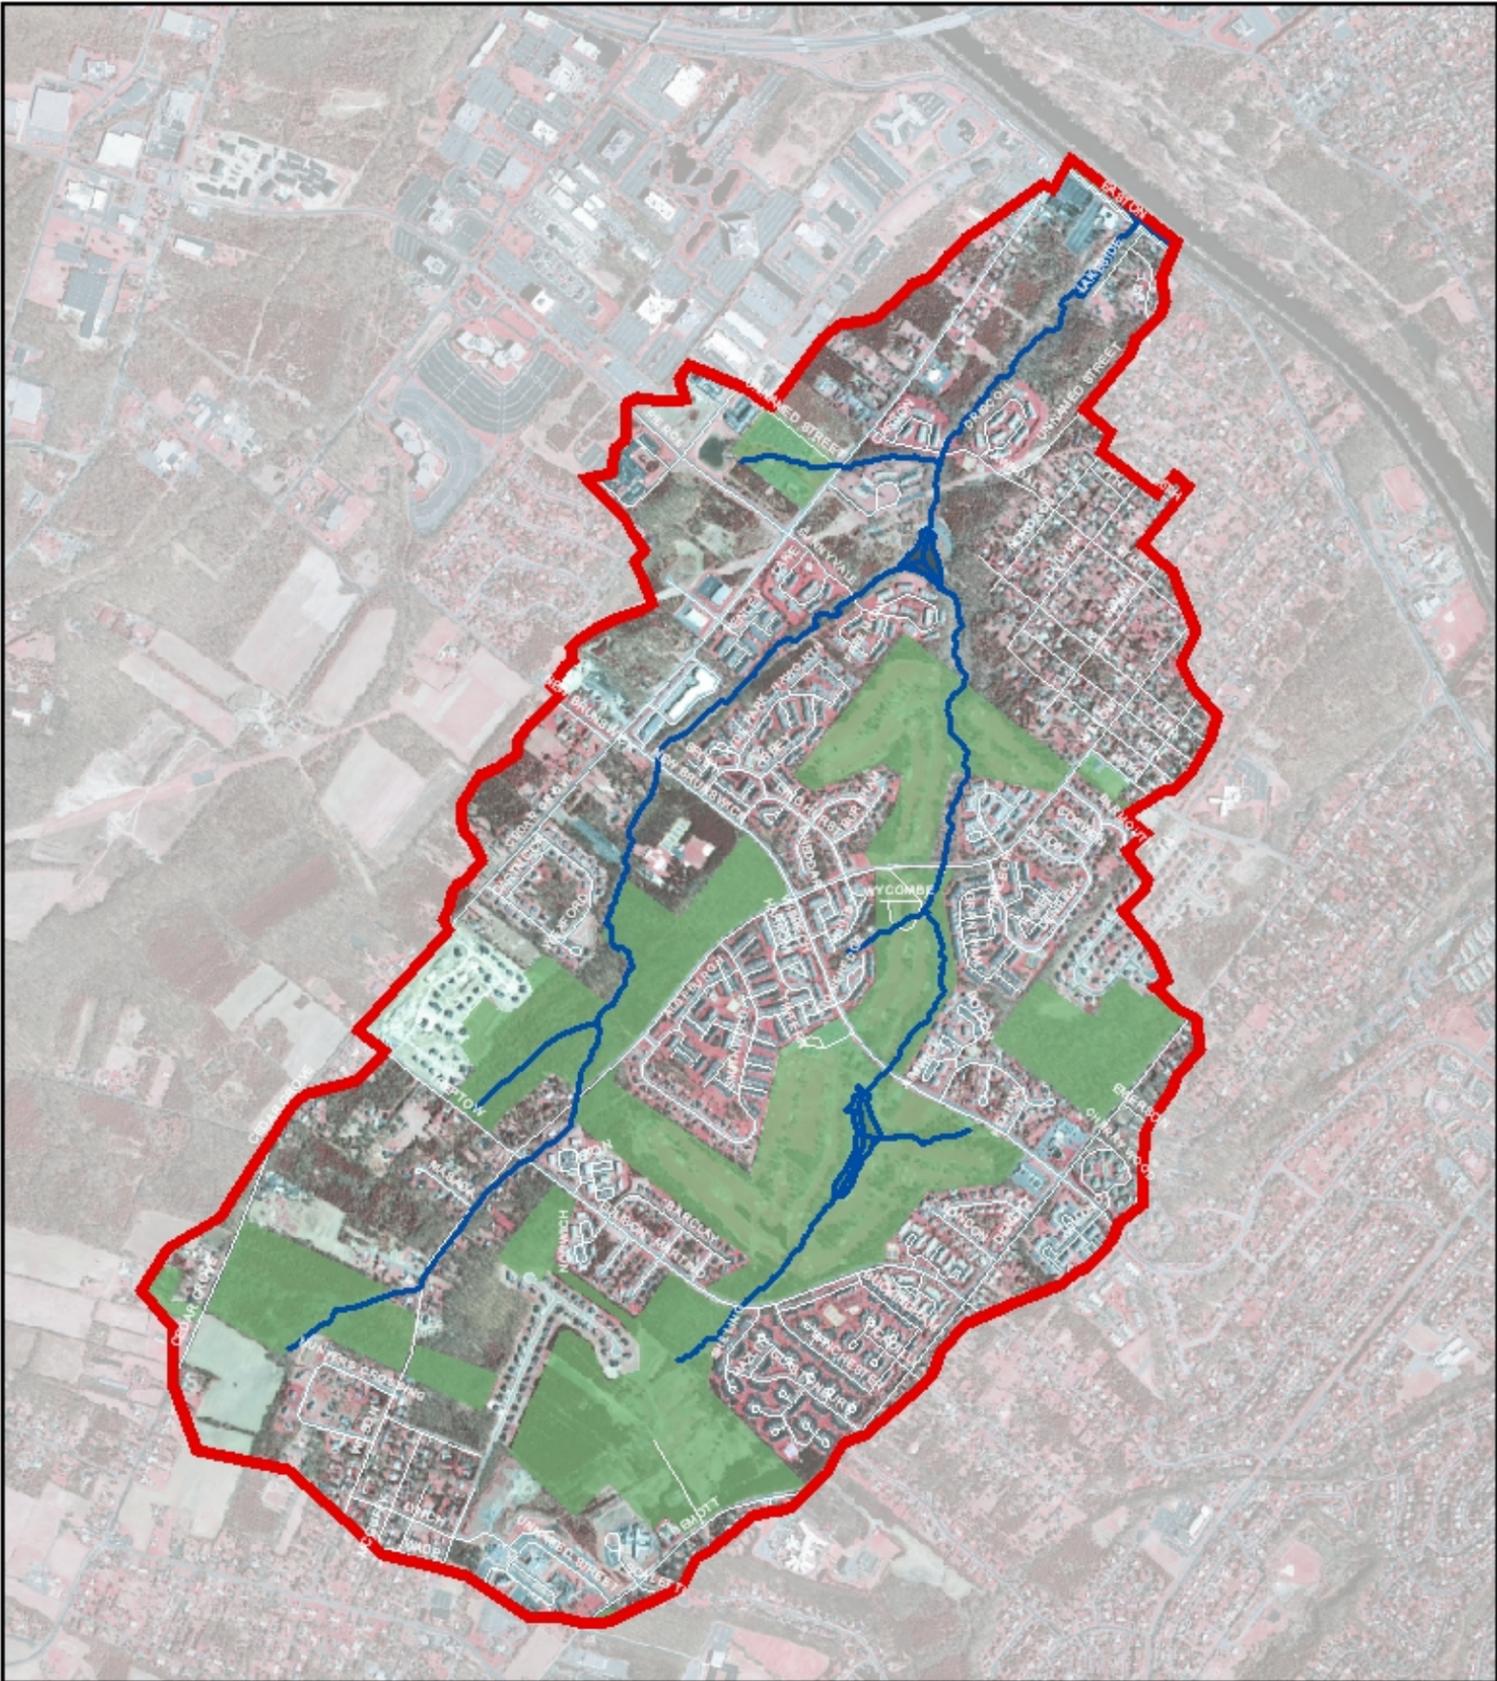
Figure 7. Preserved Lands

The total preserved open space in the Cedar Grove Watershed was 447 acres in 2009, or 25 percent of the total watershed area (Figure 7). Quail Brook Golf Course is owned by Somerset County, most of the rest of the open space in the watershed is owned by Franklin Township. There are isolated pockets of privately-owned open space in the larger residential developments which are maintained by homeowner associations.

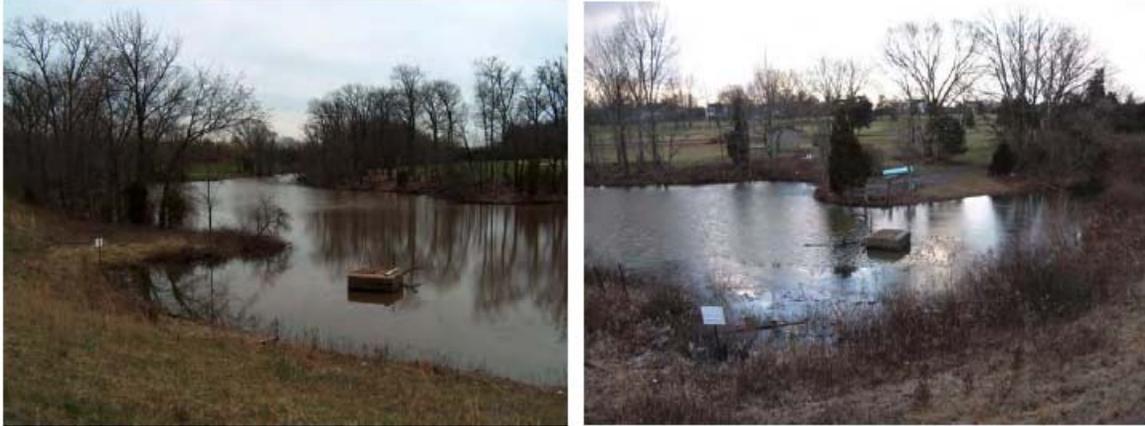
Figure 25. Golf Course Pond

The most upstream of the pond features in Cedar Grove Brook is the Golf Course Pond (Figure 25).

Two potential improvements to the Golf Course Pond were identified to increase the sediment removal rate and thereby reduce the sediment load to the downstream portion of Cedar Grove Brook:

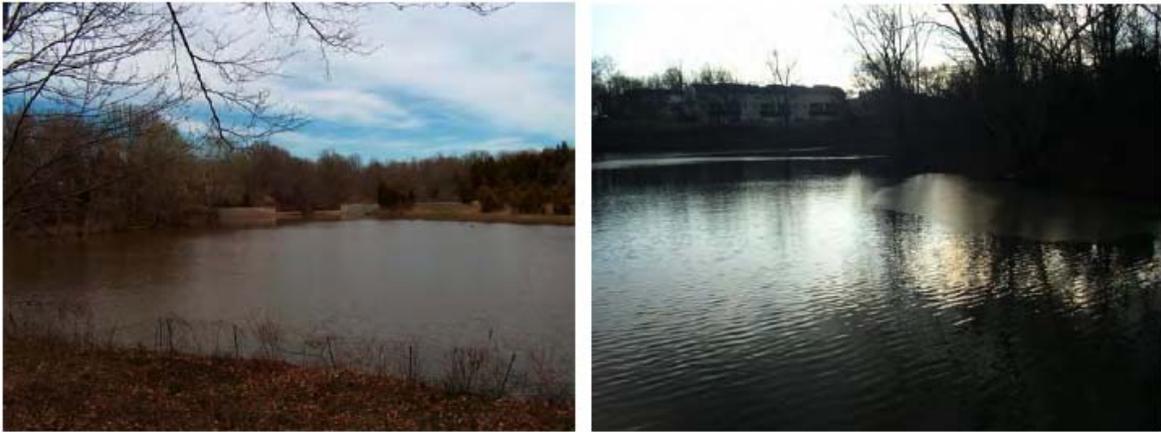
Figure 29. Ukrainian Village Pond

The Ukrainian Village Pond (Figure 29) is downstream of the Golf Course Pond close to the center of the Cedar Grove Brook watershed. The Ukrainian Village Pond is an impoundment with two tributary inlets that discharges to Cedar Grove Brook. A relatively simple modification to the outlet structure is proposed to increase the sediment removal rate and thereby reduce the sediment load to the downstream portion of Cedar Grove Brook.

The existing outlet structure for the Ukrainian Village Pond is a 1-foot square weir within a larger 11-foot weir (Figure 30). According to the WinSLAMM simulations performed for the Ukrainian Village Pond, the existing overall sediment removal rate is approximately 33%.

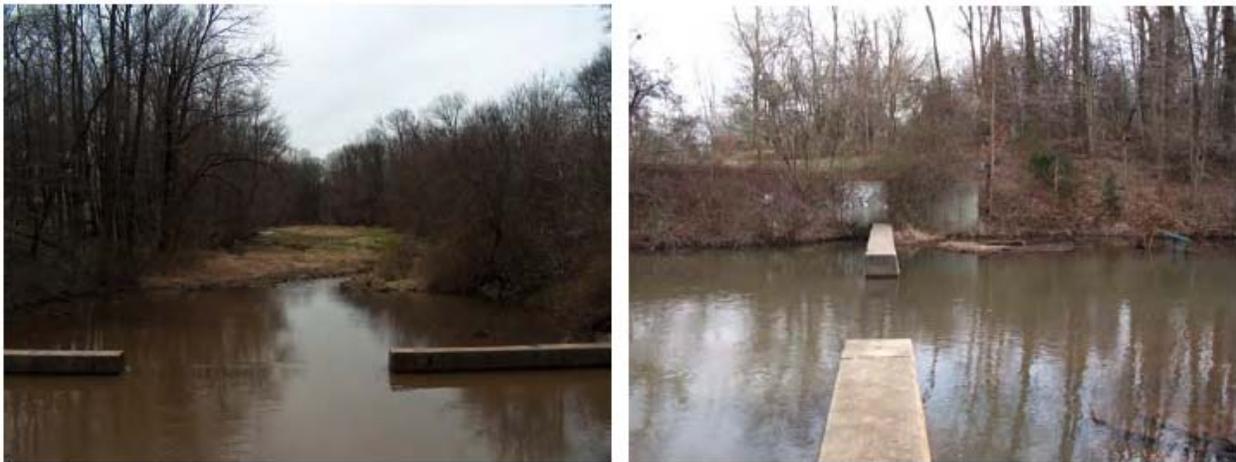
Figure 33. Lower Pond - Cedar Grove Brook Outlet

The outlet of Cedar Grove Brook (called “Lower Pond” for the purposes of this study) is impounded slightly by a dam structure just upstream of the Easton Avenue bridge with a weir that is generally submerged at the crest (Figure 33). Despite the dam structure, the outlet of Cedar Grove would not likely be identified by the casual observer as a pond under current conditions; one can see the bottom less than one foot below the weir crest. Nevertheless, the designation “Lower Pond” was adopted to reflect what this feature would become after the recommended restoration is complete. The reason is that the conceptual improvement identified for the outlet of Cedar Grove Brook to reduce the sediment load to the D&R Canal is a significant modification to the outlet structure. This modification would increase the height of the weir crest, resulting in a permanent pool of water 5 to 7 feet deep, thereby making it a more easily recognized pond feature.

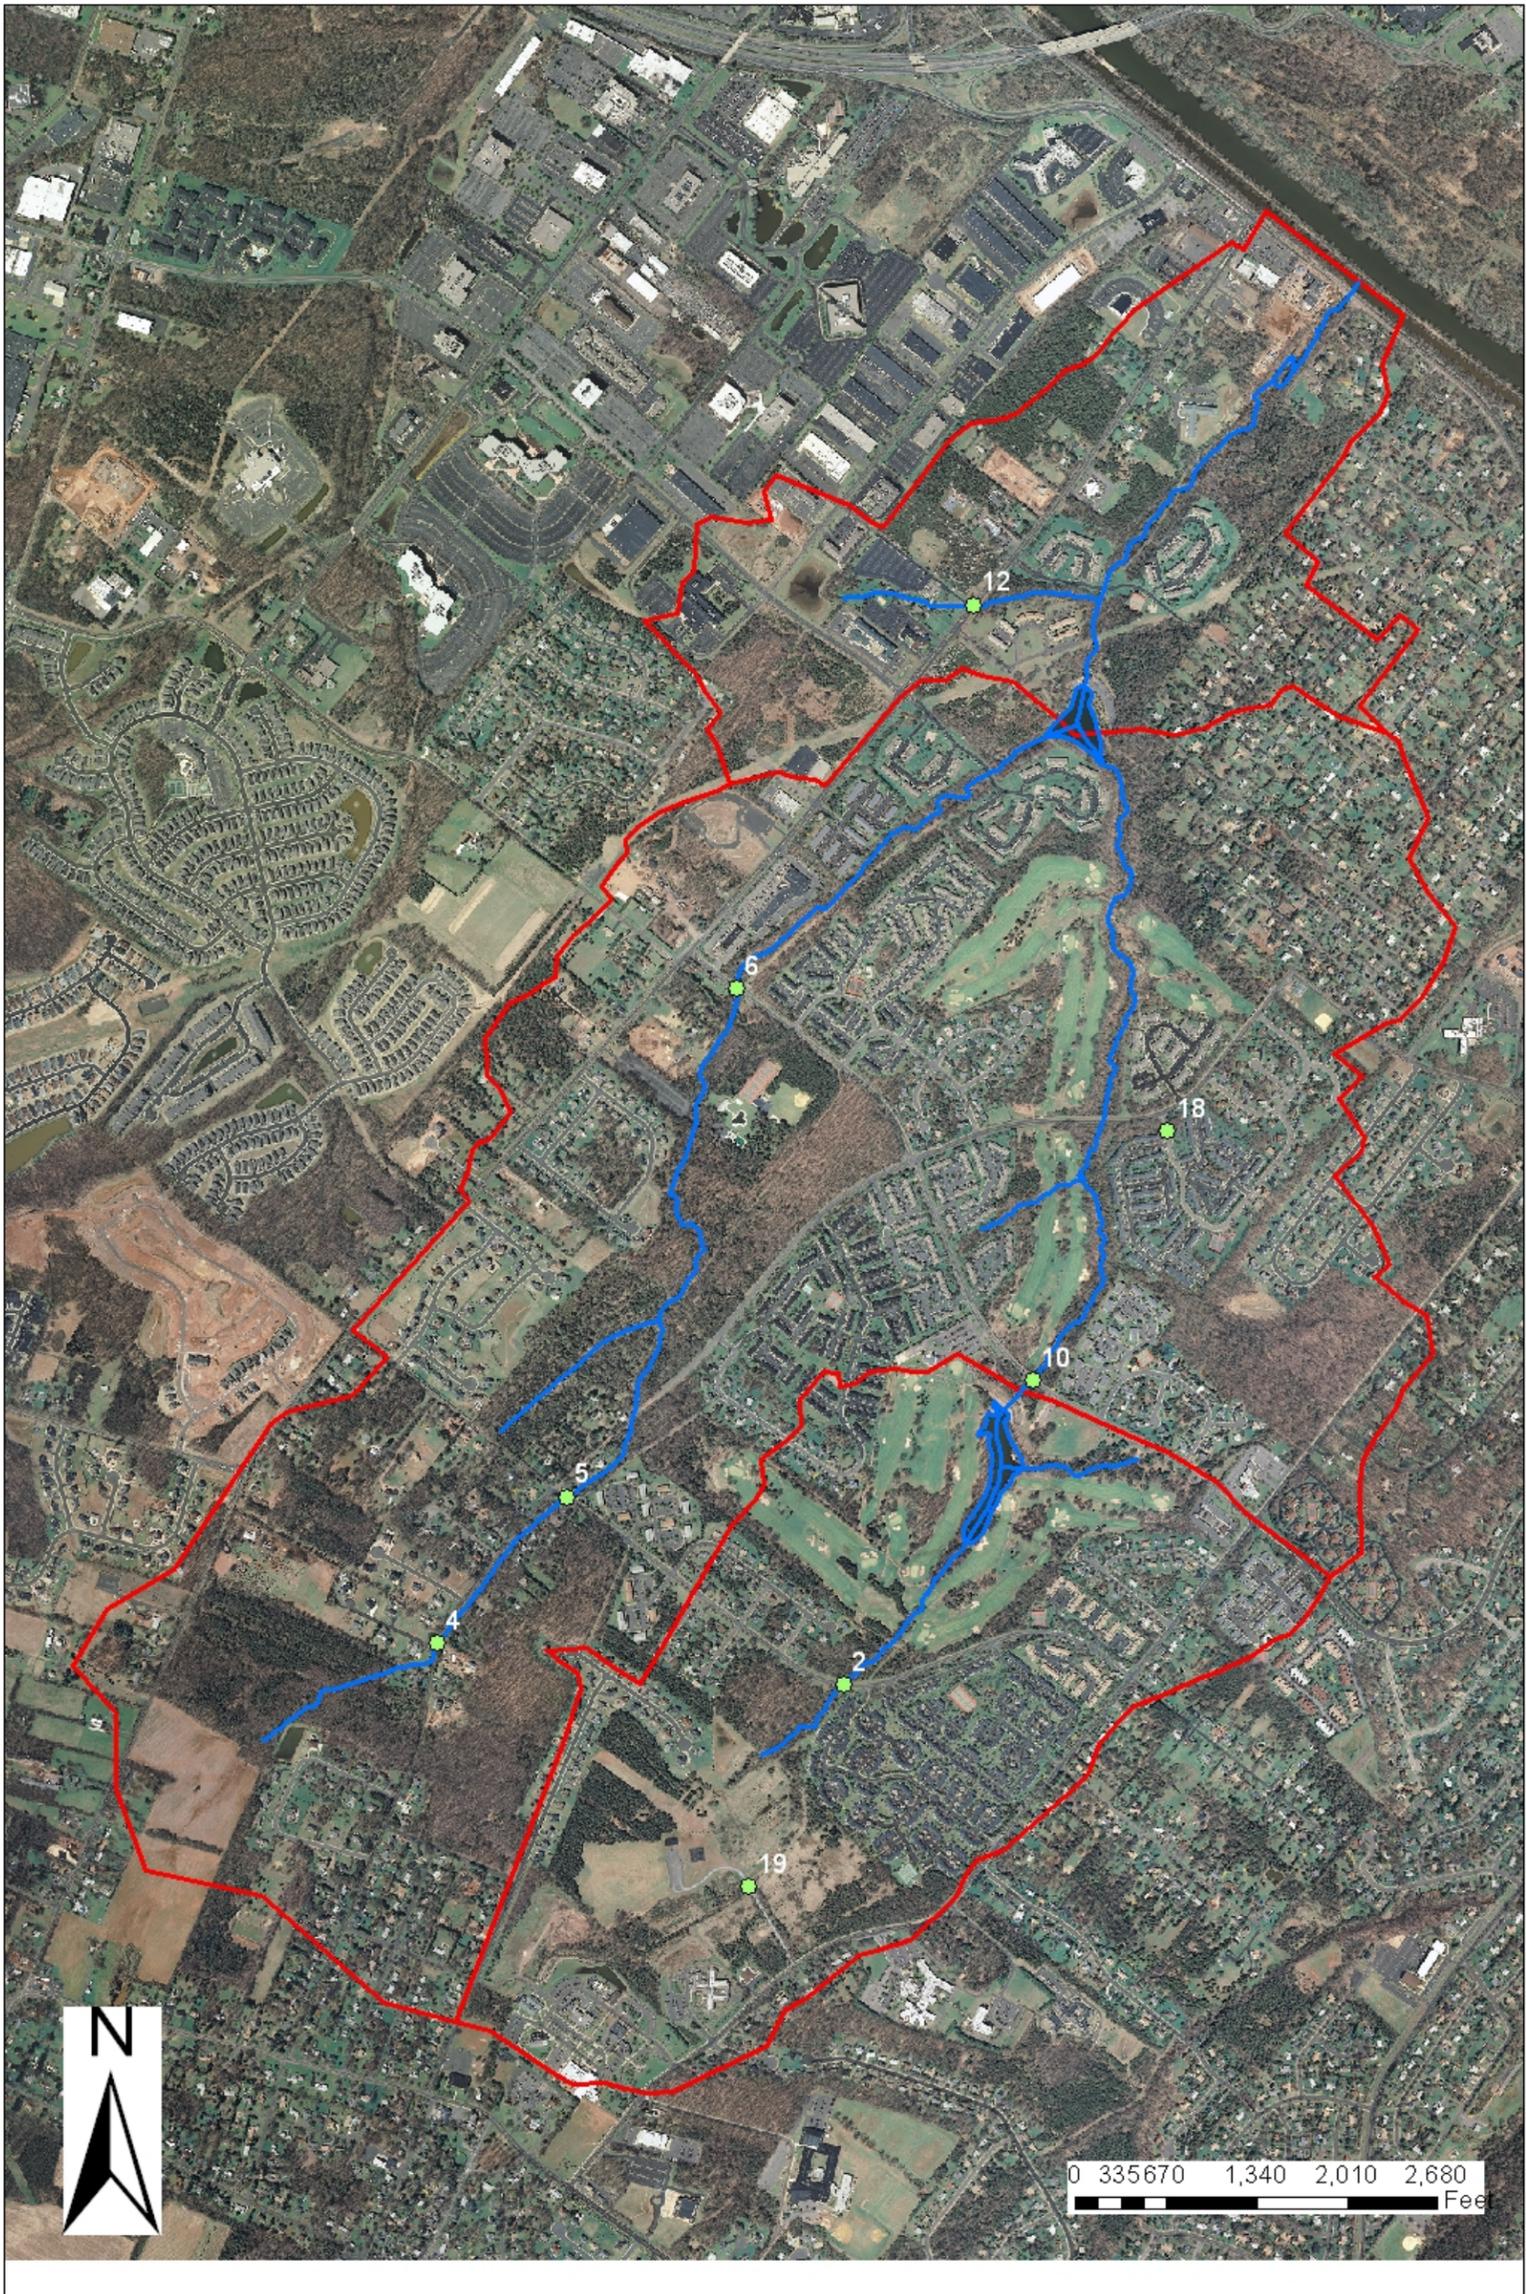
Figure 38. Potential Riparian Restoration Sites

Potential Riparian Buffer Restoration Sites

A detailed planting plan must be developed for each site prior to implementation. In addition, permitting may be required for some projects.

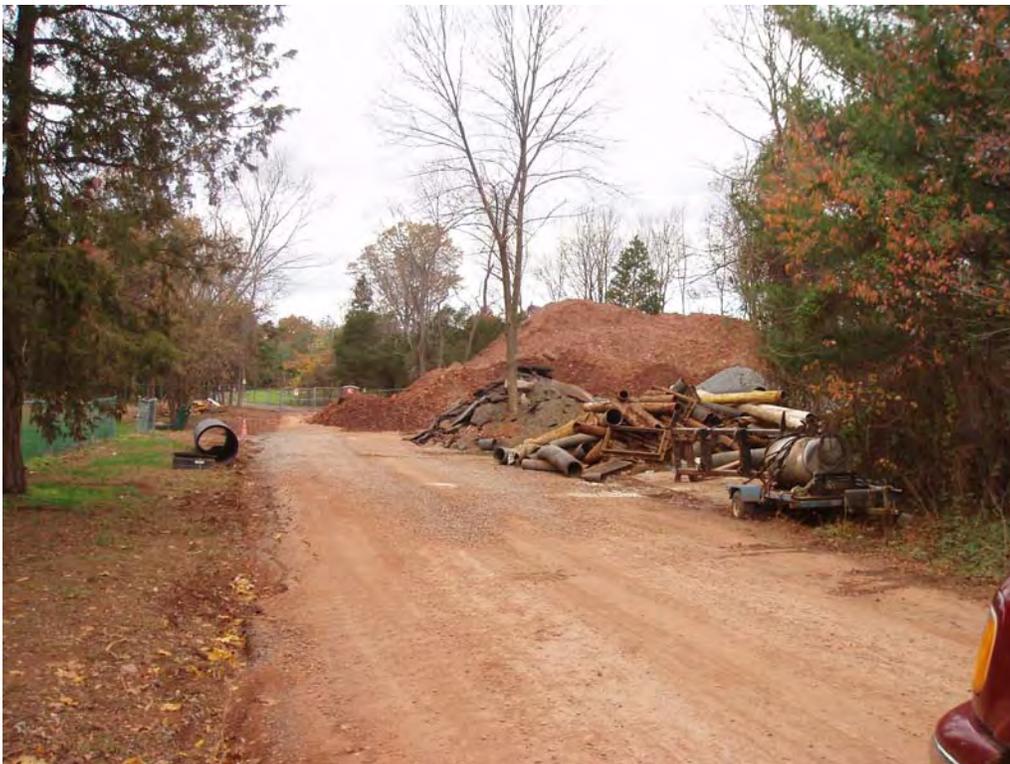
Picture 24: Overburden Pile on Lawndale Drive

IS1, effluent from the Ukrainian Village Pond, was selected as a control based on the results of the baseline and low flow events. IS2 was chosen to gauge the impact of runoff from stockpiled overburden stored on Lawndale Drive. The overburden piles were created during an ongoing storm sewer project. (Picture 24,

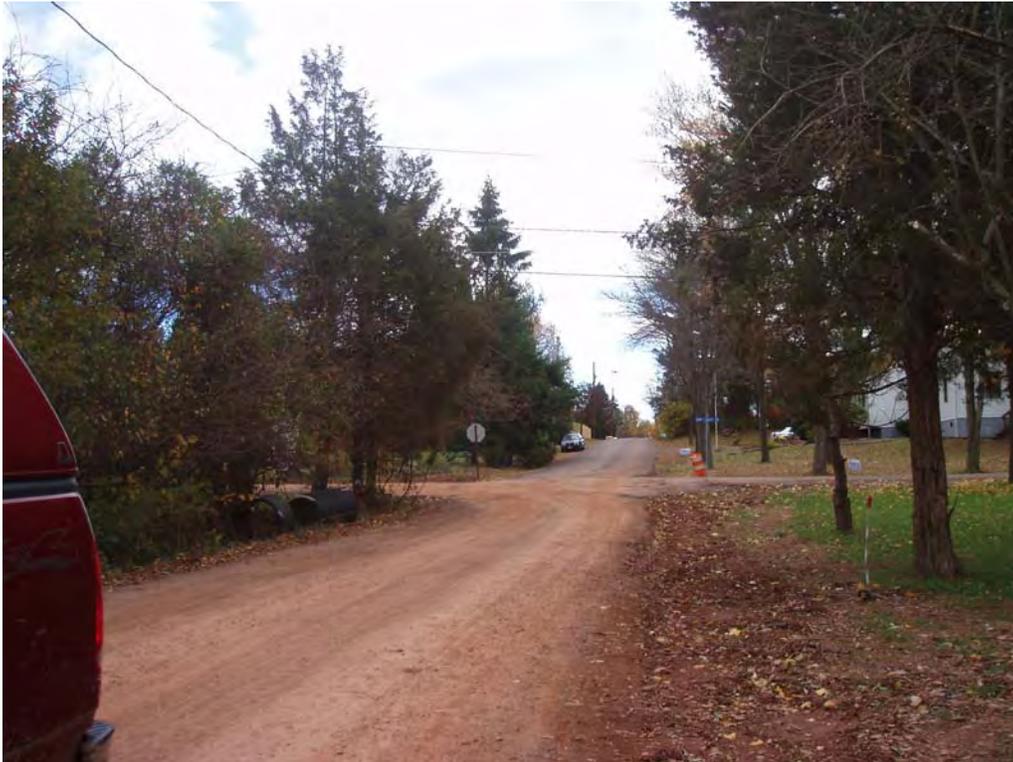
Picture 25: Lawndale Drive

Appendix C). Stormwater runoff from the overburden piles flows along a utility easement directly to the stream. In addition, the road leading to the stockpiled soil is covered with mud and silt (Picture 25, Appendix C). On a site visit on June 30, 2006 it was found that the overburden pile is no longer there and Lawndale drive is no longer covered with mud and silt (Picture 15, Appendix C). IS3 is the discharge of several hotels and apartment buildings. The base of the detention basin is not vegetated and consists mostly of exposed soil (Picture 26, Appendix C). IS4 and IS5 are surface discharges of two developments that discharge directly into the tributary and do not have detention ponds. IS6 is the detention pond discharge of a senior housing development. IS7 and IS8 were chosen to characterize stream bank erosion and the impact of construction occurring between the two sites (Pictures 27 and 28, Appendix C).

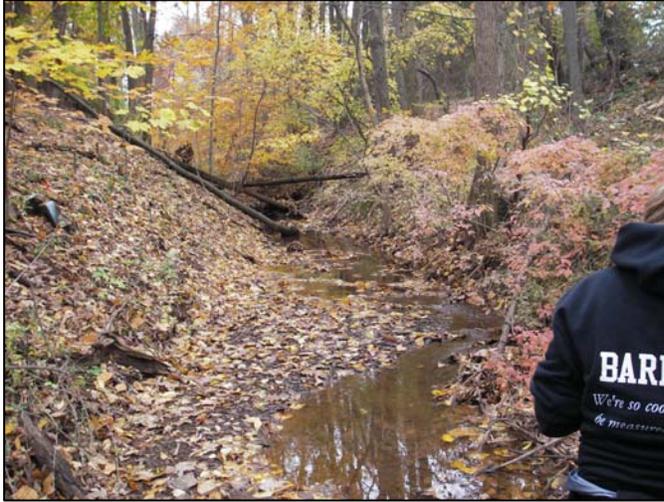
SVAP CGB-1 (5.2/poor) was located downstream of the Cedar Grove Lane road crossing on a small tributary that drains to the main stem of Cedar Grove Brook. Assessment scores ranged from 3 for channel condition, hydrologic alteration and riffle embeddedness, to 8 for macroinvertebrate habitat.

bedrock provided evidence that the reach has been actively down cutting.

The riparian corridor was inundated with invasive species mainly multi-flora rose. There was a lack of native species regeneration and virtually no native understory species population. There was an inline detention basin upstream of the Cedar Grove Lane road crossing. A large population of geese was observed. There was no riparian buffer upstream of the road crossing, only lawn. This is a potential site for **riparian buffer improvement**.

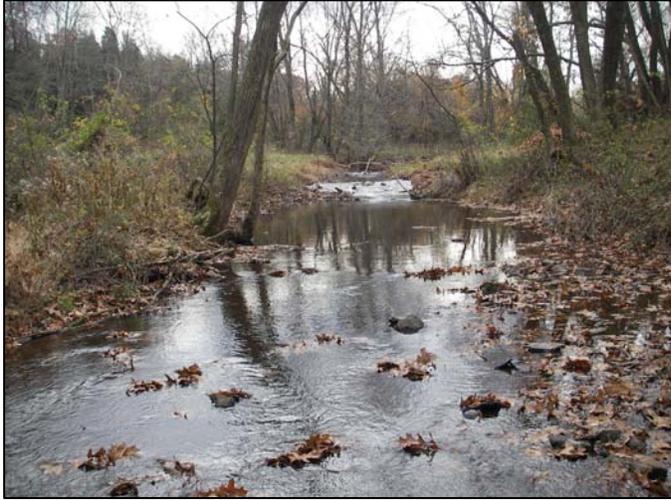
SVAP CGB-2 (7.17/Fair) was located upstream of the Lawndale Drive crossing on the mainstem of Cedar Grove Brook. A dam was present at the top of the reach and a hardened sewer line crossing was present approximately mid-reach. Assessment scores ranged from 10 for macroinvertebrate habitat, 8 for hydrologic alteration, pools, and in stream fish cover to 1 for barriers to fish movement.

A long continuous, deep glide two to three feet deep and a gradual meander bend were present from just below the dam to the grade control structure/hardened crossing at the sewer line crossing. The stream displayed a meandering pattern with a riffle/pool sequence below the hardened crossing.

The riparian corridor was inundated with invasive species, primarily multi-flora rose. There was a lack of native species regeneration and virtually no native understory species population. Rooted emergent and attached algae were moderately dense and completely covered the channel substrate.

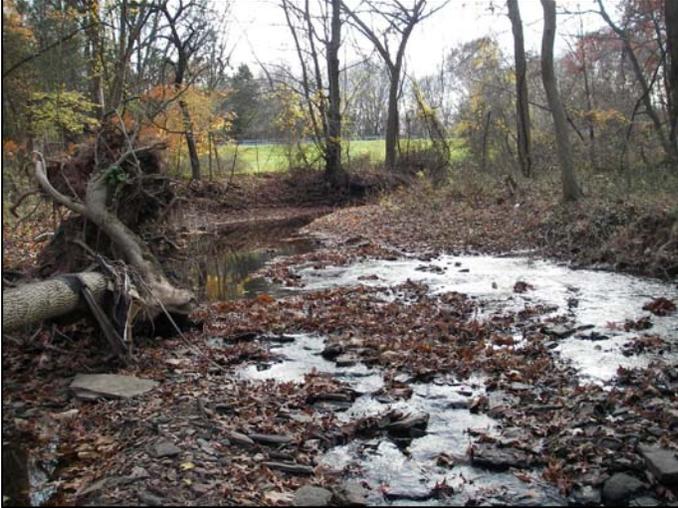
SVAP CGB-3 (7.75/Good) was located downstream of the Lawndale Drive crossing on the main-stem of Cedar Grove Brook. Assessment scores ranged from 10 for in stream fish cover, hydrologic alteration, and invertebrate habitat, to 4 for nutrient enrichment and 3 for barriers to fish movement.

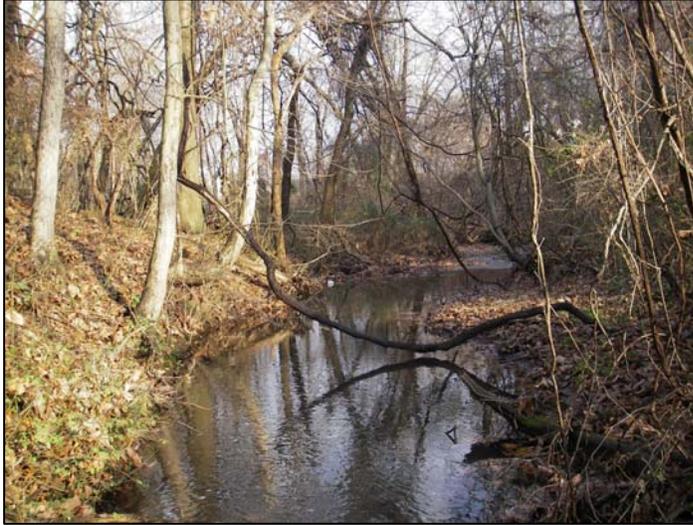
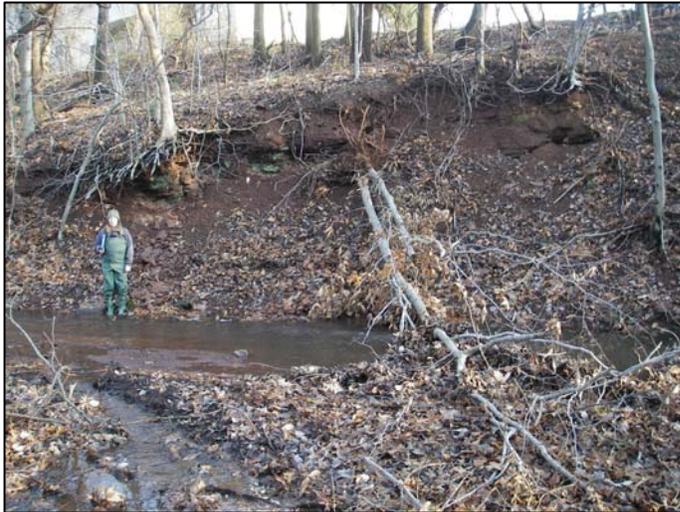
SVAP CGB-4 (6.67/Fair) was located upstream of the Sunnyvale Road crossing on the west branch of Cedar Grove Brook. Assessment scores ranged from 8 for channel condition and hydrologic alteration to 5 for in stream fish cover.

The average height of the banks was approximately one foot on the inside of meander bends and two to six feet on the outside. The banks were much higher in some areas. The bankfull elevation was at the floodplain elevation on the inside of all meander bends, allowing for floodplain access for all storm flows in portions of the reach. Erosion was observed on the outside of meander bends, and some trees had exposed roots indicating scouring during high flows. Pools were observed on the outside of meander bends, and had average depths of one to two feet. The stream was sinuous and dominated by riffle/pool morphology.

The riparian corridor was approximately 50feet wide on the left bank and 75feet on the right bank. A large population of invasive species, particularly multi-flora rose and Japanese honeysuckle, was observed on both banks. There was a lack of species regeneration and a minimal population of native understory

species. Damage from deer browse was apparent throughout the reach.

There was a large detention basin on the opposite side of Cedar Grove Lane draining into a side channel that crosses under Cedar Grove Lane and Sunnyvale Drive and joins Cedar Grove Brook downstream of the assessment reach. There was a large sediment deposit at the mouth of the side channel. The right bank of Cedar Grove Brook at the confluence was 10-15 feet high and was actively eroding. The riparian corridor in this area was ≤ 25 feet wide.

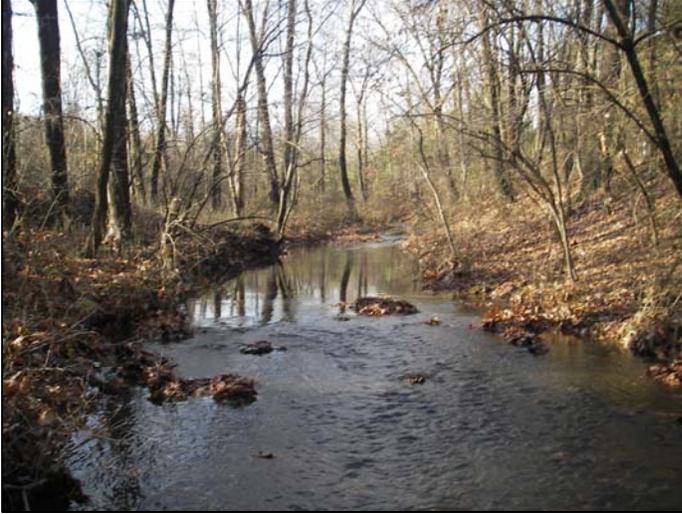
SVAP CGB-5 (5.75/Poor) was located downstream of the New Brunswick Road crossing on the west branch of Cedar Grove Brook. Assessment scores ranged from 8 for canopy cover to 3 for pools and barriers to fish movement.

The average bank height within the reach was one to two feet. The floodplain was steep and the reach was relatively straight. The upper portion of the reach was dominated by bedrock, the lower portion contained more silt and cobble. The substrate was >25% embedded at the lower end of the reach. Attached algae were moderately dense and completely covered the channel substrate.

The riparian corridor was 50 to 75 feet wide on the left bank and 30 feet wide on the right bank. The corridor lacked a native understory and multi-flora rose was abundant. Land use in the vicinity of the site included commercial development and an access road.

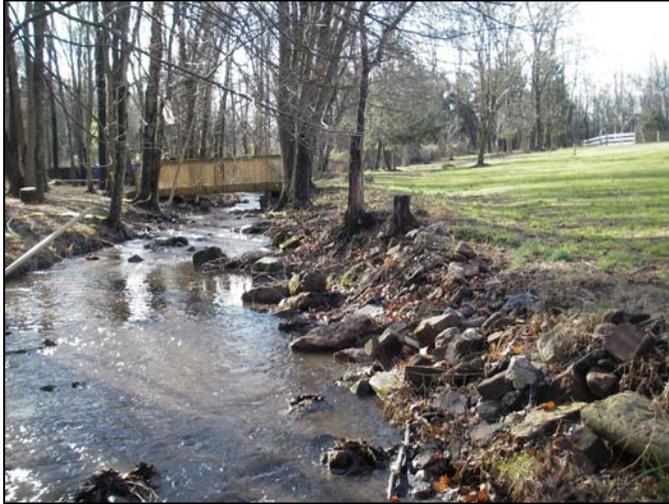
SVAP CGB-6 (6.75/Fair) was located upstream of the New Brunswick Rd. crossing on the west branch of Cedar Grove Brook. Assessment scores ranged from 10 for invertebrate habitat to 3 for canopy cover. The riparian zone received a score of 4.

points on the inside. The stream had access to the floodplain on at least one bank throughout the reach. The upper portion of the reach displayed high sinuosity and was dominated by riffle/pool morphology. Pools were observed on the outside of meander bends. No bank erosion was observed upstream of the school. The average bank height in the lower portion of the reach, downstream of the school, 0.5 to three feet. The stream was straight in this portion of the reach and some bank erosion was observed. A footbridge was constructed across the stream channel.

The riparian corridor was forested upstream of the school. Some invasive species were observed. At and below the prep school the riparian corridor on the left bank was predominantly lawn. The right bank had a canopy but lacked an understory, in part due to the school's ropes course. This reach has good potential as a **riparian buffer restoration site**.

A new stormwater outlet was observed on the school property. It was armored with riprap down to the stream channel.

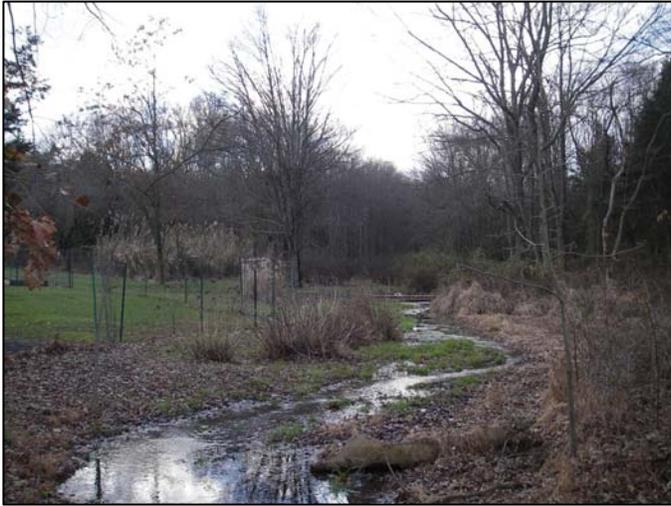
SVAP CGB-7 was located upstream of the Wilson Road crossing. This reach was not scored due to the small size of the channel and its location through private property. The upper portion of the reach (and headwaters of the west branch) was forested. The average height of the banks within this portion of the reach was 0.5feet. The stream banks in the lower portion of the reach, where the stream comes into closer proximity to residential property and the road crossing, were approximately two feet high. The riparian corridor was mowed to the stream banks through the lower portion of the reach. This site is a potential site for a **riparian buffer improvement**

project.

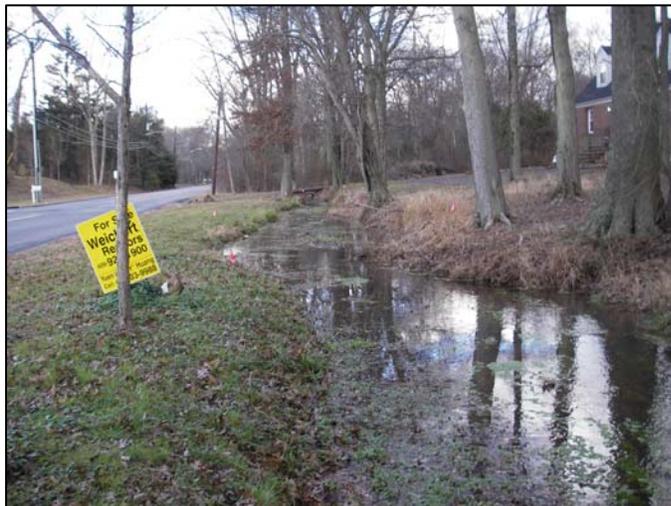
SVAP CGB-8 was located downstream of the Wilson Road crossing. This reach was not scored due to its location on private property.

The stream was channelized between Wilson Road. and residential lots. Bank erosion was observed along the reach in a majority of residential lots. The riparian corridor was comprised of lawn on the right bank and Wilson Road on the left bank. Invasive species dominated the riparian corridor where it was not managed by residents. A resident informed field staff that the stream floods the road every year during major storms.

There was additional residential construction taking place at the top of the reach adjacent to the road.

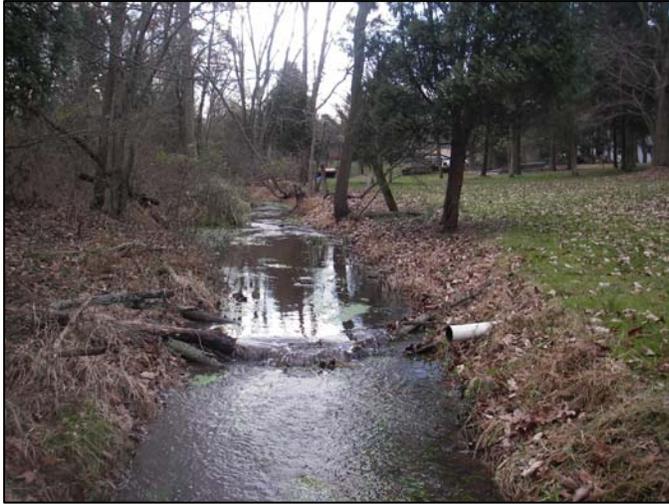
SVAP CGB-9 (6.36/Fair) was located downstream of the Treptow Road crossing on the west branch of Cedar Grove Brook. Assessment scores ranged from 10 for bank stability to 3 for pools and canopy cover.

A significant amount of fine sediment was deposited just below the crossing. The average bank height was 0.5 to two feet allowing floodplain access during storm events. The reach was relatively straight, with only a few meanders. There was minimal diversity in the flow regime. Aquatic vegetation was abundant.

The riparian corridor was dominated by a residential lawn on the left bank, and by forest and invasive species on the right bank. A pipe draining roof gutter runoff discharged into the stream from the left bank. The reach was a good candidate for a **riparian buffer improvement project**.

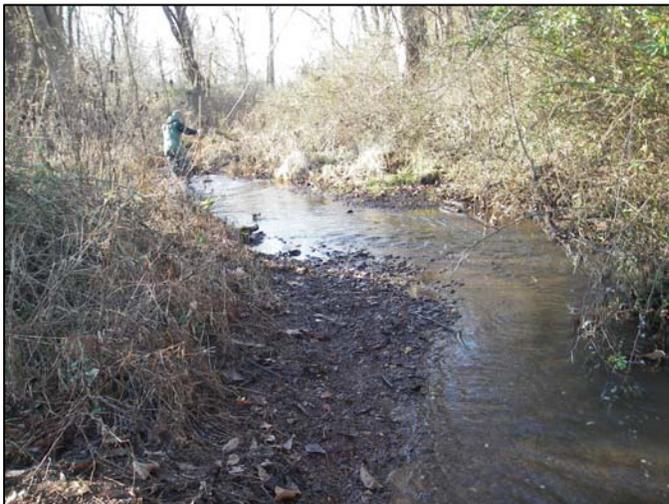
SVAP CGB-10 (6.92/Fair) was located downstream of the New Brunswick Road crossing on the east branch of Cedar Grove Brook. Assessment scores ranged from 10 for in-stream fish cover and invertebrate habitat to 4 for canopy cover.

The reach had high sinuosity and was dominated by riffle/pool morphology. Pools were observed on the outside of meander bends and had an average depth of 1.5 feet. The presence of LWD was a contributing factor to the structural complexity of the channel.

The land use in the vicinity of the site included forest and multifamily residential on the right bank and Quail Brook Golf Course on the left bank. QBGC was certified as a River-Friendly Golf Course by NJWSA in 2007.

The riparian corridor averaged 75 feet on the left bank and 50 feet on the right bank. The golf course has a no-mow area approximately 40 feet wide at the top of the reach where there was no canopy. Both banks have a large population of invasive species occupying the understory.

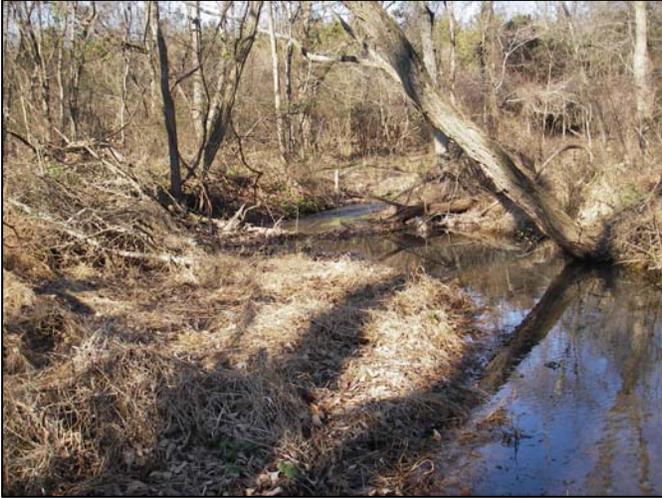
SVAP CGB-11 (7.83/Good) was located downstream of the Wilson Road crossing on the west branch of Cedar Grove Brook. A Franklin Township Preservation Area was present on the left bank. Assessment scores ranged from 10 for invertebrate habitat, 9 for channel condition and hydrologic alteration to 3 for nutrient enrichment.

allowing access to a wide floodplain during storm flows. Some erosion was occurring on the outside of meander bends. Some bank erosion was also observed where the stream straightened out, indicating high velocity during storm events.

The stream had a regular pool/riffle/glide sequence. Sediment deposition was observed in glides and pools along the reach. Rooted emergent and attached algae were dense and completely covered the channel substrate.

The riparian corridor was 100+ feet wide on each bank. There was an apparent lack of dominant species regeneration and a minimal population of native understory species. The land use in the vicinity of the site included forest on the right bank and residential on the left bank.

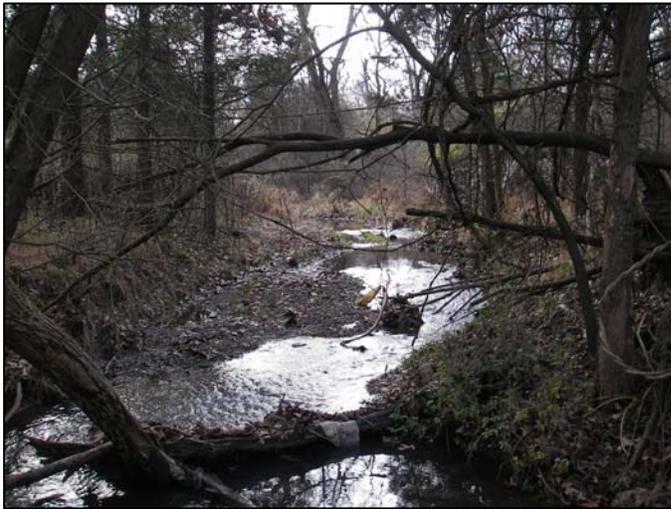
SVAP CGB-12 (5.92/Poor) was located downstream of the Martino Way crossing on the east branch of Cedar Grove Brook. Assessment scores ranged from 8 for channel condition and riparian zone to 3 for pools and riffle embeddedness.

The average bank height through the reach was one to two feet. The reach was dominated by small riffles and shallow pools. Sediment deposition was observed throughout the reach.

to a debris jam at the top of the reach.

The riparian corridor was 100 feet wide on the left bank and approximately 50 feet on the right bank. The corridor contained a large population of invasive species, particularly multi-flora rose. Native species regeneration was absent and the understory lacks native species population. The land use in the vicinity of the site included multi-family residential and forest on the left bank, and Quail Brook Golf Course on the left bank.

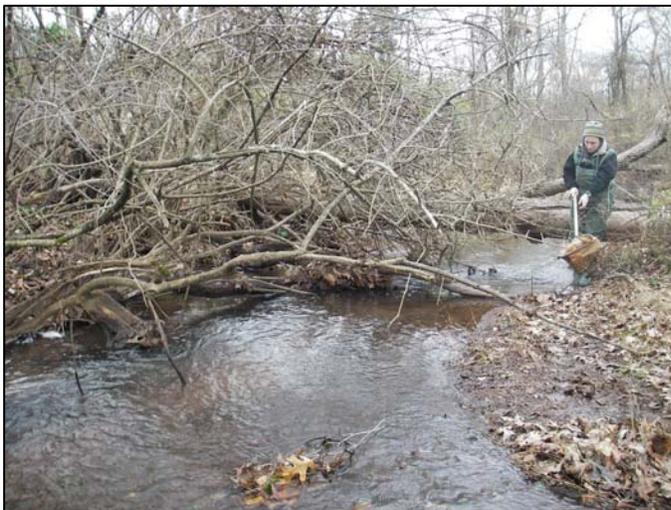
SVAP CGB-13 (7.33/Fair) was located at downstream of the Willow Road crossing on the east branch of Cedar Grove Brook. Assessment scores ranged from 10 for macro-invertebrate habitat, 9 for channel condition, hydrologic alteration and bank stability to 3 for canopy cover and barriers to fish movement.

complexity of the channel, and provides abundant fish habitat. Fine sediment deposition was observed throughout the reach in pools and on the inside of meander bends.

The riparian corridor averaged 90 feet wide on the left bank and 50 feet on the right bank. The land use in the vicinity of the reach included forest and multifamily residential on the right bank, and forest and Quail Brook Golf Course on the left bank.

A tributary from the golf course entering the main channel in this reach displayed no evidence of erosion or sediment input. In addition, a storm drain inflow from the residential development entered the reach on the right bank. The inflow was mostly armored and displayed little erosion.

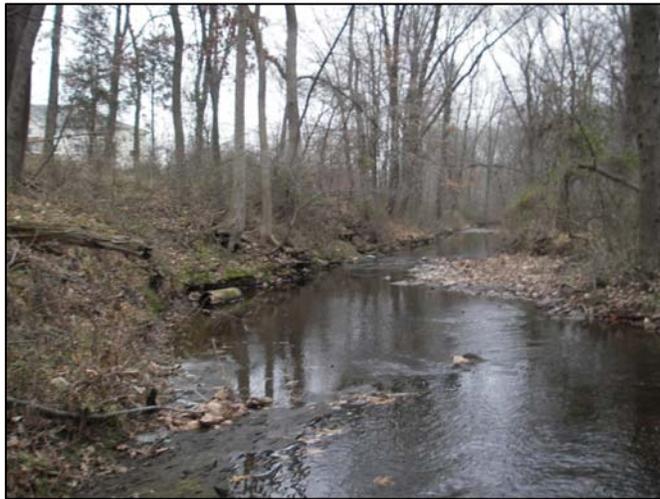
SVAP CGB-14 (4.7/Poor) was located upstream of the Easton Rd. crossing on the main stem of Cedar Grove Brook. Assessment score ranged from 8 for in stream fish cover to 3 for bank stability, nutrient enrichment and pools..

bedrock and cobble were observed at the upstream end where the gradient was steeper and riffles were more abundant. The upper portion of the reach had a meandering pattern with riffles, glides and shallow pools occurring frequently. Large, old sediment deposits inhabited by mature vegetation were observed. Recent deposition formed numerous sediment bars along straight areas, on the inside of meander bends and mid-channel. Bank erosion was observed on the outside of meander bends most often associated with large sediment deposits along the opposite bank.

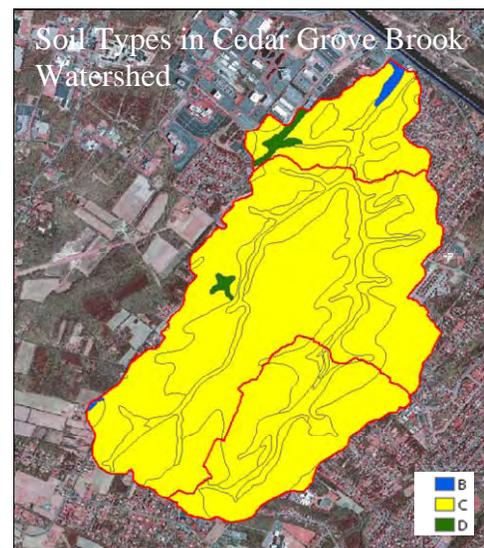
FIGURE 1
Cedar Grove Brook
Subwatershed Delineations

and Ukrainian Village Pond, a refined WinSLAMM (Version 9.3.0) simulation of the Cedar Grove Brook watershed was developed. Cedar Grove Brook was divided into three subwatersheds based on the drainage areas to the Golf Course Pond (395 acres), the Ukrainian Village Pond (1,545 acres), and the Lower Pond (1,784). The subwatershed delineations are shown in Figure 1; the 2005 sampling stations (TRC Omni, 2006) at the outlet of each pond are shown in parentheses after each pond label. The refined WinSLAMM simulation incorporated improved source terms from the stormwater sampling performed for the Canal Restoration Project in small subwatersheds that drain specific land use areas. Simulations were developed for the July 2005 and October 2005 storms (1.4 and 3.8 inches, respectively) that were sampled previously (TRC Omni, 2006). Predicted and observed loads were compared in order to understand the accuracy and limitations of both the model and the observed estimates. The refined WinSLAMM model was used then to assess the benefits of potential BMPs in terms of reduced sediment loads.

WinSLAMM simulations predict total volumes and pollutant loads to a single outlet over a storm based on individual watershed characteristics, most importantly soil type and land use (see figures to the right). A low particle size distribution was assumed for all subwatersheds; since heavier particles settle faster, assuming a low particle size provides a conservative simulation of sediment removal rates. Predicted and observed comparisons were performed for both total runoff volumes and sediment removal rates at each of the three ponds during both 2005 storms. The predicted runoff volumes and removal rates were based on the output of the WinSLAMM simulations; the observed runoff volumes and removal rates represent best estimates based on continuous depth and discrete water quality measurements.

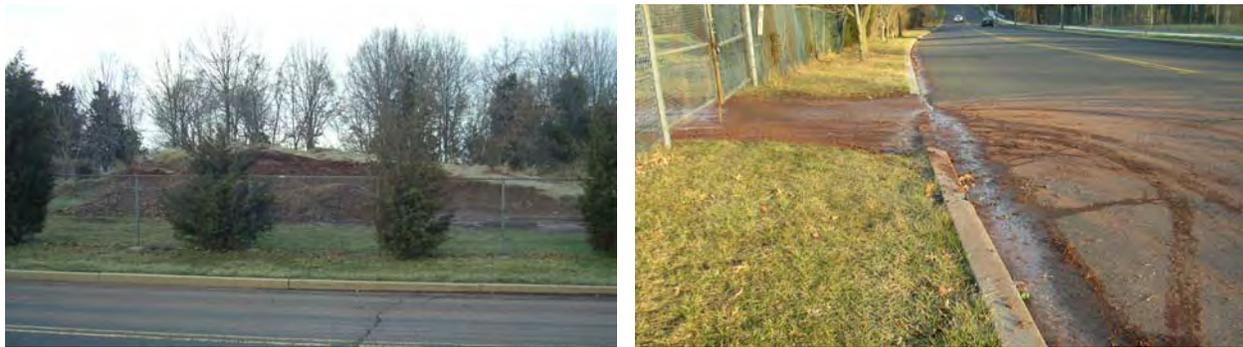
FIGURE 14: Sediment Management at Quail Brook Golf Course

There are two non-structural BMP opportunities that would appear to yield benefits in terms of reducing sediment load contributions to Cedar Grove Brook, and therefore to the D&R Canal. The first is to improve fill management practices at the Quail Brook Golf Course. It is important to understand that nothing in this study suggests that the golf course is a major source of sediment to Cedar Grove Brook or that the golf course is doing a poor job managing its fill. However, sediment loads from Institutional land use areas (including the golf course) were estimated to be second only to Residential land use areas, and the Quail Brook Golf Course comprises the riparian zone of much of Cedar Grove Brook upstream of Ukrainian Village Pond. Furthermore, the pictures in Figure 14 do suggest that there is room for improvement in terms of fill management at the golf course.

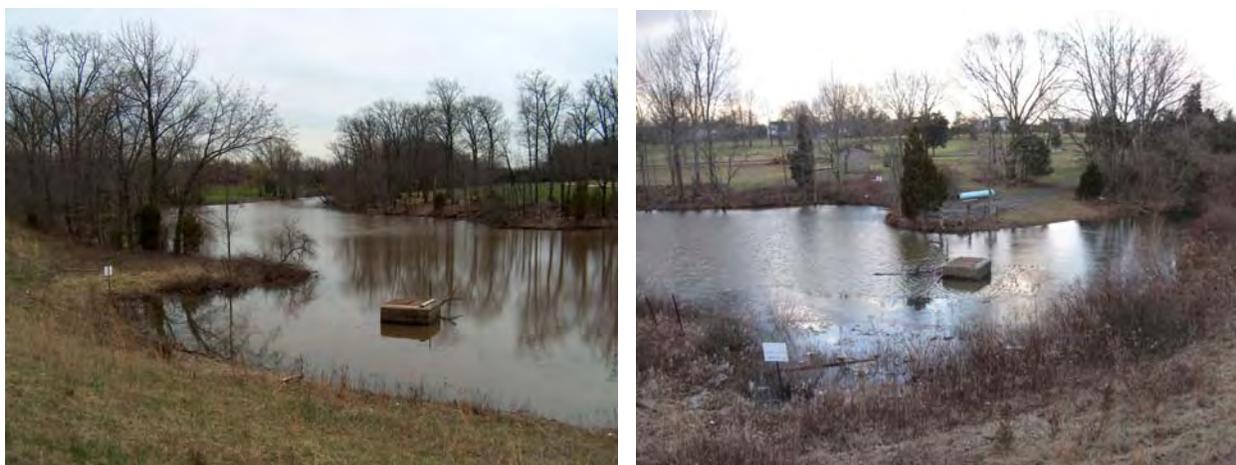
FIGURE 15: Golf Course Pond

The most upstream of the pond features in Cedar Grove Brook is the Golf Course Pond (Figure 15).

Two potential BMP improvements were identified to increase the sediment removal rate and thereby reduce the sediment load to the downstream portion of Cedar Grove Brook: 1) modification to the outlet structure; and 2) flowpath routing baffles.

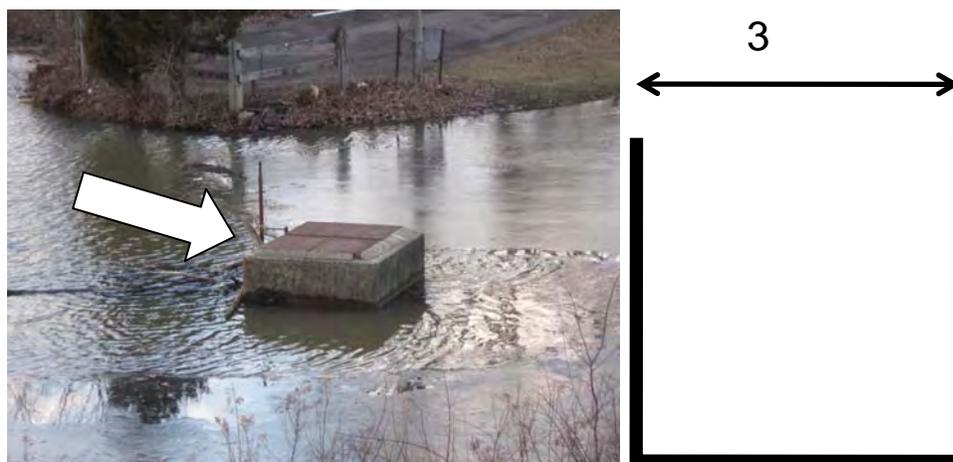
FIGURE 16: Existing Outlet Structure for Golf Course Pond

The existing outlet structure is a 3-foot long weir in the upstream side of an outlet box (Figure 16). The long-term WinSLAMM simulation suggests an overall sediment removal rate of approximately 50%; in other words, approximately half of the sediment entering the Golf Course Pond is discharged to Cedar Grove Brook. In addition, because the weir faces “upstream,” much of the pond volume appears to be short-circuited, which reduces the expected sediment removal rate.

Two relatively simple changes to the outlet structure of the Golf Course Pond are proposed. The first is to face the opening “downstream,” thereby increasing residence time in the pond, and thereby allow more time for settling to occur. More importantly, adding a smaller outlet weir at the base of the existing 3 foot weir (Figure 17) will increase the residence time as well and increase the overall sediment removal rate of the pond feature. Various weir heights and widths were explored, and their associated long-term sediment removal rates were estimated using WinSLAMM (Figure 18). It turns out that sediment removal is more sensitive to weir width than weir height. Smaller weir widths would result in higher sediment removal rates. Widths smaller than 3 inches were not explored, since such a small weir would clog too easily. In terms of the height of the proposed smaller weir, a 12 inch high weir would be marginally better than a 6 inch weir.

Adding a smaller weir between 3 and 6 inches wide and 6 to 12 inches high would substantially improve the sediment removal performance of the Golf Course Pond.
