Cedar Grove Brook Watershed Restoration and Protection Plan

New Jersey Department of Environmental Protection

Funded by Section 319(h) Grant ID: RP04-011

July 2011

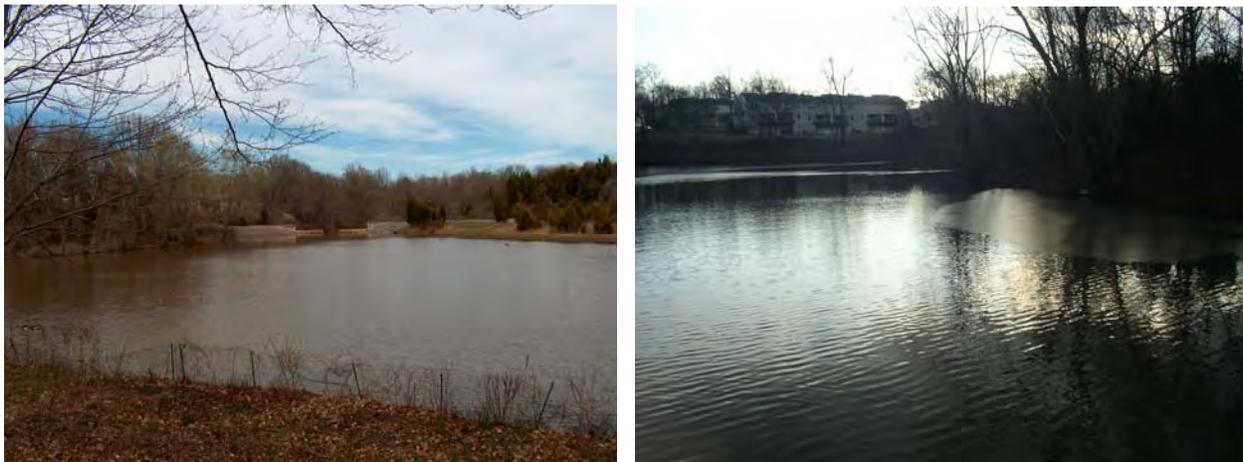
FIGURE 20: Ukrainian Village Pond

Ukrainian Village Pond (Figure 20) is downstream of the Golf Course Pond close to the center of the Cedar Grove Brook watershed. Ukrainian Village Pond is an impoundment with two tributary inlets that discharges to Cedar Grove Brook. A relatively simple modification to the outlet structure is proposed to increase the sediment removal rate and thereby reduce the sediment load to the downstream portion of Cedar Grove Brook.

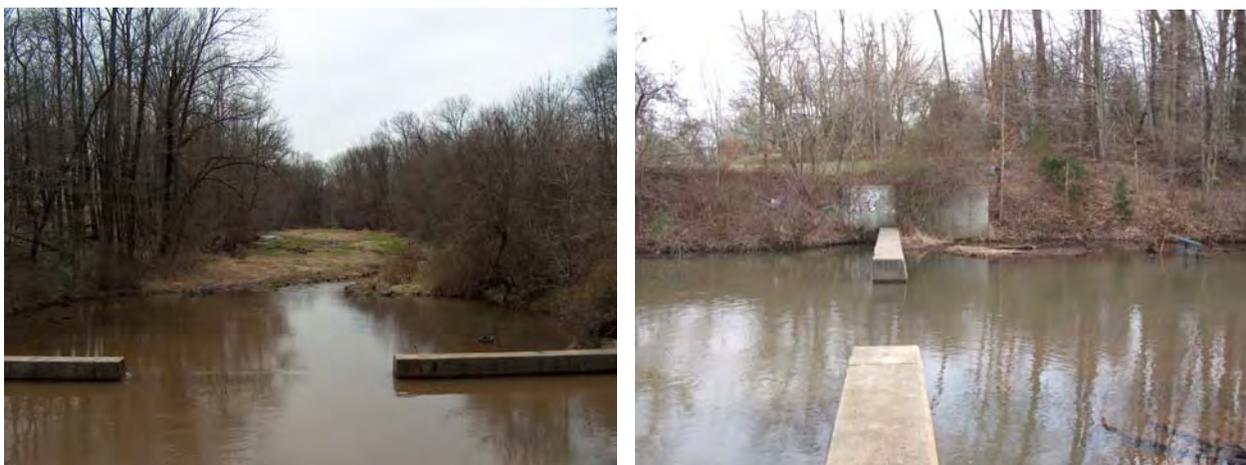
A diagram of the existing outlet structure is shown in Figure 25. The current structure is not very useful from the standpoint of sediment removal. In fact, long-term WinSLAMM simulations indicate that the existing structure might be expected to remove approximately 3% of the sediment that reaches the outlet of Cedar Grove Brook. However, the WinSLAMM simulation does not account for the fact that the weir crest is generally submerged by canal tailwater, nor does it account for the resuspension of accumulated sediment. It is very likely that the out of Cedar Grove Brook provides a net source of sediments to the D&R Canal. The outlet structure could be improved substantially by increasing the elevation of the crest and decreasing the width of the smallest weir.

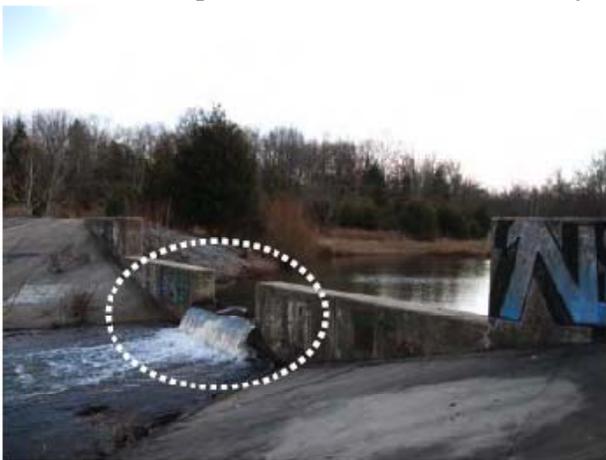
Proposed Solutions: The existing 1-foot weir provides a negligible benefit in terms of sediment removal efficiency; however, simply increasing the height of the existing weir from 1 foot to 3 or 4 feet would improve the sediment removal by approximately 15%.

Anticipated Benefits:
Increase sediment removal from 398,427lbs/yr to 458,368 lbs/yr and reduce turbidity.

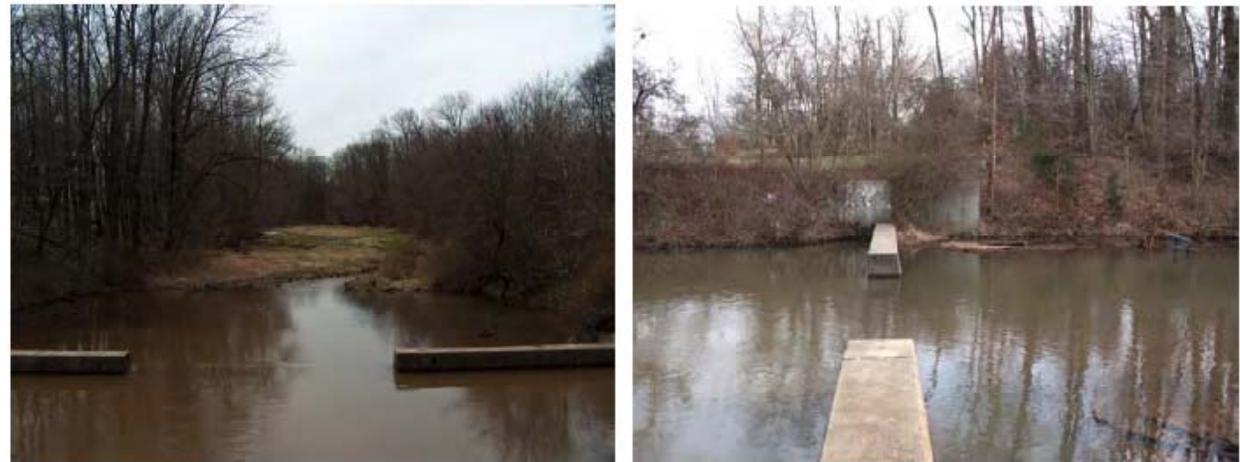
Proposed Solutions: A 5 foot weir at a significantly higher crest elevation will significantly improve the sediment removal rate of the outlet structure. Increasing the crest elevation by four feet would provide the most benefit of the elevation options explored, increasing the overall sediment removal rate ten-fold to approximately 30%. Note that this does not account for the fact that the weir crest would no longer be submerged by Canal tailwater, or the additional benefit of reduced sediment resuspension.

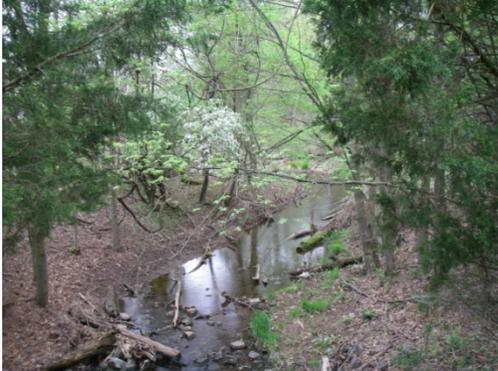
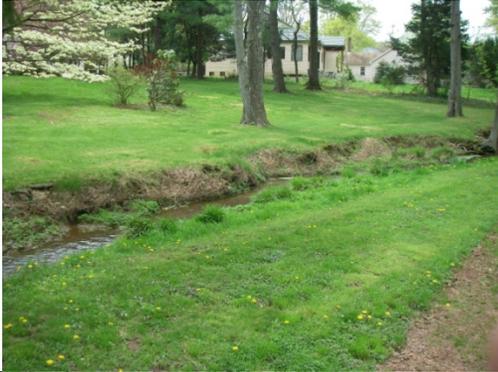
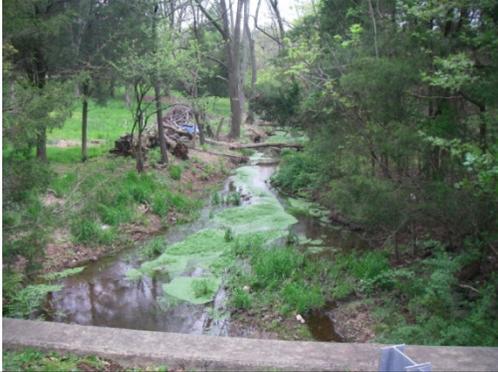
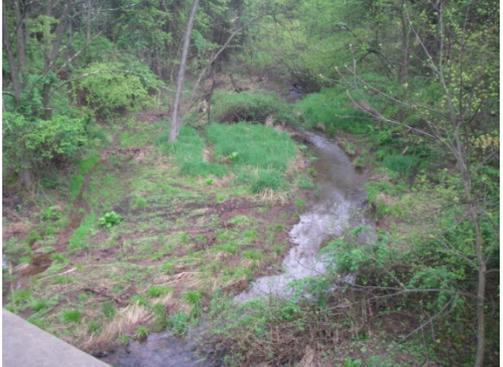
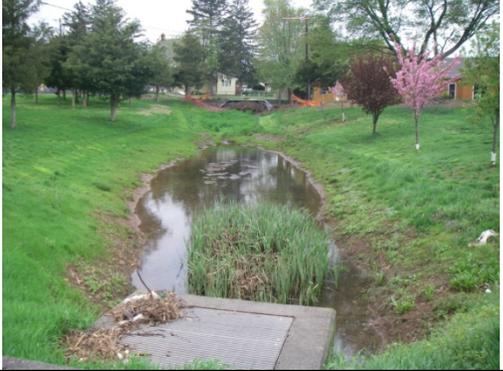
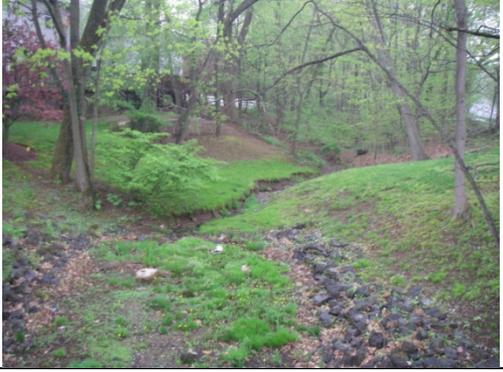
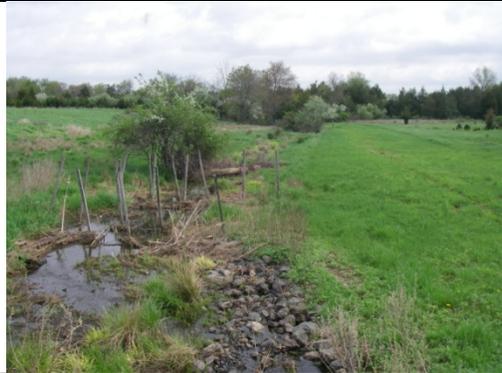
Riparian Restoration

Location: Varies, see map.		Parcel Description: Varies	
Project Type: Structural. Riparian restoration		Owner: Varies	
<i>Road Crossing ID</i> <i>SVAP #</i>	<i>Nearest Road</i>	<i>Approximate Area</i>	<i>Estimated Cost</i>
Cedar Grove Brook 2 NA

<p>Issues and Concerns: Degraded riparian areas lead to stream bank erosion.</p>				
<p>Existing Condition: Lawn area is maintained to the stream bank, or vegetation should be improved.</p>				
<p>Proposed Solutions: Work with property owners to reestablish a vegetated buffer zone.</p>				
<p>Anticipated Benefits: Stream bank stabilization, nutrient and sediment removal and reduced stream temperature.</p>				
<p>Major Implementation Issues: Some areas are on private property. Maintenance after planting</p>				
<p>Possible Funding Sources: Section 319(h), NRCS, e.g. Conservation Reserve Enhancement Program, Conservation Reserve Program, Wildlife Habitat Incentives Program</p>				
<p>Partners/Stakeholders: Property owners, Franklin Township, and NJWSA</p>				
Task	Description	Sources of Funds	Responsibility	Estimated Cost
Design	Implementation ready plans and permits	Section 319(h), Private, Franklin Twp. Stormwater mitigation fund, NRCS, USFWS, In-kind from Franklin Township and NJWSA	Property owner	\$1,000 -\$2,000 per site, depending on size of site and permitting needs

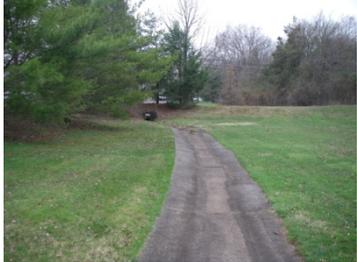
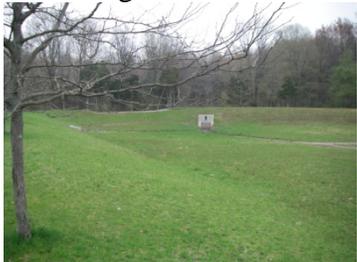
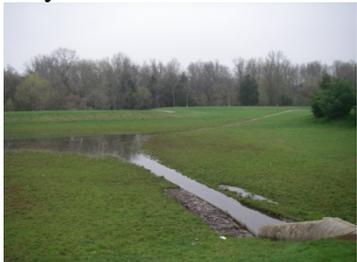
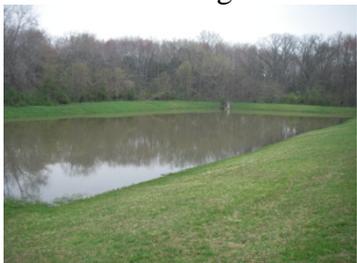
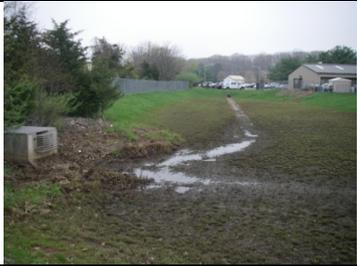
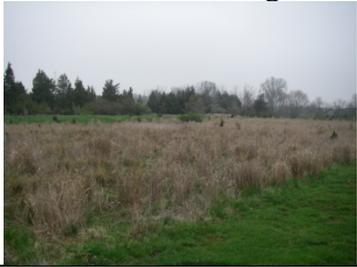
Stormwater Pond Retrofits

Location: Watershed-wide		Parcel Description: Residential and Commercial	
Project Type: Stormwater basin retrofits		Owner: Varies	
	Basin Identifier	Street Location/ Block/Lot	Recommendations
2	Candlewood Hotel Co./ First Industrial L.P.

Issues and Concerns: Many basins were not designed for water quality treatment.

Existing Condition: Many basins have low flow channels and are regularly mowed. Modifying basins to provide better water quality treatment will reduce the load of sediments and other pollutants.

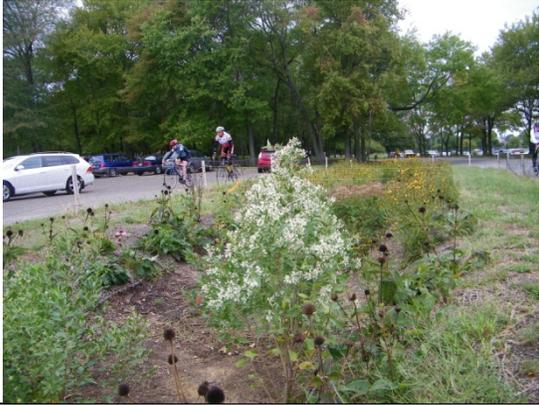
Rain Gardens

Location: Watershed-wide		Parcel Description: Residential and commercial properties		
Remediation Type: Stormwater disconnection and infiltration		Owner: Varies		
Issues and Concerns: Roofs and lawns in residential areas are potential sources of nutrients and sediments. Pollutants that accumulate can be carried to streams in runoff.				
Existing Condition Based on Field Evaluation: In many cases, residences throughout the watershed have their gutter downspouts directly connected to their driveway which then lead to the stormwater conveyance system and ultimately, the Cedar Grove Brook. Impervious surfaces increase runoff volume in the stream leading to bank erosion.				
Proposed Solutions: A rain garden could be strategically designed and placed to capture, treat and infiltrate stormwater runoff from residential areas. A rain garden is a landscaped, shallow depression that allows for rain and runoff to be collected and then either infiltrates into the soil or evapotranspirates to the atmosphere.

Anticipated Benefits: Rain gardens can, when implemented on a large scale, reduce the cumulative effects of runoff in a watershed. Sediment, runoff, and pollutants can settle out and be taken up by the plants. This will prevent these loads from reaching the Cedar Grove Brook. Additionally, rain gardens can help reduce the amount of runoff that reaches the stream.				
Major Implementation Issues: Potential physical problems include the lack of space to install a rain garden or soil that does not drain very well and soil amendments are needed. Finding willing landowners and adequate funding are other implementation issues.				
Possible Funding Sources: A rain garden program funded by 319(h) grant money, A rain garden rebate program, Out-of-pocket by landowner				
Partners/Stakeholders: NJWSA, Franklin Township, Homeowners Associations				
Task	Description	Sources of Funds	Responsibility	Estimated Cost
