WATERSHED PROTECTION AND RESTORATION PLAN FOR THE MANALAPAN BROOK WATERSHED

Middlesex and Monmouth Counties, New Jersey

Princeton Hydro, LLC

February 2011

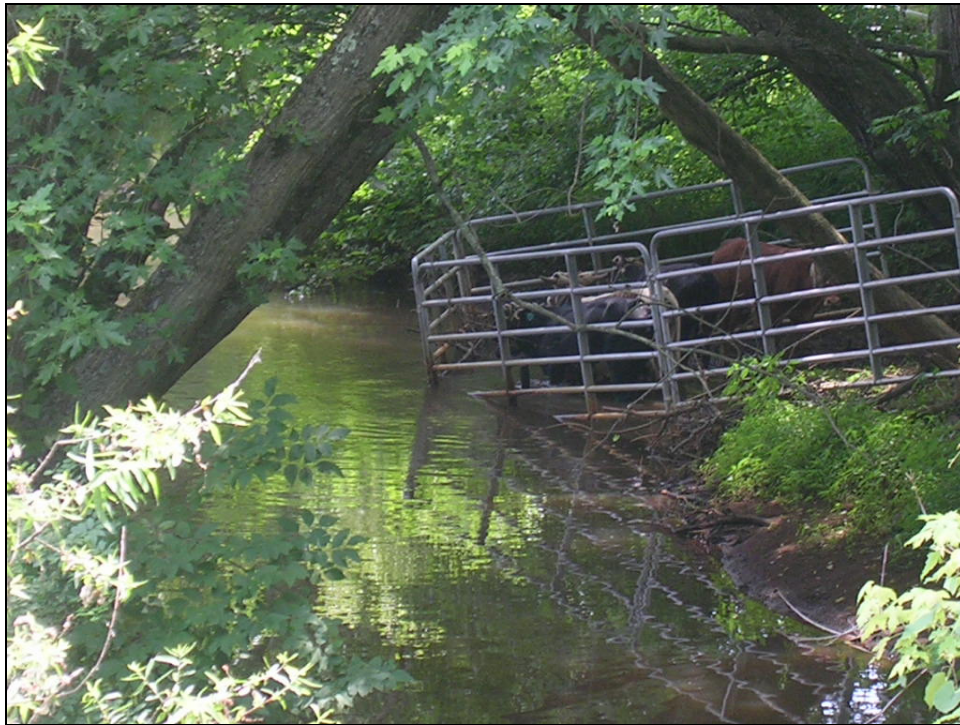
Figure 4. Livestock fence enclosure located within Manalapan Brook near station #52.

- station #86: there was minimal riparian vegetation and frequent riparian mowing along the lake shore;
- station #80: there were minimal amounts of riparian vegetation and the riparian vegetation was frequently mown along both ponds at this station;
- stations #60, #55, #54, #53, and #51: at these stations there were minimal amounts of riparian vegetation and the riparian vegetation was frequently mown along the streambanks, these conditions increase NPS and runoff and do not prevent stream access by livestock which was observed in the mainstem of Manalapan Brook in the vicinity of station #52 as shown below in Figure 4.

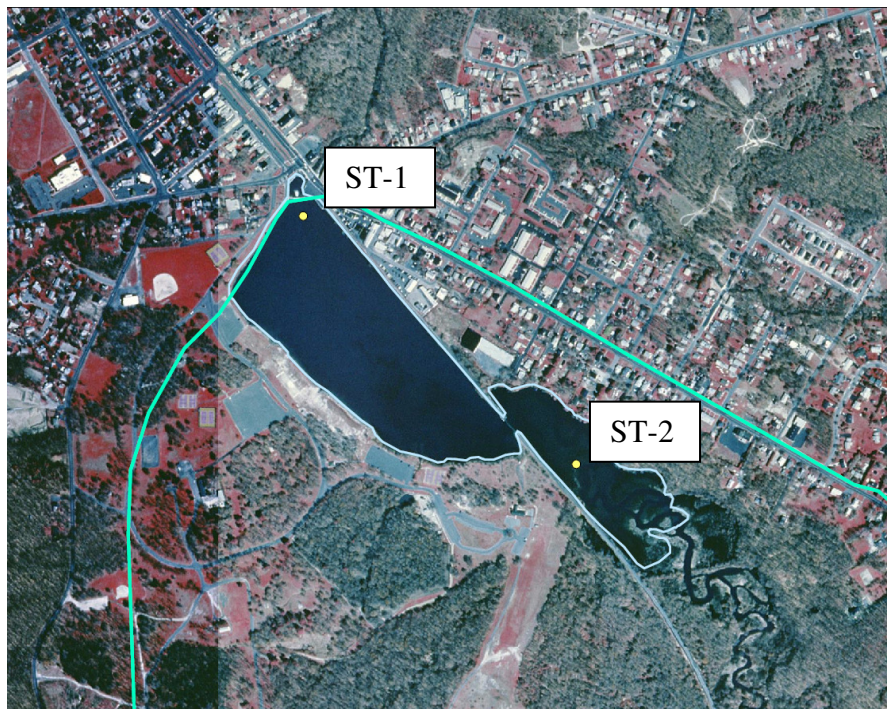
Figure 5. Sampling stations in Manalapan Lake (yellow circles).

During each sampling event, *in-situ* data were collected from two in-lake sampling stations (see Figure 5): a mid-lake sampling station located near the dam/outflow of the lake (ST-1) and a near-inlet sampling station located in the shallower, southeastern section of the lake (ST-2). In addition, *in-situ* data were also collected from the Manalapan Brook inlet. A calibrated Eureka or Hydrolab Quanta data sonde was used to collect the *in-situ* data. These data were collected in profile, from surface to bottom at 0.5 to 1.0 meter intervals. The measured parameters included temperature, dissolved oxygen (DO), pH and conductivity. Water clarity was also measured with a Secchi disk at each in-lake sampling station. The raw *in-situ* data are provided in a following section.

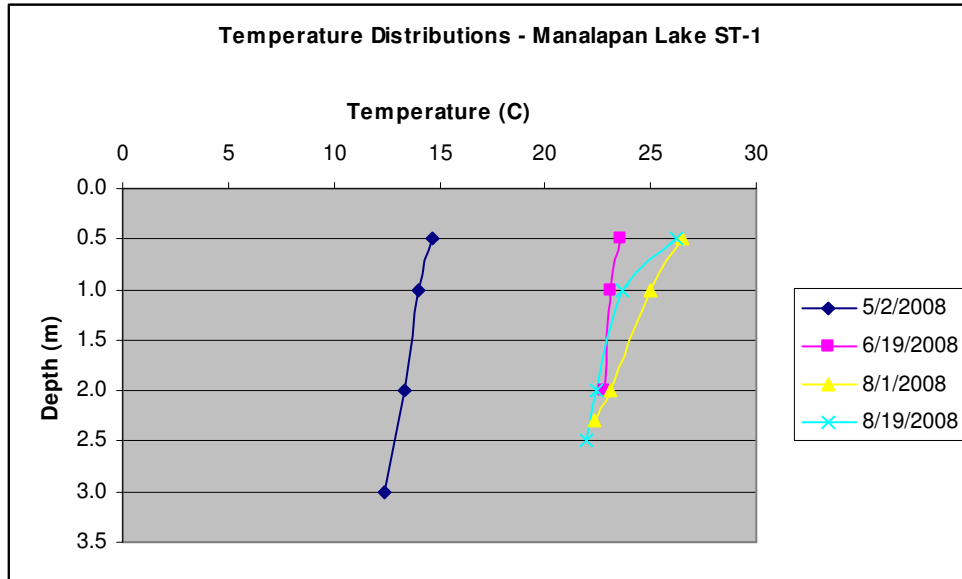
Figure 6. Manalapan Lake ST-1 temperature distributions.

Temperatures in Manalapan Lake coincided with seasonal variation in temperature and varied from 14.7°C on 2 May 2008 to 26.2°C on 19 August 2008. Thermal stratification at ST-1 was weak during the May and June sampling events; however, during the August sampling event thermal stratification was slightly stronger with temperatures varying approximately 4-5°C from surface to bottom. Temperatures at ST-2 followed a pattern similar to ST-1 with the exception of the May and June sampling events, where stratification was slightly stronger at ST-2 than at ST-1 (see Figure 6 and Figure 7). Overall, thermal stratification at both stations was strong enough to result in a reduction of bottom water DO concentrations during the mid-to-late summer season.

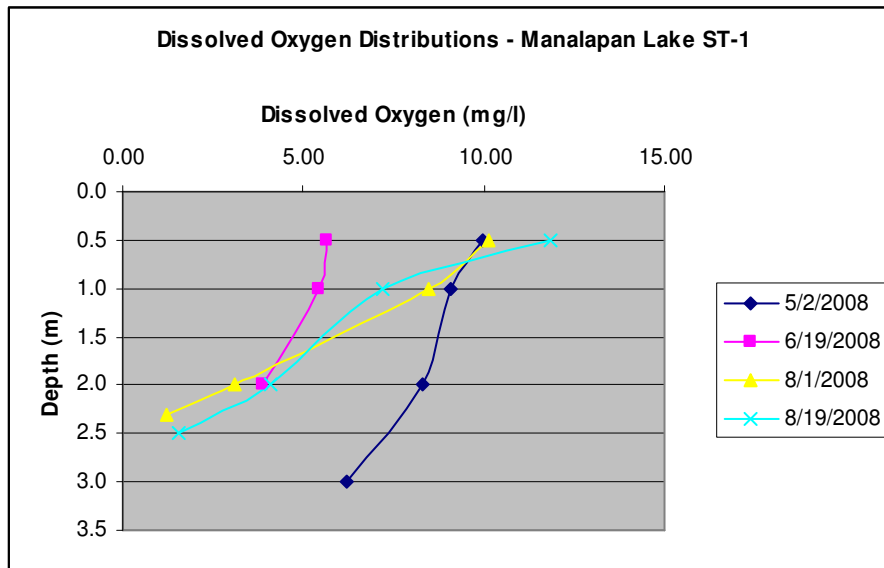
Figure 8. Manalapan Lake ST-1 dissolved oxygen distributions.

During the 1 August 2008 monitoring event, DO concentrations were similar at both ST-1 and ST-2. Surface waters were very well oxygenated (>10 mg/l); however, below 1 meter, DO concentrations declined rapidly to near-anoxic conditions (1.08 mg/l) at both stations. This is probably the result of the hot, dry weather which occurred prior to this sampling date. Such weather results in thermal stratification and associated anoxic conditions in the bottom waters. During the 19 August 2008 monitoring event, ST-1 followed a pattern similar to previous monitoring date. Surface waters at both stations were well oxygenated while bottom waters were near-anoxic (1.57 mg/l); however, ST-2 was well oxygenated from the surface to a depth of 1.5 meters (>9 mg/l). Several rain events prior to this sampling date may have weakened thermal stratification and mixed the waters at ST-2, thereby resulting in oxygenated waters at deeper depths. The dissolved oxygen distributions are summarized below in Figure 8 and Figure 9.

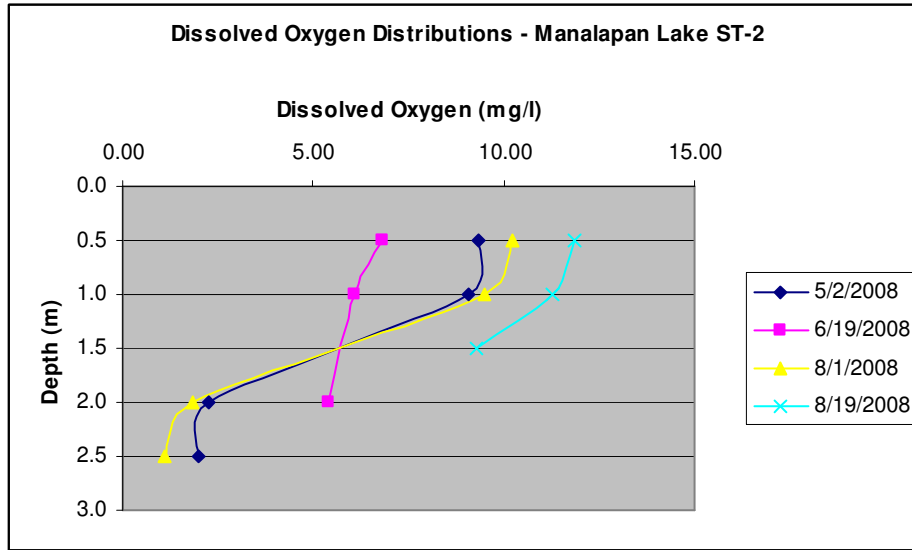
Figure 9. Manalapan Lake ST-2 dissolved oxygen distributions.

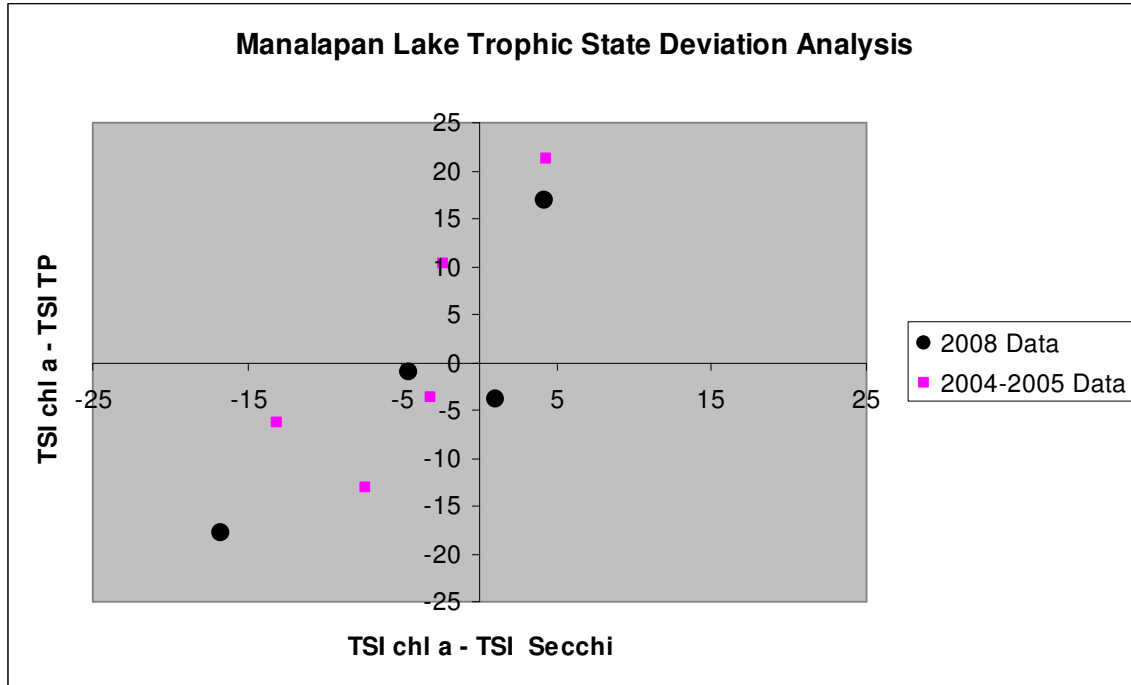
Figure 10. Manalapan Lake Trophic State Deviation Analysis.

The basic underlying assumptions of this model are that particulate matter is the sole source influencing Secchi disk depth while algal matter is the sole contributor to suspended particulate matter. Often times the basic model assumptions are not true and systematic deviations may be determined through TSI residual analysis. Princeton Hydro calculated the trophic state index of Manalapan Lake using both the data collected during the 2004-05 and 2008 monitoring events. A residual analysis was performed of all the data in order to assess whether there were any systematic deviations from the basic model assumptions (see Figure 10 below).

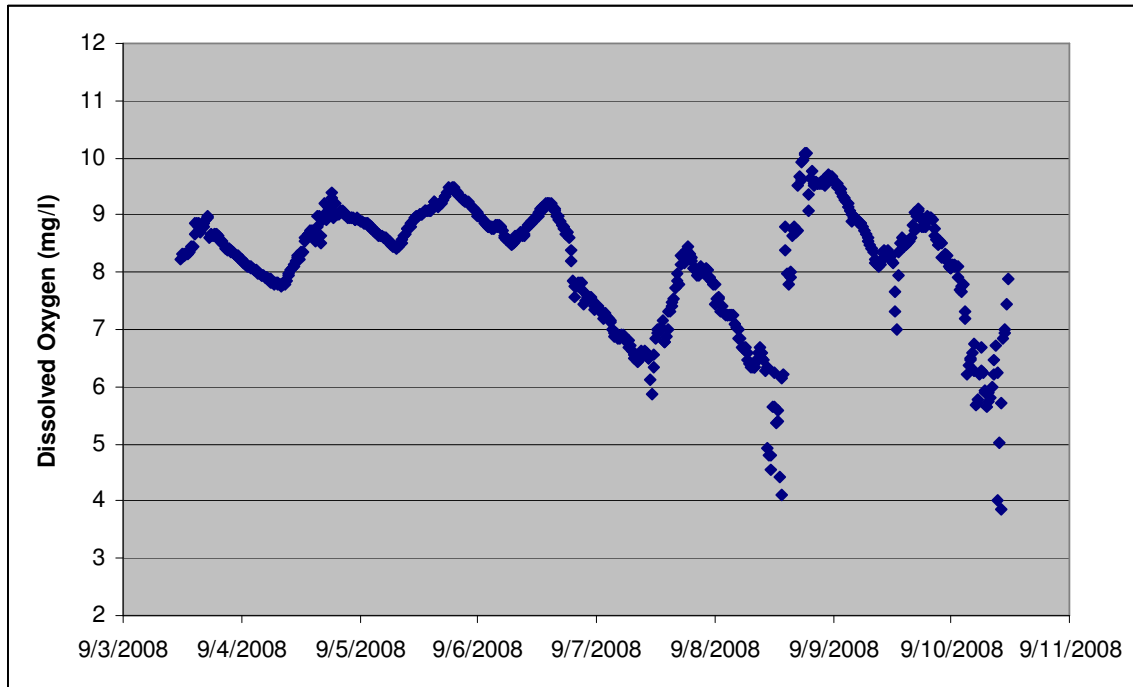
Figure 12. Manalapan Lake dissolved oxygen data 3-10 September 2008.

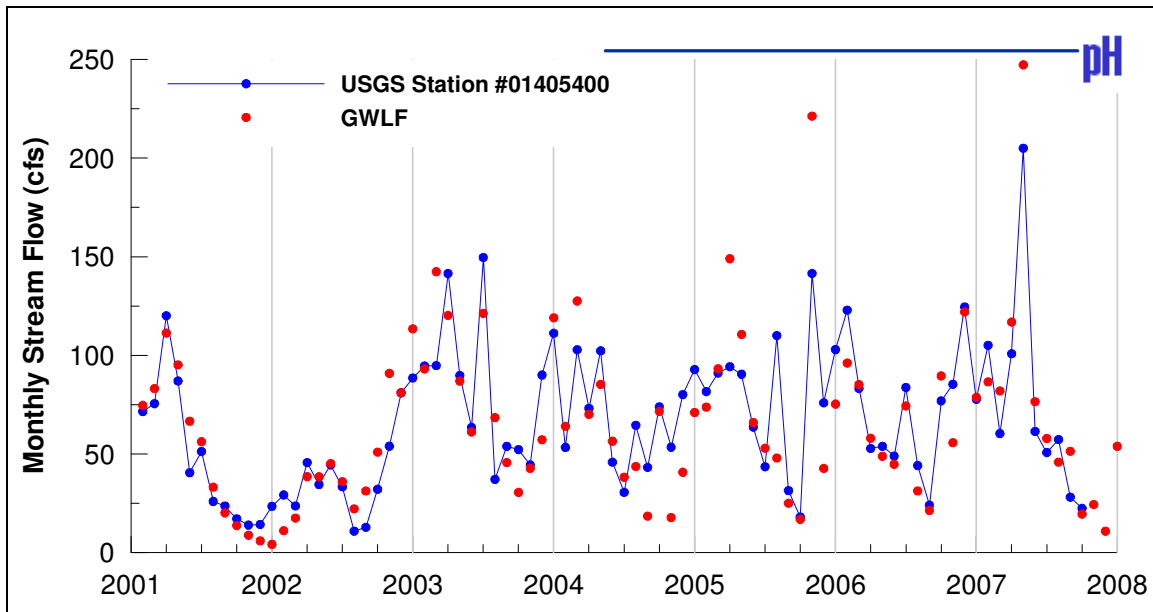
Figure 13. Time series comparison of observed and simulated stream flow.

of stream flow. The time-series plot indicates that the GWLF model generally follows the observed data. This is especially obvious during the first two years when the observed flow was less variable. Also noteworthy is the fact that the seasonality predicted by the model is similar in magnitude to that in the observed data. Although the model seems to over predict months with significant high flows (three months), overall the model is shown to reasonably predict the observed stream flow.

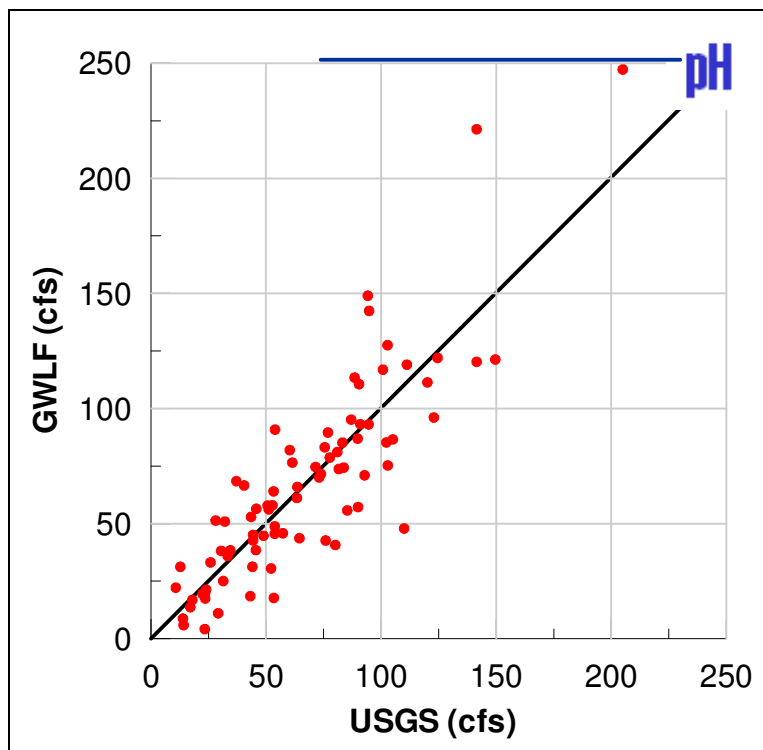
Figure 14. Comparison scatter plot of observed and simulated stream flow.

The third measure is a scatter plot comparing the observed monthly flows (x axis) to the predicted flows (y axis) (see Figure 14). A perfect 1:1 comparison between the x and y axes would indicate a perfect match between the observed and modeled flows. A linear regression of the data provides a slope of 1.00, indicating that *on average* the modeled flow provides an accurate prediction of the observed flow. While there is scatter around the 1:1 line, this figure shows that on average the model neither over estimates nor underestimates the stream flow.

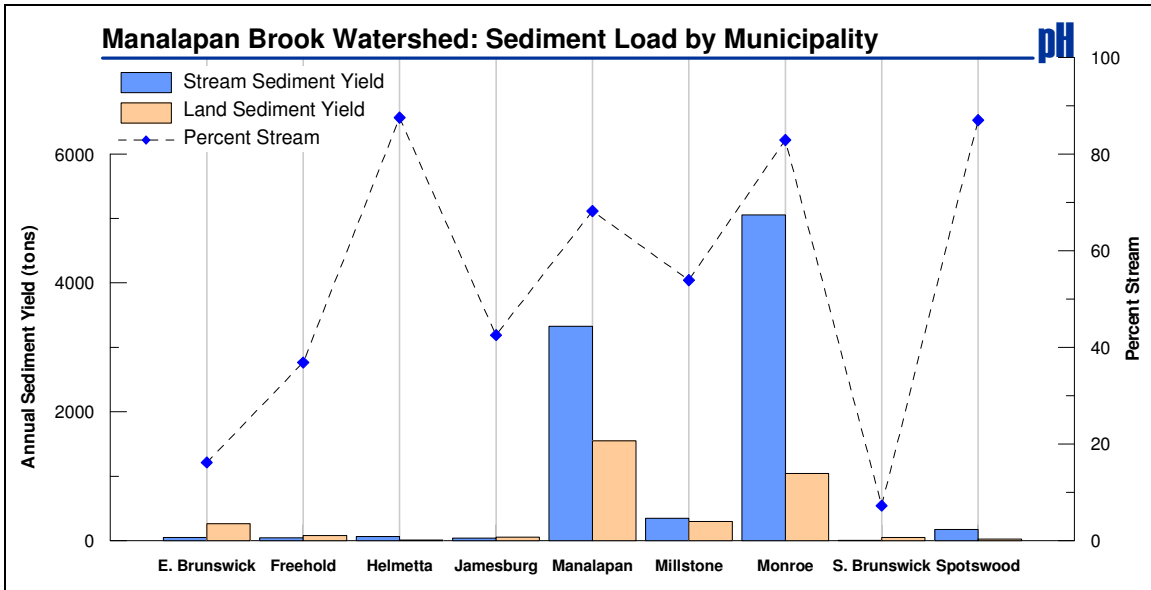
Figure 15. Total sediment load by municipality.

The sediment load results for each of the nine municipalities reveal that the municipalities of Monroe and Manalapan have the highest total sediment load. This is expected since the portions of these two municipalities are by far the largest in the watershed. In an effort to provide an even comparison of sediment loads from the individual municipalities, the sediment loads were normalized. The overland sediment loads were normalized by the area of the municipality and are presented in units of tons/mi². The streambank erosion sediment loads are normalized by the total stream length in each municipality, and these results are presented in units of tons/mile. The results are summarized in graphical format in Figure 15 (total load with percentage from streambank indicated) and Figure 16 (normalized sediment load); the raw data is provided in Table 18.

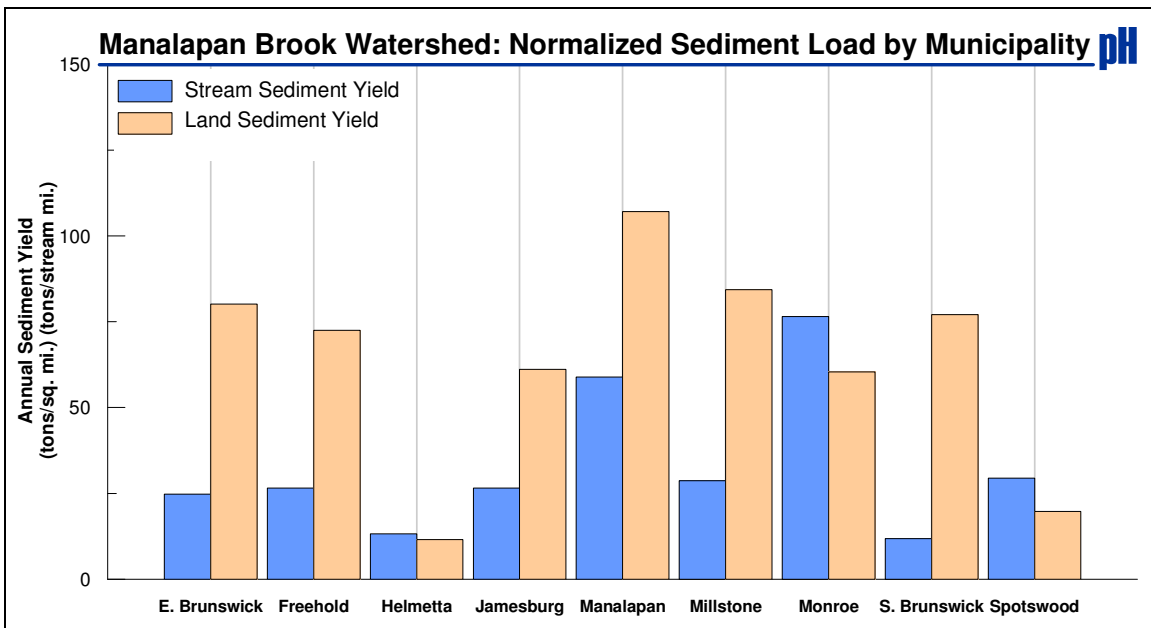
Figure 16. Total normalized sediment load by municipality.

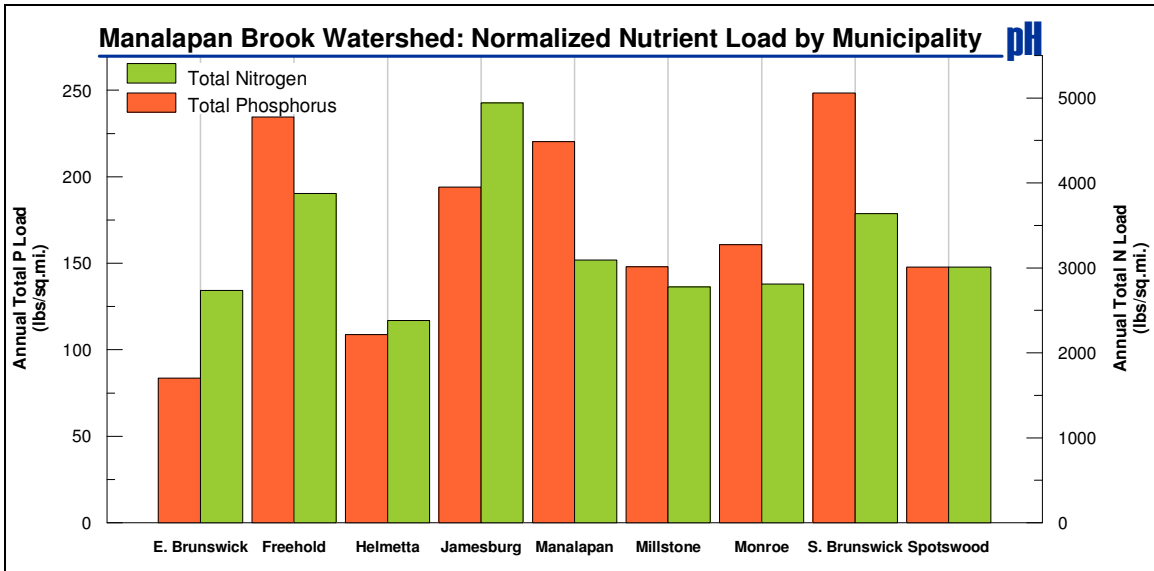
Figure 17. Summary of normalized nutrient loads by municipality.

The GWLF model was also used to calculate the nutrient (nitrogen and phosphorus) loads from the watershed on a municipality specific basis. The total average annual nitrogen load is 129,000 lbs/yr (1.0 mg/l) and the total phosphorus load is calculated as 7,640 lbs/yr (0.059 mg/l). A graphical representation of the municipalities' nutrient loads are provided in Figure 17 and a summary table of the nutrient loads for the municipalities is provided in Table 19.

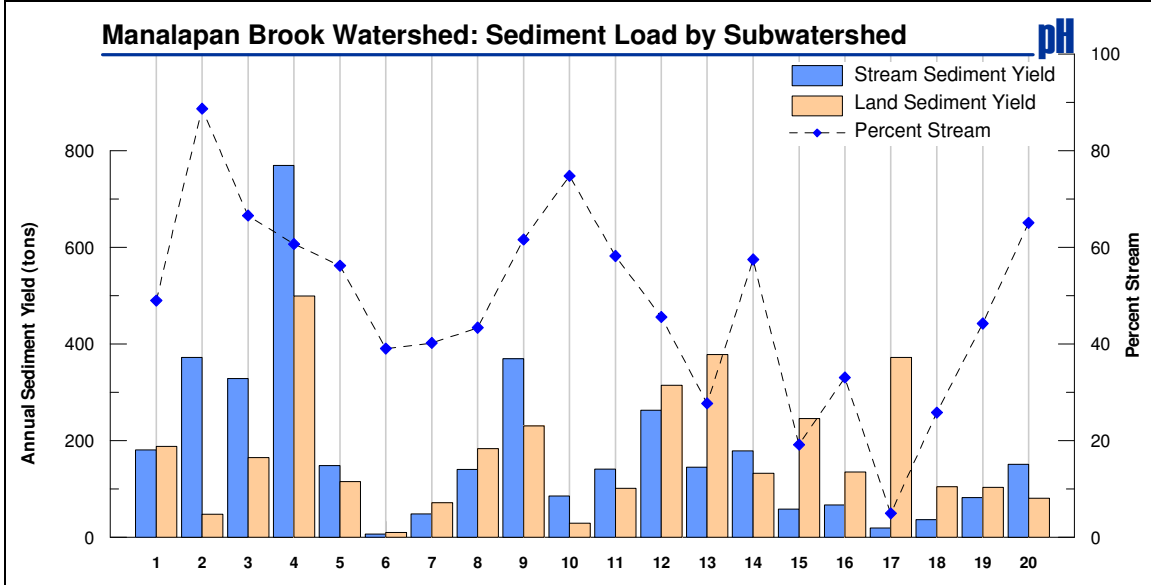
Figure 18. Total sediment load by subwatershed.

high proportion of agricultural and urban areas which are responsible for the high ranking indicated by the model results. Subwatershed #5 was found to have the highest streambank erosion sediment load, with an average annual sediment load of 165 tons/mi. Graphical summaries of the AVGWLF model results are provided in Figure 18 (total load with percentage from streambank indicated) and Figure 19 (normalized loads). The numeric results are also provided in Table 20.

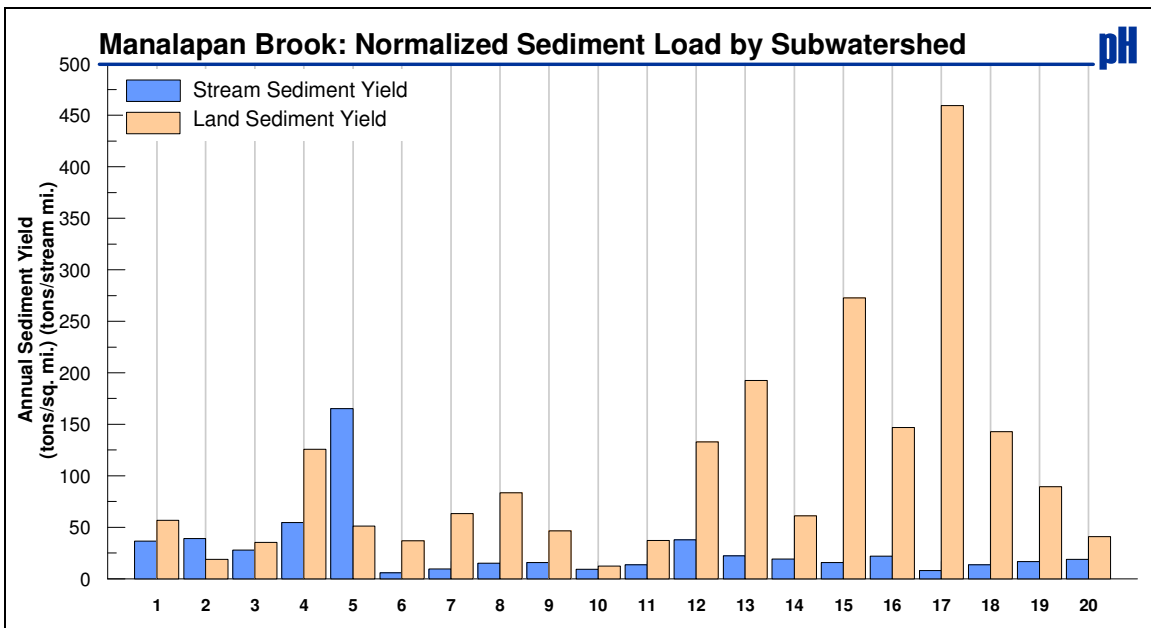
Figure 19. Total normalized sediment load by subwatershed.

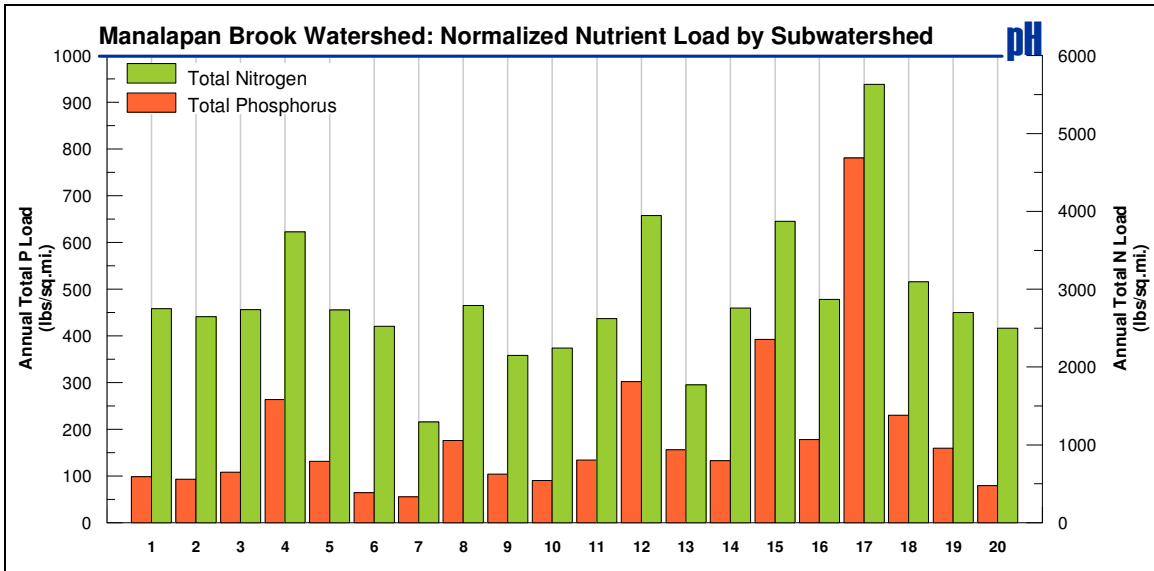
Figure 20. Summary of normalized nutrient loads by subwatershed.

In addition to the sediment loads, the AVGWLF model was also used to calculate the nutrient (nitrogen and phosphorus) loads from the watershed at the subwatershed level. The total average annual nitrogen load is 121,000 lbs/yr (0.93 mg/l) and the total phosphorus load is calculated as 6,940 lbs/yr (0.054 mg/l). A graphical representation of the subwatershed nutrient loads are provided in Figure 20 and a summary table of the nutrient loads for the subwatersheds are provided in Table 21.

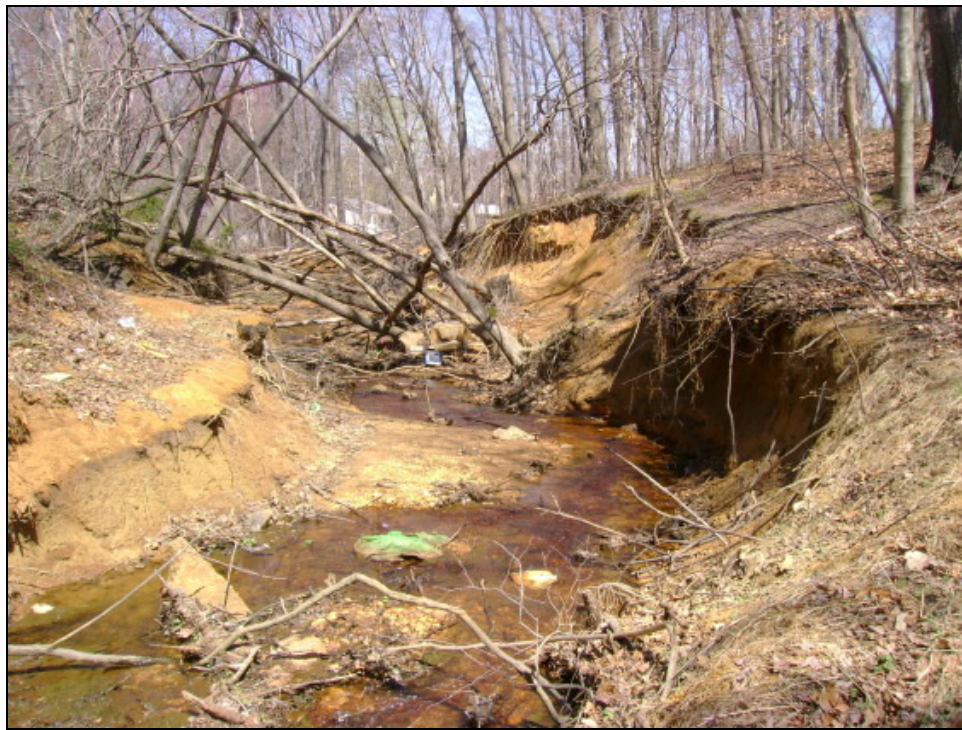
Figure 25. Station #29 looking downstream.

the residential area located at the end of Prospect Street in Jamesburg. Wigwam Pond Lane parallels the reach to the west. The streambanks in this area are actively eroding and are five to 15 feet high along the entire reach. Numerous trees have been undermined and have fallen into the stream along the entire stream reach. There is also one stormwater outfall from the nearby apartment complex on the west side of the reach. Several acid seeps were observed along the base of the reach. Glauconitic soils (surficial) are not mapped in this portion of the watershed; however, due to the extent of the apparent channel down cutting, acid producing soils have been exposed at various locations along the entire reach. The extent of the erosion is shown below in Figure 25.

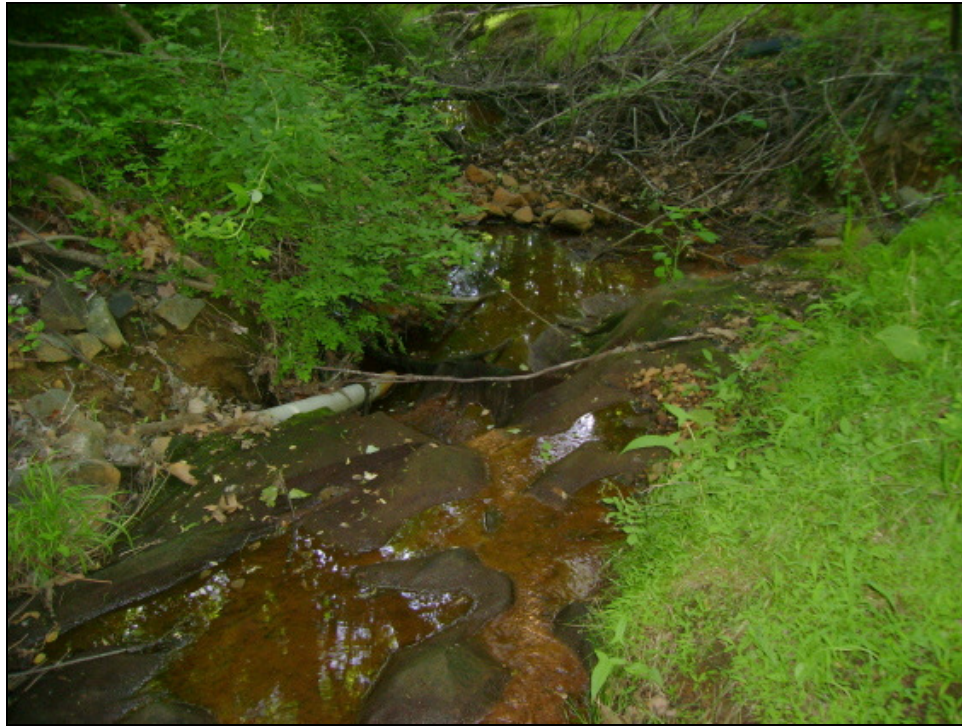
Figure 26. Station #67 looking downstream.

Station #67 is located in a headwater area of Subwatershed #12. At this station a small tributary which originates in a residential area flows under Kinney Road in Manalapan Township. There appear to have been recent culvert upgrades to the road crossing. Geotextile matting was placed to a distance of approximately 75 feet downstream of the two culverts. For approximately 150 feet downstream of the road crossing there are 3-4 foot eroded streambanks with numerous acid seeps present, as shown in Figure 26.

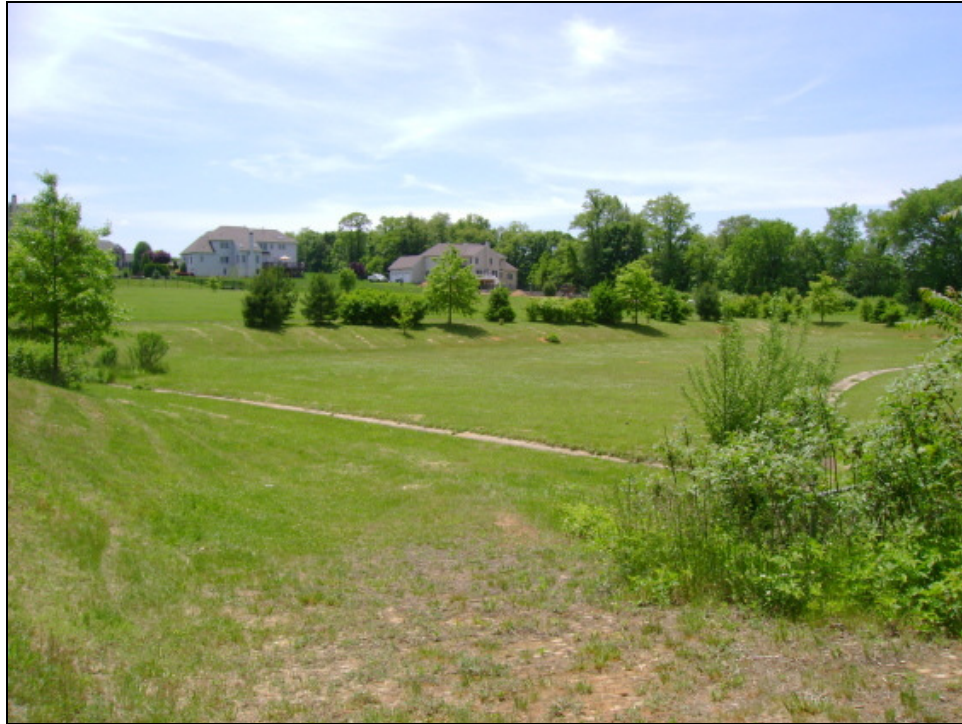
Figure 27. Large stormwater detention basin at station #80.

subdivision. The detention basin has two inlets and a series of three concrete low flow channels which route inflow from small storms directly to the outlet structure and into the adjacent tributary, as shown in Figure 27.

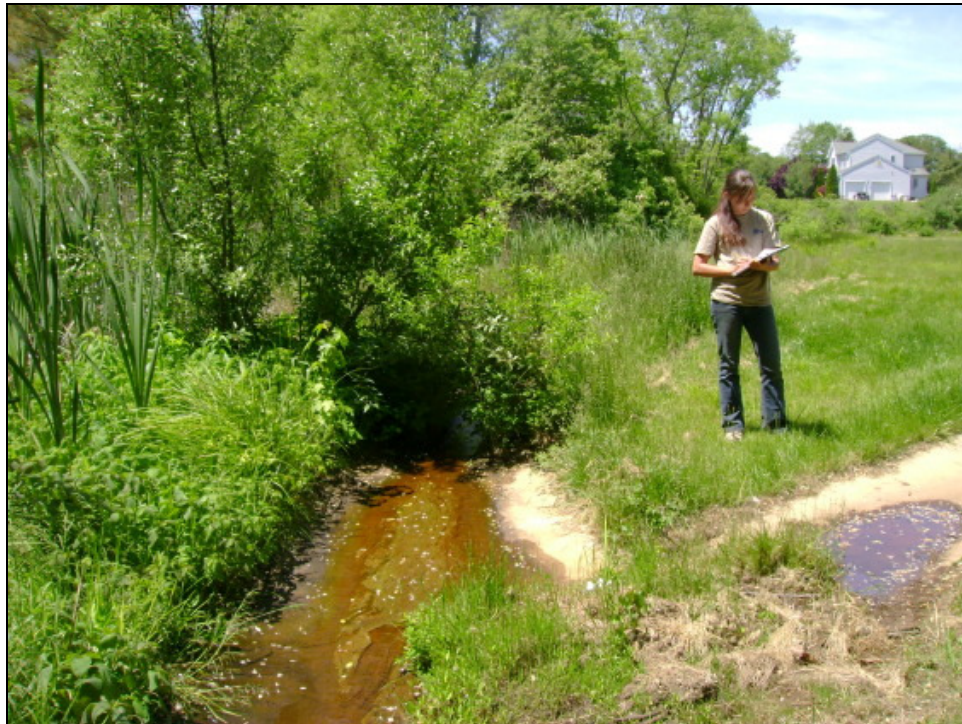
Figure 28. Stormwater detention basin located at station #84.

Station #84 is located along Thompson Grove Road in Manalapan Township. Located at the headwaters of Subwatershed #16, this portion of the watershed has experienced significant recent development primarily involving the conversion of agricultural areas to low density residential housing developments. At station #84 a large detention basin (~1.1 acres) was constructed to control runoff from the adjacent low density residential housing development (Figure 28). The site is located in the headwaters of Subwatershed #16, and it appears that the basin was built as an in-stream basin with a small tributary flowing through the basin in a concrete low flow channel. Flow was observed in the tributary during all site visits to station #84. The portion of the basin surrounding the tributary is well vegetated and contains typical wetland vegetation. The basin has a second inlet whose flow is also conveyed via a concrete low flow channel. This portion of the basin appears to be mown on a semi-regular basis.

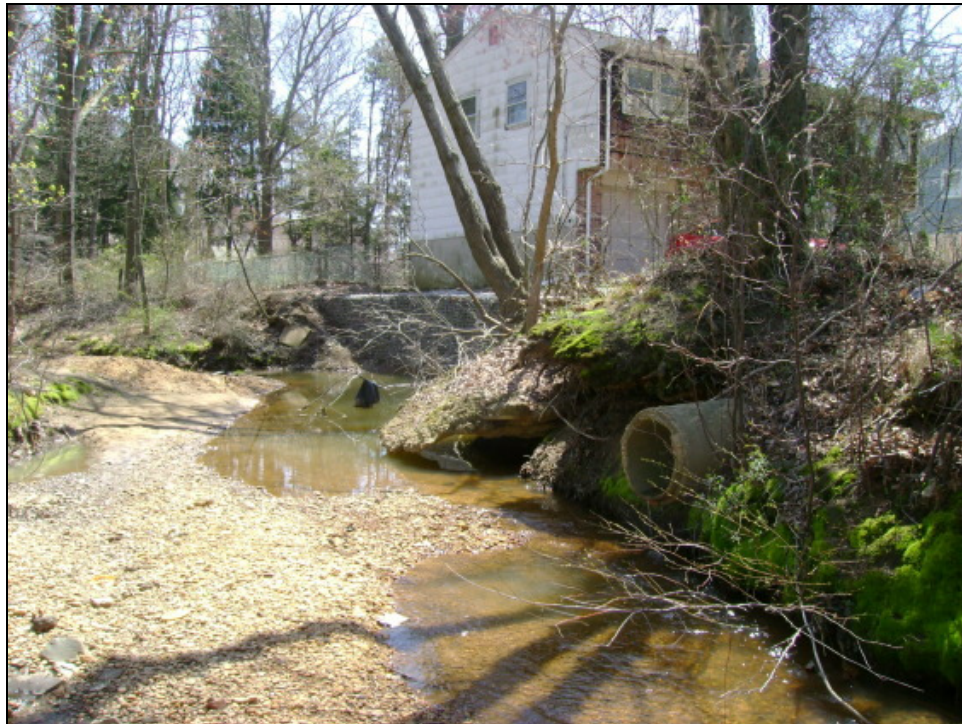
Figure 29. Station #32 looking upstream at street outfall and gabion wall.

Station #32 is located on the border between Jamesburg Borough and Monroe Township near State Street and Oakwood Terrace along the downstream reaches of Subwatershed #5. The station is approximately 0.4 miles upstream of the unnamed tributary's confluence with the mainstem of Manalapan Brook (just below Manalapan Lake). The stream has significant erosion and sedimentation along this section. The streambank is severely undercut in areas and a gabion wall has been installed in an effort to protect an adjacent property from further erosion (see Figure 29).

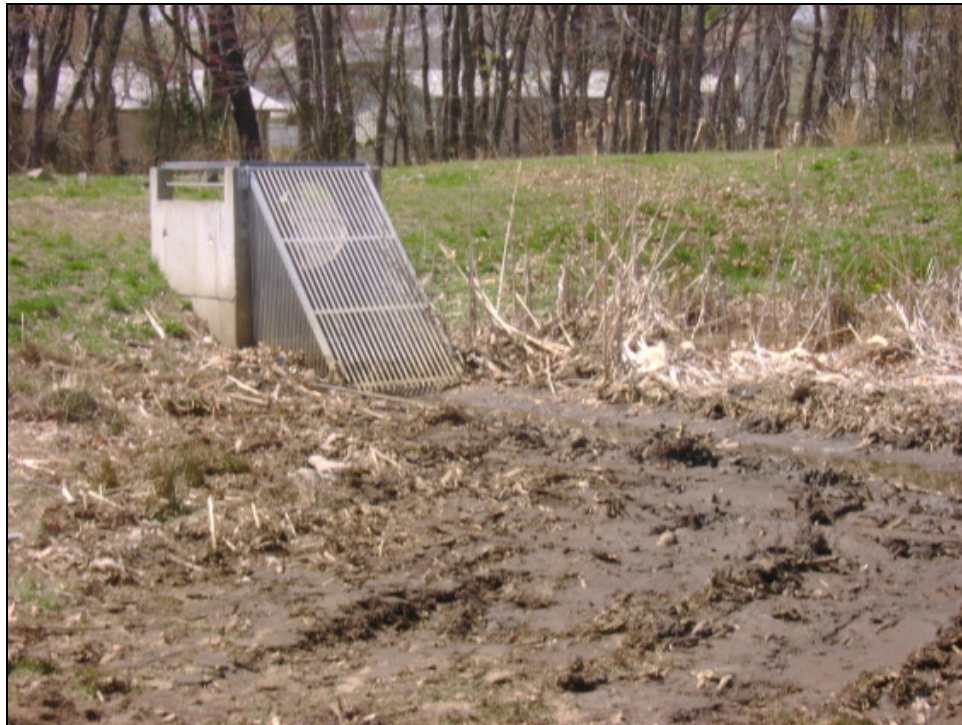
Figure 30. Detention basin outlet structure and recently disturbed vegetation.

At this location the stream receives runoff from both the adjacent street (William Street) and the outflow from a large detention basin located just off the right side of the tributary. At the time of inspection (summer 2008), the relatively large (~1.1 acre) detention basin appeared to have been recently serviced to remove accumulated sediment as is shown in Figure 30.

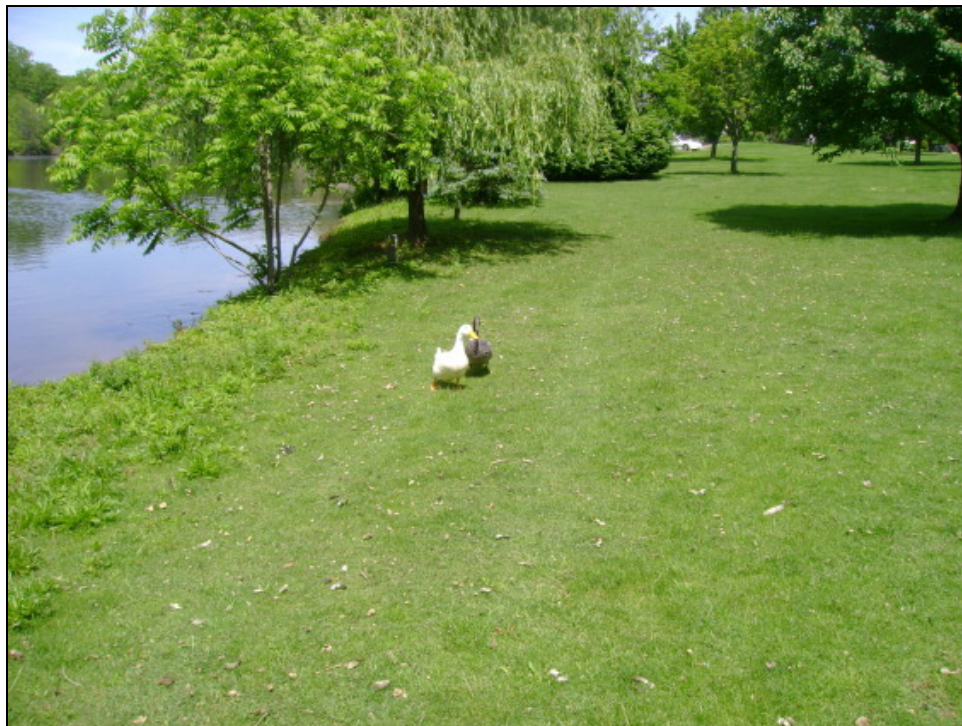
Figure 31. Shoreline located at station #86.

This area could benefit from lakeshore riparian plantings that would reduce erosion, discourage geese and help remove nutrients and sediment from runoff. In addition, signs discouraging the feeding of waterfowl and mowing grass could be installed at this location.

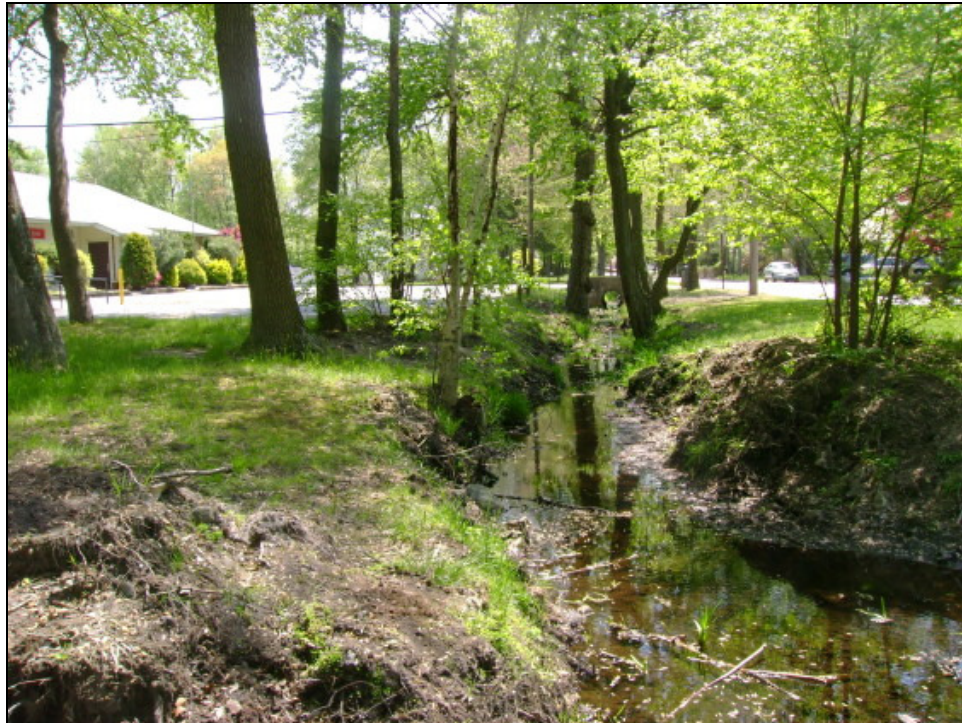
Figure 32. Station #3 near Cedar Brook.

Station #3 is located on Adirondack Avenue in Spotswood Borough, Middlesex County, along Cedar Brook in Subwatershed #1 (Figure 32). This area received significant flood damage in 2005 and at the time of the site visit (summer 2008) the twin culverts under Adirondack Avenue were nearly filled with sediment. This station would benefit from cleaning sediment out of the culverts and initiating a better maintenance and sediment removal program (Figure 33).

Due to minor erosion in the area approximately 200 linear feet of minor streambank stabilization with re-vegetation and buffer planting is recommended for this site. The amount of sediments that would be removed through this project is estimated to be approximately 230,000 pounds. The estimated cost for the proposed project is between \$25,000 and \$33,000.

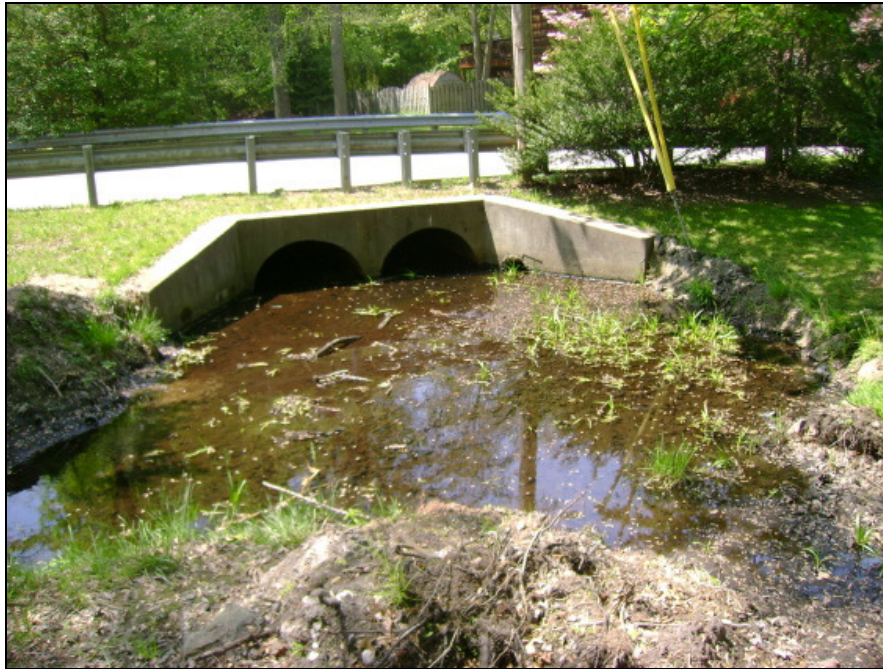
Figure 33. Sediment-clogged culverts at station #3.

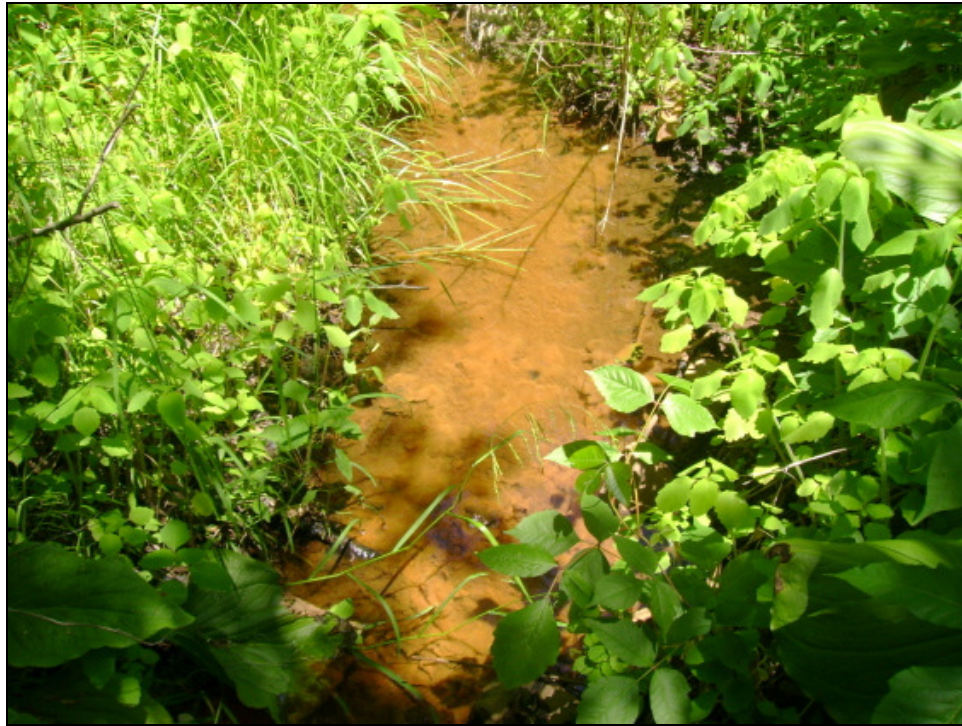
Figure 34. Iron staining at station #88.

Station #88 is located on Nottingham Court in Manalapan Township, Monmouth County in Subwatershed #19. The station is on an unnamed tributary that runs through a housing development. During the site visit, high amounts of iron staining, iron floc, and iron bacteria were observed. These conditions caused a bright orange discoloration of the water (Figure 34). Acid seeps were also observed in this area. Actions should be taken to minimize the exposure of the acid producing soils in this area. This may include the placement of a suitable soil cover to help establish stable, vegetated cover.

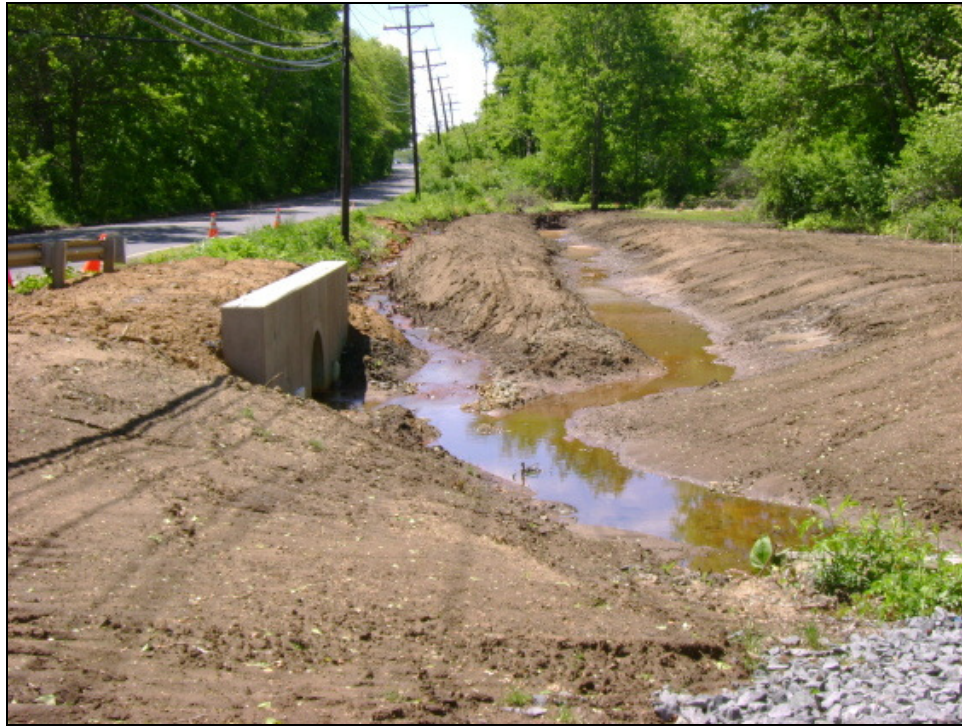
Figure 35. Construction prior to riparian planting at station #71.

Sediment loads from this station could be further reduced by the planting of supplemental vegetation or the installation of other erosion control practices. The channels created during the construction operation may also need to be stabilized due to streamflow changes resulting from upstream developments in the area.

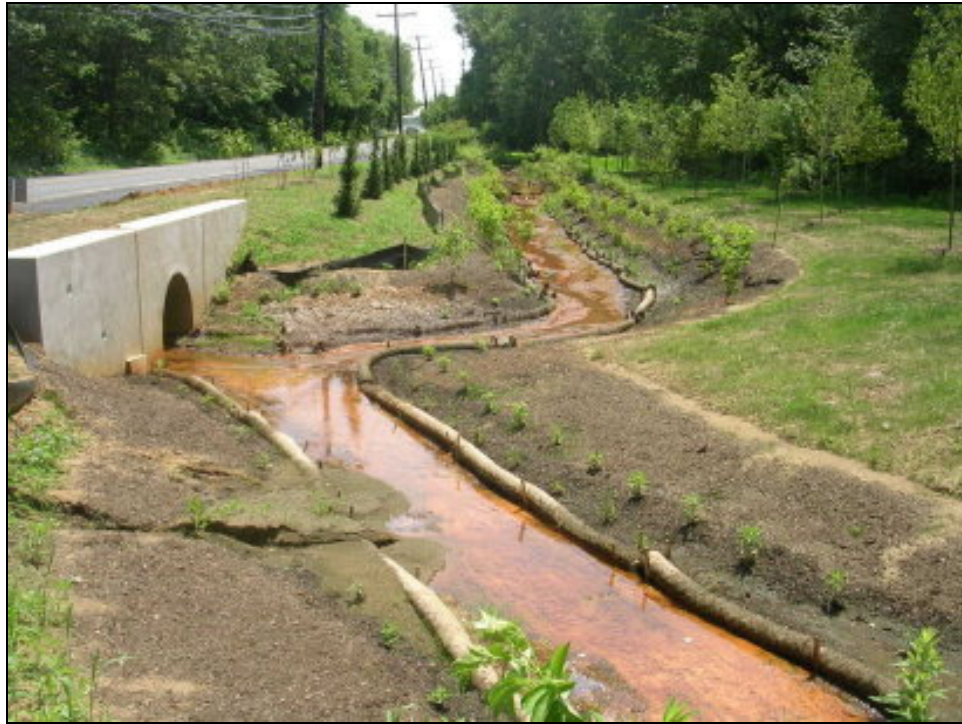
Figure 36. Station #71 after riparian plantings and partial stabilization.
