WATERSHED PROTECTION AND RESTORATION PLAN FOR THE MANALAPAN BROOK WATERSHED

Middlesex and Monmouth Counties, New Jersey

Princeton Hydro, LLC

February 2011

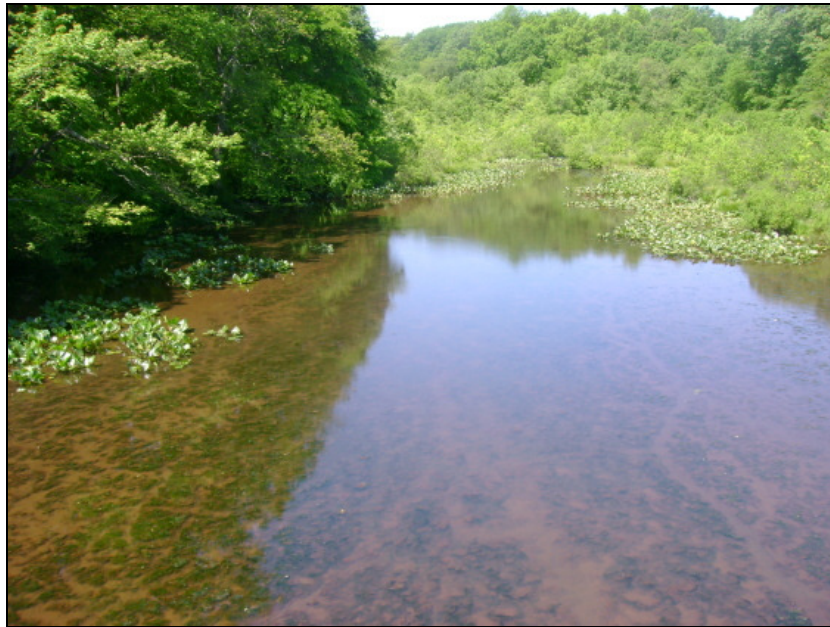
Figure 37. Station #92 pond at Charleston Springs Golf Course.

This pond serves as the primary irrigation water source for the golf course. Monmouth County owns the golf course and has implemented several BMPs; however, evidence from aerial photographs suggests that sedimentation and nutrient loading have occurred in the pond on the golf course. This is evidenced by shallow depth to sediments and the growth of nuisance algae and water lilies (Figure 37). This sediment and nutrient loading may be a result of previous (agricultural) land uses at the site.

The removal of approximately three feet of accumulated material from the pond is estimated to cost between \$580,000 and \$870,000; this price includes feasibility study, permitting, engineering, actual implementation and restoration of site. Such a project would also include additional restoration or stabilization measures that would maximize the pond's littoral fringe of vegetation to enhance pollutant uptake; however, it should be emphasized that a bathymetric study would be required to quantify how much unconsolidated material is in the pond to develop a more detailed cost estimate. The amount of sediment anticipated to be removed with the completion of such a project, through settling of solids in both the open

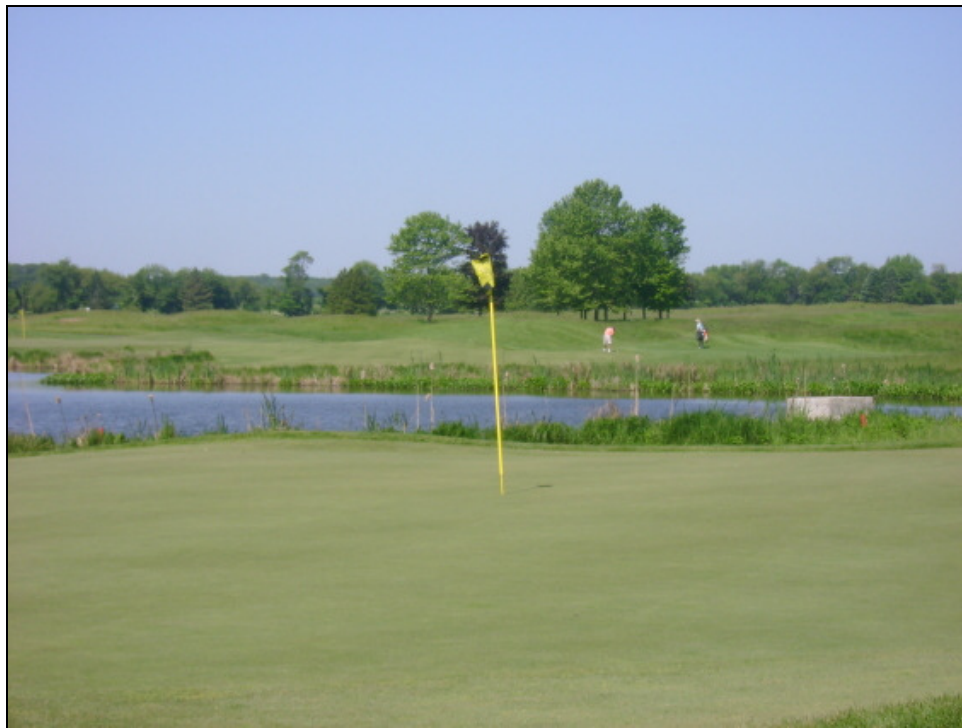
Figure 38. Station #94 at Charleston Springs Golf Course.

Station #94 is located adjacent to an unnamed tributary of Manalapan Brook at the Charleston Springs Golf Course in the municipality of Millstone, Monmouth County, and Subwatershed #18. There are several ponds located at the northern end of the golf course which are used for irrigation purposes. The county is actively trying to reduce the area of invasive species by planting native grasses during the winter. Due to the irrigation use of the ponds, Monmouth County Park System has observed that the ponds typically do not overflow during the growing season. Outflow is limited to winter months. Based on the onsite observations, this site is expected to contribute a minimal TSS load; however, increasing the width of the pond's riparian buffers would help further reduce the overflow potential and TSS load originating from the ponds.

Expanding the existing shoreline buffers and replacing any existing invasive species with native species would provide water quality, ecological, recreational

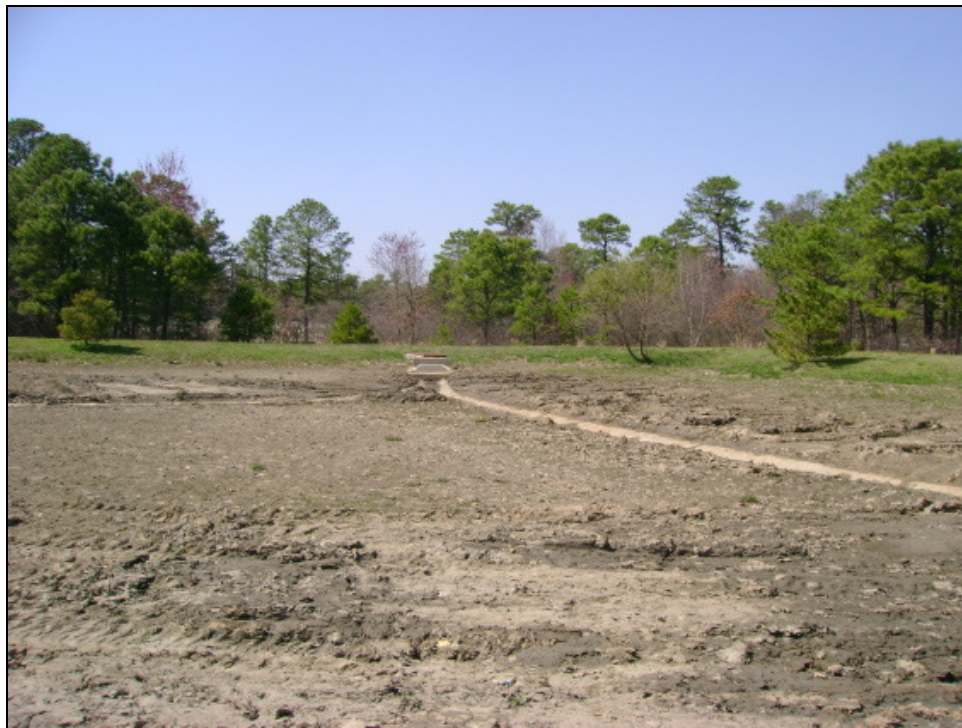
Figure 39. Recently cleared detention basin at station #15.

Station #15 is located on McKinley Road in Monroe Township, Middlesex County and in Subwatershed #2. This station is on an unnamed tributary to Manalapan Brook and was dry at the time of the site evaluation; however, this tributary receives stormwater runoff from a detention basin and a wet pond. At the time of the site inspection (summer 2008) Monroe Township recently removed 1 foot of sediment from the flow channel of the detention basin and spread the sediment around the basin (Figure 39).

The TSS removal capabilities provided by the detention basin would be drastically improved with the implementation of revised operation and maintenance practices in the basin. Such practices would not expose the entire basin bottom soils and remove established vegetation within the basin. The basin should have permanent vegetation established to minimize sediment suspension and transport from the basin. This vegetation will also encourage the removal of incoming sediment loads from the basin's contributory drainage area.

Specific recommendations for the site include some additional stabilization and planting efforts for the existing detention basin. The estimated annual sediment

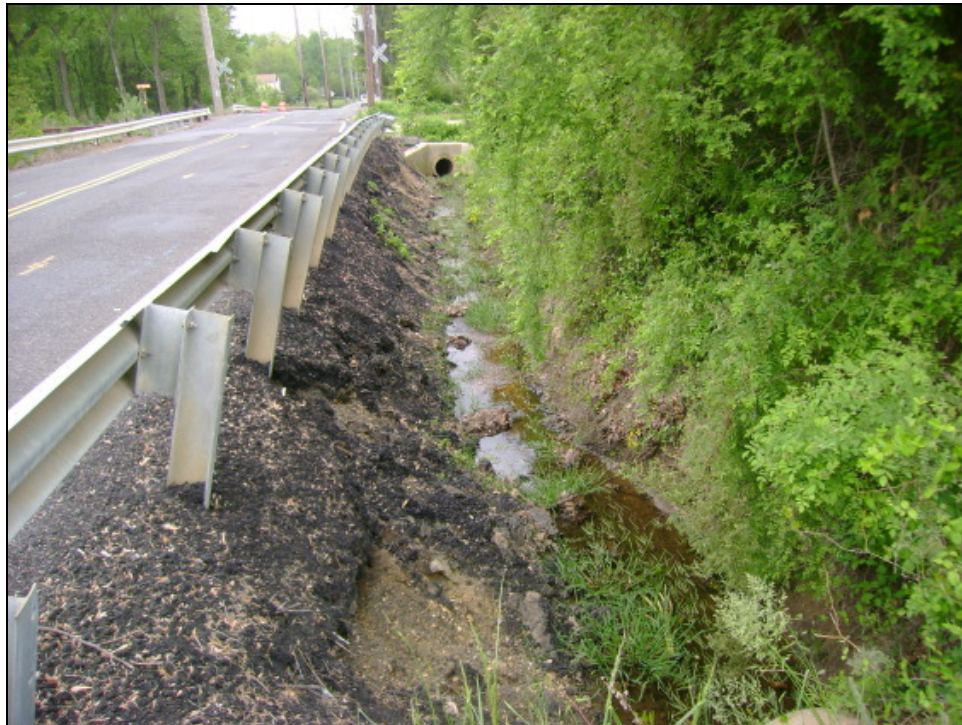
Figure 40. Tributary and culvert at station #45.

Station #45 is located near the intersection of Dancer Court and Hoffman Station in Monroe Township, Middlesex County (Figure 40). The station is in a residential area of Subwatershed #8. At the time of the assessment there was very low flow in the tributary. This area of the subwatershed has experienced recent and ongoing local development. The area has a substantial number of culverts and outfalls. In addition, there are limited riparian buffers around the tributary. These inlets may provide opportunities for stormwater management retrofits through the installation of manufactured treatment devices. These devices have the potential to provide TSS removal of 80%.

As mentioned above, some type of MTD could be installed either adjacent to or under the existing roadway to provide a means of removing suspended sediments from stormwater before it flows into Manalapan Brook. Examples of some MTDs that could be used at this site are provided in Appendix E. The design and installation of a MTD at this site is estimated to cost between \$200,000 and \$312,500, with approximately 18,000 pounds of sediment being removed on an annual basis. As with any installed MTD or BMP, the structure would need to be cleaned out on a routine basis with conventional equipment; at least 1-2 times per year.

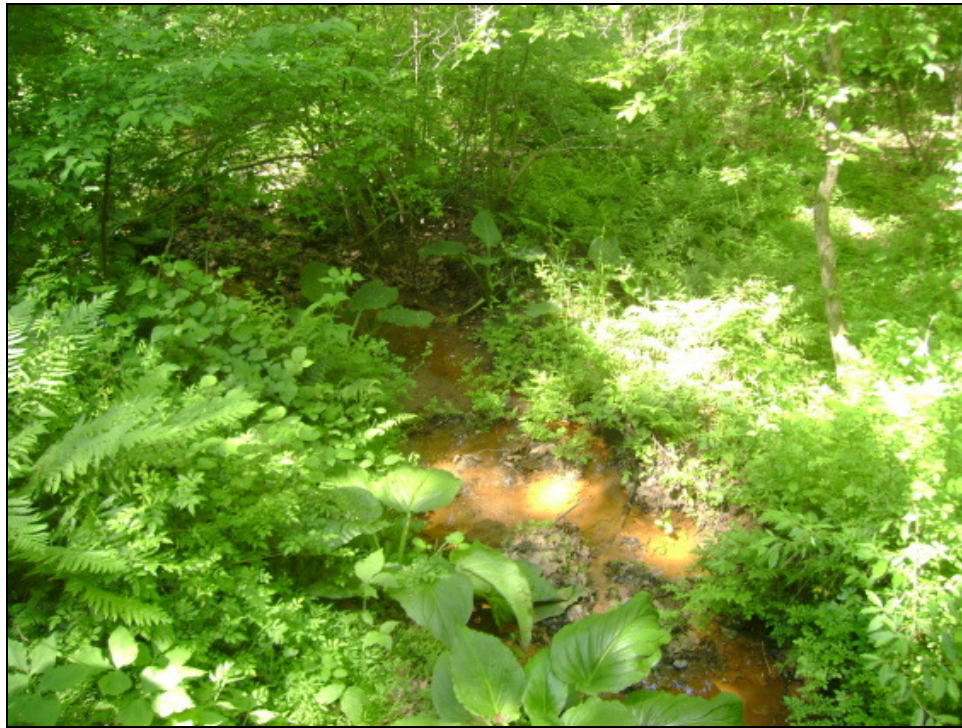
Figure 42. Tributary at station #96

Station #96 is located on an unnamed tributary at the south course of Charleston Springs Golf Course in Millstone Township, Monmouth Township, and Subwatershed 20. The station is located near a bridge that spans the tributary. The area consists of a wetland with a small tributary (Figure 42). Mitigation for this site should consist of preserving and improving the wetland. Wetlands are capable of removing as much as 90% of suspended solids that enter via stormwater runoff.

Protecting and further wetland enhancement is recommended for this site and is expected to remove an additional 6,800 pounds of sediments. Such work would also foster and enhance the ecological, wildlife and aesthetic value of the site. It is anticipated that this work will not require a significant permitting effort. The estimated cost of protecting and enhancing these wetlands potentially through additional plantings and fencing is between \$23,000 and \$36,000.

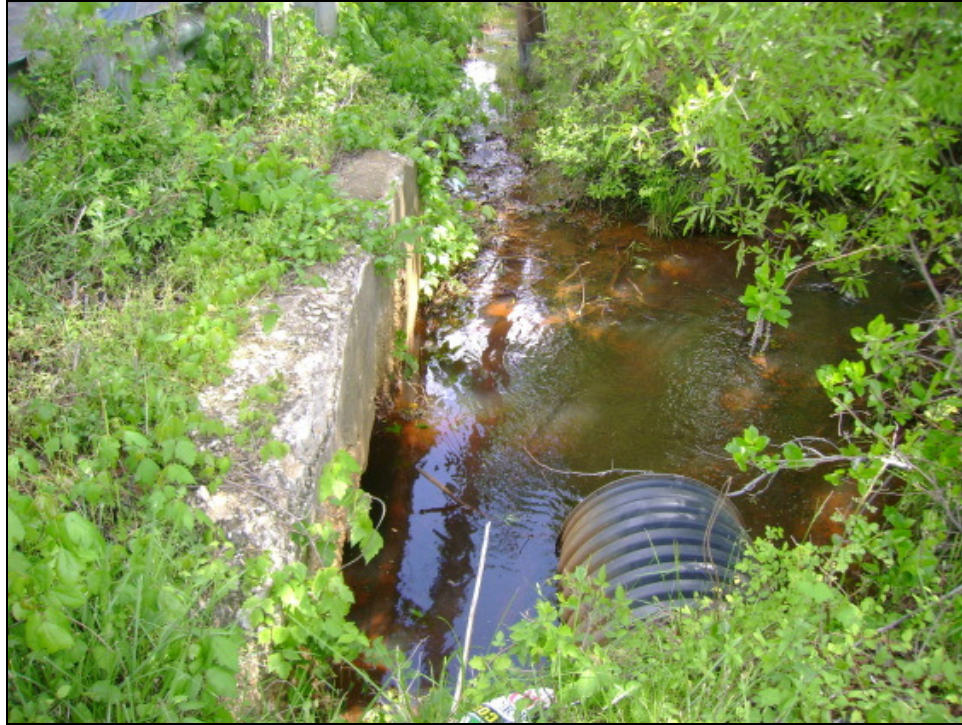
Figure 43. Culvert and swale along Federal Road at station #53.

several horse farms. The tributary is piped to a new swale and flows along Federal Road (Figure 43). Mitigation in this area should involve the encouragement of preservation of riparian areas and the planting of riparian vegetation. In addition, energy dissipation modifications should be considered where the tributary is piped into the swale. Depending on the magnitude of the storm loads that enters this tributary, a manufactured treatment device may also be considered for this site.

The restoration recommendations for this site include the installation of a MTD and expansion of existing riparian habitat. If implemented, these projects are estimated to remove approximately 518,000 pounds of TSS on an annual basis. The estimated cost to implement these projects is between \$126,000 and \$197,000.

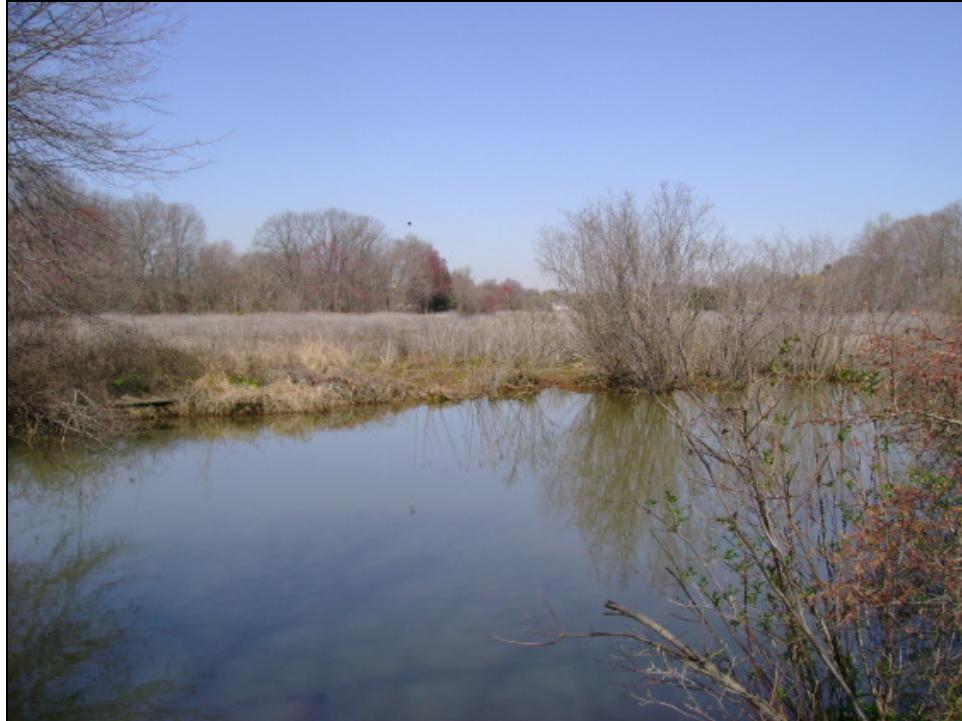
Figure 44. Manalapan Brook at station #38.

Station #38 is located on Rues Road in Monroe Township, Middlesex County where Manalapan Brook enters Manalapan Lake (Figure 44). The station is located in Subwatershed #7. Manalapan Brook meanders through several wetland areas before reaching Manalapan Lake.

flows as the water surface elevation of Manalapan Brook comes under the influence of the dam in Jamesburg.

Removing some of this accumulated material and rehabilitating this section of the lake to function as a forebay settling basin for the main body of the lake and the downstream sections of the Manalapan Brook will provide significant TSS load reductions and restore the sediment removal capacity of the area.

Based on the modeled annual TSS load entering Manalapan Lake and the expected NJDEP approved load reduction, it is estimated that the forebay of Manalapan Lake has the capacity to remove approximately 3.9 million pounds of suspended sediments per year. A preliminary estimate of the cost of removing this unconsolidated sediment and providing some additional restoration measures (see below) is estimated to cost between \$2.8 and \$4.3 million. Such sediment removing activities are expected to be required approximately once every 20 to 50 years; however, the actual frequency will depend on the degree of soil stabilization measures that are implemented upstream of the lake.

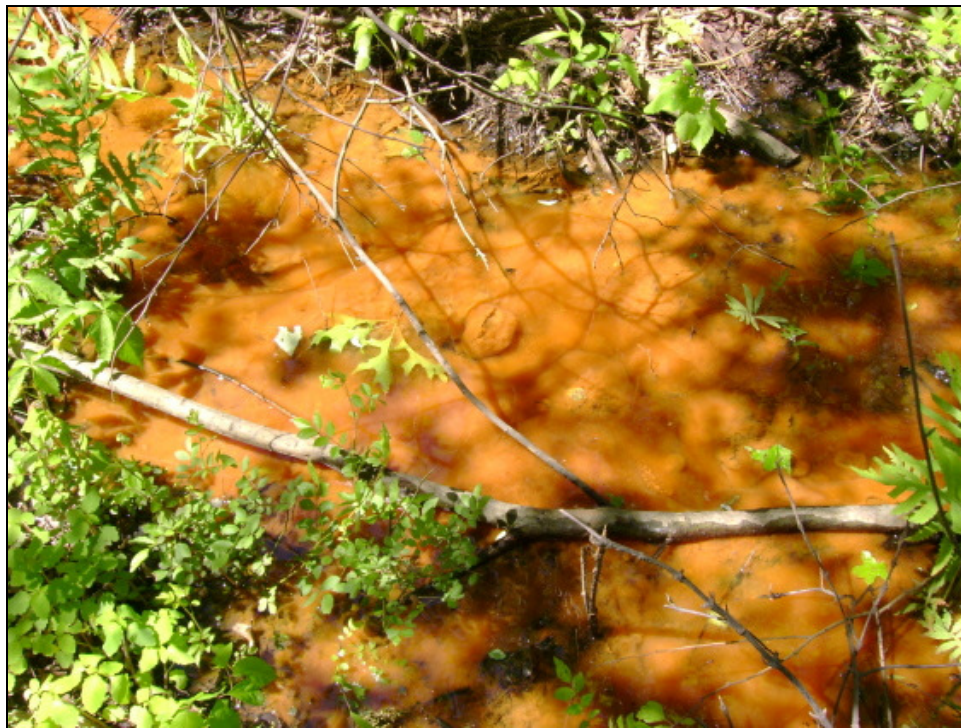
Figure 45. Iron floc accumulation at Station #61.

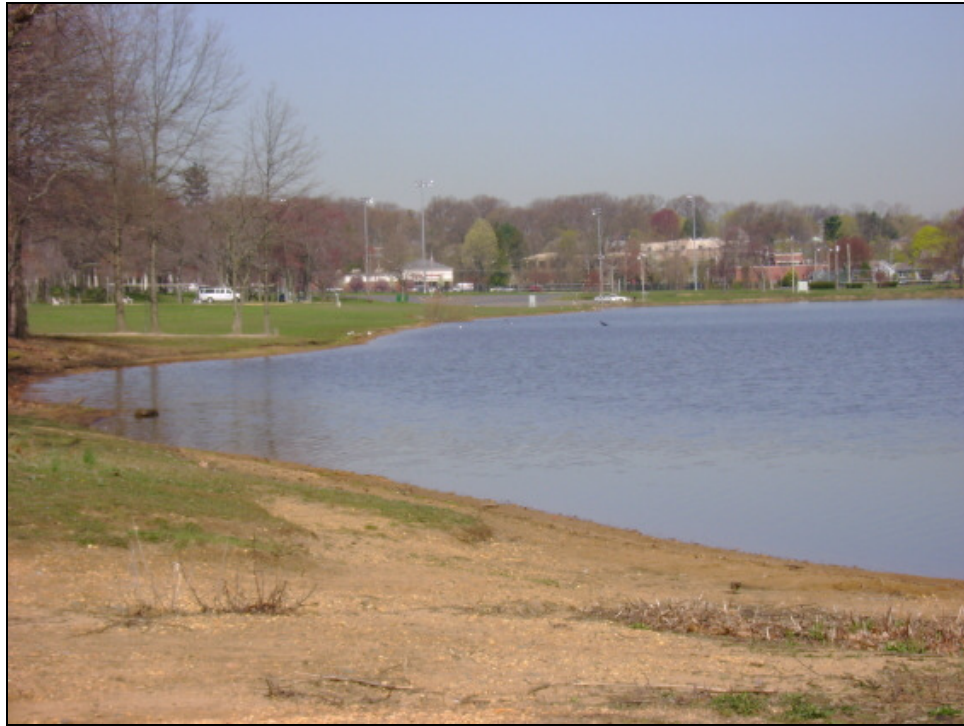
Figure 46. Exposed soil in heavily trafficked areas at station #37.

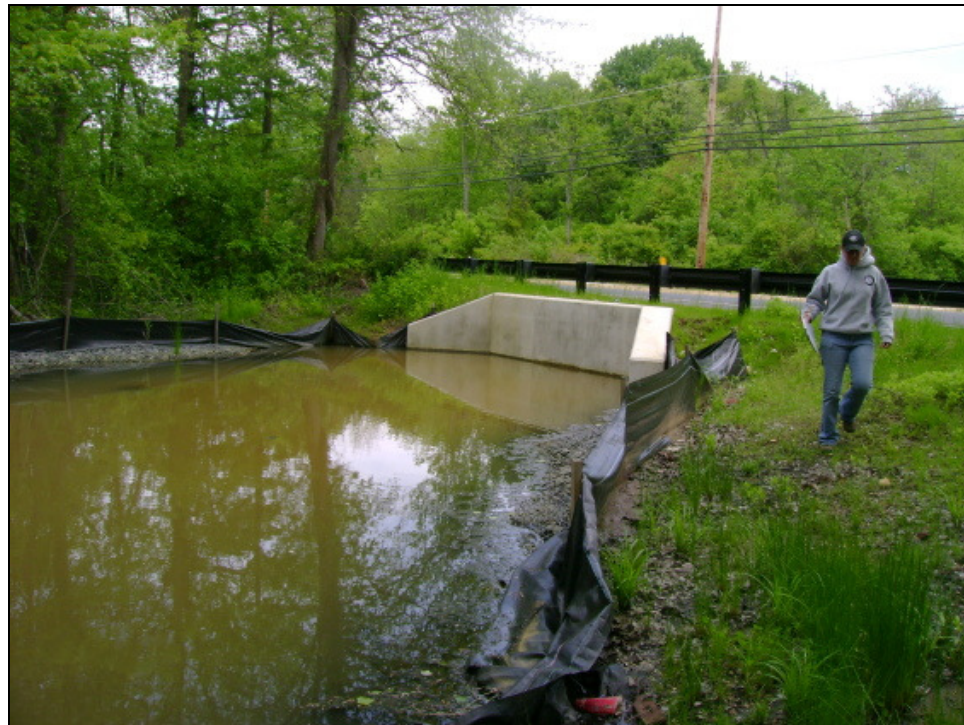
Figure 48. Construction of culvert crossing upgrade at station #63.

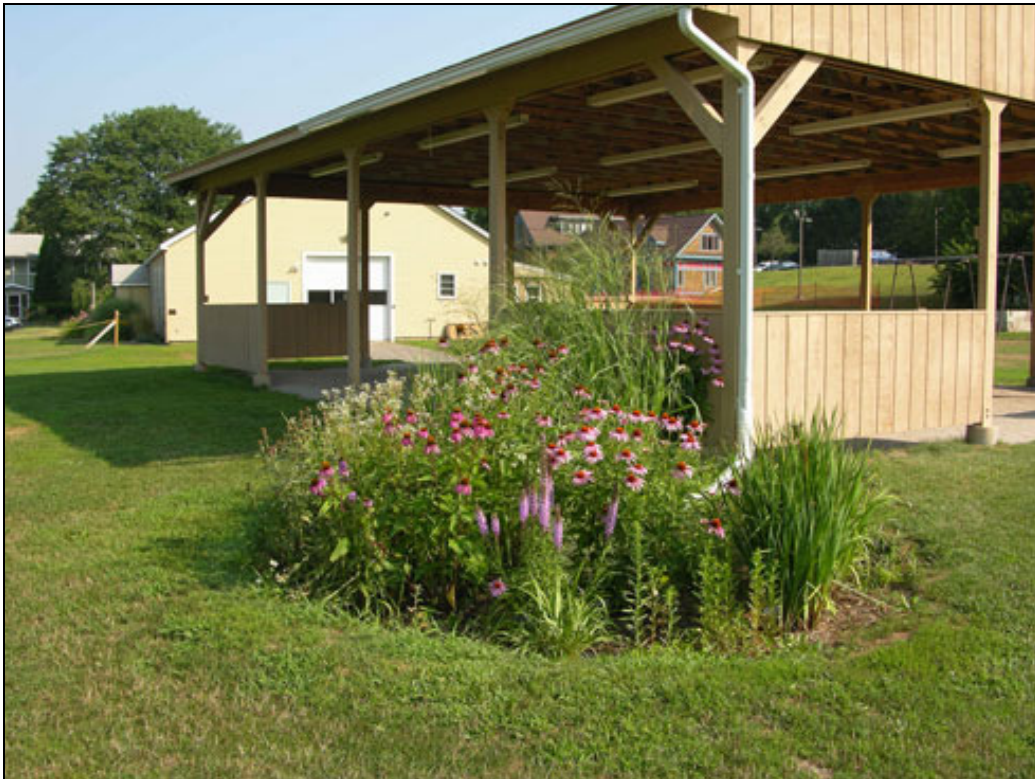
Figure 49. Rain garden photo credit: USDA.

The example rain garden shown below is especially adaptable to a residential setting where more variety and color are desired. This rain garden has a single downspout for inflow. Relatively intensely planted rain gardens similar to this one may require periodic supplemental irrigation during summer months.

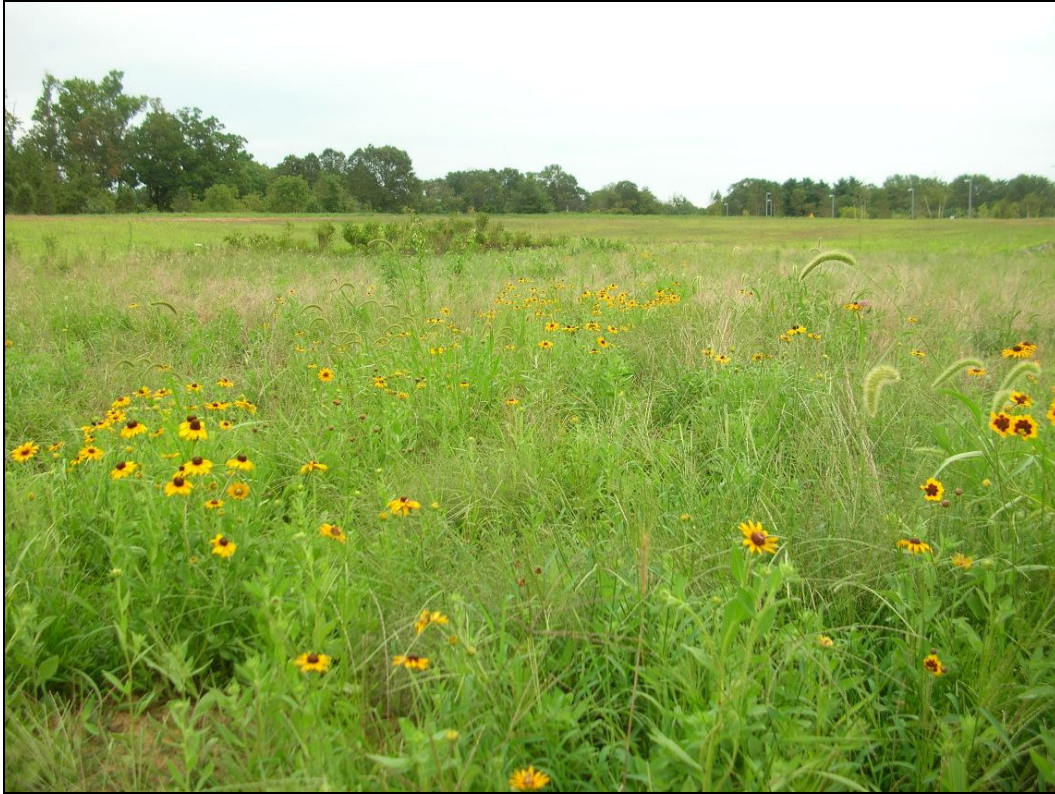
Figure 50. Rain garden photo credit: Princeton Hydro, LLC.

The large scale rain garden shown in the following example photo is maintained in a meadow condition and was planted with a native meadow and wildflower seed mix. The photo was taken during the first growing season only approximately three months after construction and seeding.

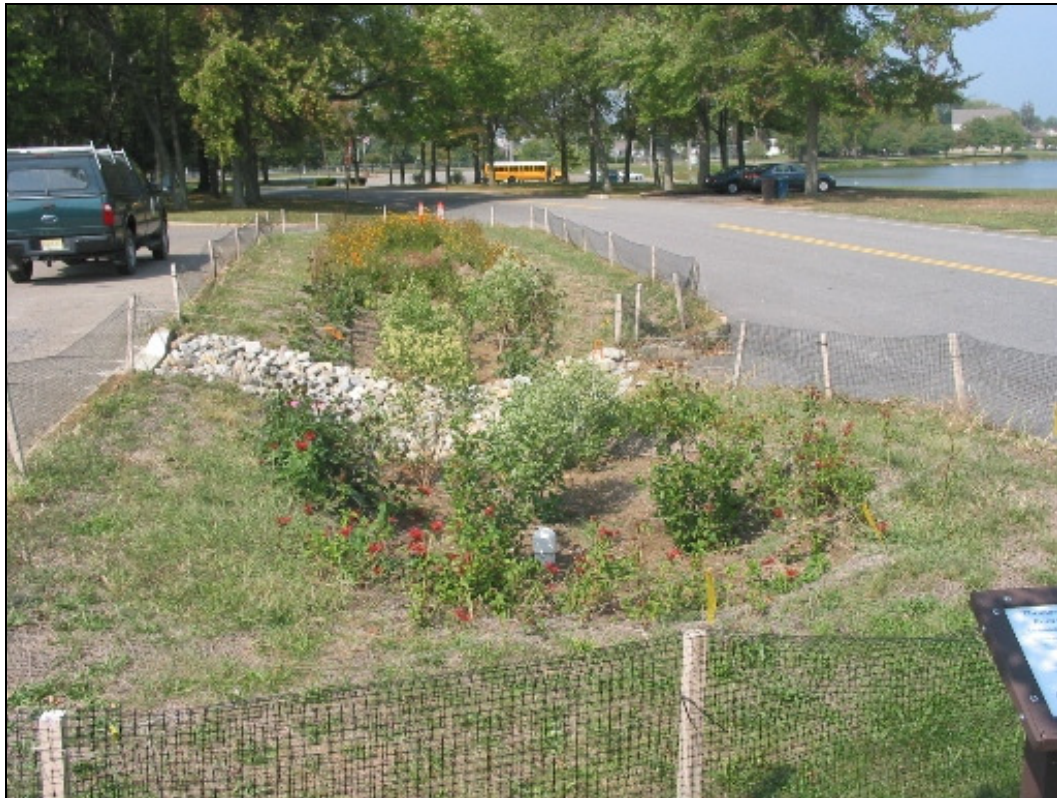
Figure 51. Completed rain garden in August 2010, photo by Rick Lear.

The demonstration project was designed as a two-phase project. The first phase entailed the design and construction of a rain garden. The rain garden was a retrofit design which made use of a large curbed traffic island within one of the park's parking areas. Soil and infiltration tests conducted in the area indicated that the stormwater retrofit would not be able to rely solely on infiltration due to compacted nature of the soils. Therefore the rain garden was designed with an 18-inch thick planting soil replacement underlain with a clean sand layer containing a fabric encapsulated perforated pipe. The underdrain was connected to an existing underdrain flowing into the adjacent roadway inlet.

Inflow to the rain garden occurs via a curb cut out along the upstream side of the garden and overflow is provided via a cut out in the roadside berm which flows into the existing roadway inlet. The inflow and outflow points are protected with stone. The rain garden was planted with vegetation well suited for the unique hydrologic conditions experienced in the rain garden. These plants include purple coneflower, joe pye weed, black-eyed susan, bee balm, and soft rush, with woody vegetation including groundsel tree, red chokeberry, and sweet pepperbush (Figure 51).

The completed rain garden provides TSS removal and other water quality functions for stormwater runoff collected from approximately 13,000 square feet of impervious area. On an average year the rain garden will treat approximately 300,000 gallons of runoff. The retrofit also slows and reduces the total volume of stormwater runoff. This provides downstream benefits including flood relief and decreased streambank erosion.

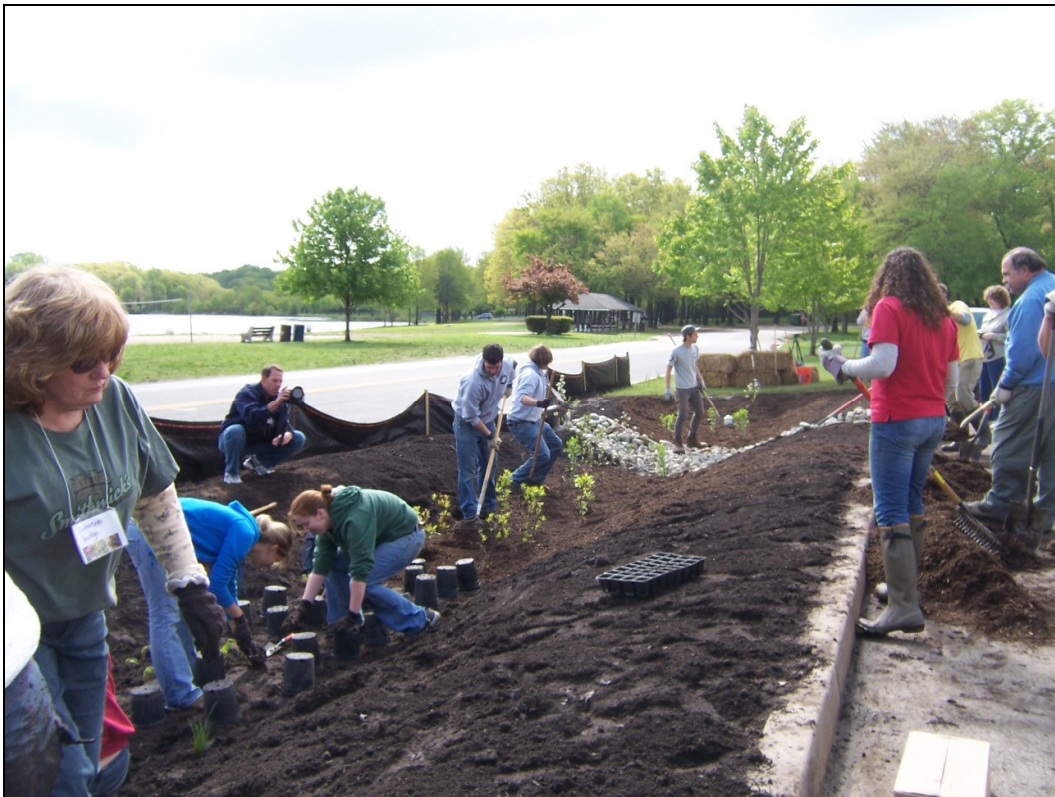
Figure 52. Planting in April of 2010 with assistance provided by the Rutgers Rain Garden Workshop Certification class. Photo by NJWSA

Princeton Hydro designed the rain garden, with input from the project team. The Middlesex County Department of Parks and Recreation, with oversight from Princeton Hydro, performed the earth-moving and site-preparation activities associated with the installation of the rain garden. Volunteers from the Rutgers Cooperative Extension Rain Garden Specialist Certification Workshop planted the vegetation in April 2010 (Figure 52). The County Department of Parks and Recreation watered the rain garden during the extremely dry conditions of the mid- and late summer of 2010 to ensure the survival of the newly planted vegetation. Middlesex County Master Gardeners will work with the Parks staff to maintain the garden.

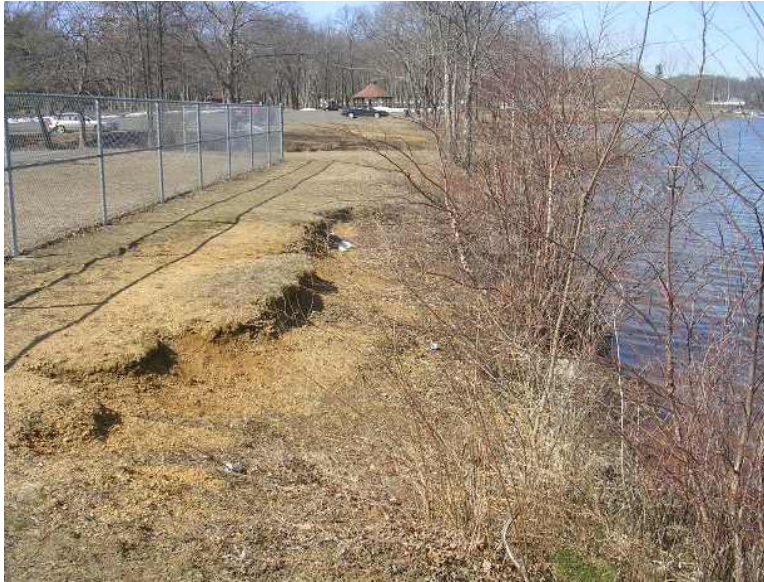
Figure 53. Project section along southern Manalapan Lake shoreline, photo taken facing west, photo taken in January 2010.

The Manalapan Lake Shoreline Stabilization project is located in Thompson Park along the southern shoreline of Manalapan Lake. The stabilization measures are distributed along a total of approximately 600 linear feet of eroded shoreline. The stabilization measures include the establishment of native vegetation, regrading, erosion control blankets and the installation of coir logs. The objective of these design measures is to reduce Total Suspended Solids (TSS) loading originating from the continued erosion and degradation of the Manalapan Lake shoreline. The persistent erosion along this area is a result of numerous factors including wind-driven wave action erosion and exposed soil conditions related to extensive Canada geese herbivory of shoreline vegetation.

The proposed design features will provide a shoreline that can dissipate and resist the wind-driven wave action along the shoreline. The design will also create a shoreline that will deter the Canada geese which frequent the lake. The proposed aquatic vegetation will reduce the wind-driven wave energy associated with the long fetch of Manalapan Lake. The additional native shoreline vegetation will stabilize the shoreline. In sections of shoreline where the erosion has resulted in steeper eroded conditions, coir logs have been proposed. The coir logs will be planted with native wetland vegetation ideally suited for the riparian location. In addition to stabilizing the shoreline and preventing further erosion of the lake shoreline, the project will also provide ecological, recreational and aesthetic benefits to Thompson Park. The material quantities and associated labor for the proposed design plans for station #37 were used to calculate a construction cost estimate of \$20,000 for the project.

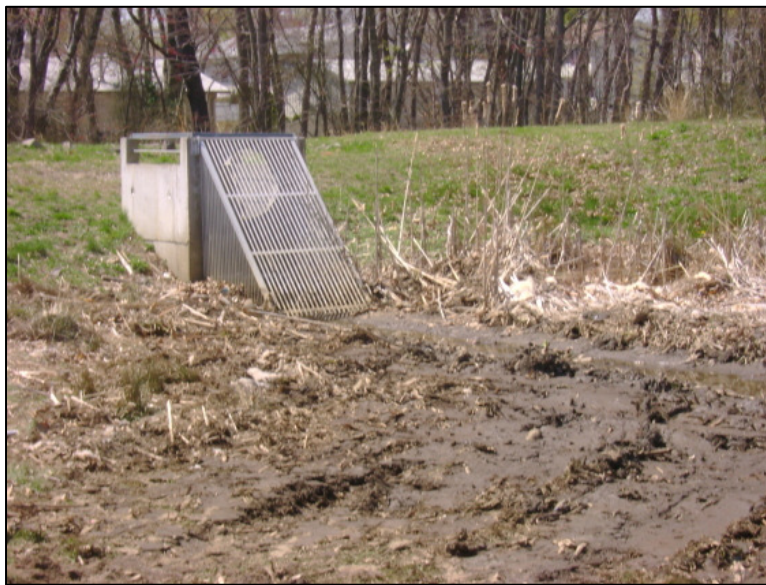
Figure 54. Detention basin at station #32 showing outlet control structure and concrete low flow channel, photo taken in summer 2008.

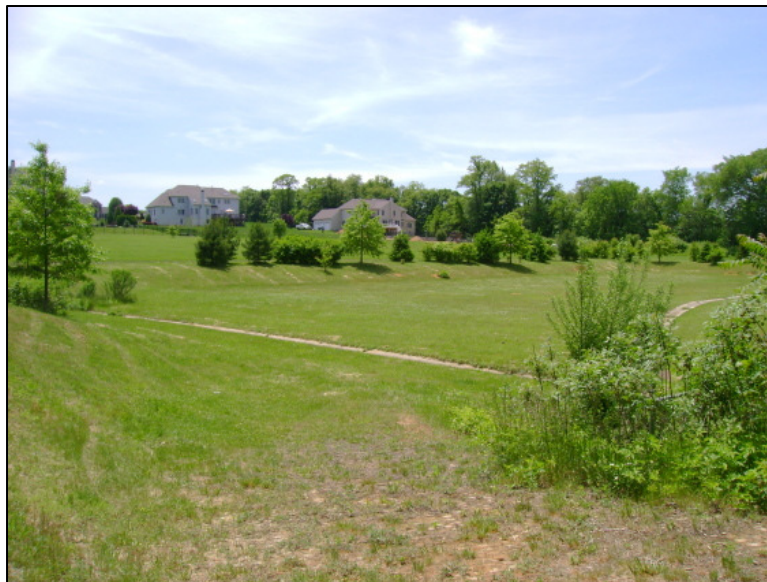
Figure 55. Dry detention basin at station #80, showing turf grass vegetation and concrete low-flow channels, photo taken in summer 2009.

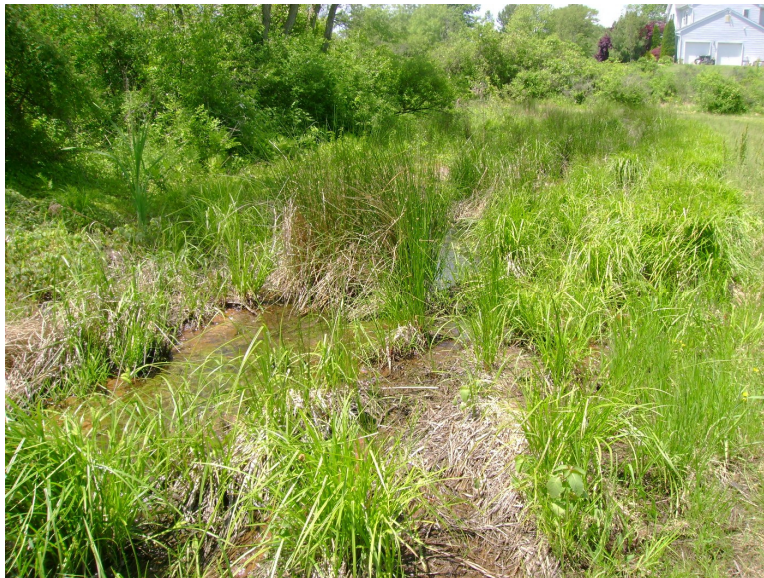
Figure 56. Photo of station #84 facing west along the southern concrete low flow channel.

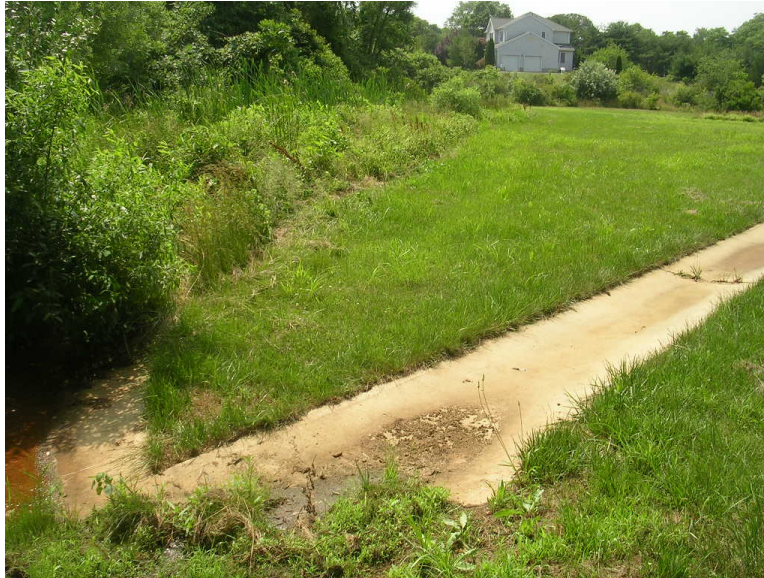
Figure 57. Dry detention basin at station #80, showing turf grass vegetation and concrete low-flow channels, photo taken in summer 2009.

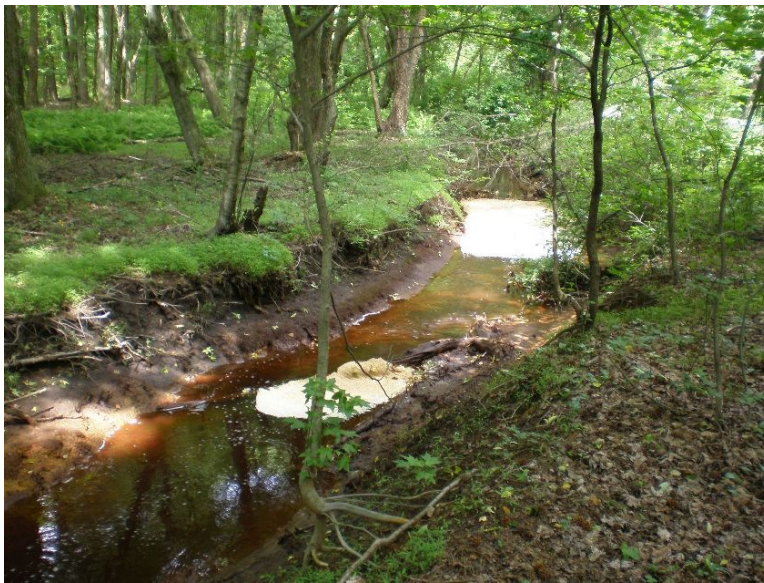
Figure 58. Stream reach at station #48, photo taken facing downstream of the road crossing, photo taken in June 2009.
