# **Health Consultation**

## **Air Quality in Paulsboro, New Jersey Following a Train Derailment and Vinyl Chloride Gas Release**

**September 5, 2014**

Division of Epidemiology, Environmental and Occupational Health  
New Jersey Department of Health

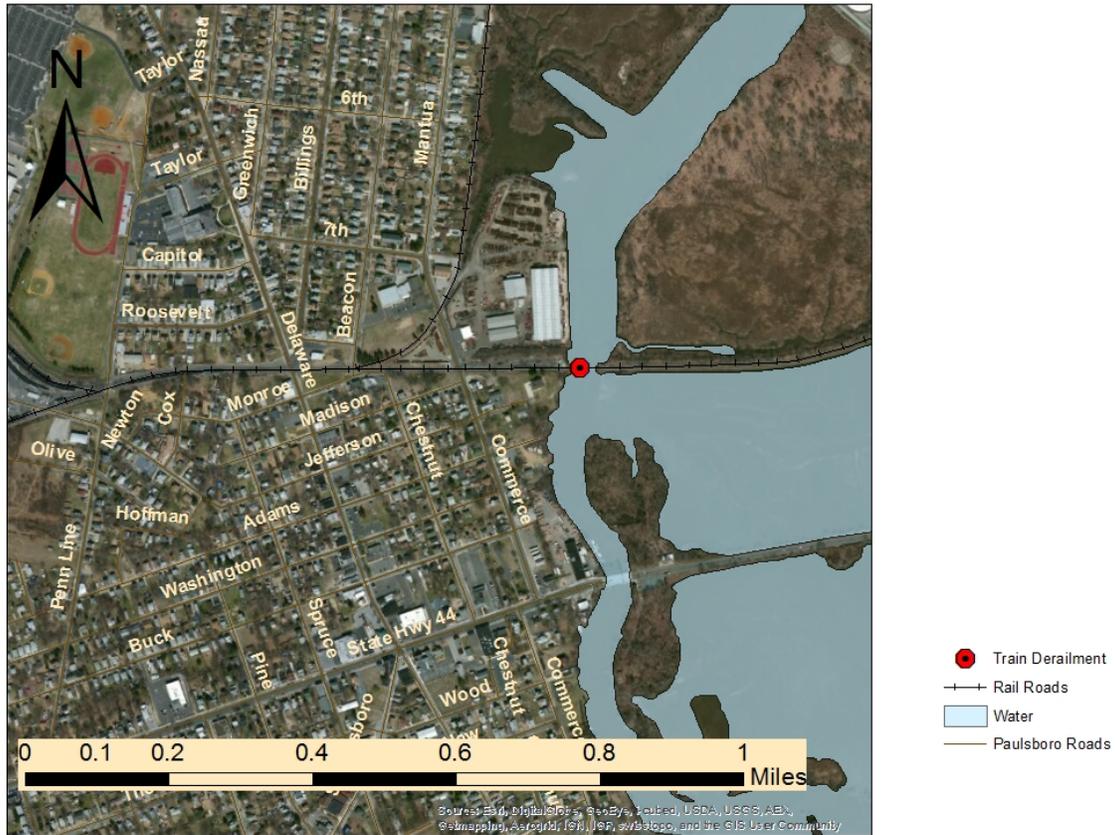
Figure 1. Location of Conrail train derailment on November 30, 2012 in Paulsboro, New Jersey.

The Conrail train that derailed consisted of two engines and 82 cars, 55 of which were carrying hazardous materials (NTSB 2013a).<sup>1</sup> Seven of the train cars derailed, four of which ended up partially in the Mantua Creek. Three of these carried vinyl chloride, and one contained ethanol. One of the vinyl chloride-containing cars was punctured as a result of the derailment; this car was carrying approximately 24,000 gallons of liquid vinyl chloride under pressure. Figure 1 is a map of the derailment location and surrounding areas.

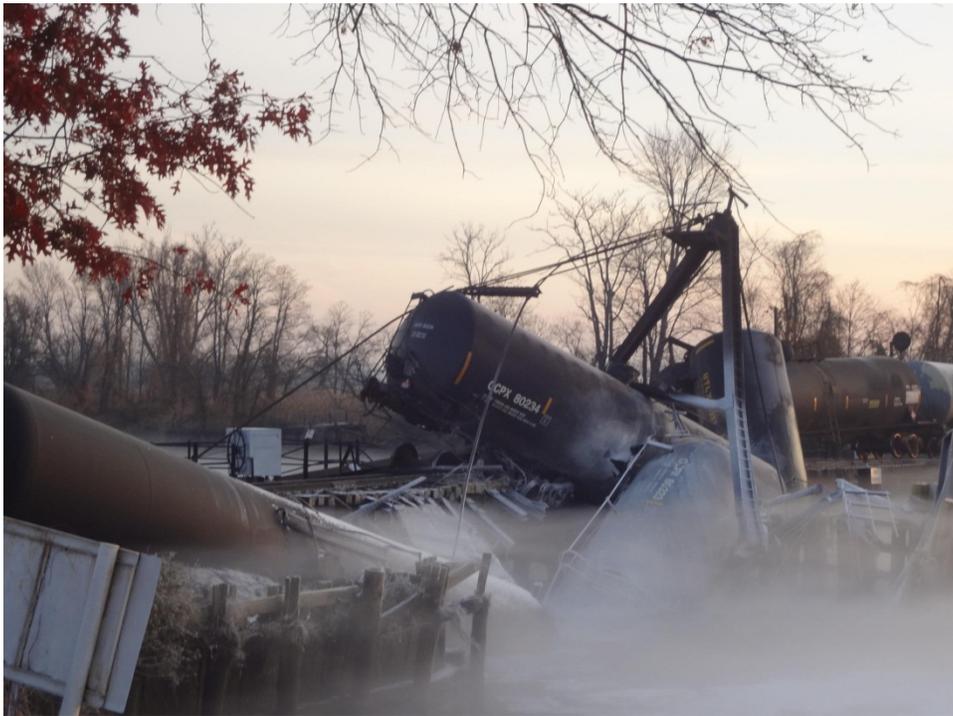
Figure 2. Witness photograph taken at 7:11 am on November 30, 2012.  
(Witness Photograph 2012a)

Once the rupture occurred, pressure caused the vinyl chloride to be released from the tank, most likely as a liquid, aerosol (mist), and gas (vapor). Ground-level photographs taken close to the scene between ten and fifty minutes after the derailment show a dense fog
