NJ FACE INVESTIGATION REPORT

FACE 01-NJ-019-01

Machine Operator Killed While Trying to Repair a Conveyor Belt

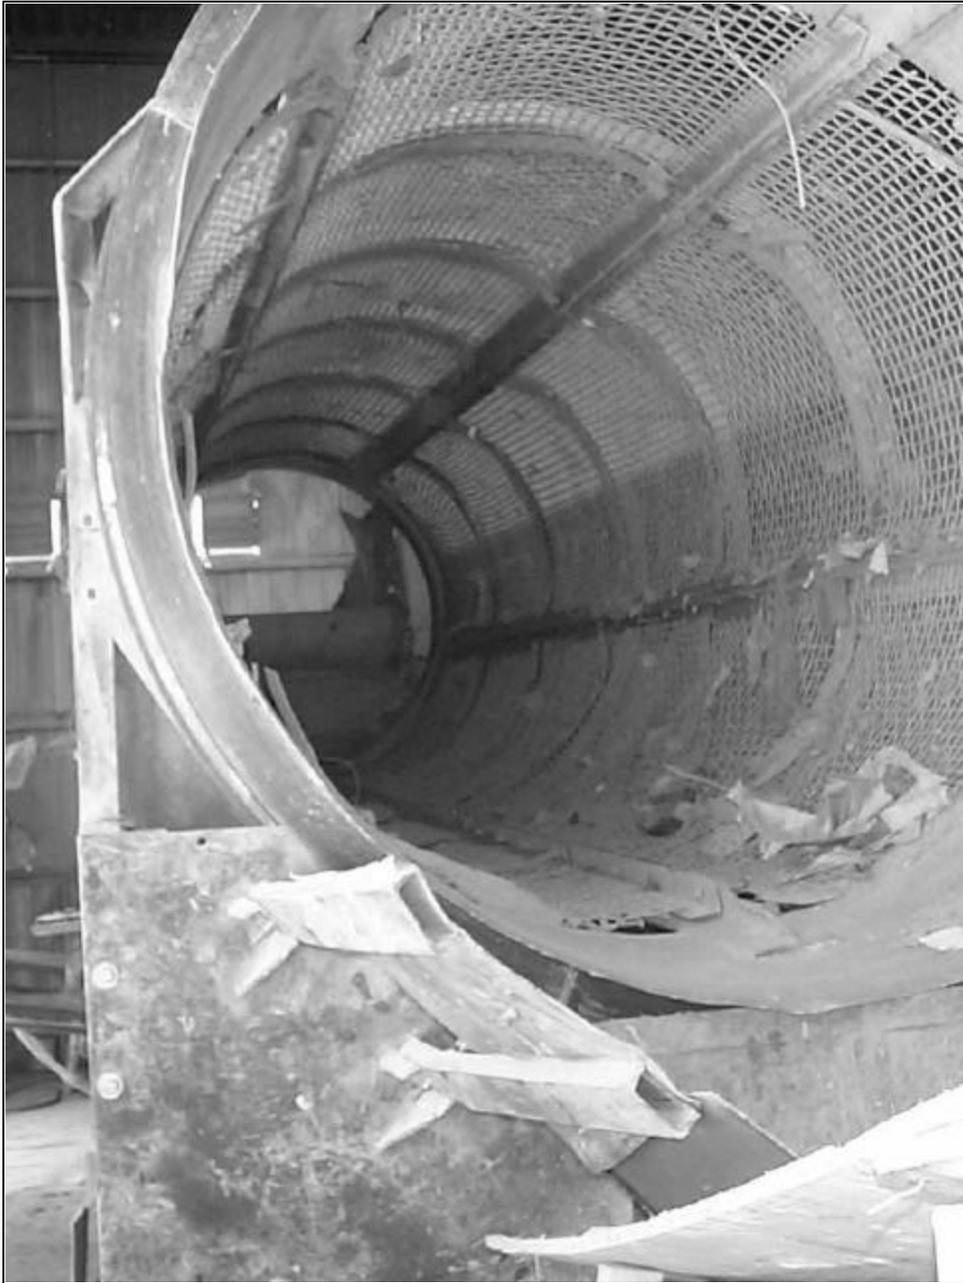
Figure 1
Rear of power-screen machine showing screened drum

Discussion: The power-screen machine was an unusual machine that was built on a tractor trailer chassis. Sections of the chassis had to be hydraulically raised and locked for operation, creating spaces for unauthorized entry or access to machinery “pinch-points.” NJ FACE recommends that warning signs and guards be placed over these areas to protect the operators. FACE also recommends installing emergency shut-off switches on the sides and rear of the machine.

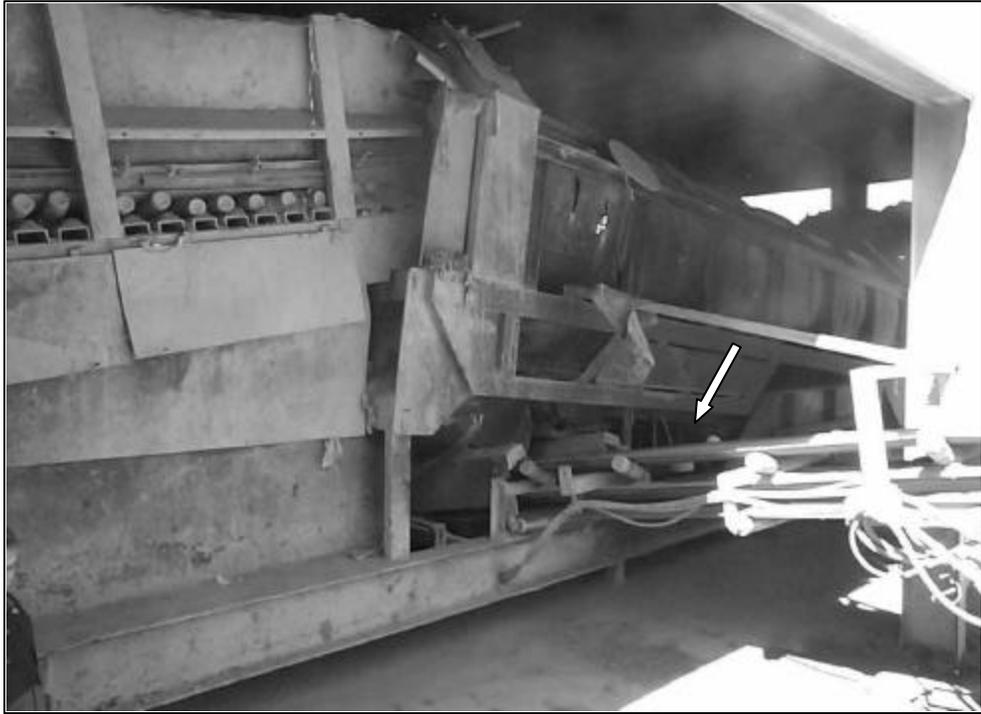
Figure 2

Side of power-screen. Victim was found in area behind the conveyor belts.

Recommendation #4: Machine openings should be marked and guarded to prevent unauthorized entry. Machines should be equipped with emergency shut-off switches.

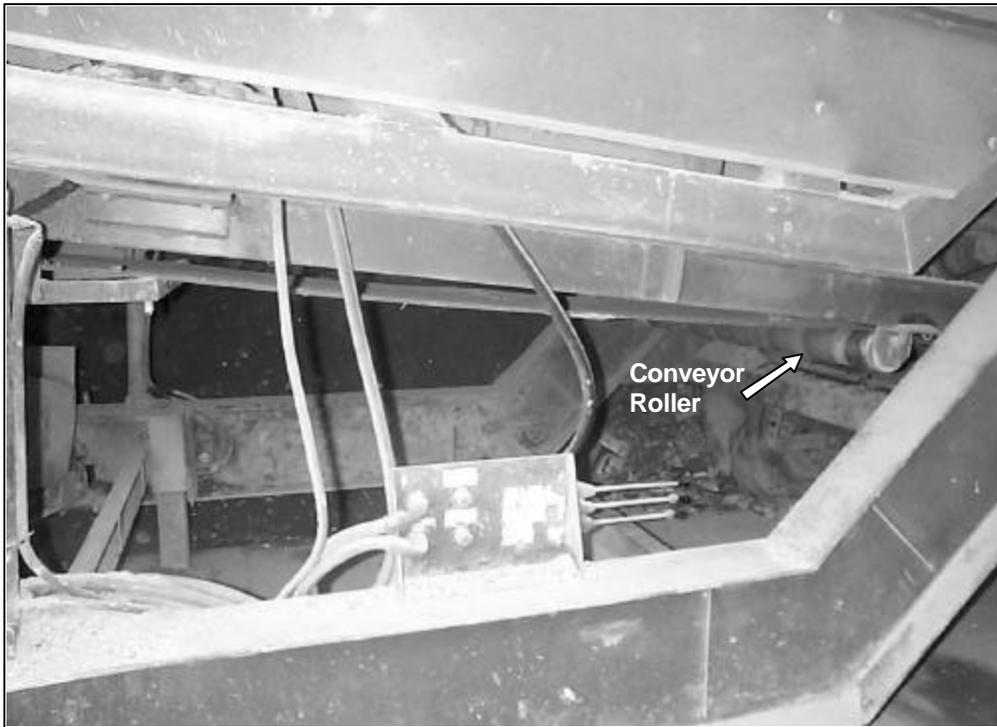
Figure 3

There were no witnesses to the incident. On March 7, 2001, a Wednesday, the victim arrived at the plant at his usual starting time of 6:00 p.m. He began his usual duties of checking and cleaning the machine and found that a conveyor belt was slipping off the rollers. He immediately informed his supervisor of the problem, who instructed him to clean the machine, start it, and then call for him. This was the last time he was seen. The victim climbed into the machine through a narrow unguarded opening in the truck chassis, apparently using a pipe to clean a roller on the faulty, 60-inch-wide conveyor (see photographs). It is possible he was caught in the moving conveyor while crawling into the machine, or while trying to clean the roller under the conveyor. Shortly thereafter, a co-worker saw the victim caught in the machine and called for help. Another co-worker, the victim's brother, pulled him from the conveyor and carried him to the plant office. At 6:25 a.m. the workers called 911 and started CPR on the unresponsive victim with instructions given by the police over the telephone. Police and EMS personnel arrived and continued resuscitation efforts. He was transported to the local hospital where he was pronounced dead from his injuries at 7:04 p.m.

Victim was found entangled in conveyor belt. Note: Levers are inactive.

Recommendation #2: Conveyor belts and other machines should be shut down, de-energized, and locked out before performing maintenance or repairs.

Discussion: The company did not have an effective lockout/tagout program at the plant at the time of the incident. Such a program would require employees to shut down and lock out the power supplies to any machines before maintenance or repairs are done. An effective program would include thorough employee training in lockout/tagout procedures and strict enforcement of the program. A lockout/tagout program may be required under the Federal OSHA standard 29 CFR 1910.147.
