# NJ FACE INVESTIGATION REPORT

FACE 01-NJ-020-01

## Truck Driver Killed In Highway Work Zone Collision

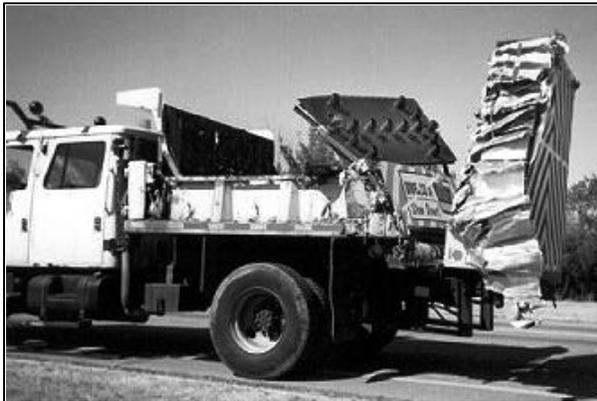
**Photo 1**  
**Impact truck with damaged arrow board and impact attenuator**

attenuator before tipping over and sliding down the highway on its right side. The ground worker saw the truck coming and dove over the guardrail. The driver of the second impact truck saw the impact in his mirror and waited for the ground worker to move away before pulling over to the shoulder to avoid the sliding truck. The tractor-trailer continued to slide for about 1,000 feet, striking a privately-owned van and just missing the patch truck.

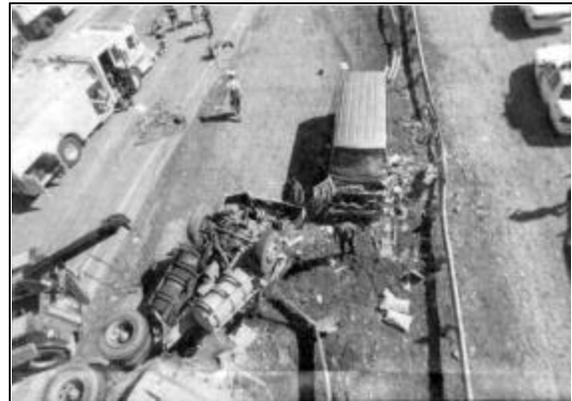
**Photo 2**  
**Newspaper photo of accident scene**

The vehicle came to rest just short of a highway overpass. Garbage was thrown across the highway from the tipped container, and the truck cab had flipped over onto its roof. Members of the road crew went to help the victim, but he was trapped in the wreckage with grievous fatal injuries. Police and EMS soon arrived and closed the highway for several hours to extricate the victim and clear away the debris. The driver of the first impact truck hit by the tractor-trailer was taken to the local hospital where he was treated for minor injuries and released.

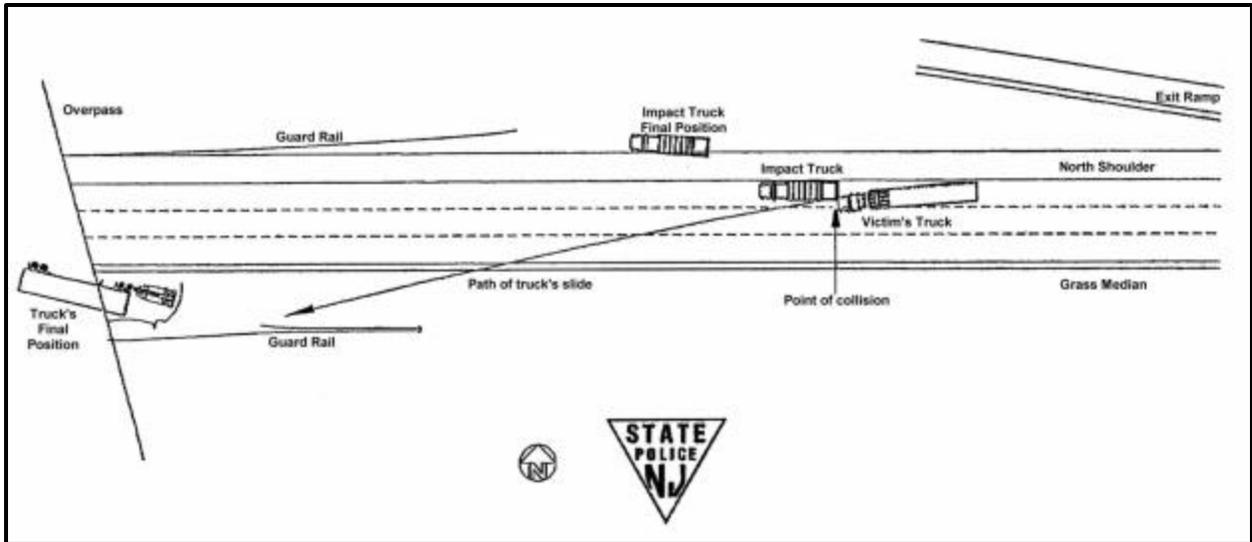
The crew reported that traffic was heavy that morning as their vehicles moved along the highway at about 15 mph, filling the potholes as they came to them. The patch truck contained two tons of asphalt, enough to patch potholes for 1 to 1.5 miles of highway. At 10:25 a.m., the driver of the towed signboard saw the victim’s truck approaching the work zone. The truck was an articulated 18-wheel tractor-trailer pulling a container filled with municipal waste. The tractor-trailer did not appear to reduce speed as it passed the signboard and arrow board trucks on the highway shoulder. The victim’s truck continued in the right lane until he came to the first impact truck. Apparently seeing the truck at the last moment, he turned left to avoid the collision. His truck struck the left rear corner of the impact

**Figure 1**  
**NJ State Police MVA Illustration (edited)**
