INVESTIGATION REPORT

FACE 02-NJ-030

Crane Rigger / Spotter Run Over by Mobile Gantry Crane

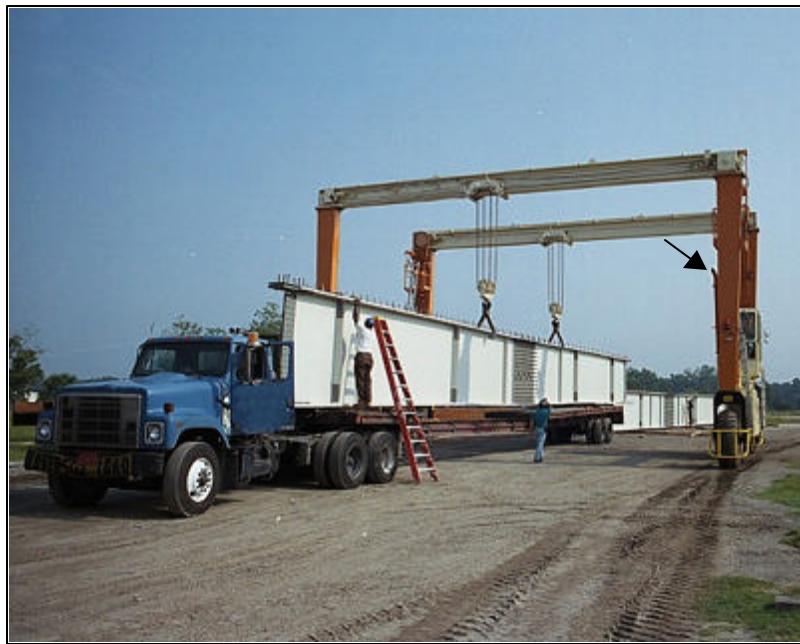
The incident occurred on Wednesday, May 15, 2002. The victim arrived for work to begin the plant's single 7:00 a.m. to 5:00 p.m. shift. He went about his usual duties, rigging loads and spotting for the plant's single mobile gantry crane. This crane was a large, box-like assembly of steel I-beams designed to straddle a large load, lift it, and carry it to where it was needed (see Photo 1).

Photo 1
Manufacturer's photo of mobile gantry crane
Note arrow pointing to operators cab

The diesel-powered crane had a lifting capacity of 100,000 pounds and measured approximately 45 feet wide by 38 feet long by 30 feet high. It rode on 62-inch-high pneumatic rubber tires and was run by an operator riding approximately ten feet from the ground in a raised cab. Although visibility from the operator's cab was generally good, the crane had a number of blind spots and visibility was blocked when carrying or straddling a load. To compensate for this, a spotter would walk along with the crane to look for obstacles and direct the crane's placement for loading and unloading. The spotter

Discussion: The wheel that struck the victim was unguarded. The crane was originally equipped with guards designed to protect the wheels and related machinery around the wheels. Over time, the guards on the front wheels were lost and never replaced. Although not designed to protect personnel, the guards do provide some protection and warning for workers near the wheels.

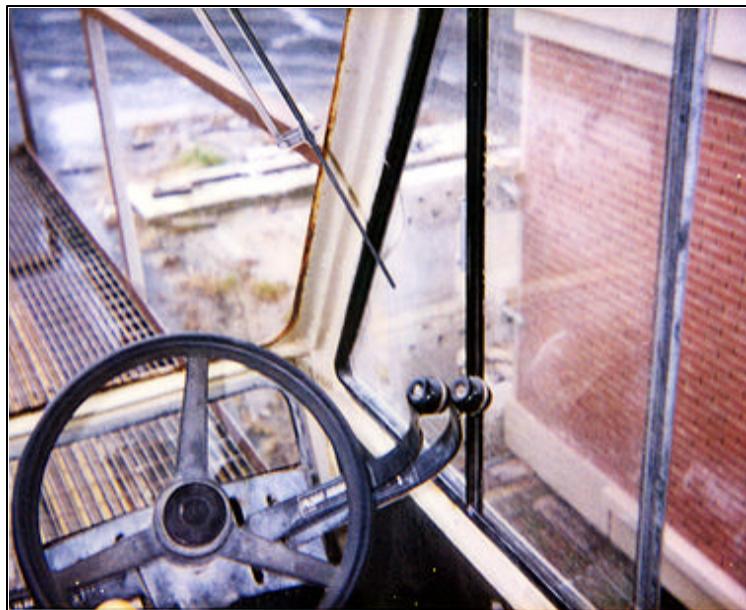
Photo 2
View from operator's cab overlooking straddled load (brick wall)

crane moved forward to straddle a storage rack. This rack had a concrete slab stored lengthwise on its edge, creating a 15-foot-high wall that blocked the operator's view of the right front tire. The second spotter was walking ahead of the victim when he looked back to see him on the ground, moaning after being run over by the wheel. He called out for the crane to stop and ran to notify the supervisor, who called 911. The victim was conscious but in severe pain with crushing injuries to his pelvis. Paramedic

Discussion: In this incident, the crane operator lost sight of the victim when he was behind a large concrete slab. Visibility from the raised operator's cab is generally good, but there are a number of blind spots and visibility can be blocked by suspended loads and straddled objects. NJ FACE recommends that the employer consider installing devices that would allow greater visibility, such as parabolic mirrors and/or video cameras whose images are shown in the operator's cab. The crane's manufacturer should be contacted to see if they recommend any specific devices and to discuss any proposed methods, as the employer noted that maintaining these devices may be difficult and hazardous (e.g., climbing the crane's superstructure to clean a video camera). Other devices such as proximity detectors that sense objects near the wheels should be explored.
