NJ FACE INVESTIGATION REPORT

FACE 03-NJ-010

Construction Worker Struck and Killed by a Pile Falling From a Crane

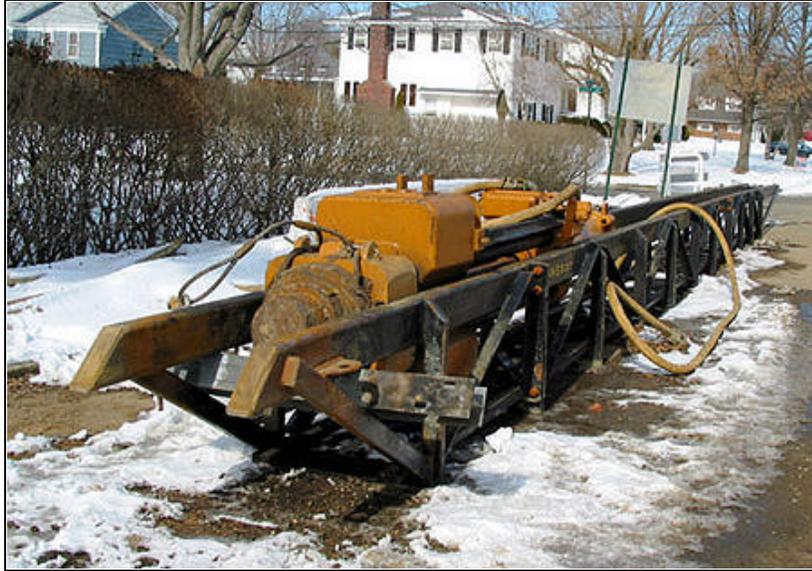
Photo 1
Pile driver leads, hammering mechanism,
and pneumatic air hose

sink the piles. This device used air pressure to raise and drop an 11,200-pound hammer onto a pile, driving it into the ground much like a carpenter would hammer a nail into wood. The hammering mechanism moved on steel tracks called leads (see Photo 1). The leads, which were longer in length than the piles, were lifted vertically into position with a crane over the area where the pile was to be driven. The bottom of the leads had an anchor that sank into the ground, holding it in place. To raise a pile into the leads, the crane operator first lowered the hammering mechanism close to the ground where a worker would attach chokers (flat nylon straps) to the hammer. The chokers were slung around the top of the pile, which was lying on the ground nearby. As the hammer was raised back up, the pile was lifted with it until it was fully upright in the leads (see Figure 1). The hammering mechanism was started, and the machine repeatedly raised and dropped the hammer on the top of the pile, driving it into the ground. Several different types of piles were used at the site, including steel, sheet metal, and timber piles. To determine how deep to sink the piles, the company first drove smaller test piles before using the main 18-inch-diameter piles. The test piles were 40-foot-long, 12-inch-diameter steel pipe piles that weighed approximately 2,000 pounds.

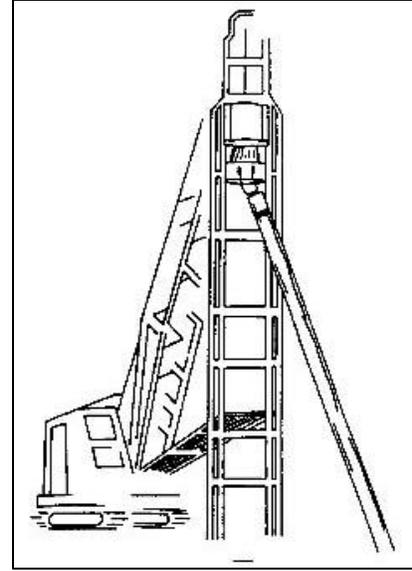
Figure 1
Illustration of pile being
raised into the leads

check the crane and test its brakes. He did this by raising and lowering the hammer 10 to 12 times over a ten-minute period before determining that the machine was working correctly. At approximately 11:30 a.m., the crane operator gave the OK and the crew went back to work. The crane operator swung the pile driver over to a 12-inch-diameter steel test pile and lowered the hammer. The victim and a co-worker rigged the pile to the hammer with two new 12-foot-long, 3-inch-wide nylon chokers, each rated for 7,000 pounds. Standing near the shore on a small floating platform, the victim guided the compressed air hose leading to the pile driver hammer as the crane operator raised the hammer and pile up into position. Once the pile was in the leads, the crane operator lifted the whole assembly a few feet off the ground and started to swing it into position. As he was doing this, the crane line that supporting the hammer mechanism slipped and went slack, causing the hammer to fall against the nylon chokers holding the pile. This pinched and severed the straps holding the 2,000-pound steel pile. The pile fell, striking the victim who had turned away from the crane.

Discussion: In this incident, the victim was standing near the pile with his back turned when the pile fell from the leads. To prevent future incidents, NJ FACE recommends that all workers stand clear of the pile driver when piles are raised into position. The distance should be at least the length of the pile. If circumstances require the worker to stay in the perimeter, the worker must remember to watch the pile and leads at all times and have an escape path available.

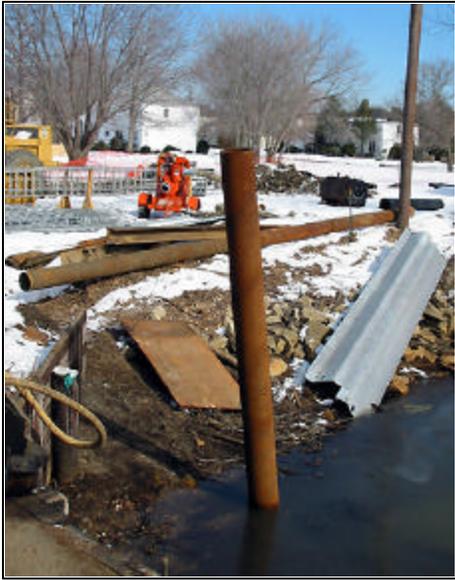
Photo 2

**Piles: steel pipe pile in water,
sheet pile to right**
