INVESTIGATION REPORT

FACE 03-NJ-020

Forklift Operator Killed When His Forklift is Overturned by a Backing Truck

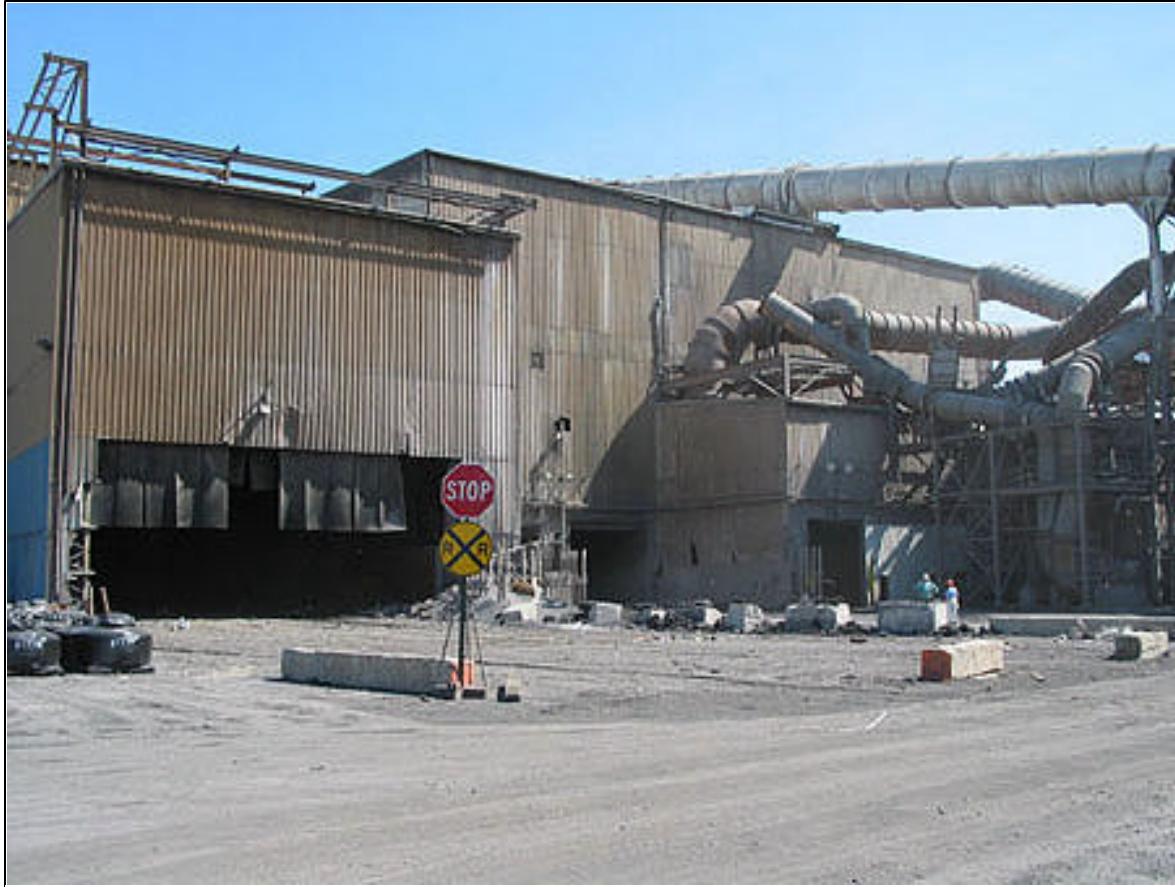
The incident occurred on Wednesday, April 9, 2003 in the yard outside the melt shop. The victim arrived for his usual 3:00 p.m. to 11:00 p.m. work shift. He was working with a 9,000-pound capacity, counterbalanced forklift truck to transport materials stored outside into the plant. At approximately 4:00 p.m., he drove his forklift into the yard to get a palletized, 3,000-pound industrial bag (supersack) of bulk material stored about 100 yards away from the plant. The yard was a large area of packed dirt with railroad tracks running into the plant. The area also had unpaved dirt roadways running through it to allow access for the large industrial dump trucks to collect slag from the furnace. The weather was drizzling and the yard was wet with large puddles of standing water. The victim drove his forklift to the storage area, picked up a supersack, and started driving back to the plant. As he drove across the yard, he crossed over the train tracks and approached a large industrial dump truck owned by the slag recovery company. Dump trucks routinely park and operate in the area to collect slag, and the victim chose a path that crossed behind the truck to return to the plant.

No one directly witnessed the incident. The driver of the slag truck was standing nearby on fire-watch, waiting for a front-end loader to emerge from the melt shop tunnel with a load of slag. When the loader appeared, the driver went back to his truck, reportedly seeing the victim's

Photo 1
Incident Site
(Concrete dividers installed after the incident)

forklift approaching from the yard. He entered the truck, which was parked across his view of the victim, checked his mirrors, and started backing. He moved about three to five feet when he felt the truck stop. Thinking that something was wrong, he got out of the truck and found the victim's forklift behind the truck, tipped over on its side. The victim, who was not wearing his seat belt, was trapped under the body of the forklift. The truck driver tried to lift the forklift off the victim and was joined by the operator of the front-end loader who had just driven into the area. A crane operator within the plant saw the tipped forklift and called for assistance. On the ground, the front-end loader operator went back to his machine and used it to partially lift the forklift. The truck driver went to get a second forklift and the two men used both machines to upright the victim's forklift. At this time, the plant's emergency response team arrived and started resuscitation efforts on the victim. The police and Emergency Medical Service arrived and found the victim unresponsive. The victim was pronounced dead at the scene by telemetry at 4:14 p.m.

Recommendation #2: Employers should have clearly outlined traffic lanes for vehicles and industrial trucks.

Discussion: To help prevent incidents such as this, NJ FACE recommends that employers create a traffic control plan including traffic lanes for vehicles, industrial trucks, and pedestrians. The lanes

should be clearly marked and well lit, and all vehicles should be required to travel within the lanes. It was noted that the employer installed concrete dividers after the incident.

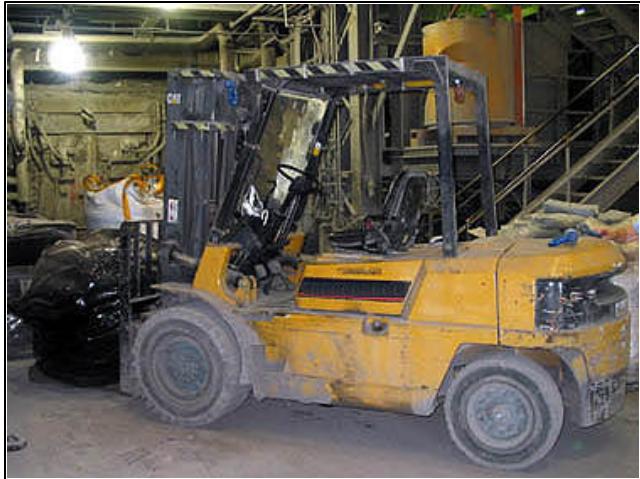
Photo 2
Identical Forklift Truck

Investigations by OSHA and the police found that the backup alarm on the dump truck and the flashing light on the victim's forklift were both operating normally. Tests found no evidence of alcohol or drug involvement with the dump truck operator or victim. OSHA later cited the employer for violation of seat belt and employee training regulations.

Recommendation #3: Operators should always wear a seat belt while using a forklift or other industrial truck.

Discussion: The forklift operator in this incident was not using a seatbelt, which would have secured him to the seat and prevented him from being crushed under the forklift. NJ FACE recommends that all forklift owners train their employees to use seat belts and enforce a policy requiring seat belt use. Federal OSHA also requires that all operators use seatbelts in forklifts or other industrial trucks that are equipped with them. Although not a factor in this case, it should also be noted that OSHA may cite an employer who has not taken advantage of a manufacture's retrofit program to install seatbelts on older industrial trucks that are not equipped with seatbelts.

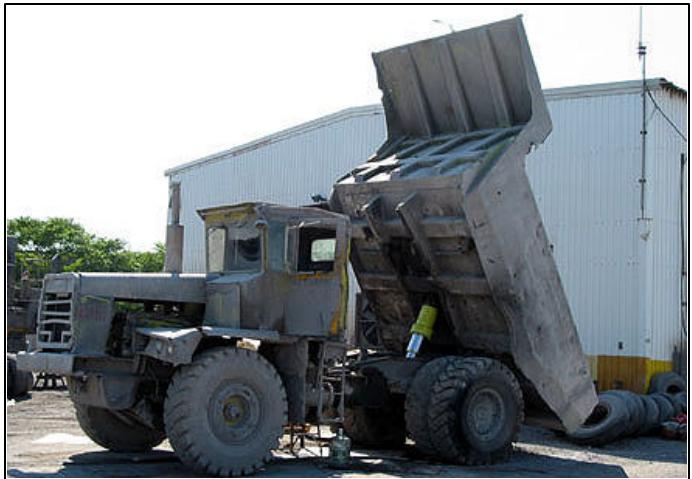
Photo 3
Identical Dump Truck

Recommendation #4: Employers should consider installing devices to increase the truck driver's range of vision.

Discussion: In this incident, the driver of the dump truck initially saw the victim but lost sight of him when he was directly behind his truck. NJ FACE recommends that the employer consider installing devices that would allow greater visibility, such as parabolic mirrors and/or video cameras that display images in the operator's cab. The truck's manufacturer should be contacted to see if they recommend any specific devices and to discuss any proposed methods. Other devices such as proximity detectors that sense objects near the vehicle are also available.
