NJ FACE INVESTIGATION REPORT

FACE 03-NJ-042

Hispanic Tree Trimmer Killed After Being Pulled into A Wood Chipper

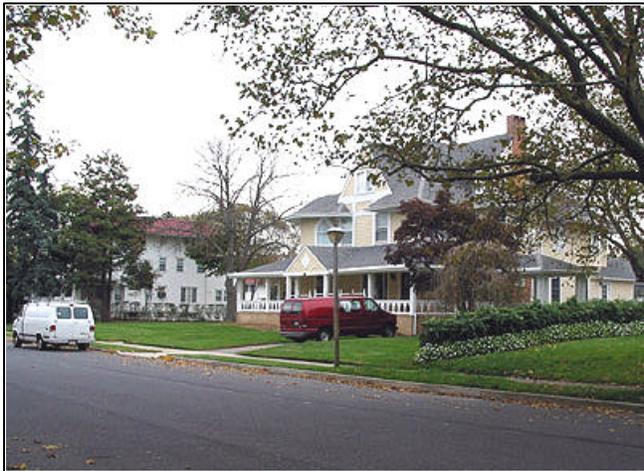
The incident occurred on Sunday, June 14, 2003. A crew of seven workers met at the site and started work at 8:30 a.m. All were family members of the two partners: three cousins, one uncle, and one brother-in-law. They set up a wood-chipping machine at the curb in front of the house and started dragging the brush, branches, and trunk wood to the machine. The wood chipper was a diesel-powered machine towed to the jobsite by a box truck (see Photo 2). The machine accepted brush and wood up to 12” in diameter through a large hopper at the rear of the machine. When wood and brush were pushed into the hopper, two rotating feed wheels took hold of the material and directed it against the cutting knives on a rotating disk, quickly reducing the wood to small chips. The chips blew out through a chute where they were collected in the back of a box truck.

Photo 1
Site of Incident

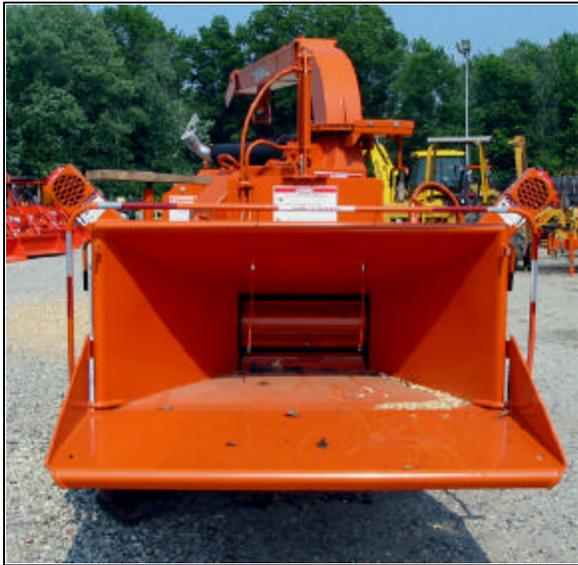
victim's load was a section of the tree's top that was approximately eighteen inches long and three to four inches in diameter. The section had small stumps projecting from it where small branches had been cut off. After putting the load in the hopper, the victim held onto the top of the chipper and used his foot to push the load into the feed wheels. As he did so, one of the small branch stumps projecting from the tree section caught his sneaker. The feed wheels took hold of the trunk section, pulling the trunk and victim into the chipping knives.

Photo 3
New chipper showing feed wheels, hopper feed table, and emergency stop pull cords in hopper

Discussion: The wood chipper involved in this incident was an older model machine that was purchased in used condition by the company. This machine did not have a number of safety improvements that were included in later models, including a feed table that prevents workers from getting too close to the feed wheels, and emergency pull cords that reverse the feed wheels (see Photo 3). These devices may have prevented the victim from kicking the brush into the hopper. NJ FACE recommends that machine owners should contact the equipment manufacturer or dealer to ask if safety modification kits are available. The equipment dealer for this machine stated that the manufacturer provides free update kits for older machines. The manufacturer would send the kit to a service representative, who would charge only for the labor to install it on the chipper.
