NJ FACE INVESTIGATION REPORT

FACE 03-NJ-070

Highway Worker Struck and Killed by an Auto While Filling Potholes

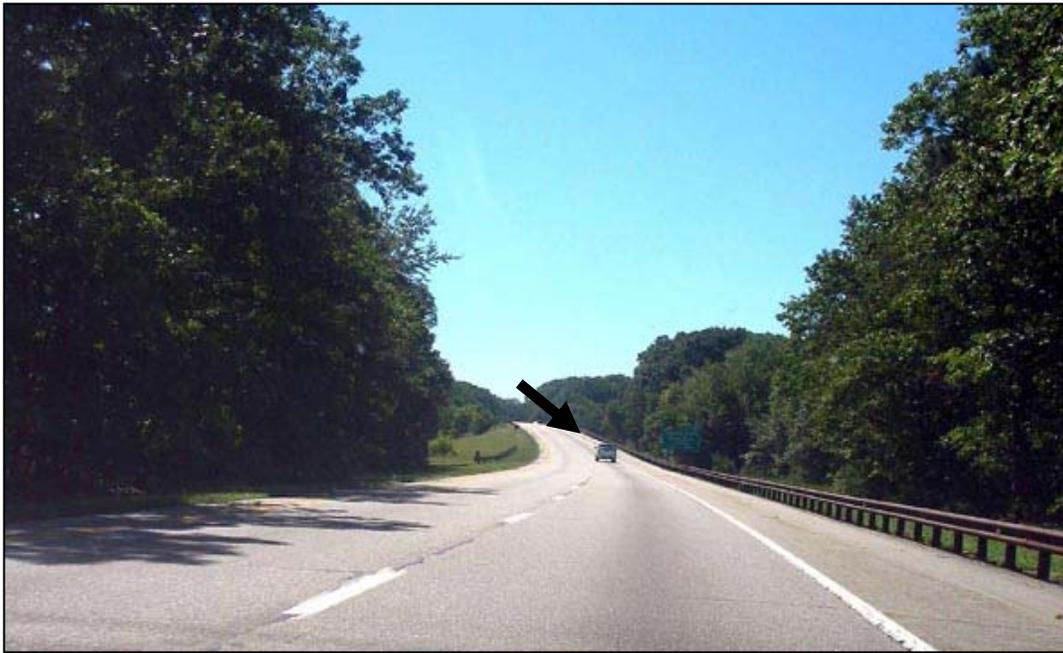
Photo 1
Highway leading to incident site (arrow)

The two-man crew left the garage a few minutes after receiving their assignment. The crew started work on the southbound side, filling two potholes before reversing direction to move northbound. At 11:05 a.m., the crew approached an eight-by-four-inch pothole on a gently curving section of highway with a mild incline (see Photo 1). A guard rail ran along the right shoulder of the road. The co-worker drove the truck onto the shoulder, and the victim asked him to “get close to the rail, I’m skinny enough” (to get out). As the two men left the truck, each was wearing a yellow and orange ANSI Type II safety vest. The truck was also equipped with a flashing amber light bar on the roof. The two went to the rear of the truck to get their shovels, with the victim standing closest to the highway. At that time, witnesses reported seeing a Volvo sedan traveling erratically across the highway lanes for approximately two miles. Witnesses reported seeing the driver’s head bobbing, indicating the driver may have been falling asleep. The two men did not see the car as it approached them and moved onto the shoulder. The sedan struck the victim at 11:15 a.m., completely sever the victim’s lower left leg and throwing his body into the back of the pickup truck. The car struck the truck, pushing it forward about 15 feet. The car then moved back into the traffic lane for a short distance before moving back to the shoulder where it struck the guardrail and came to a stop. There were no skid marks at the incident scene, indicating that the driver did not use his brakes before the impact. The co-worker was standing directly beside the victim when he was struck by the car. He saw

Recommendation #1: Mobile highway work crews should use truck-mounted traffic attenuators and sign boards as per the USDOT *Manual for Uniform Traffic Control Devices*.

Discussion: Due to the short time spent repairing a pothole, this operation was not covered by the highway authority's highway work-zone procedures. This operation only used a single truck with flashing lights, providing minimum protection for the workers. To provide additional protection, NJ FACE recommends that employers follow the recommendations outlined in the US Department of Transportation *Manual for Uniform Traffic Control Devices, Millennium Edition* whenever working on an active highway work-zone. Under these guidelines, this type of operation would be considered a mobile work zone, requiring the use of a vehicle equipped with a truck-mounted attenuator and a separate vehicle with a signboard to help direct traffic away from the area. The manual also gives specific practices for many other types of work-zone operations.
