# NJ FACE INVESTIGATION REPORT

FACE 04-NJ-013-01

## 20-Year-Old Man Killed When Struck By Tree Falling from Tree-Cutting Machine

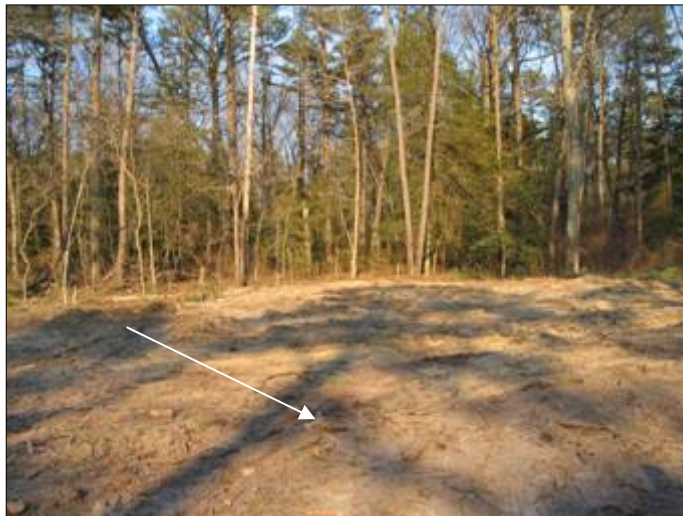
The incident occurred at a wooded site in a rural area in New Jersey. The site was a 100 foot x 100 foot plot of land (see Figure 1), that was to be clear-cut by the family-owned landscaping business. A construction company purchased the plot in April 2003, and hired the landscaping company to clear the trees to prepare the area for development. The landscaping company was to clear all trees within the 1000-square-foot area that was demarcated with yellow stakes. According to the owner, it was to take approximately two days to clear the lot. The majority of the clear cutting would take place on the first day. Work on the second day would entail using a chainsaw to cut the felled trees into approximately 17 foot logs and removing all branches, which would be chipped onsite.

Figure 1. Cleared lot. Arrow indicates approximate lot location where tree struck victim.

**Discussion:** According to OSHA logging Regulation 29 CFR 1910.266, all ground work should be done at a distance of least two tree lengths of the tallest tree being felled. This is critically important in any logging operation, such as the use of a tree-cutting machine. In this case, since the lot was only 100 feet by 100 feet, and the tree that fell was about 70 feet tall, a safe distance did not exist in the work area. In this case, an alternative solution would be to stagger the job shifts such that all bucking takes place either after all trees are felled, or only while the machine is not running.

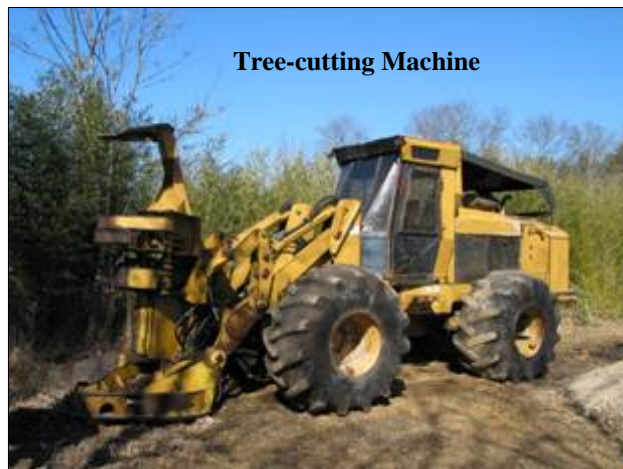
The tree-cutting machine was a four-wheeled, diesel-powered tractor, similar to a front-end loader, with a specialized tree-cutting device, a feller-buncher, mounted on the front (see Figures 2 and 3). The specialized device, which was hydraulically operated, consisted of a large, rotating circular saw at the base (see Figure 4). Directly above the saw was a series of interlocking arms that could be opened and closed (see Figure 5). The tree-cutting machine was operated as

Figure 2 (left): Tree-cutting Machine; Figure 3 (right): Feller-buncher

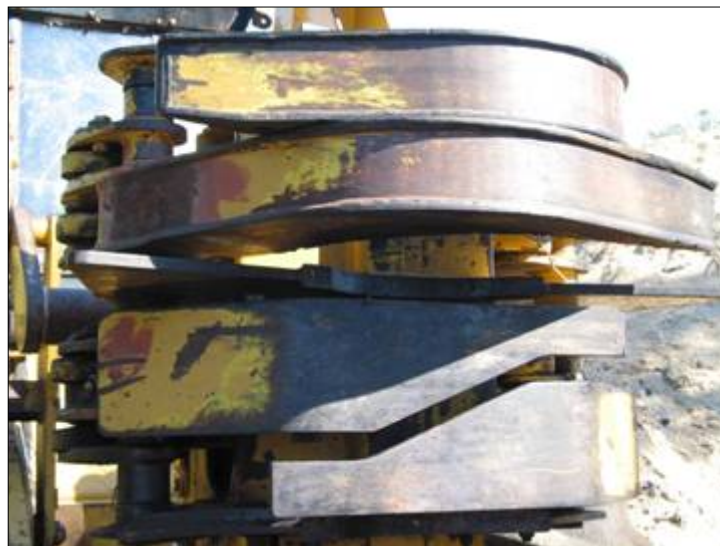
Figure 5. Interlocking grasping arms

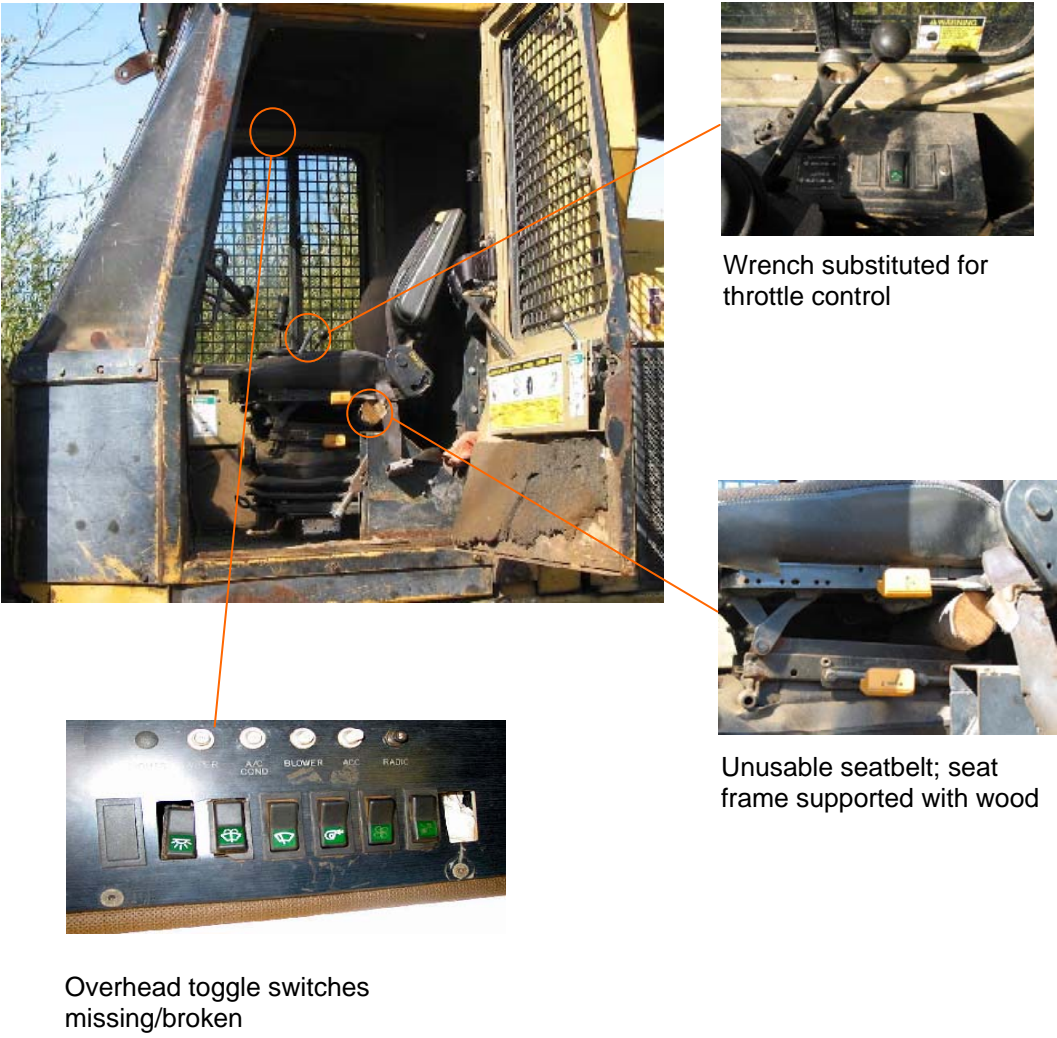
**Discussion:** As per 29 CFR 1910.266(f), all machines be should be inspected before their initial use during each workshift, and any defects or damage should be repaired. In addition, operating instructions must be available in the area where the machine is being operated or on the machine itself. A well-maintained, serviceable machine is a fundamental element to ensure employee safety. In this case, a wrench was substituted for the throttle control, a log was used to maintain the seat height, half the seatbelt was missing, and several switches were broken (see Figure 7).

Figure 7. Cab interior of tree-cutting machine.

**Recommendation #2: All machines used at the worksite should be maintained in serviceable condition.**
