NJ FACE INVESTIGATION REPORT

FACE 06-NJ-076

Hispanic Day Laborer Electrocuted When an Aluminum Extension Ladder Contacted an Overhead Power Line

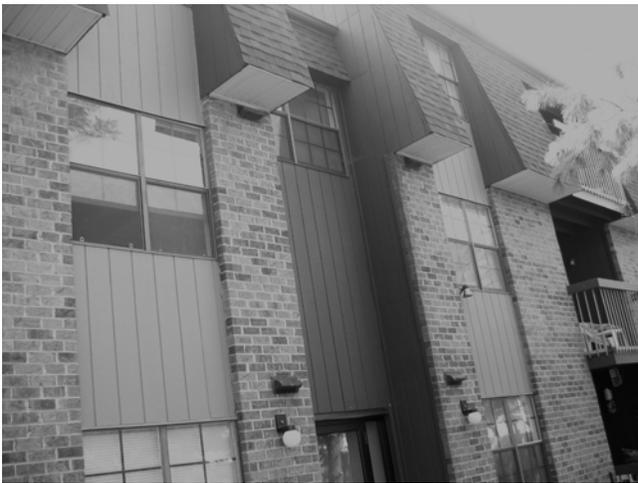
The workday began at 6:30 a.m. when the two employees picked up the company truck and equipment. The victim and his co-worker arrived at the condominium complex at 8 a.m. They worked from a list of items that the general contractor required to be completed, and spent the day replacing roofing shingles, accessing the work areas using ladders. By 3:20 p.m., the victim and his co-worker had only two corner overhangs on which they needed to apply finishing

touches to complete the job, which they estimated would take one-half hour. The co-worker left to obtain additional materials. When he returned, the victim informed him that they needed to move the extension ladder that they had been using. The aluminum extension ladder could extend to 32 feet and had a maximum working length of 29 feet. It had been retrieved from a pile of damaged ladders at the general

contractor's offsite storage yard. These ladders had been discarded, but the subcontractor's employees were apparently unaware of this. The foreman had previously told the workers to use the ladder in question only to reach scaffolding, which was no longer in place. Although the rung locks on the ladder worked, there was a rope, but no pulley, to adjust its length. The co-worker reported that he told the victim that they should shorten the ladder before moving it, but the victim replied that instead of shortening it he would carry it extended. The victim told his co-worker to support the ladder so it wouldn't fall. Although the co-worker said that he usually carried a ladder with it held parallel to the ground, this time they carried it while it was upright. Both were apparently unaware of the overhead power lines in the area. They walked approximately 24 feet when a slight wind caused the ladder to sway. The victim was walking backward, holding the ladder by the rungs while his co-worker walked forward holding onto the

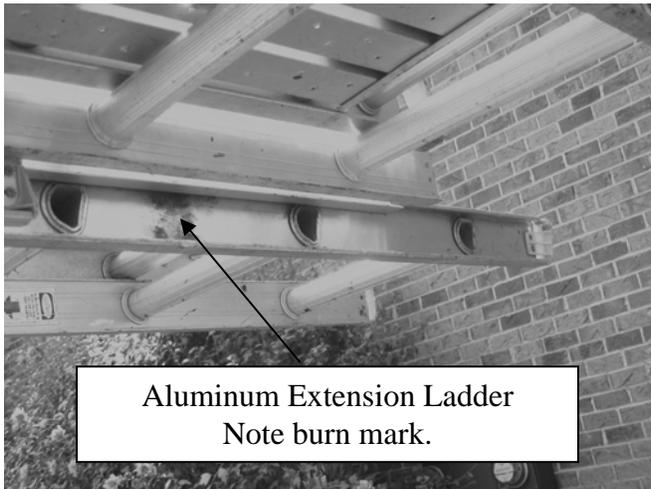
The extended aluminum ladder contacted the 13-KV overhead power line, which was 25 feet above the ground. When it made contact, the co-worker reported that he heard a sound like thunder and saw fire come out of the power line. Both workers released the ladder and it fell to the ground. According to his co-worker, the victim was initially able to crawl, but not able to rise to his feet. Sparks ignited the dry grass at three small spots and the co-worker stomped out the fire. At the time of contact, the co-worker reported that he felt a shock that seemed to travel from his head down through his feet. Although his shoes were not damaged, he developed a

dime-size burn on the arch of his right foot. One of the nearby residents reported hearing a boom and saw that her interior lights went out. She looked out a window and saw the victim lying on the ground with his co-worker trying to assist him. The resident called 911 and reported that emergency responders and paramedics arrived quickly to the scene. The victim was treated at the site and transported to the
