NJ FACE INVESTIGATION REPORT

FACE 06-NJ-078

43-Year-Old Construction Foreman Dies After Struck by Steel Pile

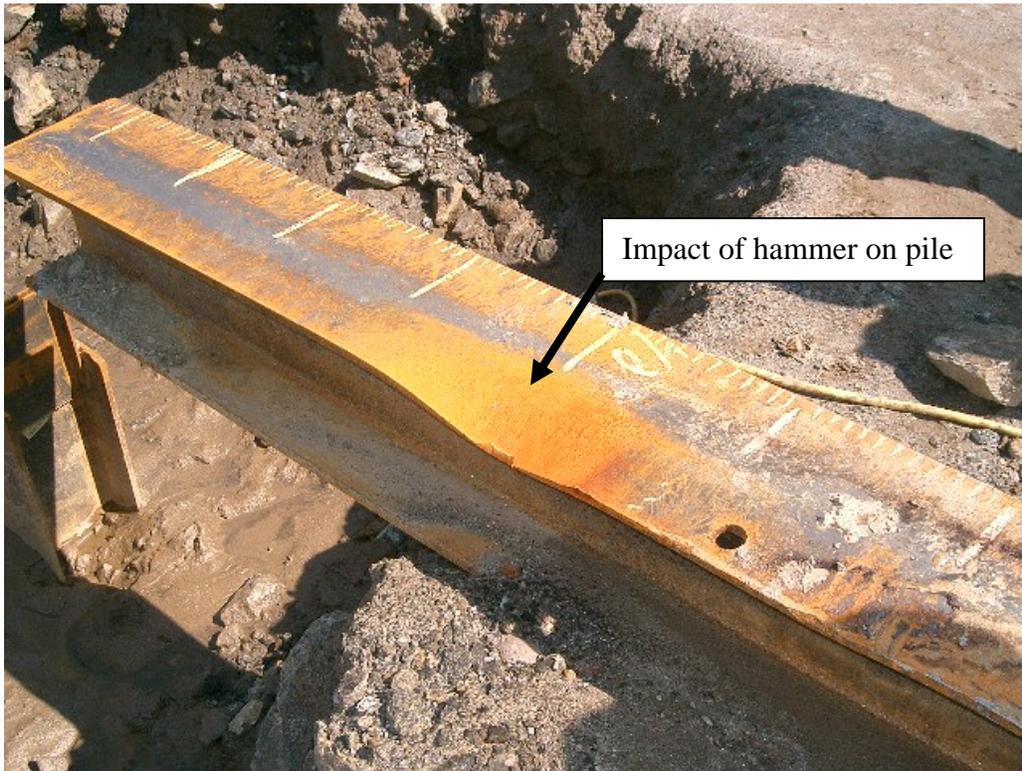
Figure 4: Pile as it rested after crushing victim. Note the muddy conditions.

According to the spotter, the setting of the extension proceeded correctly, as per the operator. The victim was ensuring that the pile was in position. Then the leads of the crane swung causing the beam to tilt over to one side (the victim's side), positioning the extension pile directly over the victim. According to the spotter, the normal practice would then be to swing the extension back and straighten it out. However, at this point the hammer was inadvertently dropped, and it hit the misaligned extension pile (see Figure 3-4), which caused it to fall.

Discussion: Specific safety and health issues associated with excavation need to be addressed in accordance with 29 CFR 1926.651. Specifically, daily inspections of excavations should be made by a competent person for evidence of hazardous situations, and inspections are to be conducted after every rainstorm. In this case, the conditions at the bottom of the pit were muddy (see Figure 4), and could have hindered the egress of the victim.
