# NJ FACE INVESTIGATION REPORT

FACE 12-NJ-010

## **Hispanic Laborer Crushed Between Lift Arms and Frame of Skid-steer Loader**

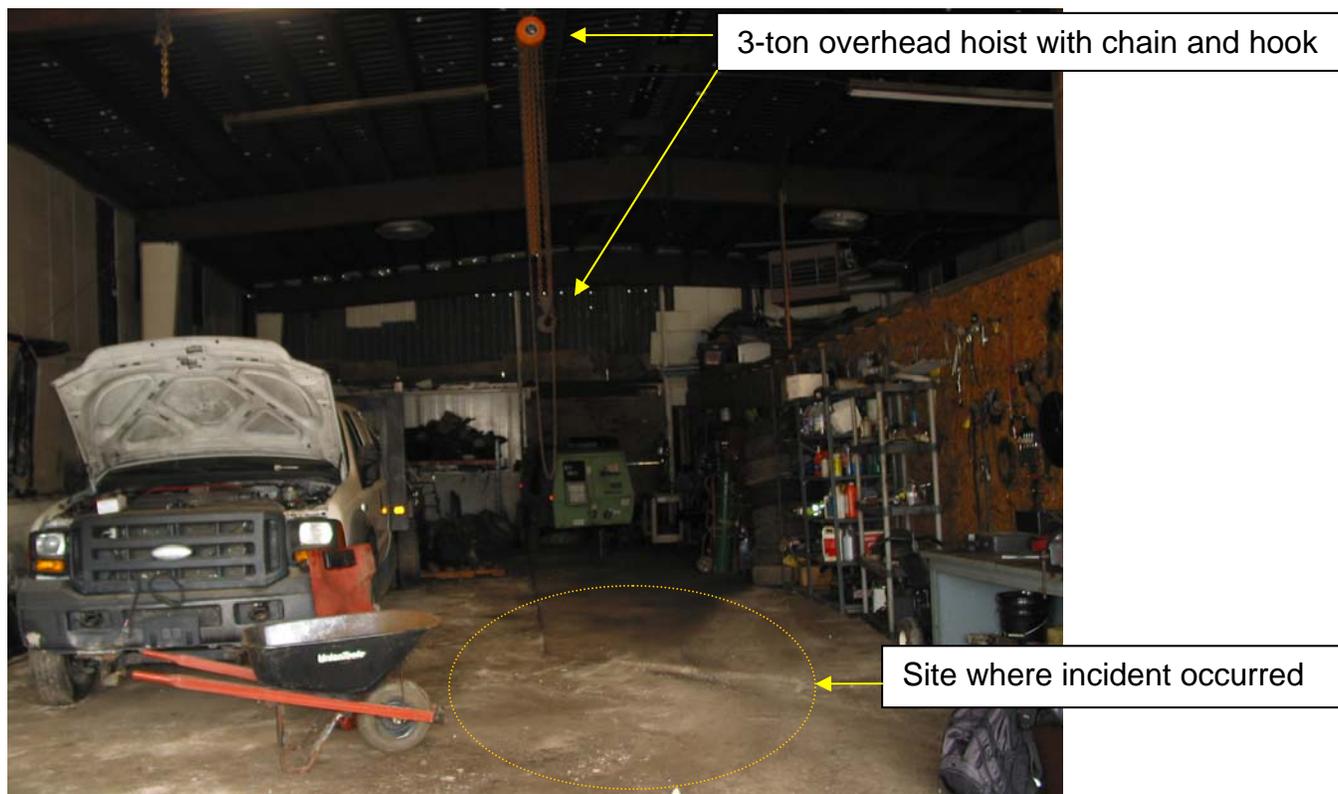
**FIGURE 1. Incident site; inside and outside views of garage.**

The incident occurred on a mild winter evening (approximately 35°F at the time of the incident), and took place at a garage and storage area for a company that performs snow removal. The garage consisted of two garage bays with roll up doors and an exit door on the building's side. The incident took place in the largest section of the garage, in the maintenance area (see Figure 1). The owner of the company had come to the site the day before the incident, was working outside the building and attempted to lift the bucket using the pedal (which operates the lift arms) in the cab. The bucket did not lift by use of the pedal, so he assigned the deceased with the job of fixing the pedal. As the victim was very familiar with all the machines on site and was the company's sole mechanic, he decided to come back later and attempt to fix the pedal. According to onsite interviews by OSHA, the victim had worked on the machine several times before. On these occasions, to raise the bucket, the employee wrapped a chain around the bucket and attached it to a hook connected to a 3-ton overhead hoist.

**a. Inside view of the garage.**

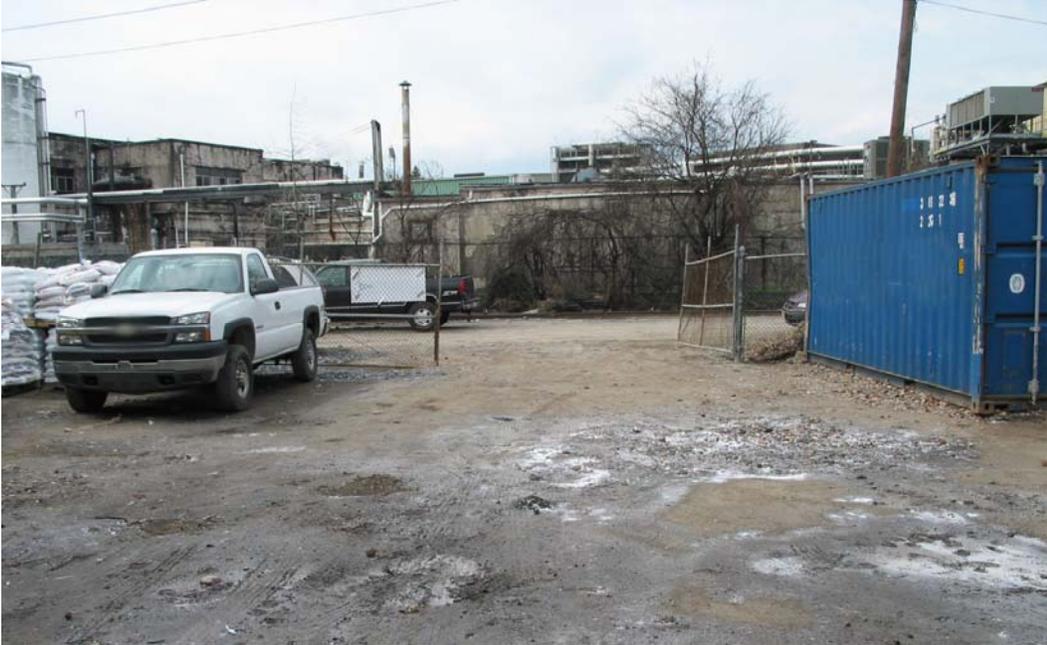
a. Outside of garage.

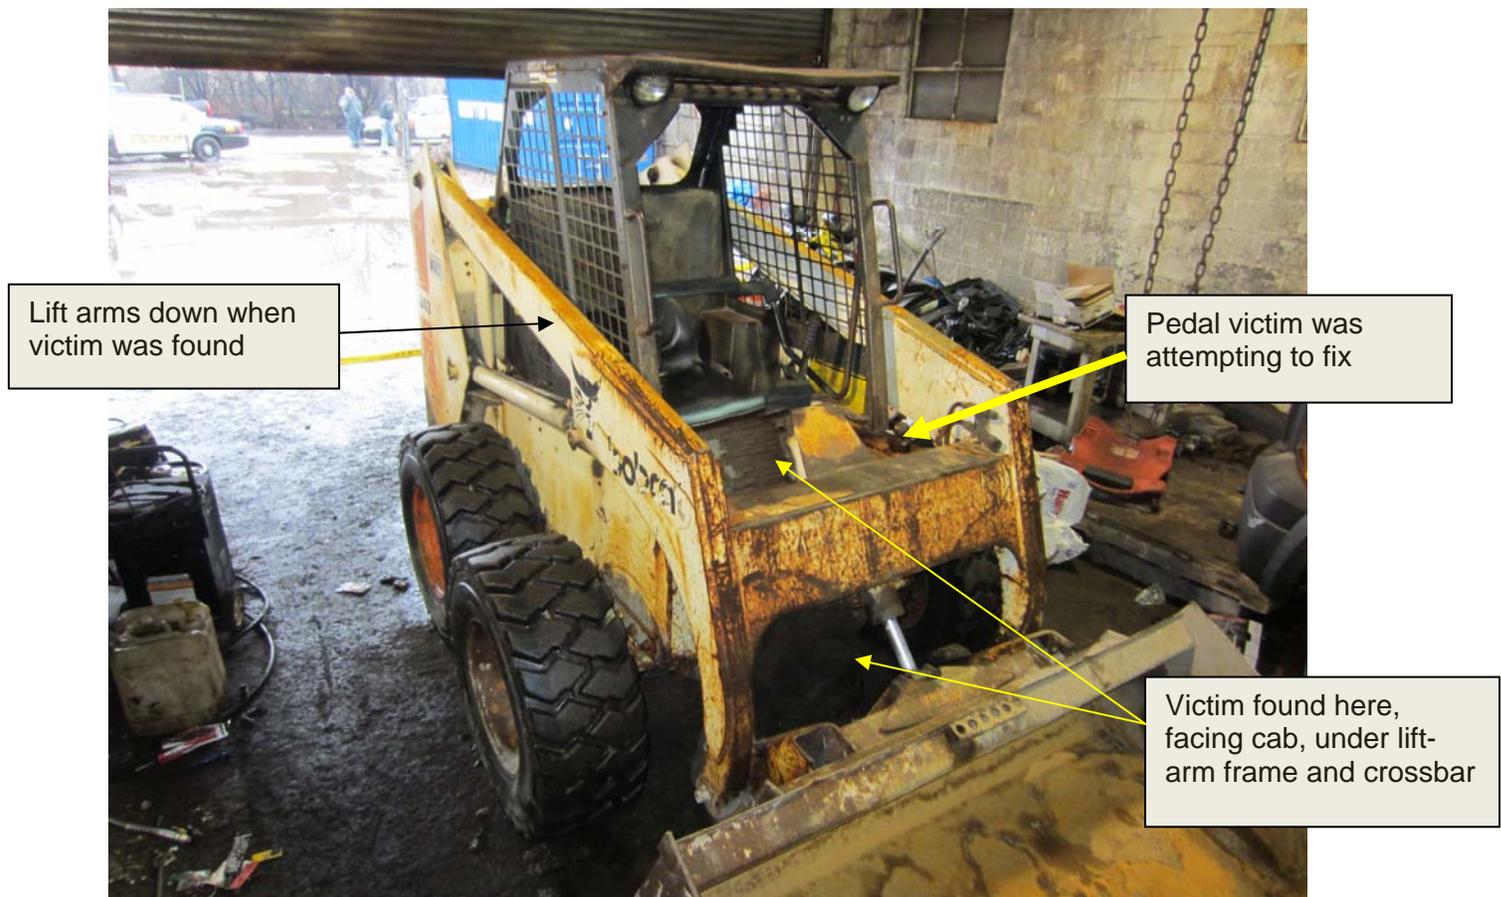
Based on the investigation by NJ FACE, OSHA, and a safety engineer from the manufacturer of the skid-steer loader, the machine was not running at the time of the incident. There was gasoline left in the

engine when the emergency personnel arrived and a tow truck driver was able to drive the machine out of the garage. Had the machine been running all night, there would have been no gasoline left in the tank. In addition, during the investigation conducted by the safety engineer, since the pedal was damaged, the only way the safety engineer could lift the bucket with the machine running was by using a pry bar on a linkage behind the pedal. There was no bar of this kind found anywhere near the victim when the victim was discovered. It was therefore concluded that the bucket was raised via the overhead three-ton, hand-operated chain hoist (Figure 1). However, no chains were found wrapped around the bucket or anywhere on the ground at the site. It was deduced that the hook was connected directly to the bucket.

Since the engine had not been running during the incident, there would be no hydraulic fluid running through the cylinders (which, according to the safety engineer, would cause the arms to quickly slam down through cavitation). In addition, no lift-arm supports were in place at the time of the incident.

FIGURE 2: Skid-steer loader involved in incident.

**Recommendation #1: When maintenance is performed on a skid-steer loader and the bucket needs to be raised, lift-arm support devices must be in place.**

Working under a raised bucket can be very hazardous. However, the use of appropriate lift-arm supports can protect a worker at risk. There are two common types of lift arm supports; pin-type or strut type, which should be provided or purchased from the manufacturer. Currently, most manufacturers include lift-arm supports as standard when purchasing a skid-steer loader, but this was not always the case. It is unknown whether or not arm supports were included at the time of purchasing this loader in 1985. In this incident, lift-arm supports were not in place after the victim lifted the bucket using the three-ton overhead hoist. A helpful resource is the NIOSH Alert entitled, *Preventing Injuries and Deaths from Skid-Steer Loaders*.<sup>1</sup> This publication not only outlines critical safety considerations, but provides real case studies of fatalities.
