# NJ FACE INVESTIGATION REPORT

FACE 12-NJ-021

## **Laborer Killed after being Struck by a Slab of Concrete that had been Lifted**

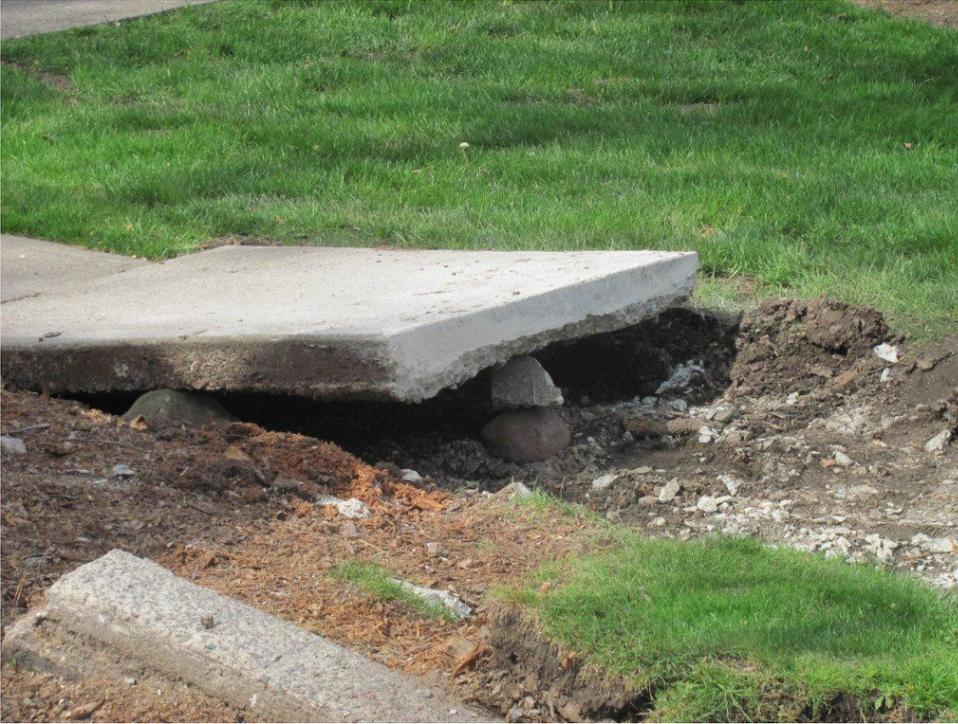
On the day of the incident, the victim and three co-workers arrived at the work site in the morning. The assigned task was to lift the sidewalk slabs and re-grade the soil underneath (rather than breaking up and replacing the concrete). In order to lift a slab, the four-worker crew would pry it up slightly (using a pry bar) and place large stones underneath to hold it in place (Figure 2). The crew would then connect a 40-foot-long chain to the bucket hook of a skid-steer loader and wrap the other end around the slab, connecting it to itself with a 2" pelican hook (Figures 3 and 4). The chained slab would then be lifted via the skid-steer loader and moved away, allowing the ground underneath the slab to be properly graded.

**FIGURE 2: Sidewalk slab propped-up by stones.**

If the method utilized during this incident continues to be used, NJ FACE makes the following additional recommendations: 1) use wood or small cement blocks in good condition to prop-up the slab; 2) ensure that the chain and hooks can handle the approximate load of the slab; 3) employ tag lines when moving the slab to keep workers clear of the hazard; 4) take extra care when using a skid-steer loader to lift and move heavy objects (according to onsite interviews, the skid-steer loader made “jerky” movements and it was difficult to move the slab smoothly).

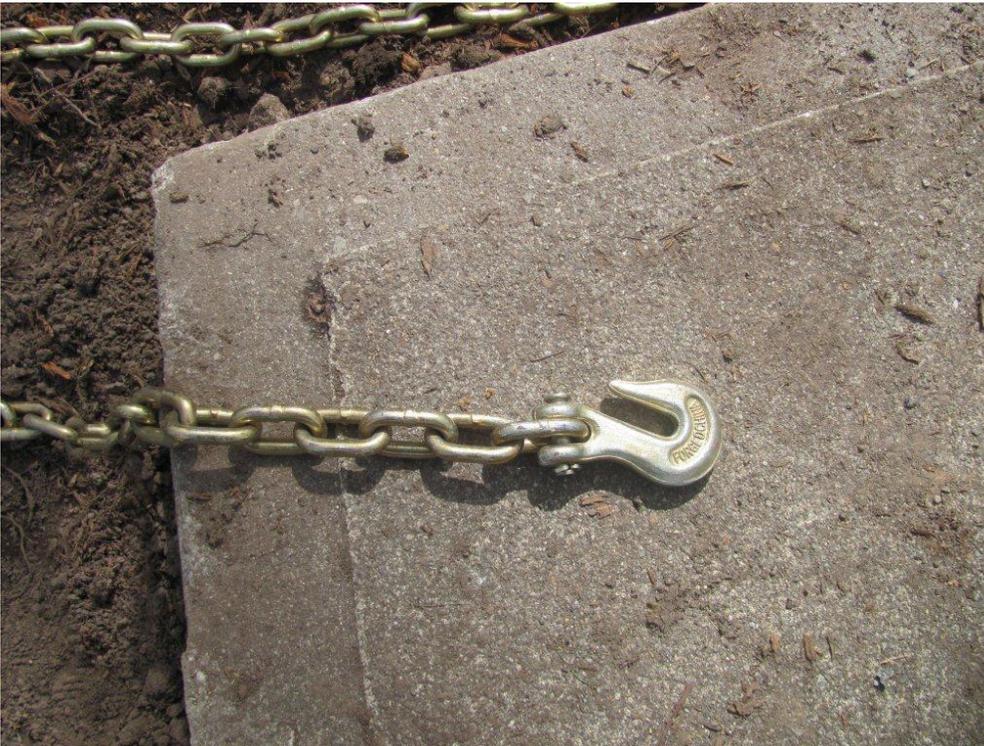
The slab that was lifted at the time of the incident was approximately 58" long x 48" wide x 5" deep, and weighed approximately 1200 lbs (assuming 150 lbs/cubic foot<sup>1</sup>). According to the crew, the slab was unstable, so three workers (including the victim) helped walk the slab away by holding it at three different places, guiding it, and keeping it balanced. The slab was then placed on the ground and the

**FIGURE 3. Chain with two-inch pelican hook used to lift the slab.**

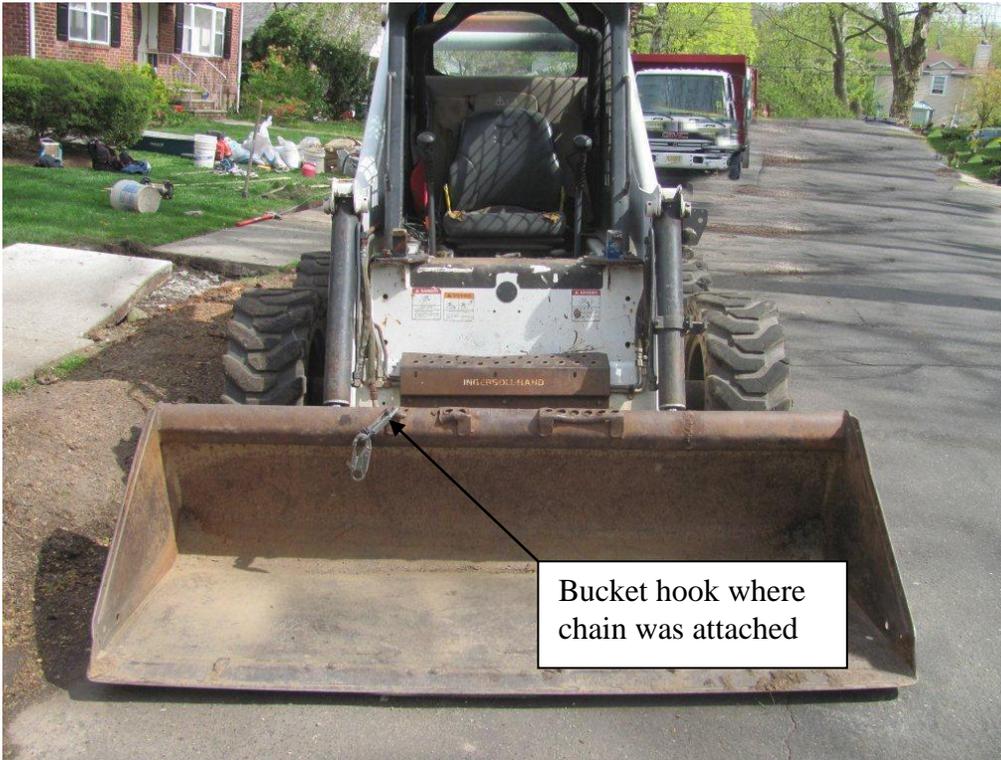
crew began to re-grade the soil. When finished, the slab was being walked back into place by the victim and lowered. During this time, for an unknown reason the victim knelt down, perhaps to fix part of the re-grade, and asked the skid-steer operator to raise the slab back up. As the slab was lifted, it swung and hit him in the head. The victim sustained blunt force trauma injuries, including a fractured skull. The victim died minutes after the injury. A crewman called 9-1-1 and the police arrived on the scene immediately.

**FIGURE 4. Skid-steer loader; note bucket hook where chain was connected.**

Many safer alternatives exist for re-grading the ground beneath concrete slabs. The important commonality between them is that the slab is never suspended off the ground. One alternative is to raise the concrete by cutting/jacking and filling (also known as slabjacking or mudjacking). This process is accomplished by drilling small holes into the concrete (or lifting the concrete using specialized jacks or pry bars) then pressure injecting (or hand-filling) material underneath the slab to fill the gaps, leveling the concrete.<sup>2-3</sup> Another method is to pry the concrete up and place metal rollers between wood boards underneath; the slab can then carefully rolled away, the soil re-graded, and the slab rolled back into place.<sup>4</sup>
