NJ FACE INVESTIGATION REPORT

FACE 13-NJ-074

Tree-care Worker Electrocuted While Trimming Branch Near Power Line

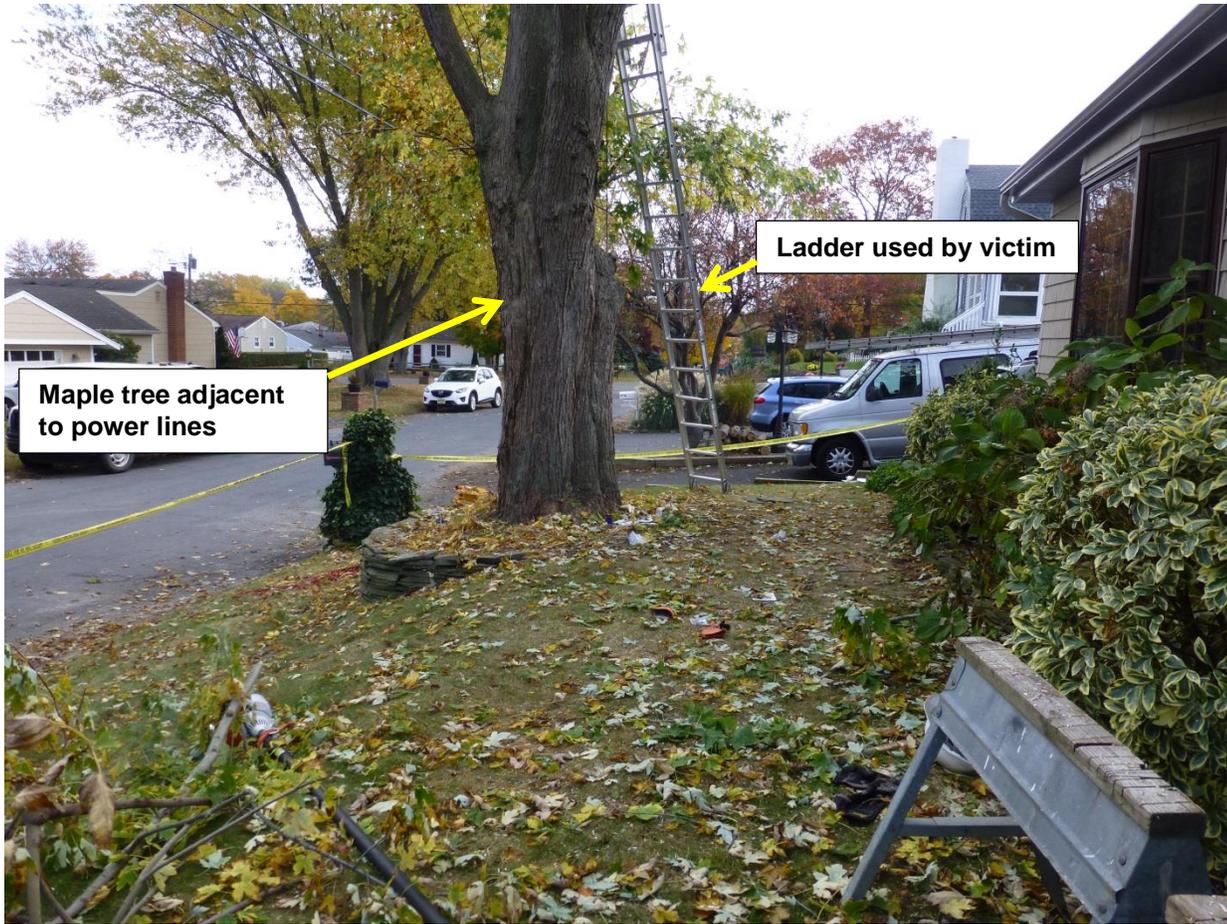
FIGURE 1: Incident site; front yard of residential property.

The incident occurred on a clear, dry winter day (approximately 52° F at the time of the incident, maximum wind speed was about nine miles per hour, and no recorded precipitation). The incident site was the front yard of a residential property in southern NJ (Figure 1). The homeowner had hired the victim’s company to trim some trees on the property, including a large maple tree in the front yard. The victim was sole proprietor of the company, who would hire general laborers as needed to assist in larger tasks. For this particular job, the victim hired two laborers to work as ground crew. Their tasks included cutting, roping off the area, clearing branches, cleaning debris, etc.

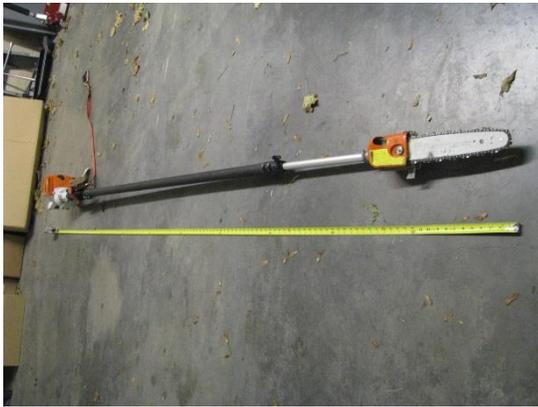
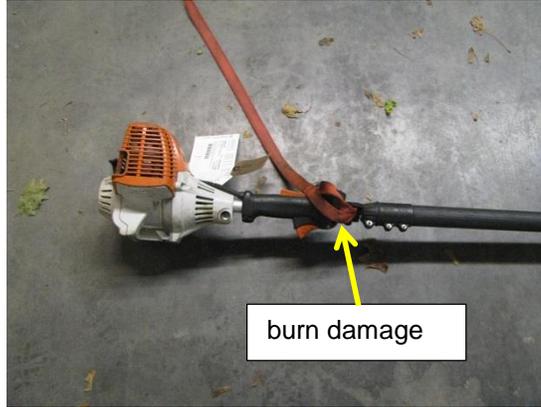
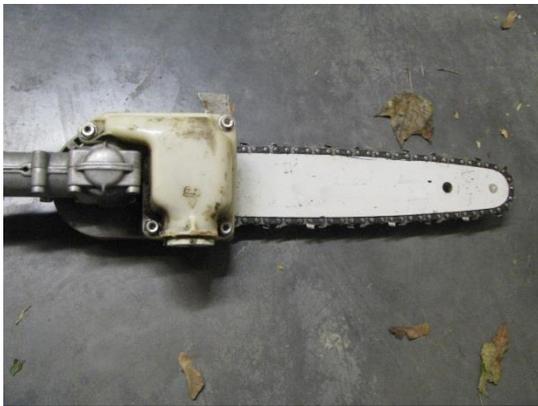
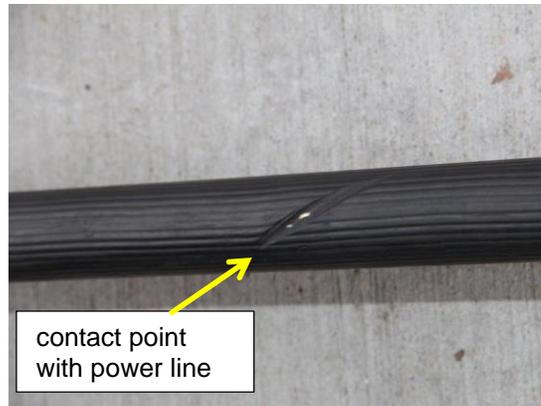
FIGURE 2. Extendable power pole saw; a. full view (10°); b. throttle end; c. saw end; d. close-up view of contact point with 7.5kv transmission line.

The job required three days to complete and the incident occurred on the third day. The first day was allocated for assessment; the second day involved trimming another tree on the side of the property; and the third day was to trim the maple tree in the front yard. On the day of the incident, the three workers arrived at 10:00 am, the victim set up a 40-foot aluminum extension ladder in the maple tree (Figure 1), tying off the ladder to the tree with rope. According to the two ground crew workers, the goal was to trim several of the branches near the power lines using a power pole saw (Figure 2a). The saw was extendable to 16 feet, although at the time of the incident, it was extended to 10 feet. It had a control end with a throttle (Figure 2b), and a cutting end (Figure 2c).

Based on burn damage found on both the throttle (Figure 2b) and the victim’s right hand, it was concluded that the current traveled down the pole to where the victim was holding the saw. The current then passed through the victim to the ground via the aluminum ladder, as evidenced by a burn mark on the victim’s shin.

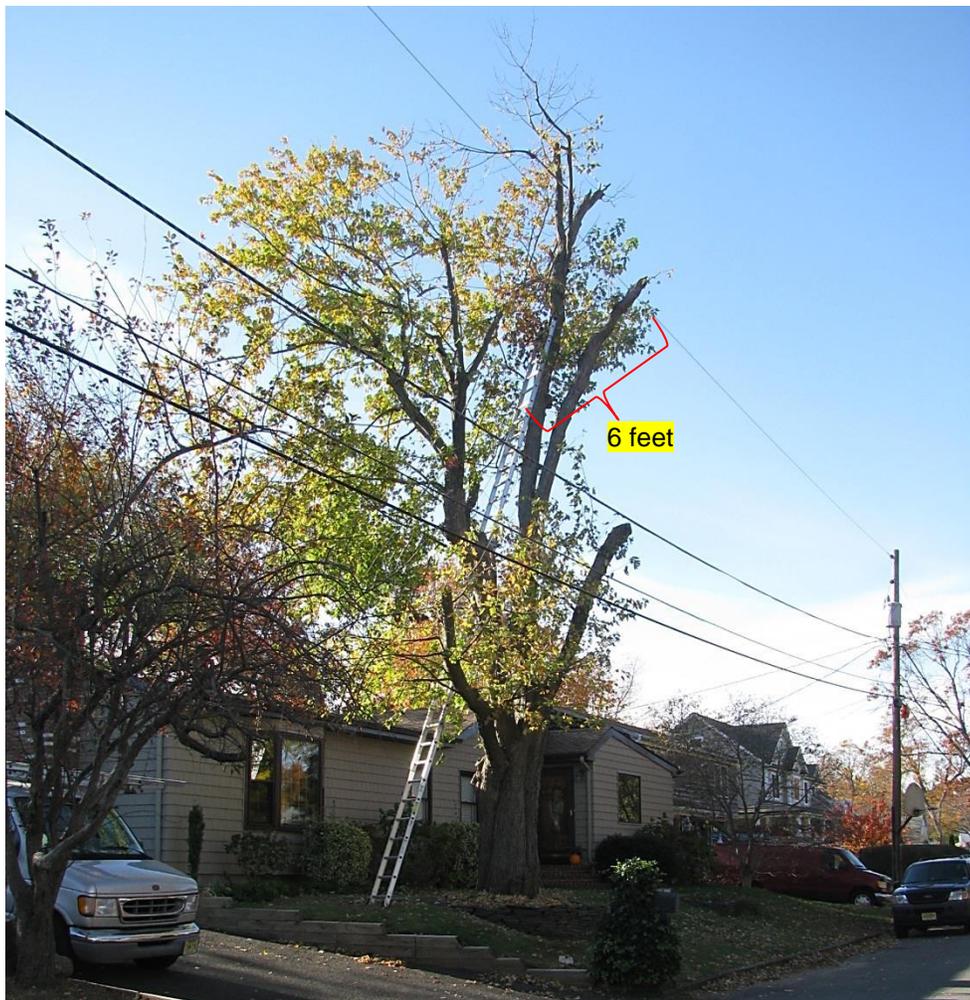
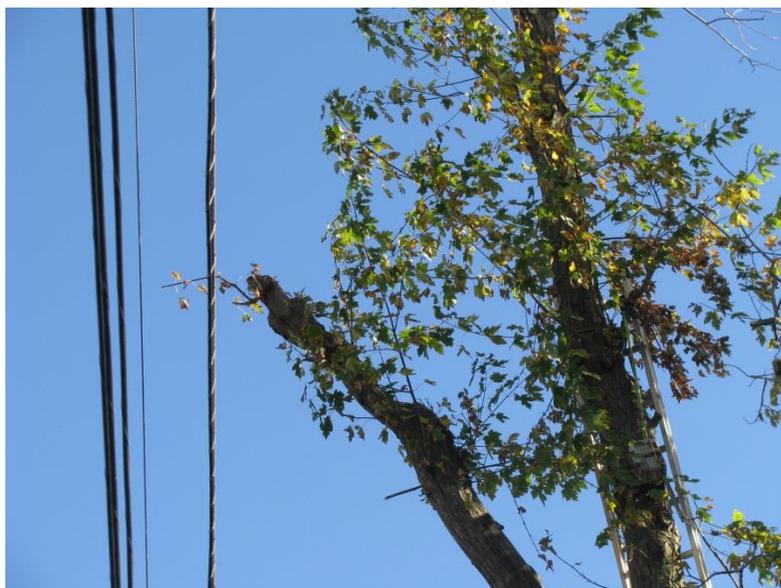
FIGURE 3. Branches to be cut near power line: a) full view; b) close up near wire.

branches that would fall to the ground). He was wearing a hard hat, gloves, eye protection (goggles), and a harness (which was not attached to the tree). Shortly after starting, a neighborhood resident came over to inquire about hiring the company to do work. The victim stopped trimming, came down from the ladder, and spoke with the neighbor. Afterwards, he went back up the ladder (to a point approximately 30 feet high) to cut a “nub” that was next to the power line (Figure 3).

Based on measurements from scene by the local power company, the lateral distance from the point where the victim was working to the primary power line was six feet. The victim “drop started” the saw (i.e. pulling the starting cord handle and simultaneously allowing the saw to drop) and it is believed that this is when the pole contacted the 7.2-kilovolt transmission line (see Figure 2d). The ground crew and neighbor stated they saw the victim “go rigid” and witnessed sparks and smoke. The victim remained in this rigid state for approximately 15 seconds, and then fell backwards off the ladder. One of the ground crew workers attempted to catch him, and sustained a broken femur. The police were called and arrived in about three minutes. The victim was transported to the hospital and died 31 hours later due to high voltage electrocution.
