INVESTIGATION REPORT

FACE #97-NJ-047-01

Forklift Operator Crushed to Death Between Forklift
Truck Cage And Metal Beam

DATE: February 23, 1998

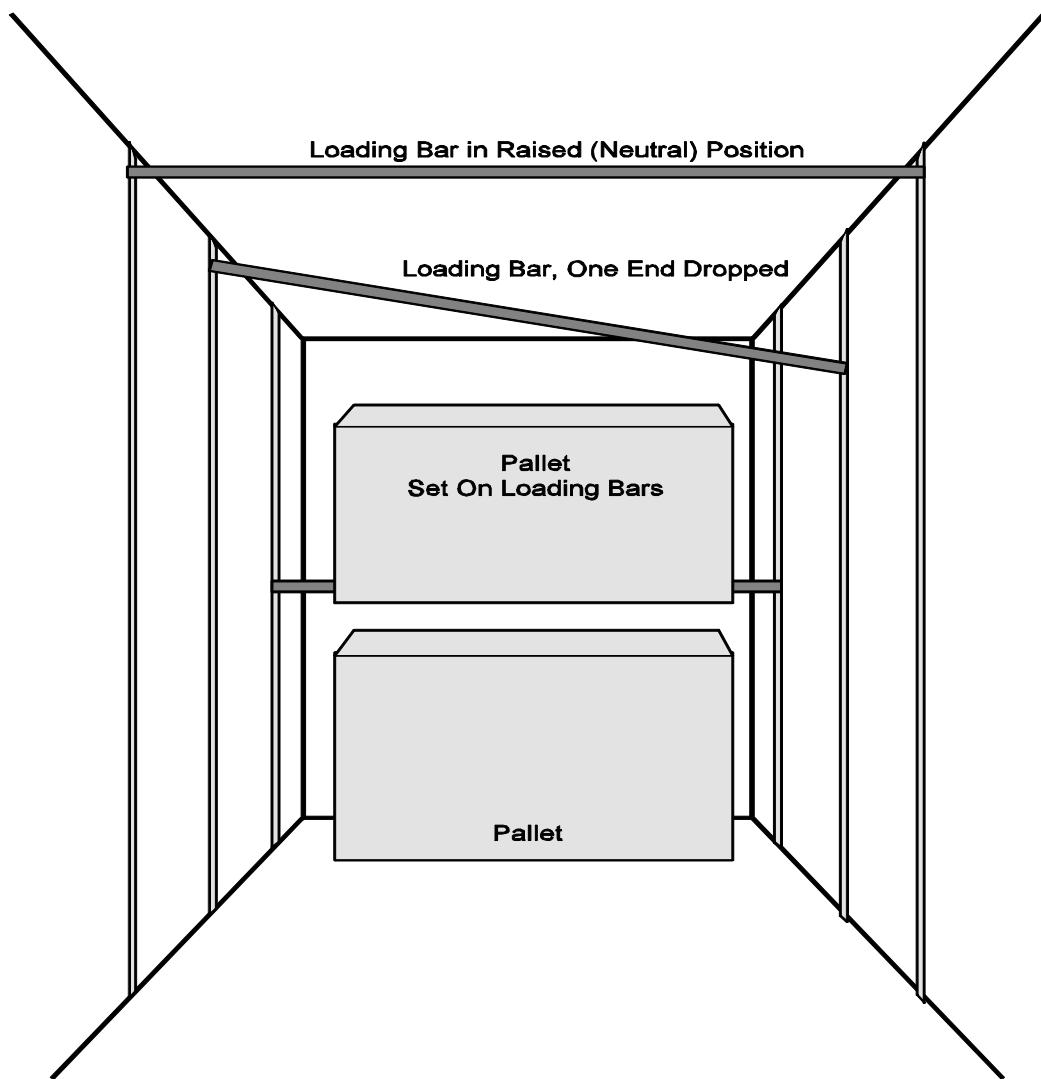
Figure 1
Interior of Trailer Showing Loading Bar Positions

To increase efficiency, the company had recently purchased a number of "logistical" trailers. These were specially designed trailers equipped with horizontal metal loading bars that held pallets of freight off the floor of the trailer. This better utilized the space within the trailer and prevented damage caused by stacking pallets directly on top of each other. The loading bars were adjustable aluminum bars running along vertical metal tracks mounted on the sides of the trailers. Designed to hold 1,500 pounds, the loading bars locked into slots in the metal tracks and could only be lowered using a metal handle to unlock the mechanism. A racheting feature allowed the bars to be manually pushed up without the handle. When the loading bars were not in use, they were pushed up to their neutral position against the roof of the trailer. The trailer measured nine feet high by 8.5 feet wide by 63 feet deep and was equipped with a translucent fiberglass roof that illuminated the interior.

There were no witnesses to the incident. The weather was warm and clear when the victim arrived for work at 5:00 that evening. This was a relatively quiet night, as the work load after the July 4th holiday was light due to many customers closing down for vacation. As usual, there were two supervisors and a lead man on the dock. The victim started his forklift and went about unloading the large trailers as usual. At around 7:00 p.m. he started to unload freight from a logistical trailer. When he was about two-thirds into the trailer, he came up to a loading bar that had not been fully raised to the ceiling. One end was locked into the first slot from the ceiling and was hanging down about 18 inches from the trailer roof, creating an obstacle that he could not drive his forklift under. The victim apparently stopped his forklift just short of the load bar and stood up in the lift's cab to push the bar up, bringing his head and upper body outside of the forklift's protective cage. As he leaned over the steering wheel and control levers to reach the bar, he apparently leaned against a lever that caused the idling forklift to move forward, crushing the victim's head against the lift's cage and load bar.
