# NJ FACE INVESTIGATION REPORT

FACE 98-NJ-071-01

## Marine Terminal Laborer Run Over by a Trailer Being Loaded Onto a Barge

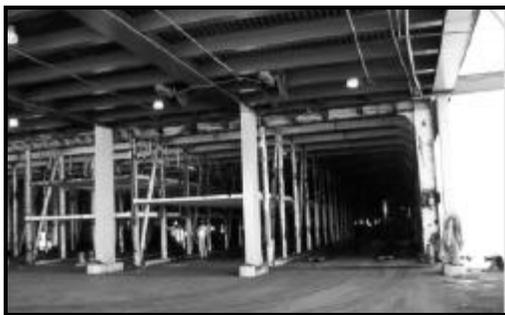
**Photo 1**

The incident site was a barge shipping terminal located on an island in a large river. This facility had a single dock with a multi-level loading ramp, a large parking lot for storing trailers and cars, and the business offices. A massive shipping barge docked at the facility once a week from its Caribbean terminal. The barge measured 730 feet long by 100 feet wide and contained three decks that were capable of holding 350 trailers and 500 cars (see photos). Each deck had eight narrow lanes separated by concrete curbs. Loading was done from the barge's open stern that

Photo of car loading lanes (left-center)  
and trailer loading lanes (right)

**Discussion:** The very narrow traffic lanes in the barge did not leave any room for the victim to work as the trailer was being loaded. To prevent future incidents, FACE recommends that the employer develop procedures for working safely in the barge. One such procedure would be to prohibit any workers from being in the barge during trailer loading, or to block off one or more lanes between the workers and trailers to provide a buffer or safety zone. All employees must then be trained on these procedures which must be enforced by the supervisors.

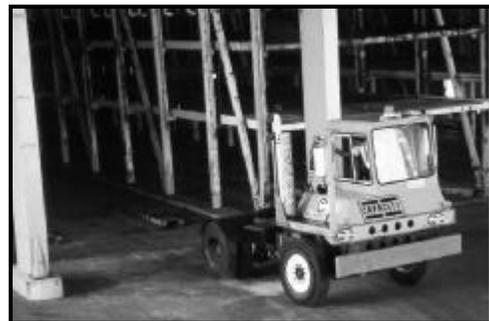
**Photo 2**

The incident occurred on Friday, August 7, 1998 after a loaded barge arrived at the terminal. After tying off the barge and adjusting the ballast so that it was even with the dock, the truck drivers started to unload the trailers. They used "hustlers" to move the trailers, which were trucks equipped with low gear transmissions. This gave the hustler enough power to pull the heavy trailers up the loading ramps but not enough speed to be used on the highways. The trailers were unloaded by backing the hustler down a barge lane until it contacted the stand that held the front of the trailer. This "pullman" stand was welded to the barge deck and is designed to collapse out of the way as the hustler hooked onto a trailer. The driver then connected the pneumatic brake line to the trailer, pulled it out of the barge, and parked it in a nearby lot. The hustler trucks were equipped with backup alarms and flashing warning lights.

Hustler truck backing down a trailer lane

**Discussion:** It was noted during the site visit that the truck drivers connected the pneumatic brake line but not the electrical line from the hustler truck to the trailer. This provided the trailer with compressed air for braking but no electrical power for operating the brake or reverse lights. The extra light from the trailer’s reverse and brake lights will increase visibility for drivers, spotters, and others working nearby.

**Discussion:** The examination of the hustler truck found that the yellow strobe warning light on the truck’s roof was not operating. FACE recommends that all warning lights, alarms, and other safety devices be regularly inspected to ensure that they are working properly.
