NJ FACE INVESTIGATION REPORT

FACE 99-NJ-062-01

Machine Operator Crushed in a Paper-Pulp Storage Tank

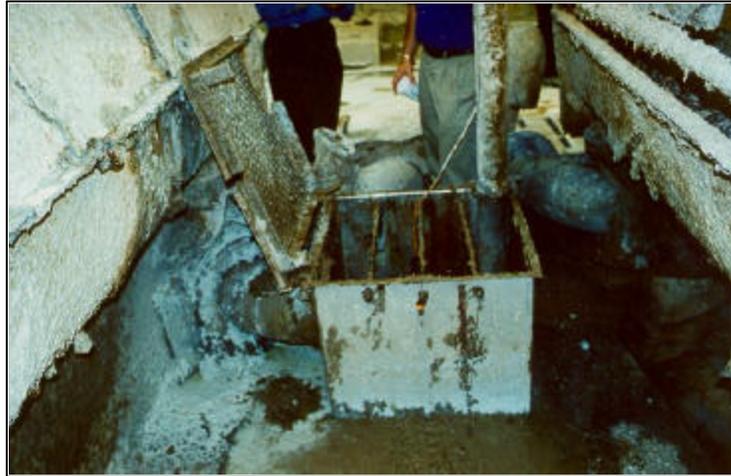
The victim’s work area was near a paper pulp chest that fed one of the paper machines. The hatchway to the chest is located between two large machines. Employees sometimes used this as a shortcut, climbing over some pipes and the hatchway to get by the machines. The hatchway measured 24 inches square and was raised 22 inches off the ground, with the chest underneath about twelve feet deep. A heavy metal grate was fitted to the hatchway. Paper pulp is pumped into the chest through a four-inch diameter pipe passing down through the hatchway. Inside the tile-lined chest was a propeller agitator that circulates the pulp. One of the victim’s responsibilities was to watch the chest and refill it when needed. Every 45 to 60 minutes he would throw a switch located about 30 feet from the hatch that activated the pump feeding the four-inch filler pipe. The pump was shut down when the chest was full, often when the operator saw pulp overflow the hatchway onto the floor. The victim also assisted with other processes around the plant.

Figure 1
Photo of paper pulp chest hatch
(Safety bars were installed after the incident)

It is not known how or why the victim was in the chest. It is possible that the victim fell in as he walked over the open hatchway while taking a shortcut between the machines. He may have also fallen in while looking down or sitting on the edge of the hatchway. The victim's medical condition and long working hours may have fatigued the victim and contributed to this incident.

Following this incident the employer installed metal bars across all the chest hatches to prevent unauthorized or accidental entry. The employer may want to consider installing railings near the machines and hatch to prevent it from being used as a shortcut.
