NJ FACE INVESTIGATION REPORT

FACE 99-NJ-090-01

Laborer Crushed Between the Cross Member of the Boom Lift-Arms and Frame of a Skid-Steer Loader

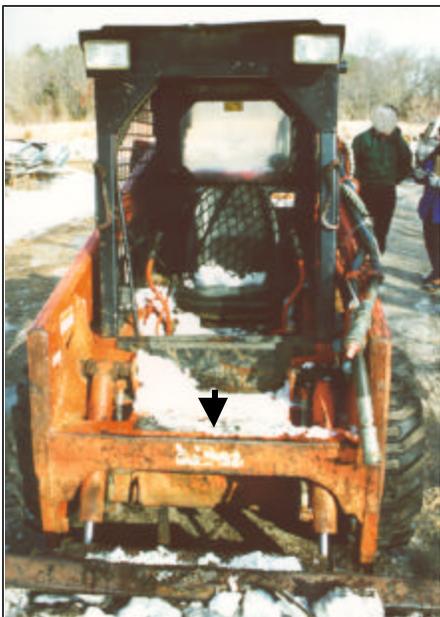
Arrow points to cross member of boom lift-arm assembly of the skid-steer loader.

Reaching in, he activated the control to raise the boom. As the boom raised, he was also raised since the cross member on which he was standing was part of the lift-arm unit. This reportedly caused his head to hit the front of the cab roof, so he used the control to lower the boom. When he did this, he lost his balance. His feet slipped off the cross member, he fell forward, and the lower part of his torso was caught between the cross member and loader frame as the bucket lowered. His hand was reportedly on the control bringing the boom down. Probably in a panic, he was unable to move the worker asked what to do and the victim told him to turn a.the machine off and then to turn it back on. The third worker, who had been splitting wood at the site, came to

Discussion: The skid steer-loader in this incident was designed, configured and equipped with safety devices to protect workers from the hazards of inappropriate operation. The skid steer-loader was also equipped with skid-resistant surfaces on the boom cross member connecting the right and left side lift-arms. This surface was intended for use during safe boarding of the machine, not for use as support while the machine was in operation. The victim may have not realized that he was exposed to injury from nip points when activating the controls from outside the operator's compartment or the potential for loss of balance due to machine motion. However, if he had been safely seated in the operator's

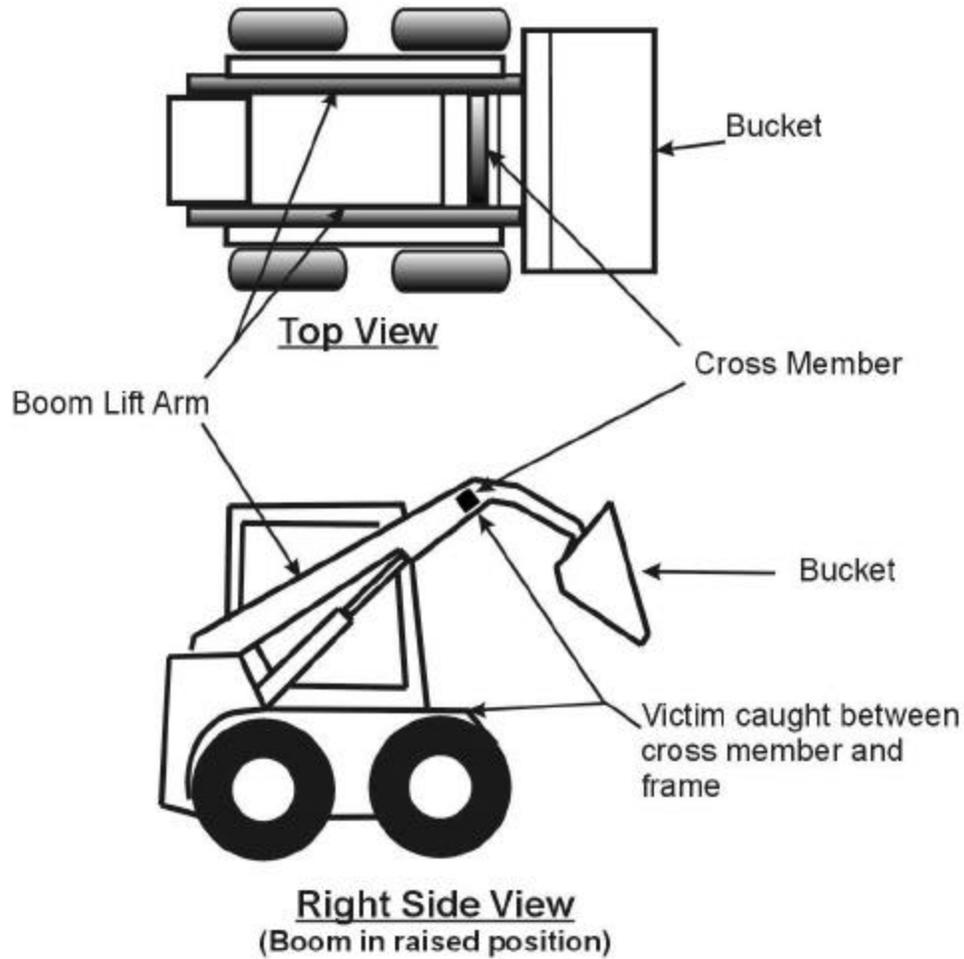
illustration not to scale.

The victim was employed by a landscaping company that also cut logs into firewood. The company had been in business for 10 years and had not had a previous serious injury. There were three employees plus the owner. Training was on-the-job; there was no formal training program. The site of the injury was a large field where their equipment was kept and firewood was stored until ready for delivery. The skid-steer loader involved in this incident was manufactured in 1983 and owned by the company for five years. The loader was fully operational and all safety features were intact and functioning. The company owner did his own machine maintenance. Please see page 6, Skid-Steer Loader illustration.
