# NJ FACE INVESTIGATION REPORT

FACE 99-NJ-108-01

## **Municipal Utility Worker Falls While Clearing a Clog in a Conveyor Chute**

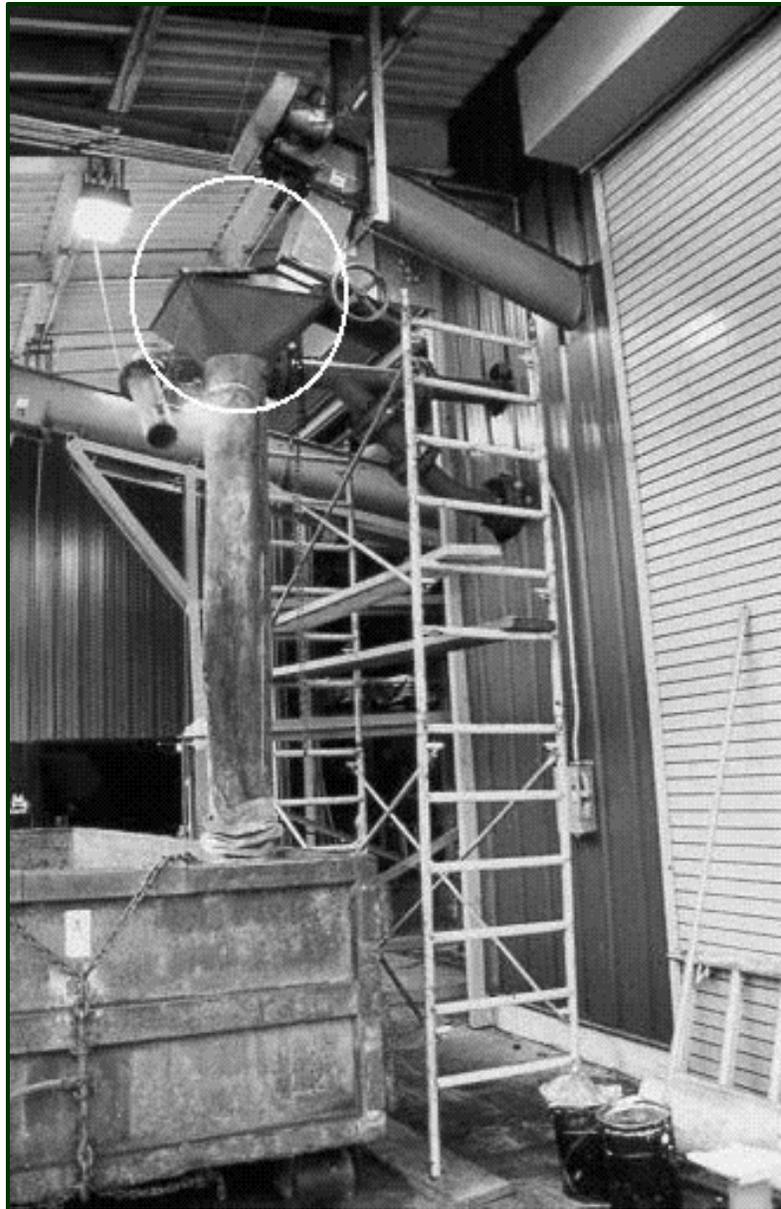
**Figure 1**

The incident occurred outdoors at a loading dock near the plant's sludge dryer. A screw conveyor moved the dried sludge from the dryer and out of the building to a loading dock. The conveyor ended at a hopper feeding a large flexible fabric chute (sock) that directed the flow of sludge into a Dumpster located below. The hopper measured about 30 by 30 inches and was approximately 13 feet off the ground and seven feet from building (see photo). All parts of the conveyor and hopper were enclosed, with a hinged door at the top of the hopper to allow access to the top of the sock. At full speed the process could fill a 23-yard Dumpster in about eight hours. Drying was a continuous process that took two to three hours to shut down, and the conveyors were run even as the workers unclogged jams in the sock and hopper

It is not known how the victim fell. The top of the hopper was sloped downward and not designed for a worker to stand on. In addition, the area between the hopper and the loading dock roof was low and crowded by the machine, making it difficult for the six-foot tall victim to stand or move. The hopper may also have been slippery from the moisture and cold temperatures. It was reported by the co-worker that the victim was wearing a half-mask dust respirator when he fell.

Photo of sludge conveyor (hopper circled)

**Discussion:** The hopper and surrounding area were not designed for workers to stand on. In areas that require routine maintenance, FACE recommends that a catwalk or other permanent work platform be constructed to allow workers easy and safe access to the machinery. A mobile personnel lift is also acceptable for areas that need occasional access. For areas that cannot be protected with work platforms, an appropriate fall protection program must be developed. This system may use harnesses, lifelines, safety nets, or other means to protect the employee while working at heights greater than six feet. More information on fall protection systems is provided in the attached OSHA publication, *Fall Protection in Construction*.

**Discussion:** There were no written procedures available for the operation and maintenance of the sludge dryer and conveyor. Given the limitations of the machine (it could not be easily shut down) and its tendency to jam, FACE recommends doing a Job Hazard Analysis (see Recommendation #4) to develop written procedures for the operation and maintenance of these machines. FACE also recommends contacting the manufacturer of the machine for advice in correcting the following problems found during the investigation:

1. The formation of plugs (clogs) in cold weather.
2. The formation of plugs (clogs) when the sludge level reaches the bottom of the fabric chute.
3. Unclogging the machine while it is still in operation.
4. The use of improvised tools (i.e., a broken shovel handle) to unclog the machine.
