A Cultural Resource Survey of "Fenwick Manor,"  
Block 846, Lots 1.01 and 1.02, 15 Springfield Road,  
Pemberton Township, Burlington County, NJ

Pinelands Development Application No. 85-0426.02

Barry J. Brady, Ph.D., SOPA - Principal Investigator  
NJ Pinelands Commission  
P.O. Box 7  
New Lisbon, NJ 08064

February, 1992

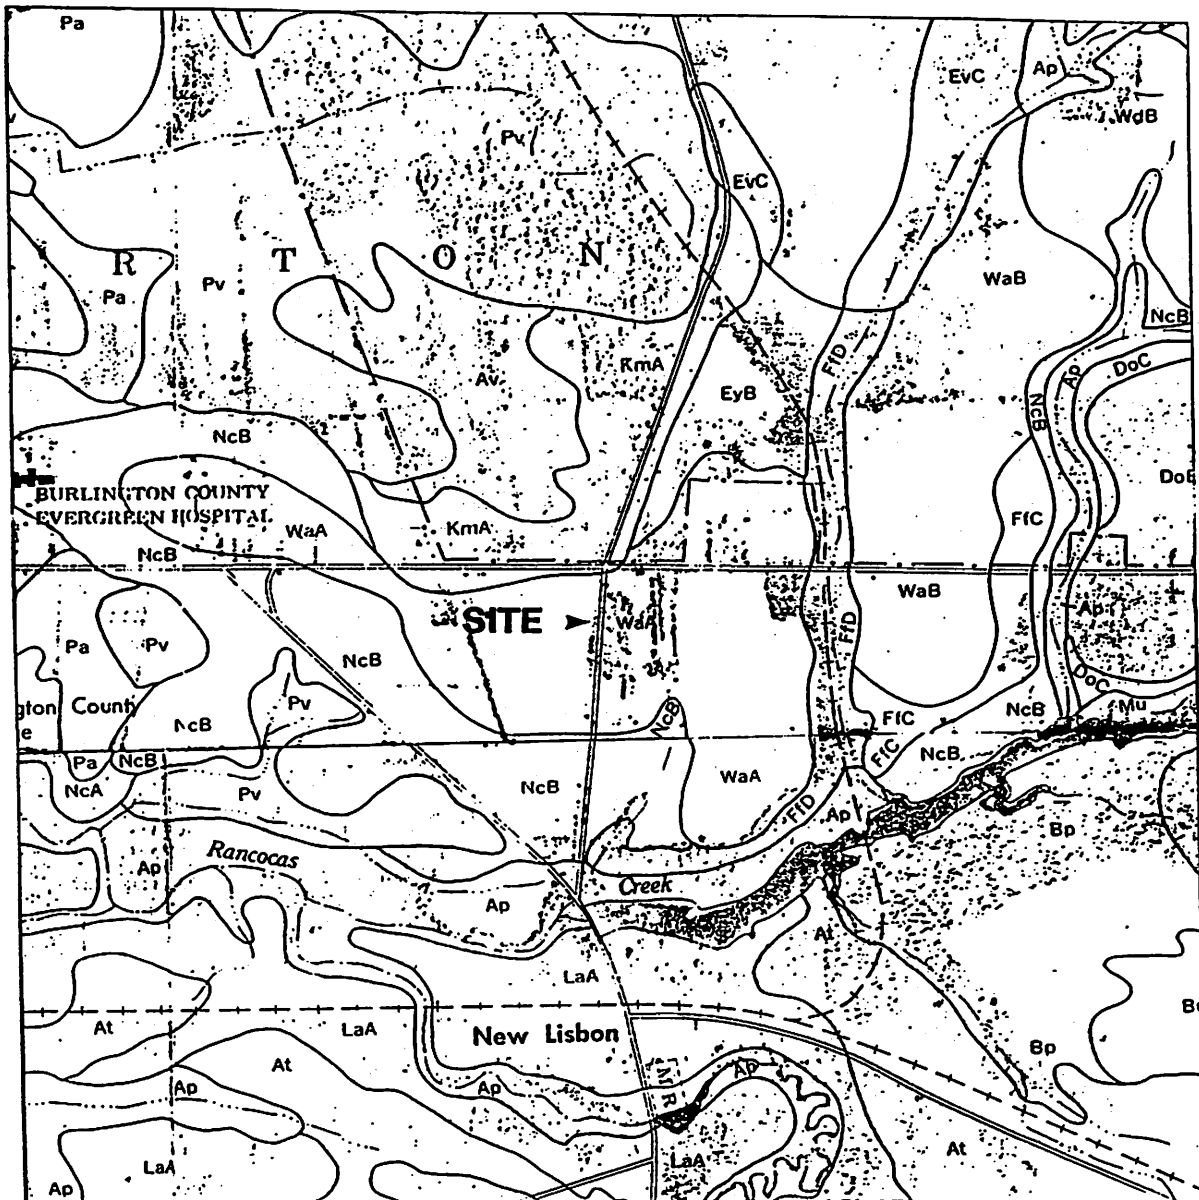
FIGURE 2  
Project area soils

The soils throughout the project area are uniformly of the Westphalia series (WaA) (see figure 2: sheet nos. 32 and 40 from the Soil Survey of Burlington County, New Jersey).

The soils on both of these lots are uniformly of the Westphalia series (WaA) (source: Soil Survey of Burlington County, New Jersey), a well-drained loamy fine sand that in undisturbed areas normally supports a mixed hardwood forest of oak, hickory, poplar, etc. In Burlington County, most of the Westphalia acreage has been exploited for agriculture. Various cereal and truck crops do well in this soil.

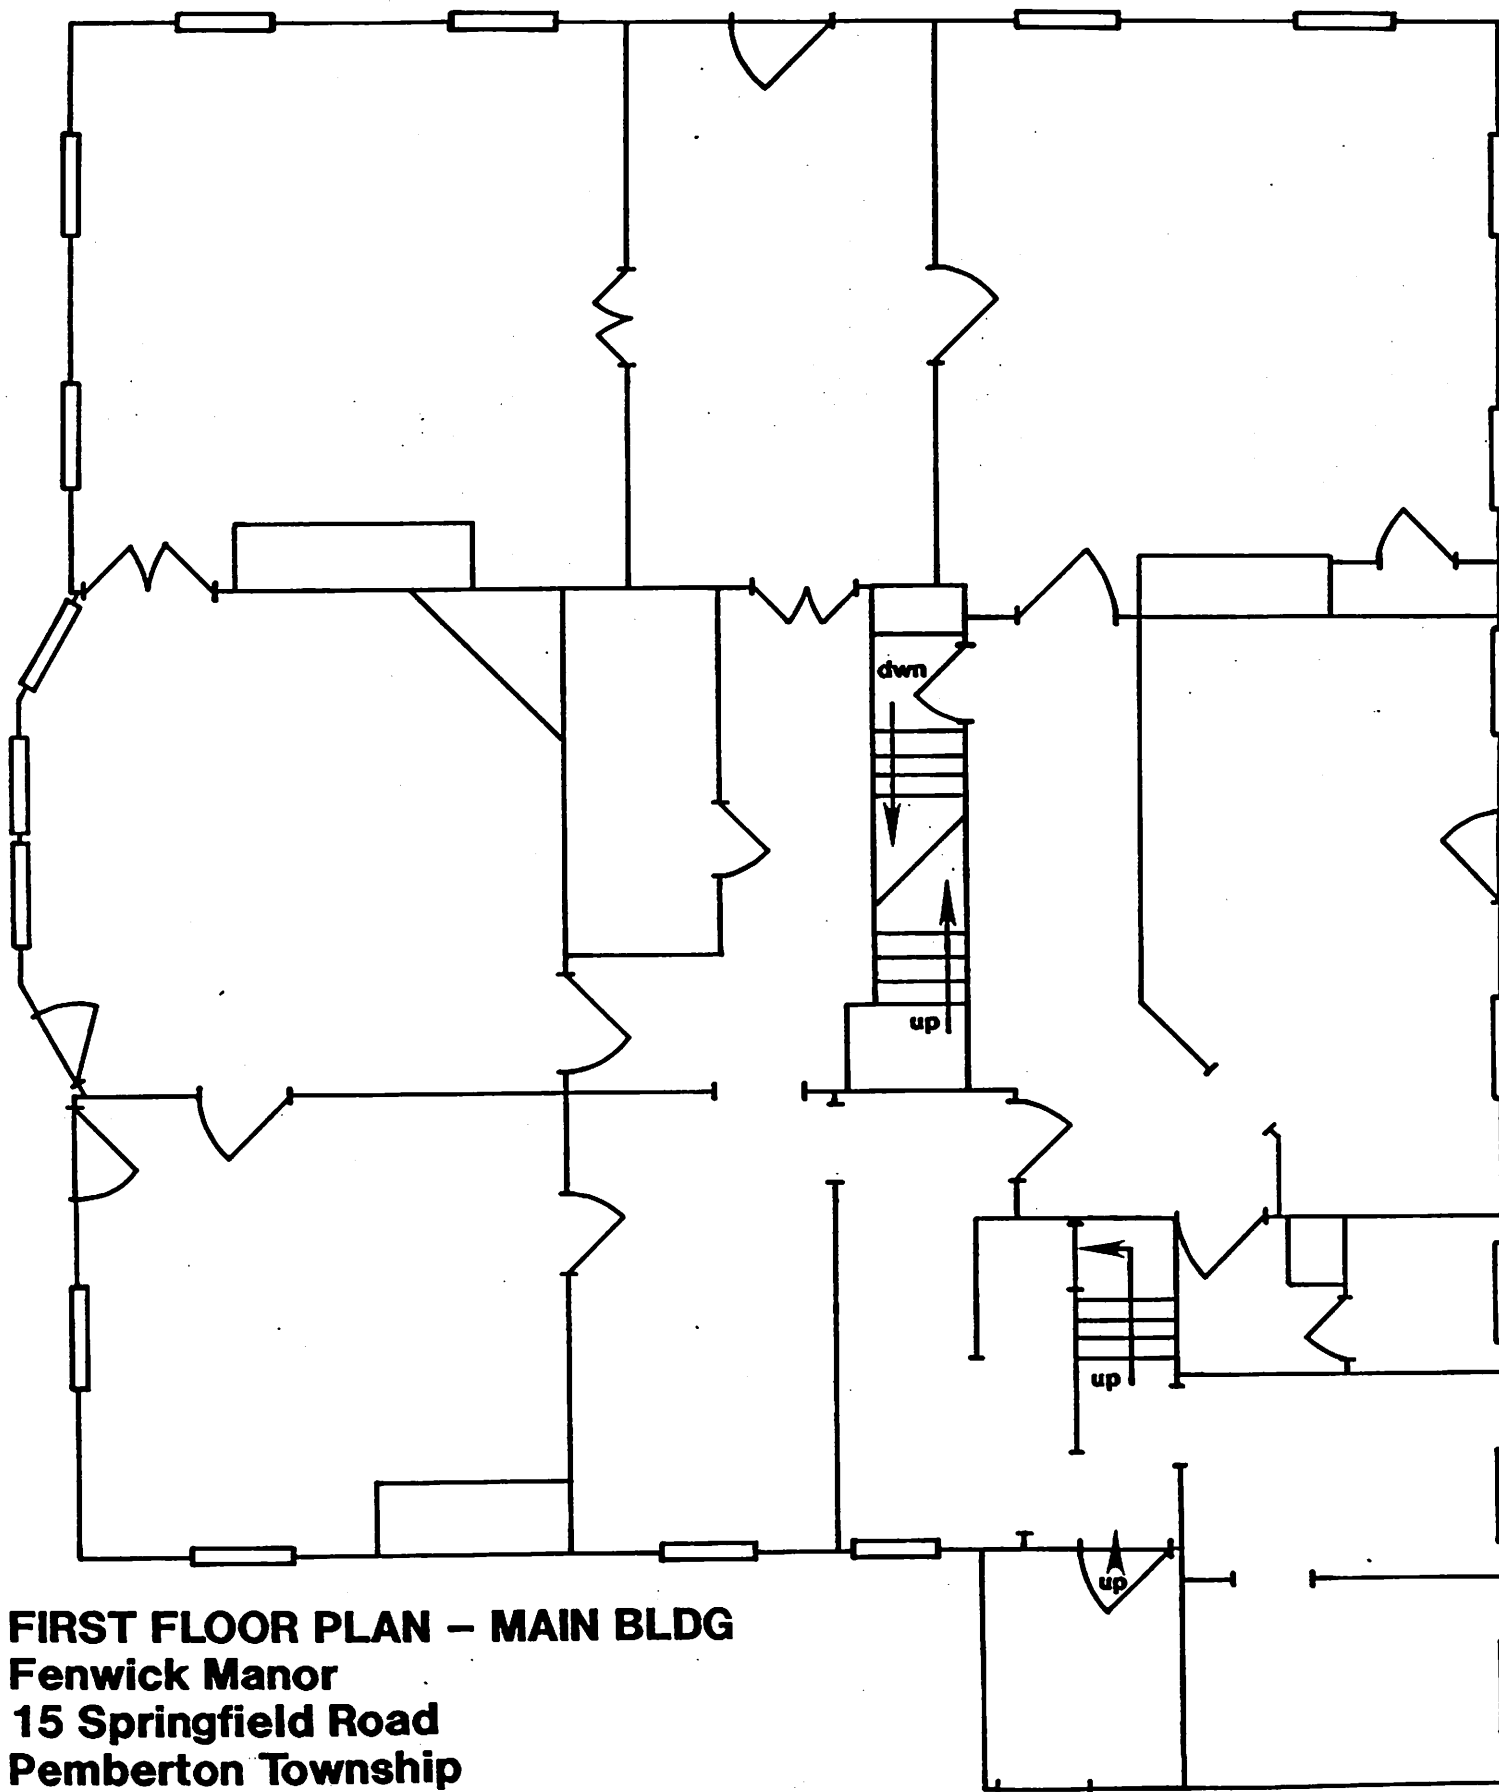
FIGURE 3

**FIRST FLOOR PLAN – MAIN BLDG**

**Fenwick Manor**

The interior of the house has been very much altered and the original floor plan mostly obscured in the 20th century. The main entryway has not been greatly altered, however, and includes a center hall flanked by two large rooms with fireplaces. One of the fireplaces features a fireback labeled "Mark Richards, Philad,<sup>A</sup>". In each room, the mantel surrounds are decorated by punch hole details of corner rosettes and fan patterns. There is a similar arrangement of rooms directly above on the second floor. The main staircase and the rooms further to the east, in what was the original section of the house, reflect the dictates of more recent occupants and are not historically accurate.

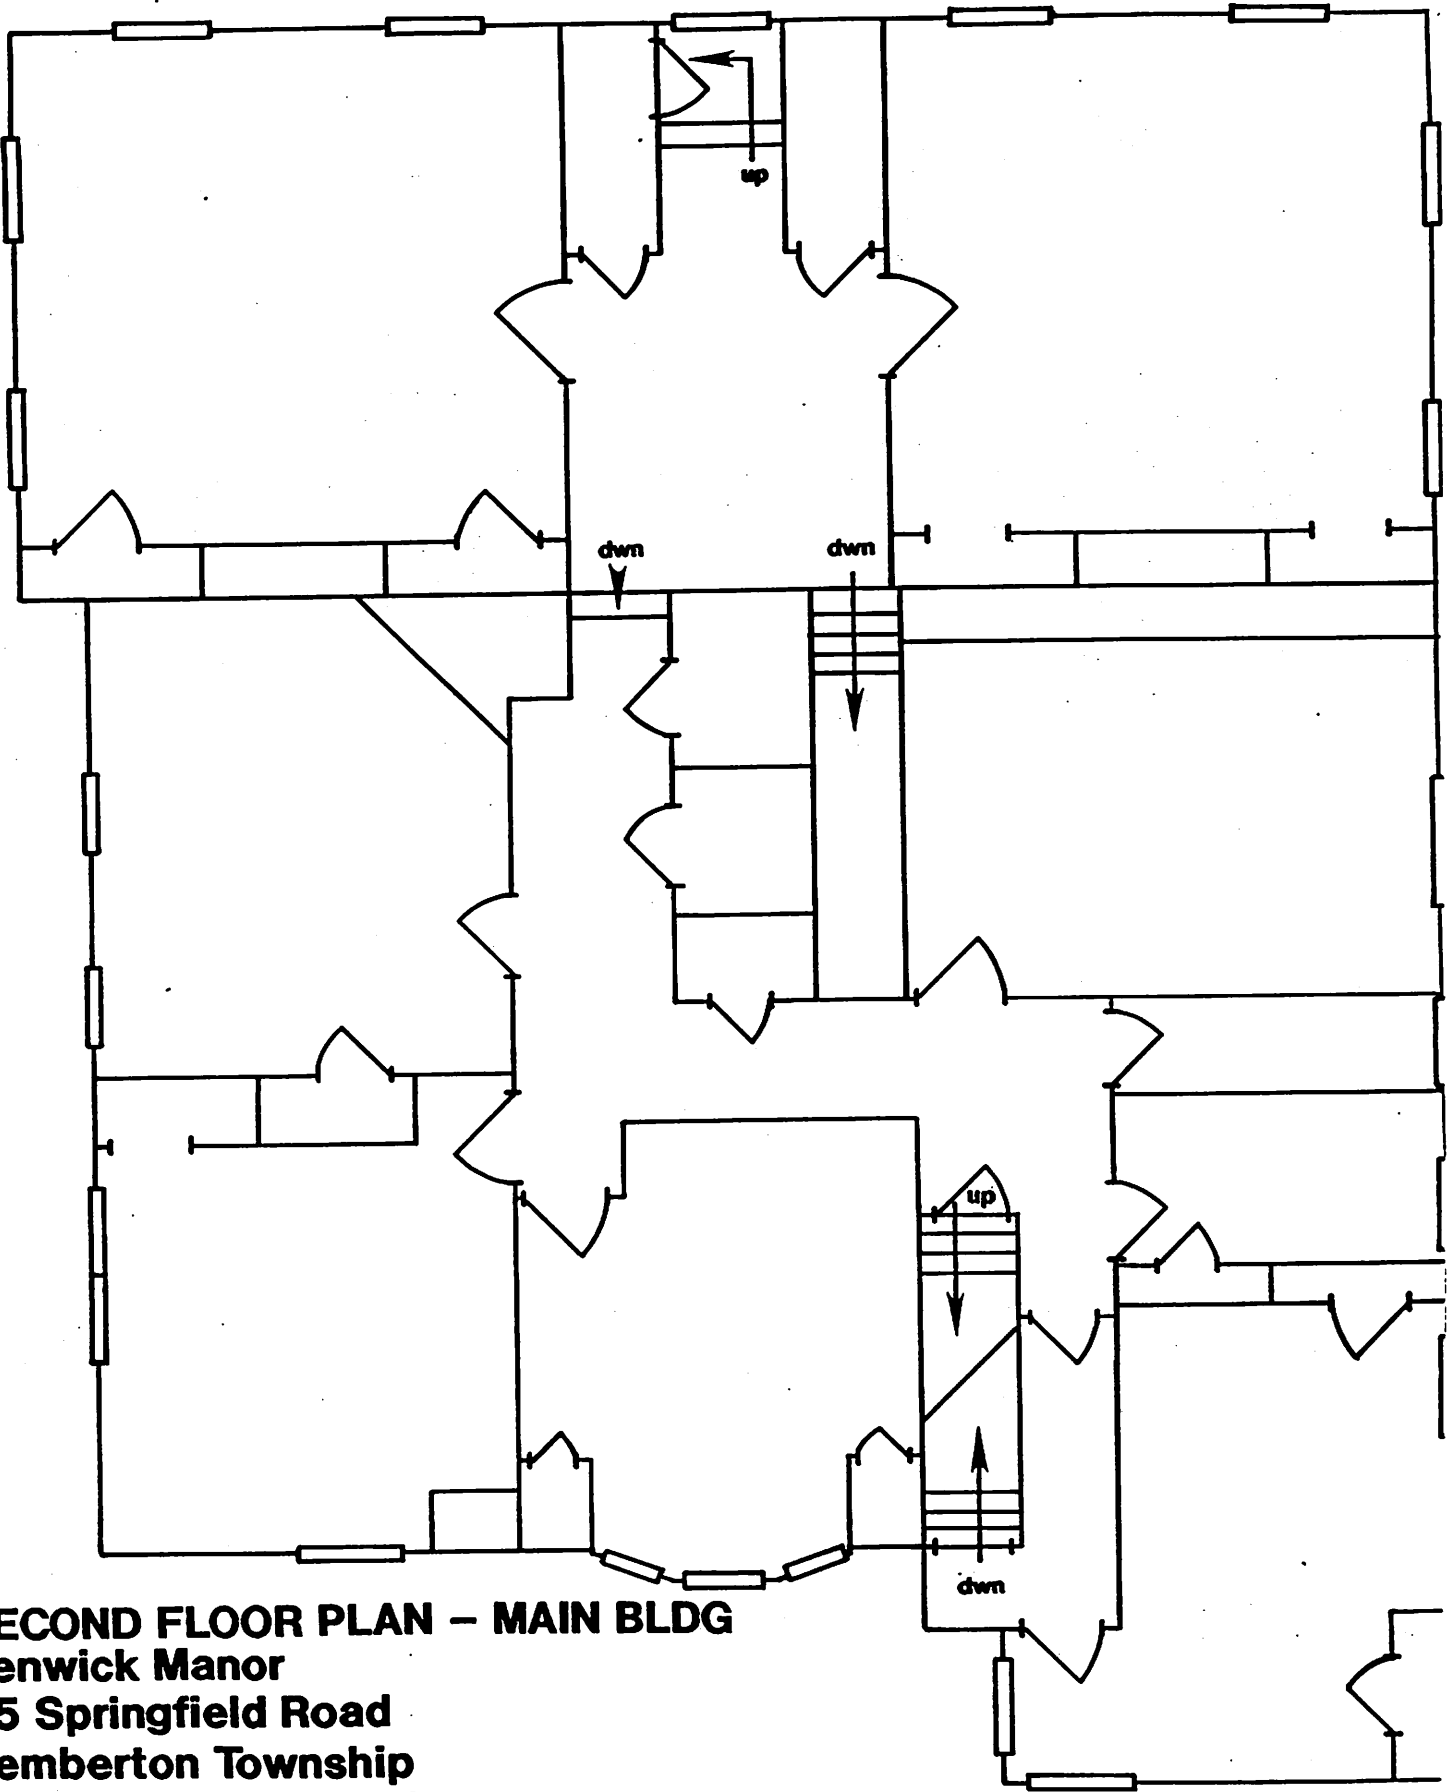
FIGURE 4

**SECOND FLOOR PLAN – MAIN BLDG**  
**Fenwick Manor**  
**15 Springfield Road**  
**Pemberton Township**  
**Burlington County, NJ**

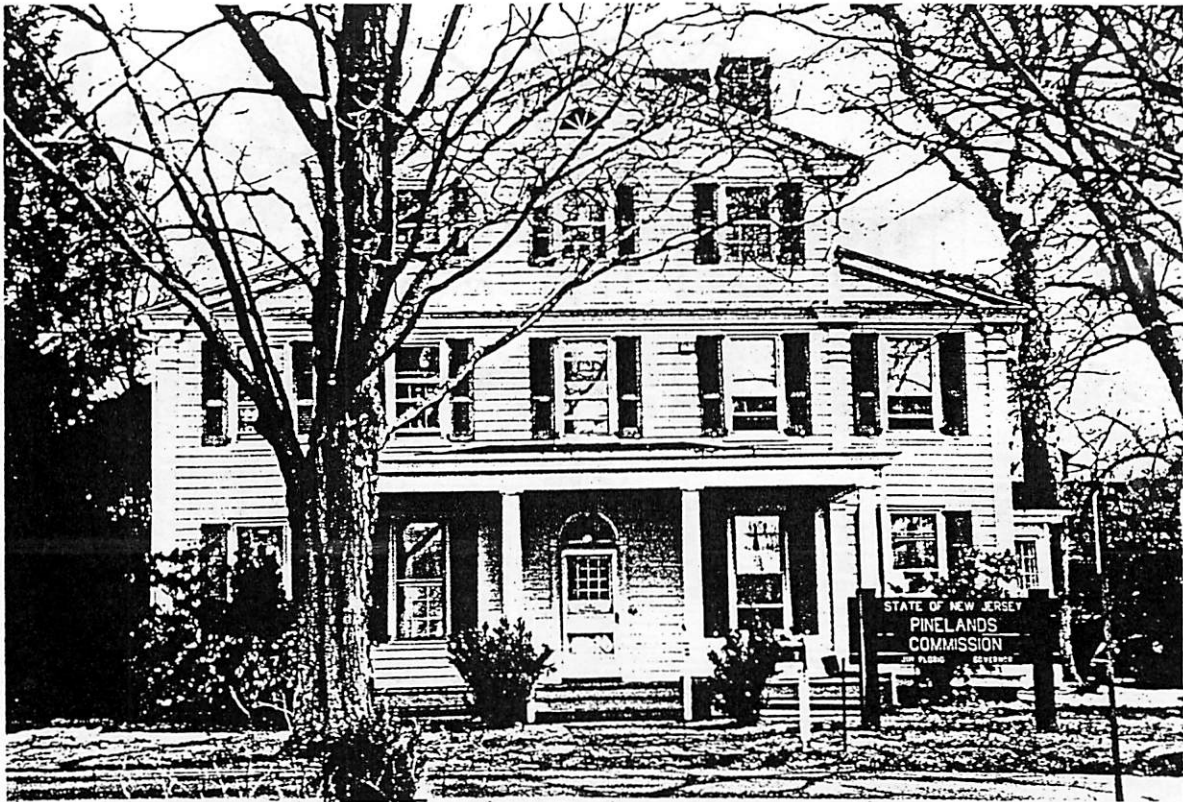
The late Federal style facade of the house is especially striking because of the broken pediment appearance of the roofline and the mixing of Federal and Greek Revival detailing. The gabled roof over the central, three bay portion of the facade interrupts the symmetrical roofs over the north and south wings, in effect giving each wing a shed roof. The broken pediment effect is conveyed by the ornate eaves which project from the wings and connect with the protruding pedimental

From the evidence of the earliest foundation, the ground floor joists and some interior detailing, this facade appears almost certainly to be a later extension, but one probably added shortly after the house was built. The front door opens on to a narrow hall, at the rear of which is an infilled arch with a Federal style door in the center. The original western foundation wall runs directly beneath this interior arched doorway, strongly suggesting this was at one time the entryway into the house. Of course, the style door within the arch would be consistent with the presumed period of construction in the 1820's.

A. Facade (west elevation) of farmhouse, looking east

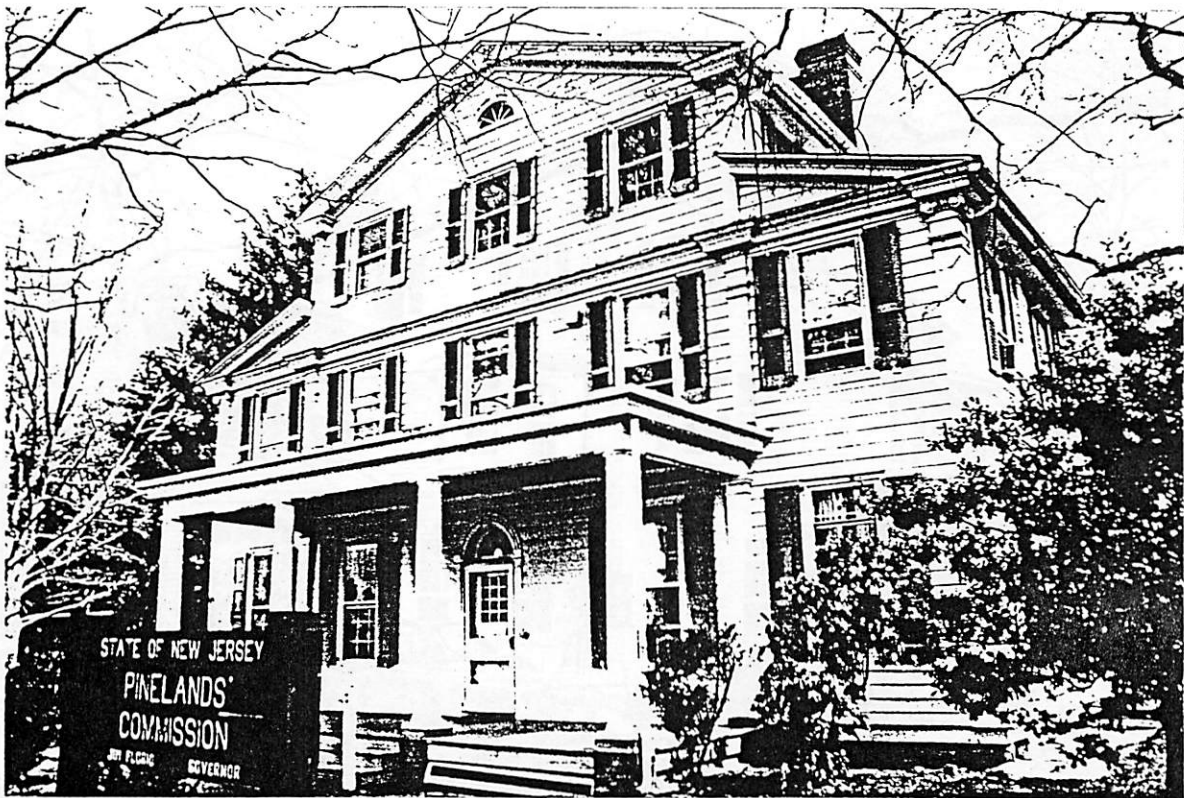
B. Same, looking northeast

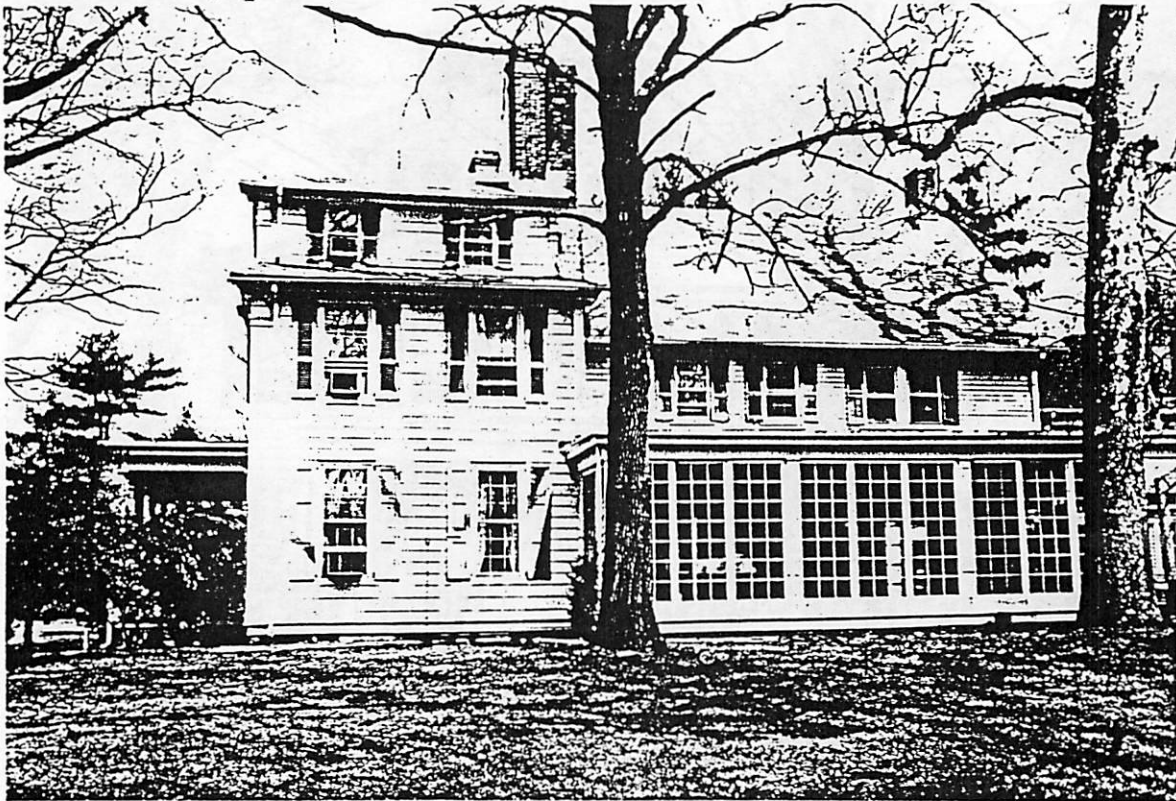
A. South side of farmhouse, looking north

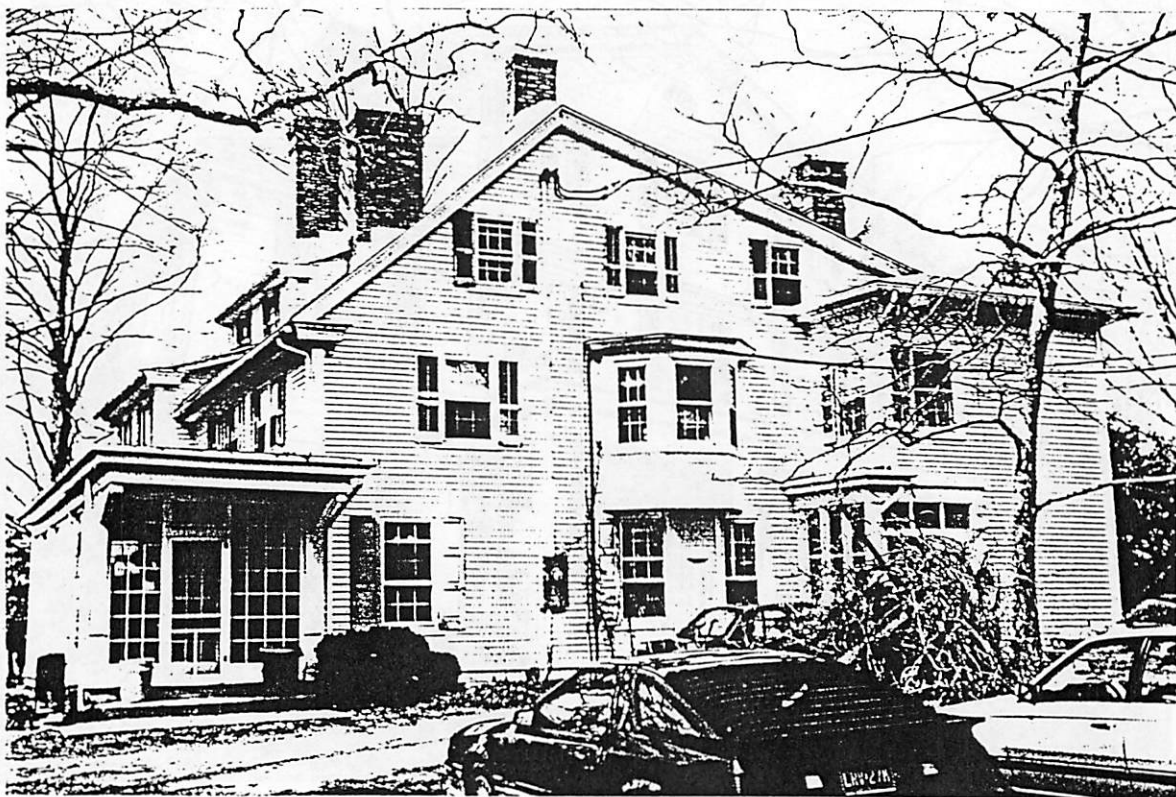
B. Rear (east side) of farmhouse, looking west

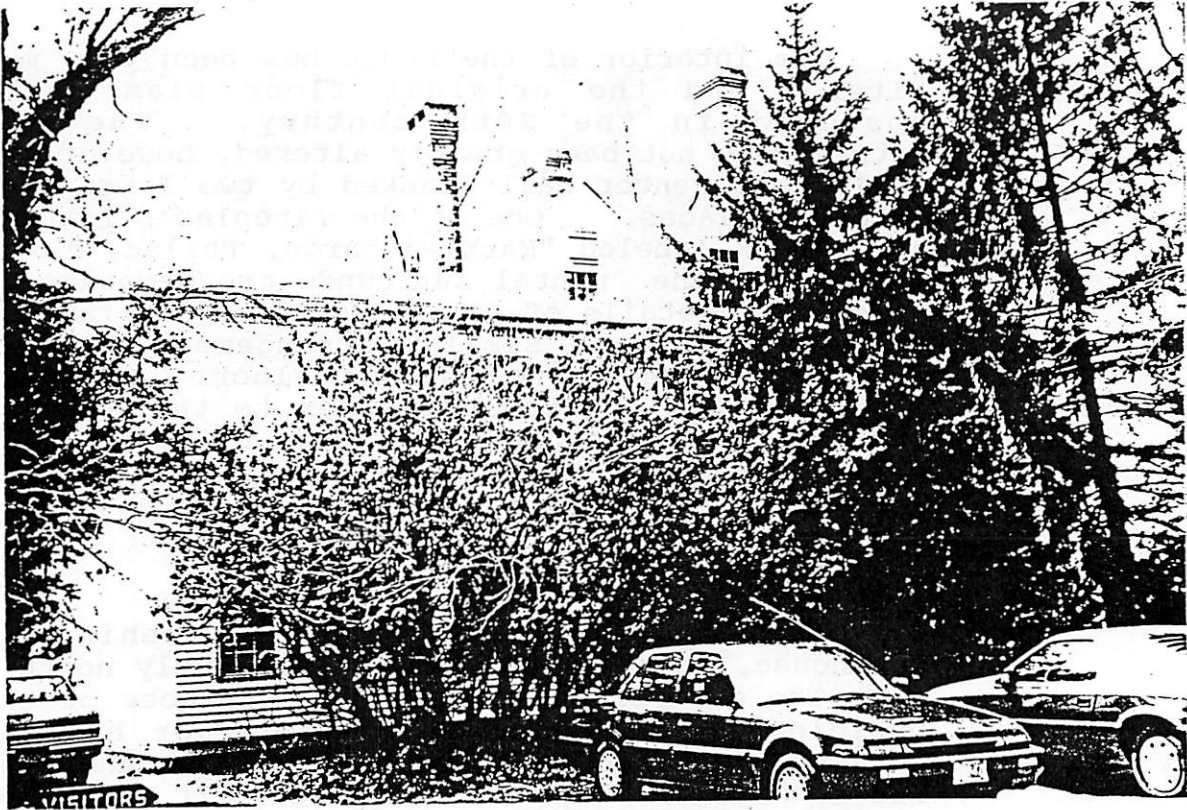
The north elevation of the house is the most simply treated. There is a door in the center of this side which has a hipped hood with console supports. There are also two gabled dormers in the roof above the second story. Windows on the first floor are 9/9 (in the extension of the west) and 9/6, 6/6 and 12/8 on the second and 6/6 on the third.

A. North side of farmhouse, looking south

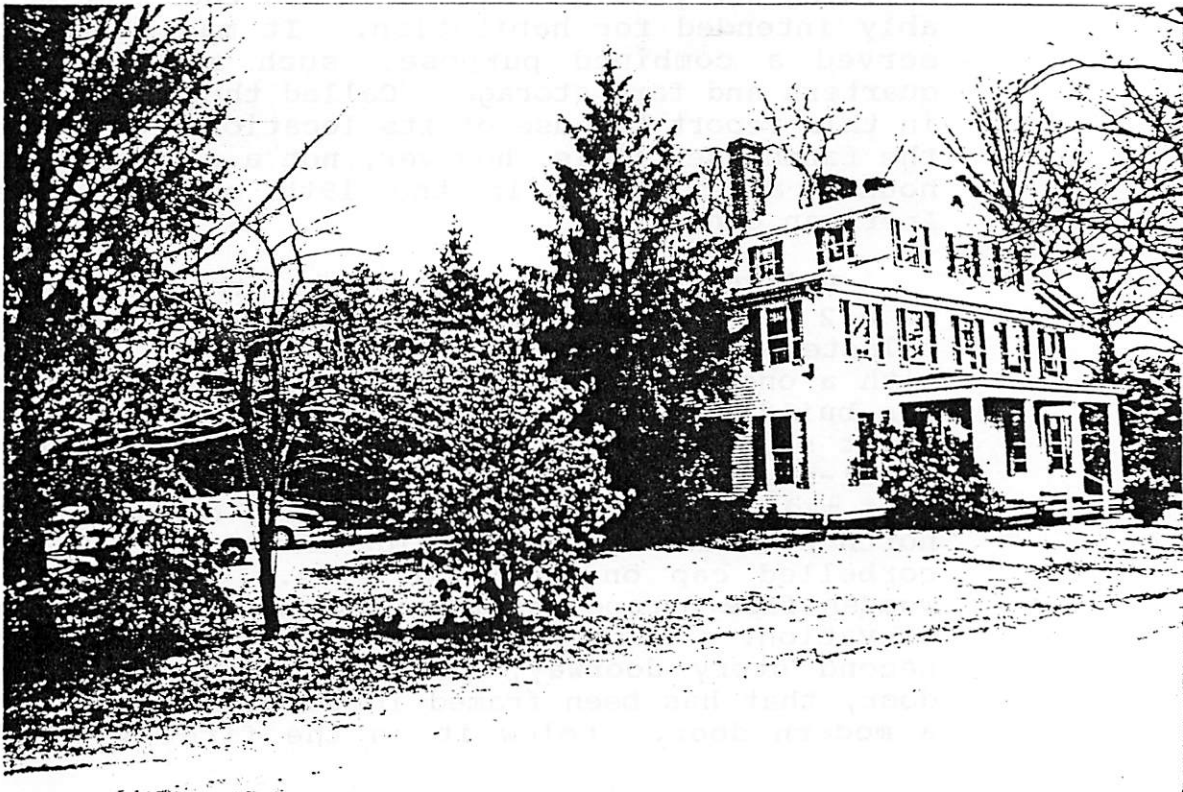
B. North side and facade of farmhouse, looking southeast

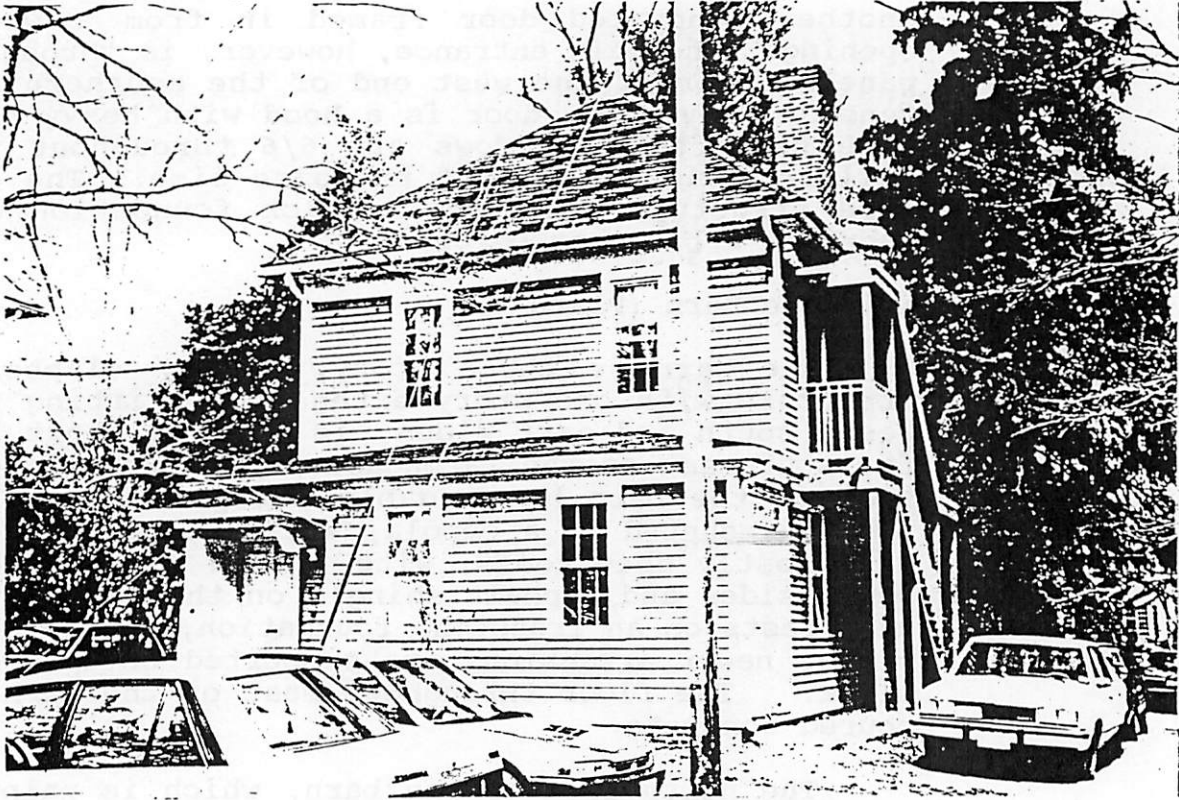
another renovated door framed in from a wider opening. The main entrance, however, is through a paneled door at the west end of the southern extension. Over the door is a hood with heavy console supports. Windows are 6/6 throughout the building, but not all of the same size. The entire structure rests on a brick foundation and there is a basement below.

A. South side of back house, looking north

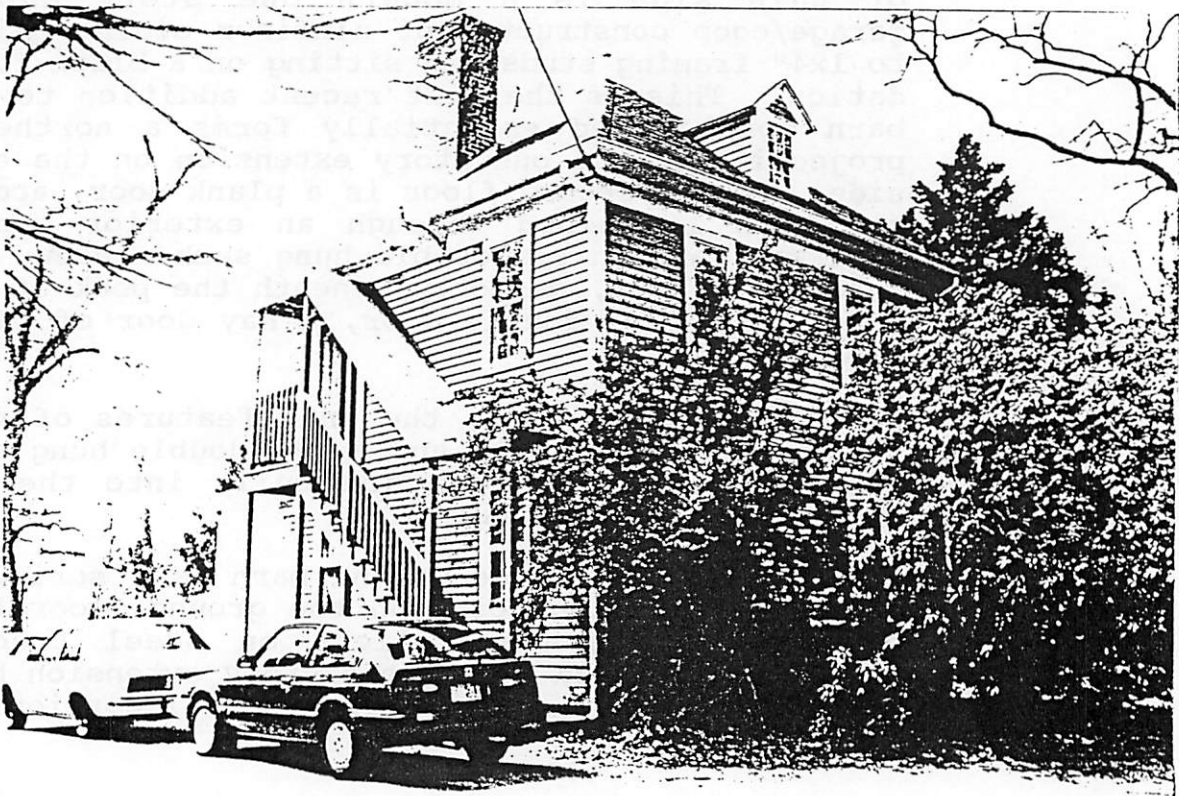
B. North and east sides of back house, looking southwest

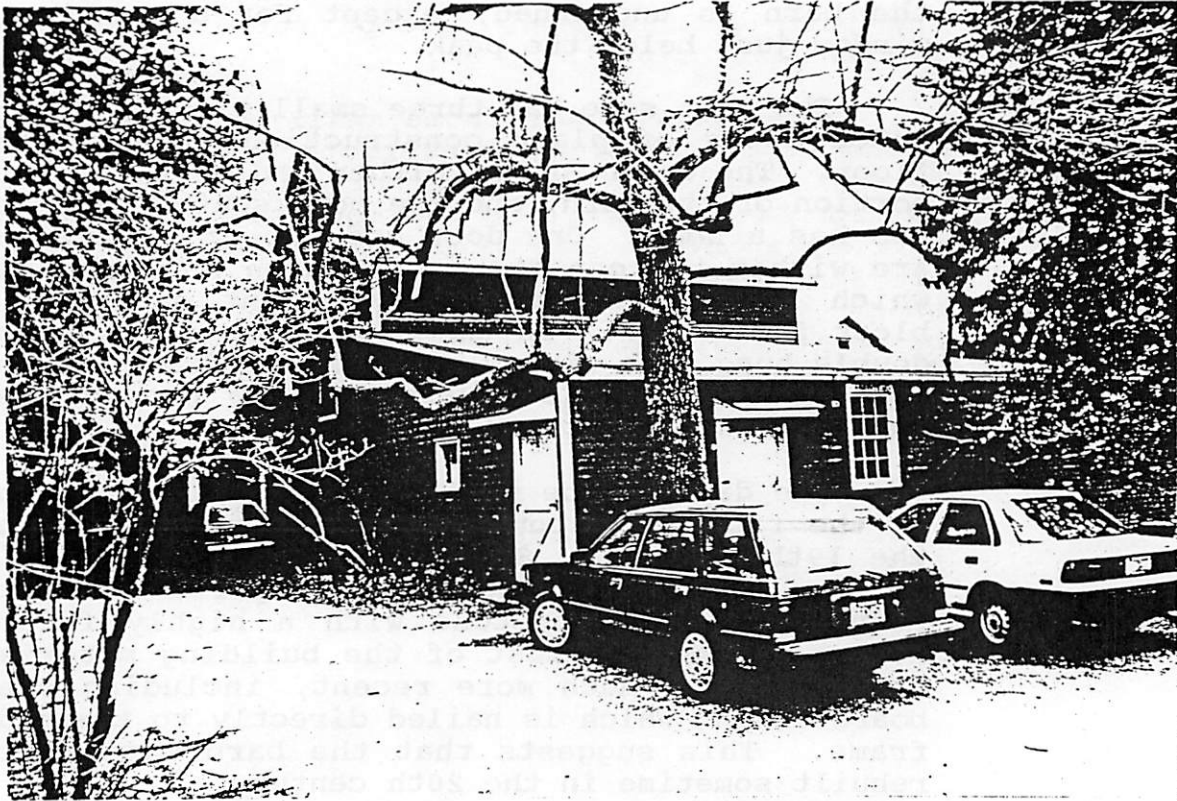
The barn, a three story, frame, clapboard structure with one story extensions skirting the west, south and east sides, is located about 125 ft. southeast of the farmhouse. The central portion of the barn has a gabled, asphalt shingled roof surmounted by a cupola, while the extensions have mostly shed roofs, with tin on the west and south sides and asphalt shingle on the east. The barn rests on an ironstone foundation, though some of the newer extensions are supported on concrete block. The floor throughout most of the barn is poured concrete.

The north face of the barn, which is painted red with white trim, has three small windows (two four-light windows and one six-light) and a door with a hood on the first floor. The door is at the northwest corner and gives access to the one story extension. Projecting out from the east end of this side is a modern one story gabled garage/coop constructed of aluminum siding nailed to 1x4" framing studs and sitting on a block foundation. This is the most recent addition to the barn complex and essentially forms a northerly projection of the one story extension on the east side. On the second floor is a plank door, access to which is gained through an exterior wooden stairway, and an 8/8 double hung sash window. On the third floor, directly beneath the peak of the gable is a wide double door, a hay door of plank construction.

On the west side, the only features of note are a door with a hood and a 6/6 double hung sash window. Both of these are built into the one story extension on this side.

A. North and west sides of barn, looking east southeast

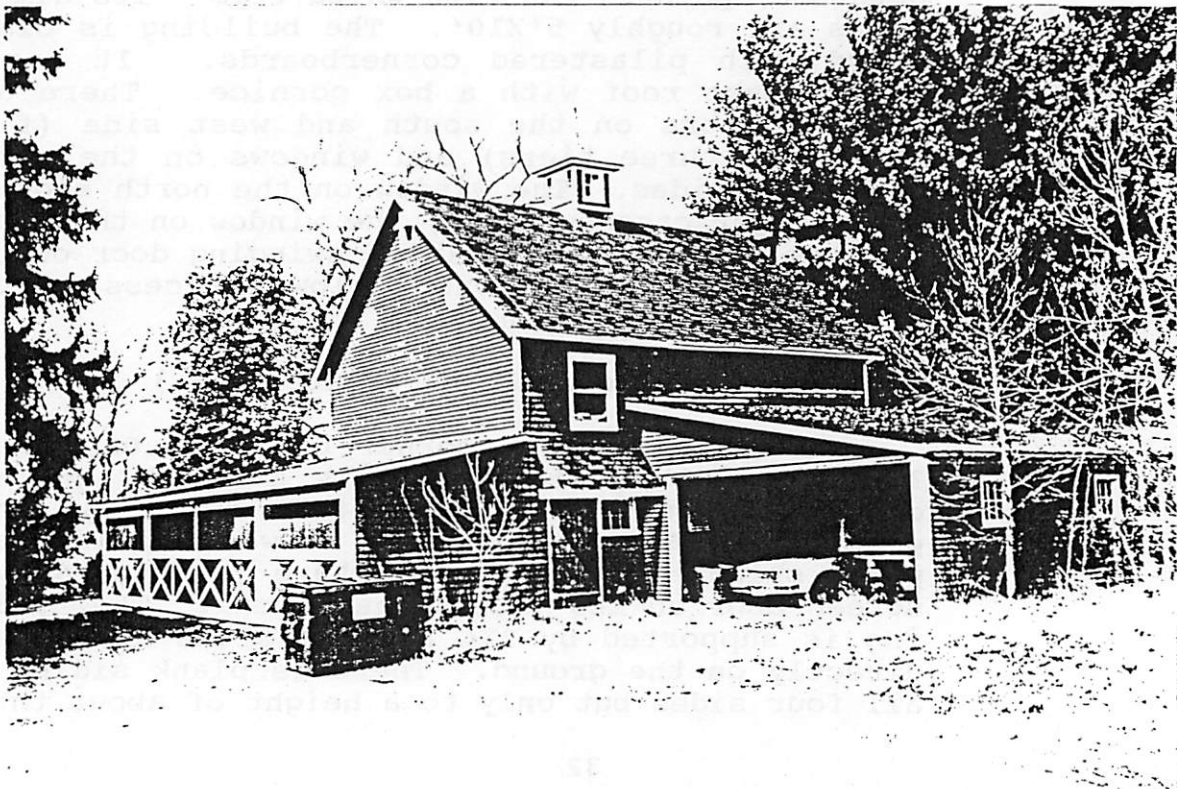
On the south side of the barn is a series of four broad sliding doors on the ground floor that operate by means of rollers on steel tracks. These are attached to the one story extension here and are obviously modern. The central portion of

the barn is unadorned, except for a small vent window just below the peak.

The east side has three small windows and two dutch doors of plank construction on the first floor. The doors are at either end of the central portion of the barn, and the more southerly of the two has a hood. One door and two of the windows are within the one story extension on this side, which is another relatively recent garage on a block foundation. On the second floor is an 8/1 double hung sash window near the southeast corner. The cupola above is square, with a hipped roof, and has a 2/2 window on each side.

The date of the barn is unknown, but elements of the fabric and construction technique indicate the 19th century. Some of the exterior framing members are pegged together and portions of the foundation are ironstone with a highly friable mortar. However, most of the building materials are obviously much more recent, including clapboard siding which is nailed directly to the older frame. This suggests that the barn was largely rebuilt sometime in the 20th century.

B. South and east sides of barn, looking northeast

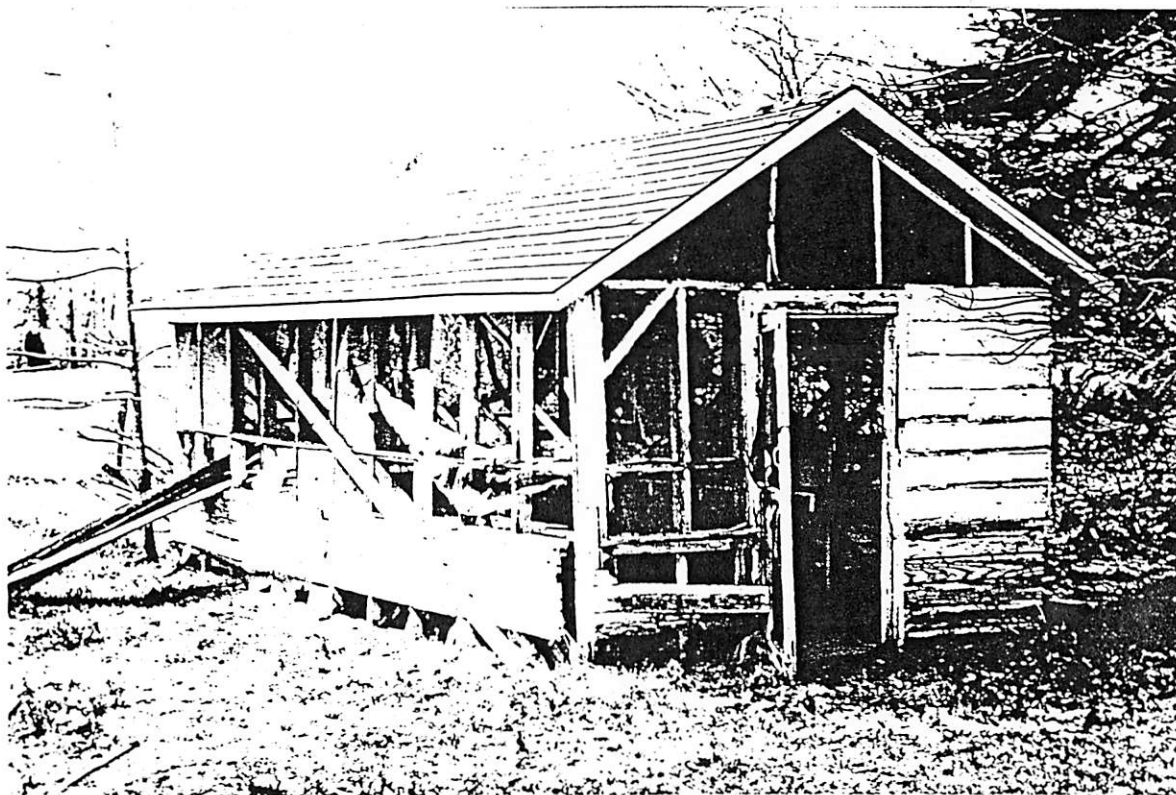
#### v. The Screened Building (Plate VI.B.)

At the southeast corner of lot 1.02, about 300 ft. south of the barn, is a small, gabled, open sided building of uncertain function. Approximately 8'X20' and built of wood with an asphalt shingle roof, the structure is entered by a screen door on its (north) gable end. The building is supported by 2X4 framing studs which rest directly on the ground. There is plank siding on all four sides but only to a height of about three

B. Screened building, looking southwest

ft. Above the plank siding is wire screening, nailed directly to the studs. The floor is poured cement and the interior is unappointed but for wide benches along three sides and a plain corner cupboard next to the door. There is a water line nearby and the structure may have served as a potting shed or summer greenhouse. It is made entirely of modern materials.

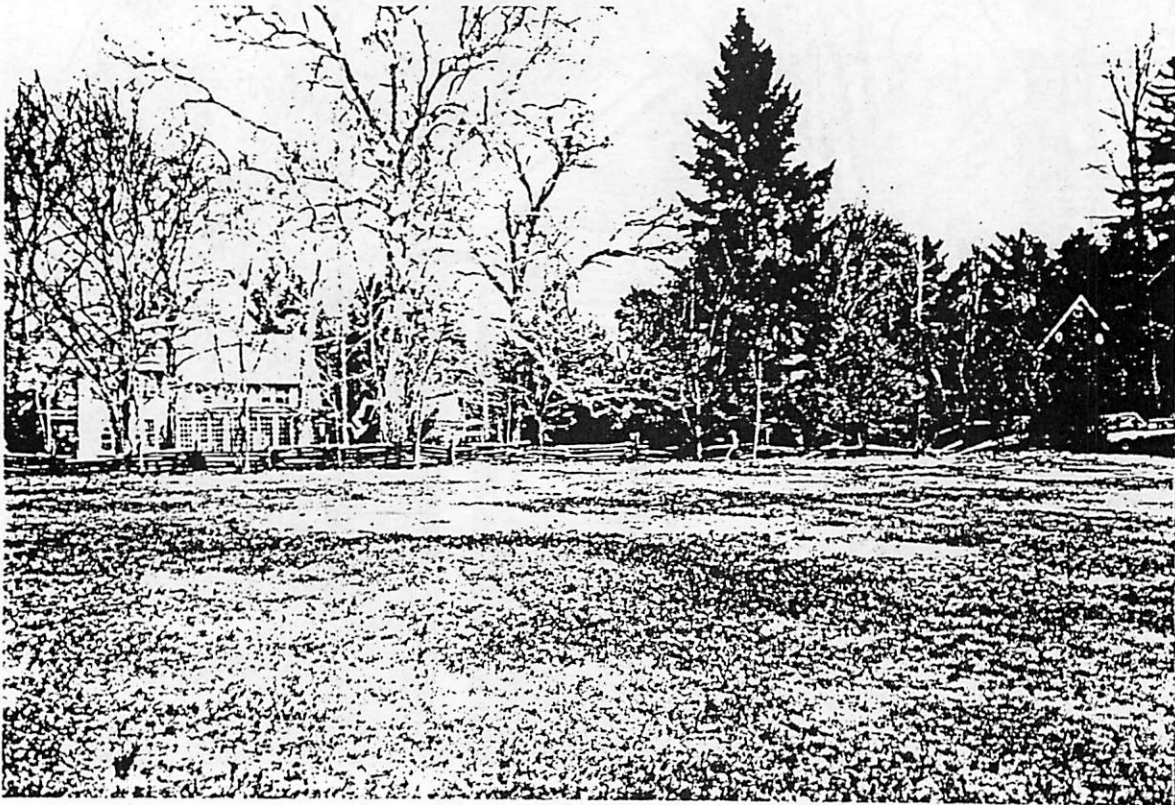
Main farmstead buildings, looking north from lot 1.02;  
farmhouse on left, back house in left center, barn on right  
(outhouse obscured by vegetation)

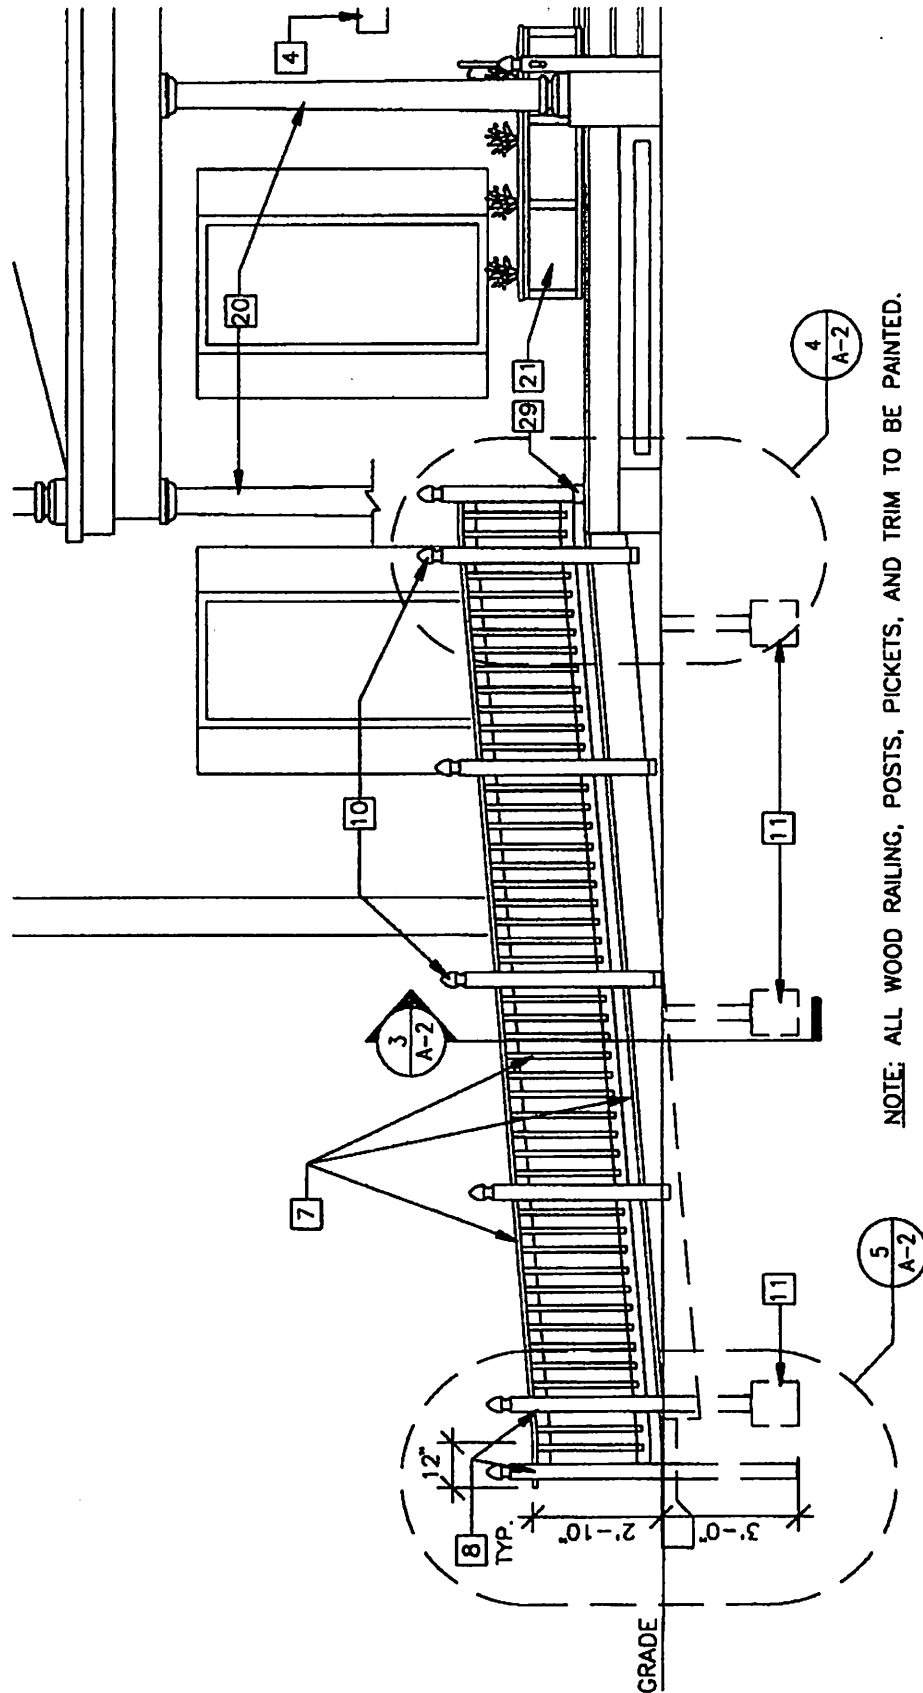
1  
A-2

# FRONT ELEVATION

- 27 NEW 2 X 4 WOOD TOP RAIL, ANCHOR HANDRAILS TO RAILING.
- 28 NEW METAL POST BASE PLATE AND ANCHOR.
- 29 NEW METAL POST ANCHOR. BOLT TO EXISTING PORCH.

- 30 SINK POST 3'-0" MINIMUM BELOW GRADE.
