A Cultural Resource Survey of "Fenwick Manor,"  
Block 846, Lots 1.01 and 1.02, 15 Springfield Road,  
Pemberton Township, Burlington County, NJ

Pinelands Development Application No. 85-0426.02

Barry J. Brady, Ph.D., SOPA - Principal Investigator  
NJ Pinelands Commission  
P.O. Box 7  
New Lisbon, NJ 08064

February, 1992

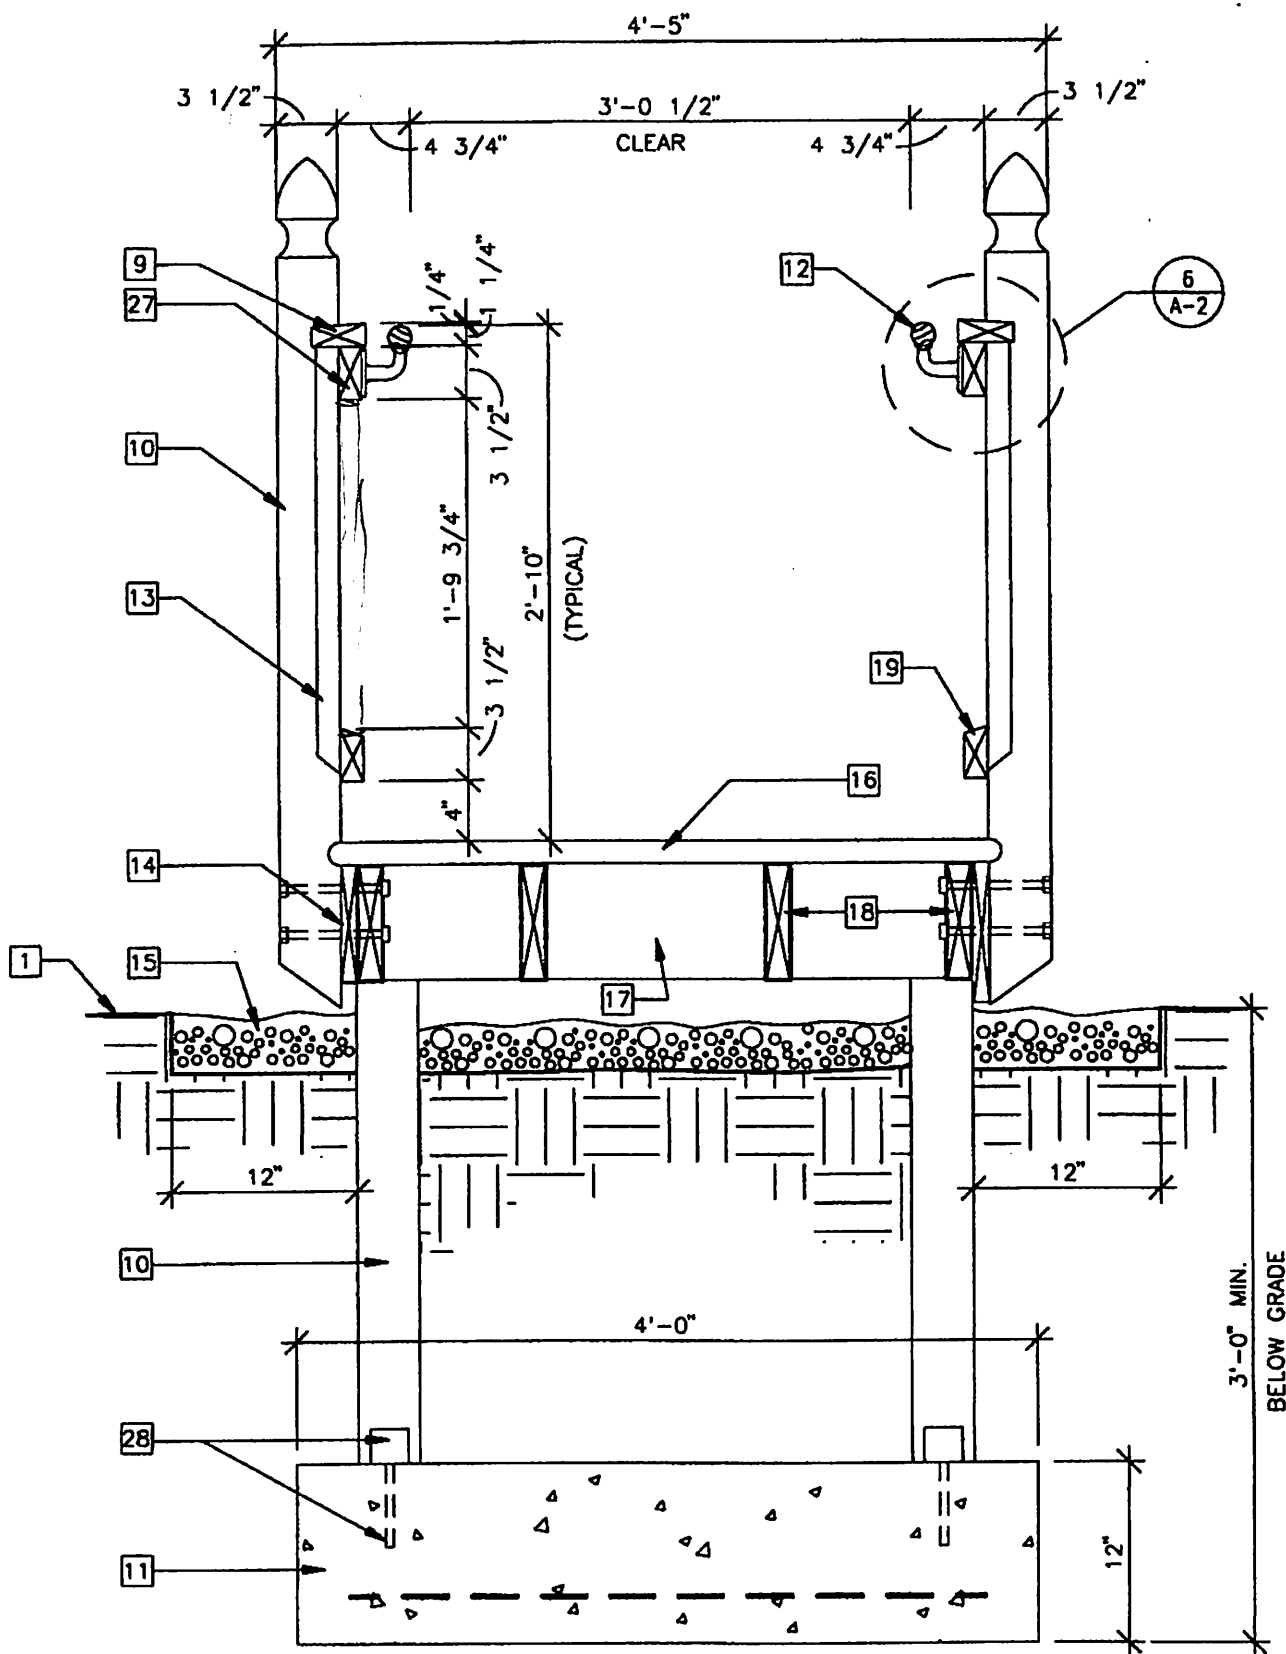
3  
A-2

SECTION @ RAMP
