SCOPE OF WORK

Proposed Southern Region Medical Examiner's Office

TLC Building on Vineland Developmental Center West Campus
Vineland, Cumberland County, NJ

Project No. M1619-00

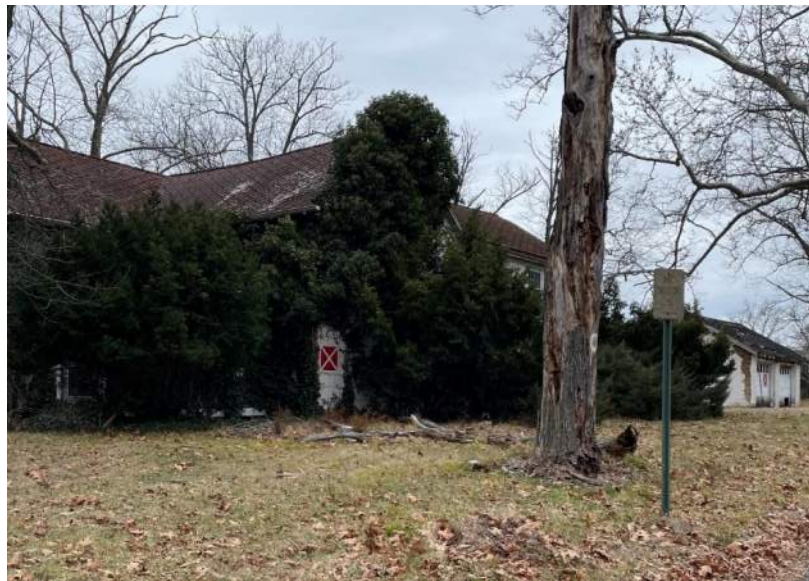
Figure 2.1: Wood Frame House

The existing wood frame house, garage, playgrounds, and wooden sheds will all need to be completely removed.

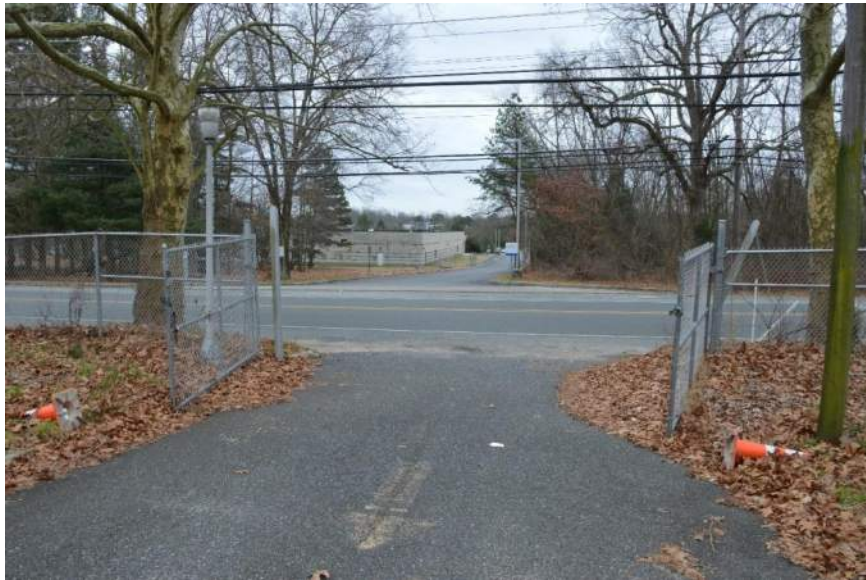
Figure 2.5: Entrance Gate

There is an existing fencing around the original Block 2101 Lot 53 which is in a fair condition. There are sections of fencing where the barbed wire is damaged or missing. The entrance and exist gates are both double-swing chain link gates which need to manually opened/closed and locked.

Additional fencing would be required to enclose Lot 53.02. Motorized gates with controlled access should be considered. New fencing is required to provide a secure fenced in area with gates for the 55' storage trailers area.

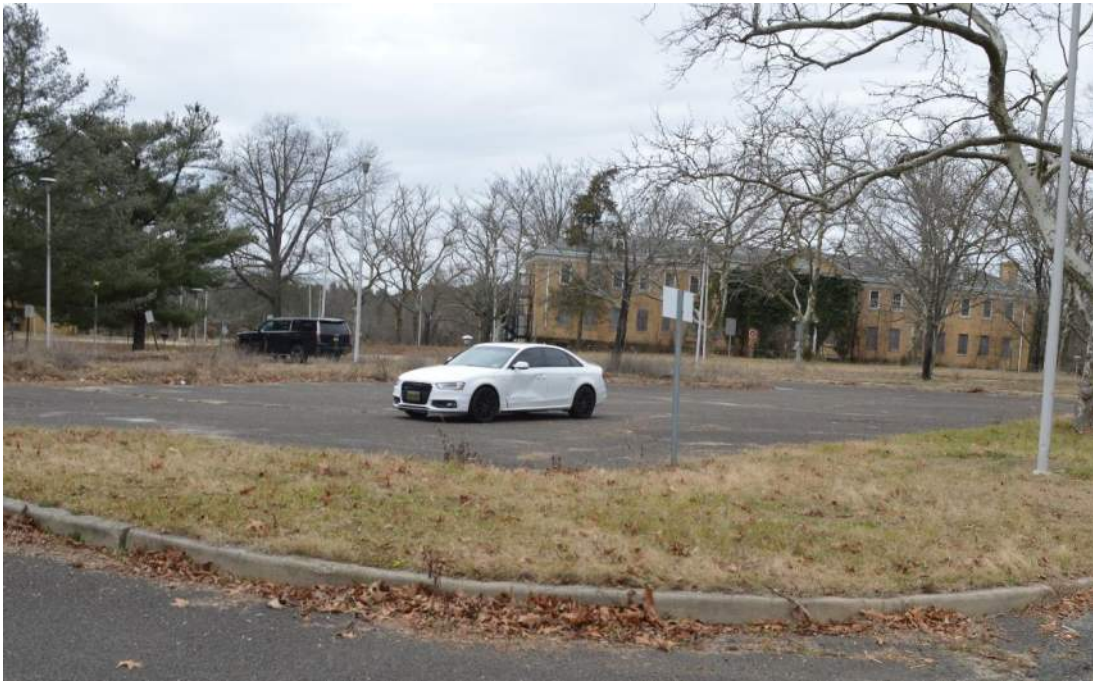
Figure 2.6: Parking Lot (32 Spaces)

The project demands a significant increase in parking. There is a need for employee and visitor parking totaling (50) cars plus at least two (2) ADA parking spaces. A separate area is needed for six (6) funeral home vehicles and five (5) 16' box trucks. There are (20) 55' storage trailers which will need to be stored on site. These trailers are used for off-site refrigerated body storage. The limited onsite space requires the trailers to be parked in a manner which will block access to the trailers in the back.

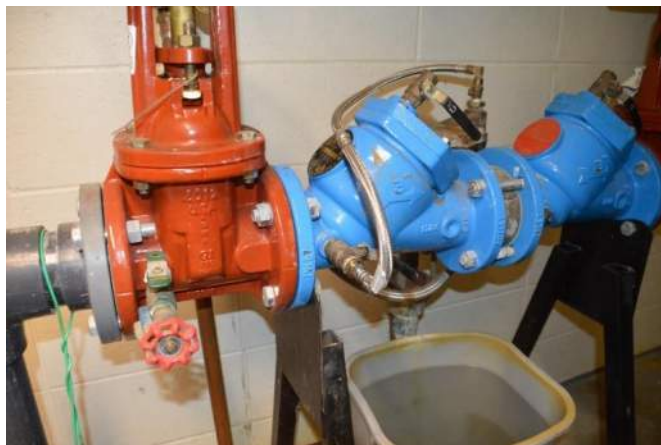
Figure 2.8: Domestic Water Into Building

The existing domestic water, fire protection supply line, natural gas piping, and sanitary connections have remained in service and would be suitable for the building's proposed use.

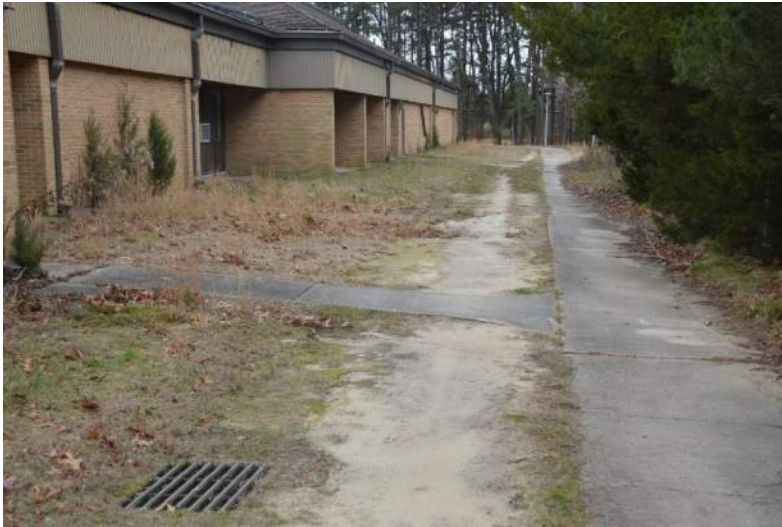
The existing stormwater system consists of a network of cast iron inlets and reinforced concrete pipes which drain into an on-site infiltration basin. The building's roof leaders drain to the surface with the water directed towards one of the several catch basins surrounding the building. Inlets also collect the stormwater from the parking areas and roadways. Several inlets are damaged but no apparent issues with the stormwater piping.

Figure 2.9: Roof Leaders and Inlets Around Building

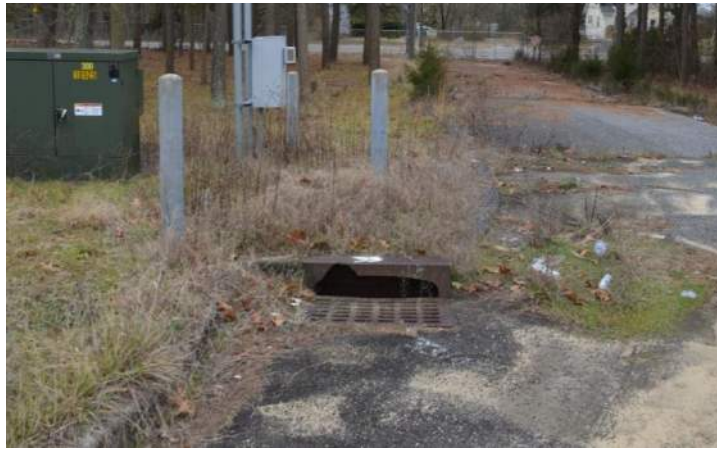
Figure 2.11: Example of Damaged Inlet

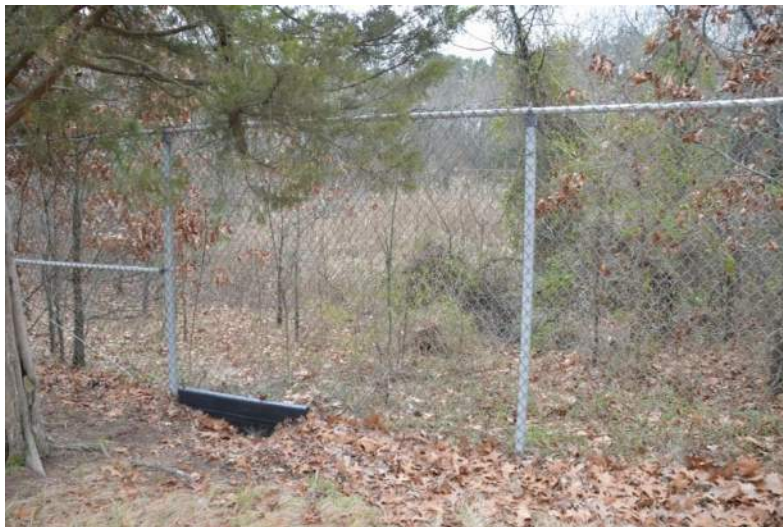
The infiltration basin has been left unmaintained and trees and brush have established within it. Based on the vegetation observed, the basin may now even be delineated as wetlands. Additionally, while not included in the scope of work for this study, it is recommended that it be reviewed to determine if any area will be classified as wetlands within the boundary of the site.

Figure 2.12: Unmaintained Infiltration Basin

An existing retention basin is identified in the Feasibility Study and may require expansion, as contingent on adding impervious surfaces. The Consultant shall evaluate surfaces considered pervious, or semi-pervious, for the exterior Mass Casualty trailers. There is reference in the Feasibility Study to evaluate overgrowth within the existing retention area. If necessary, expand the existing retention basin or augment with a new storm water management design, with detention, infiltration, and water quality measures incorporated if required. Storm water management measures for water quality for the project shall meet the requirements of N.J.A.C.7:8 Storm Water Management. Where possible and beneficial, utilization of pervious surfaces shall be a consideration. The playground surface may be removed.

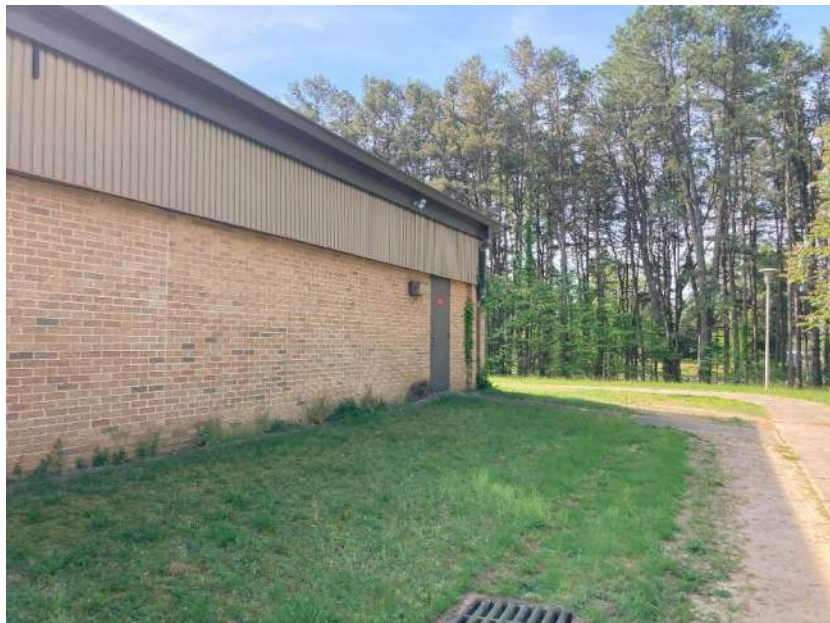
The typical exterior façade of the building is made up of multiple materials. A brick veneer commences at grade and terminates at approximately 7'-0" above grade. The façade transitions from brick to a painted metal panel at approximately 7'-0" above grade and terminates at approximately 11'-0" above grade. An approximate 1'-0" high painted metal fascia completes the composition of the façade and terminates approximately 12'-0" above grade at the underside of the existing roof overhang (See figure 3.1).

Figure 3.1 Typical elevation

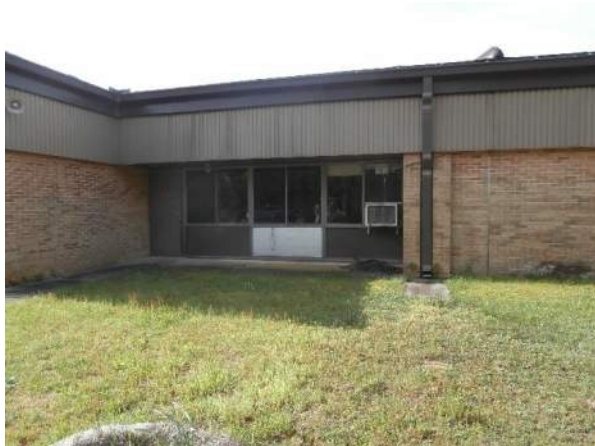
The typical façade assembly outlined above is broken up throughout with portions of painted metal framing walls that include painted metal infill panels along the bottom third of the wall. The remainder of the wall consists of glazed infill panels within the painted metal framing. Solid painted metal access doors are also located within these portions of walls that enclose the previous classrooms and Arts & Crafts uses. This wall assembly commences at grade and terminates at the underside of the painted metal wall panel that is consistent with the typical façade assembly (See figure 3.2 & 3.3).

Figure 3.2 Window wall elevation

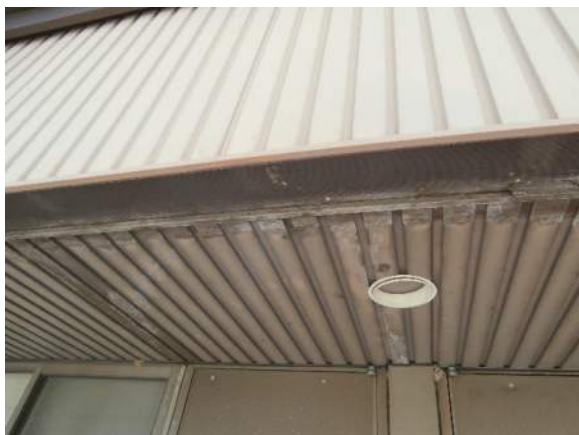
Figure 3.4 Metal soffit ceiling

The glass and metal panel portions of the façade are recessed into the building and have a painted metal soffit ceiling with recessed light fixtures (See figure 3.4). Along the south façade at the existing Trash Room the recessed area has a painted plaster ceiling (See figure 3.5). The primary entrance vestibule is located along a portion of the north façade. Pairs of aluminum and glass frame doors along with aluminum framed glass walls provide the makeup of the assembly of the primary vestibule. Four (4) secondary vestibules are located at the north, south, and east elevations. The north and east elevation each have one secondary vestibule while the south elevation has two. The construction of the secondary vestibules consists of brick veneer walls, aluminum and glass framed entrances with pairs of aluminum and glass doors (See figure 3.6).

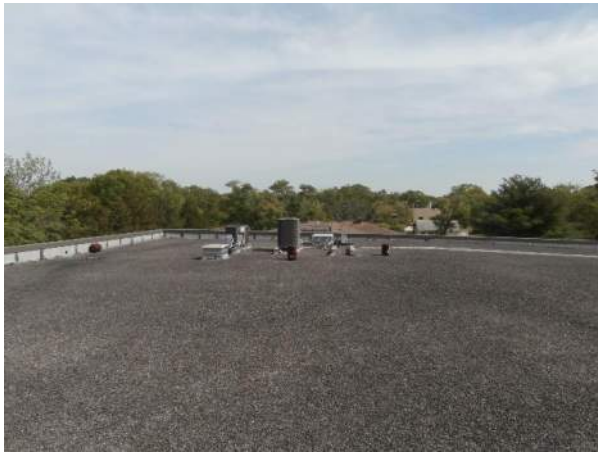
The existing roof systems on TLC include a flat built-up roofing system and a steep sloped asphalt/fiberglass shingle roof system (See figure 3.7 & 3.8). Based on the review of owner supplied documents both systems were replaced in 2002. The existing flat roof system is only located in a portion of roof area above the existing Gymnasium space and can be accessed via a roof hatch that is accessed by a caged ladder within the existing Stage Area (See figure 3.9). All other roof areas have a steep sloped asphalt/fiberglass roof system. Continuous painted aluminum gutters are located along the entire perimeter edge of the building with painted aluminum rainwater leaders to handle the rainwater that drains from the steep sloped roof system. The existing flat roof system drains via four (4) 5" diameter roof drains that are equally distributed along the east and west edge of the roof. Two (2) overflow through wall scuppers, one on the east and one on the west edge of the roof, are provided should the primary roof drains not function and the overflow scuppers distribute the rainwater from the flat roof to the steep sloped roof areas (See figure 3.10).

Figure 3.7 Typical flat built up roof

Replace the entire roof (sloped and flat) with new roofing materials. Sheathing, sub-straight, etc. shall be evaluated and replaced where damaged.

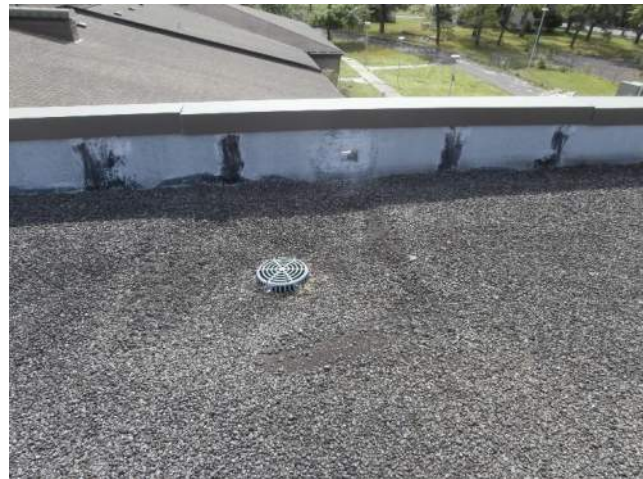
Figure 3.10 Typical roof drain and overflow

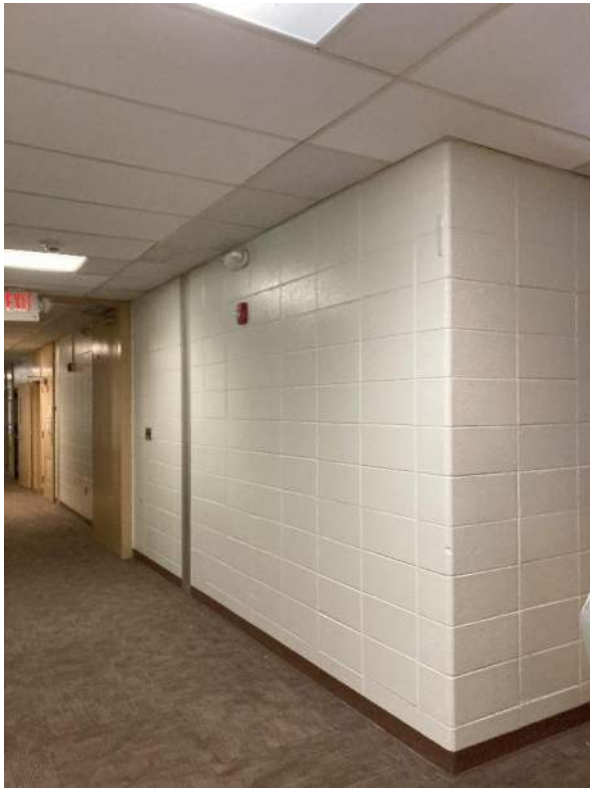
Figure 3.11 Typical CMU wall

The interior finishes and partition types vary based on the programmatic function of each space. Most of the existing partitions that were observed in the field and reviewed on the owner supplied documents consisted of painted concrete masonry units (CMU) (See figure 3.11). Additionally, there are existing partitions that are used at the office and conference room spaces in the east wing that are constructed of metal studs with 2" sound attenuation blankets with $\frac{3}{4}$ " plaster over metal lath (See figure 3.12). Refer to Exhibit C. The existing partitions in the toilet rooms are constructed of CMU with wall tile finish from floor to ceiling.

Given that the existing building has been off-line for more than (10) ten years the interior materials and finishes have experienced damage. Furthermore, many of the interior finishes are dated given that it appears most of the finishes are original. The change of use code requirements will also require that the interior materials be upgraded as needed to meet the code requirements for interior finishes. It is recommended that all interior wall, floor, and ceiling finish systems be replaced.

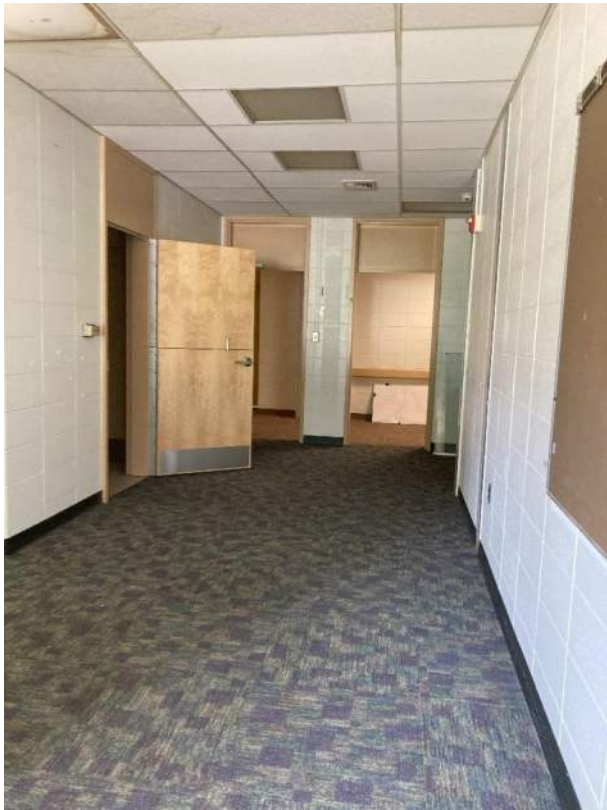
Figure 3.13 Carpet flooring

Existing floor finishes observed throughout the building include carpet tile (See figure 3.13), porcelain floor tile (See figure 3.14), and vinyl composite tile (VCT). VCT was used primarily in classrooms, multipurpose rooms, storage rooms, and building support spaces (See figure 3.15 & 3.16). Carpet tile was found throughout the offices, conference room, lobby and corridors within the north, south, and east wing. The existing gymnasium space has a wood plank floor system (See figure 3.17). A resilient wall base was used throughout the building apart from toilet rooms, which utilized a tile cove wall base that matched the floor tile.

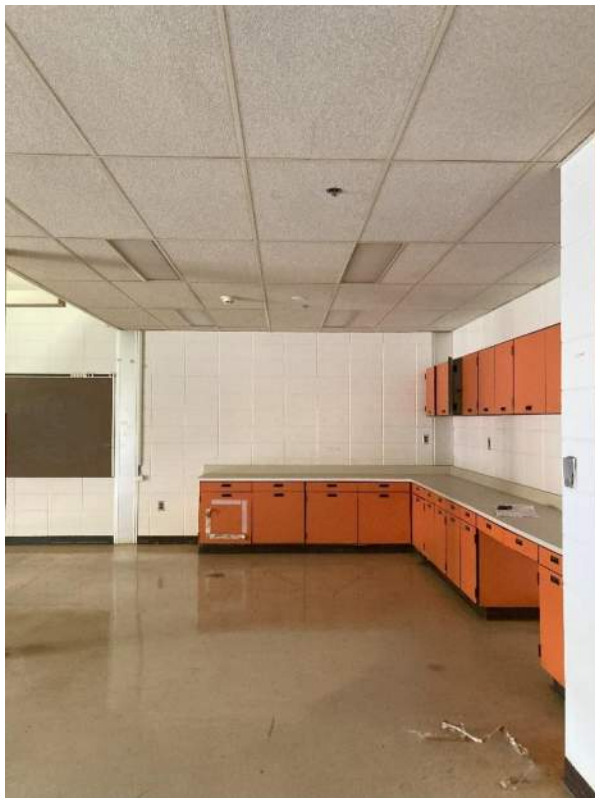
Figure 3.18 ACT ceiling

Existing ceiling systems were consistent throughout with the system comprising of a suspended ceiling grid with acoustical ceiling tiles (ACT) used the ceiling grid. The ACT panels appear to be a standard 2'-0" by 4'-0" panel throughout (See figure 3.18 & 3.19). In addition to the ACT ceiling system, painted gypsum board soffits are found within the existing classroom spaces.

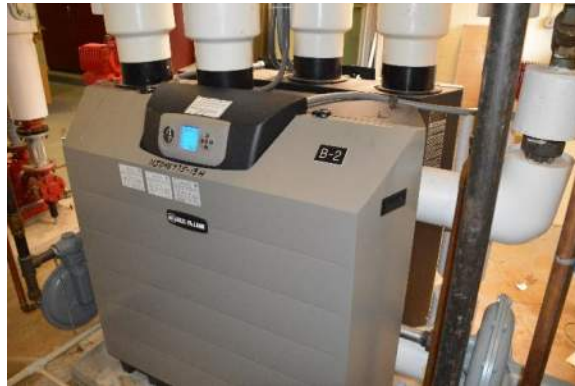
Heating for the building is provided by three gas-fired, heating hot water condensing boilers. The heating system consists of the boilers, two hot water circulating pumps, an air separator, an expansion tank, a chemical pot feeder and associated hot water piping distribution system and peripheral heating elements such as fan coil units, duct mounted hot water heating coils, finned tube radiators and convectors.

Figure 4.1 Existing gas-fired, heating hot water condensing boilers

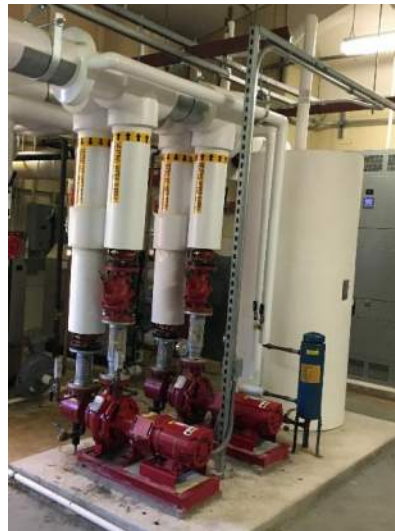
Figure 4.2 Existing two hot water circulating pumps, an expansion tank and a chemical pot feeder

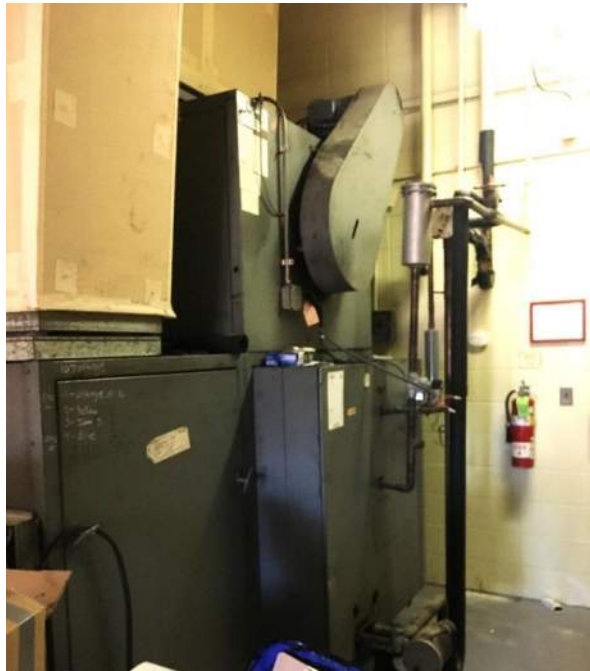
Air conditioning and ventilation for multiple spaces in the building is provided by five air handling units and associated roof mounted condensing units, multiple unit ventilators and

Figure 4.3 Existing air handling unit in Mechanical Equipment Room 129

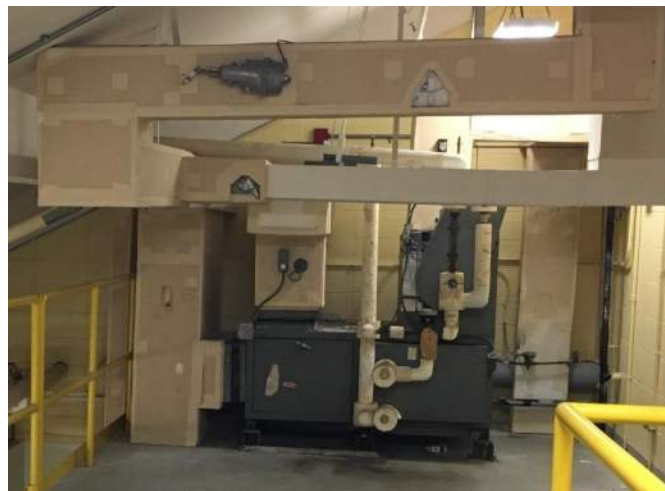
Figure 4.4 Existing air handling unit in the Mezzanine

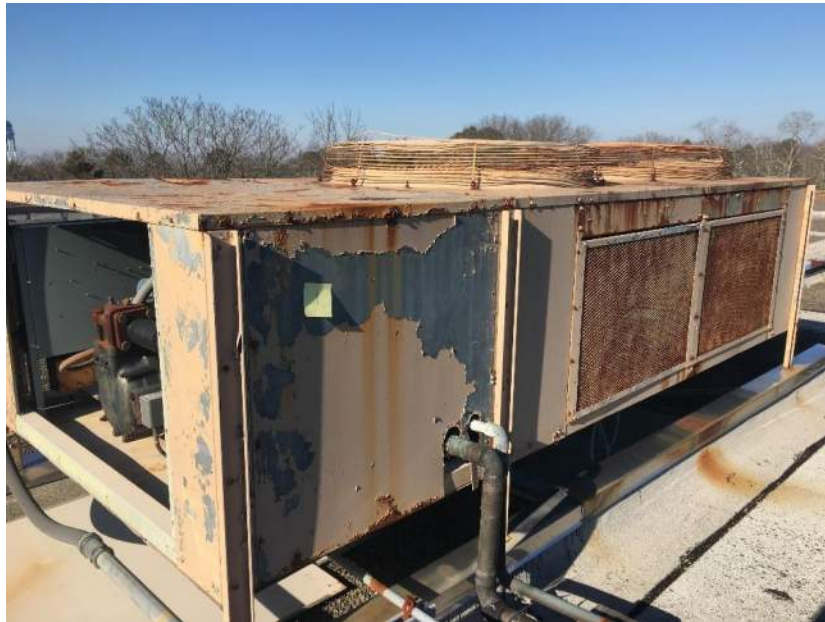
Figure 4.5 Existing roof mounted condensing unit

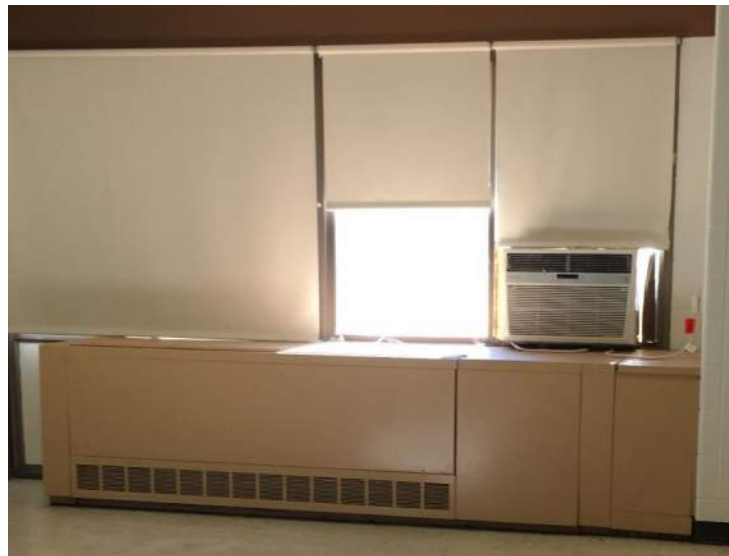
window type air conditioning units. Only two rooms have individual ductless split system heat pumps.

Figure 4.6 Existing unit ventilator and window type air conditioning unit

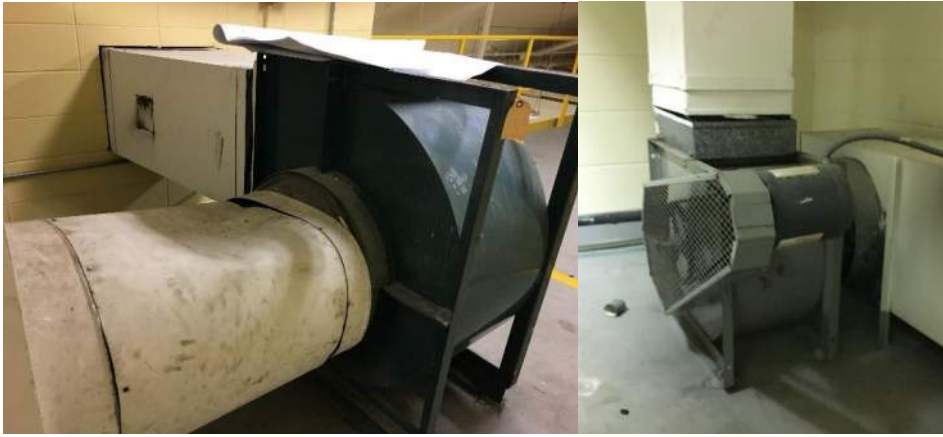
Thirteen space mounted fans exhaust air from the gymnasium, multiple restrooms, and the kitchen to outdoors. The air distribution system consists of supply, return and exhaust ducts and air distribution devices.

Figure 4.7 Existing space mounted exhaust fans

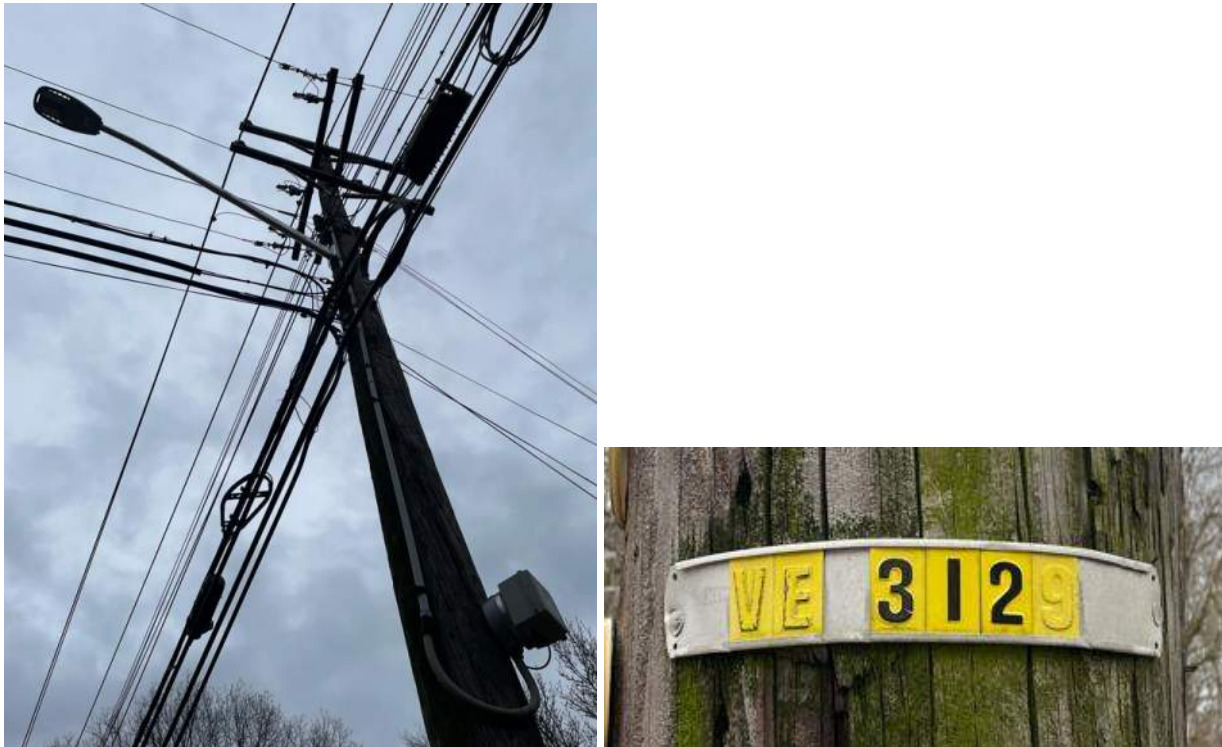
The electrical service for the building comes from a medium voltage pole #VE 3129 located across Almond Rd.

Figure 5.1 - Utility Pole #VE 3129

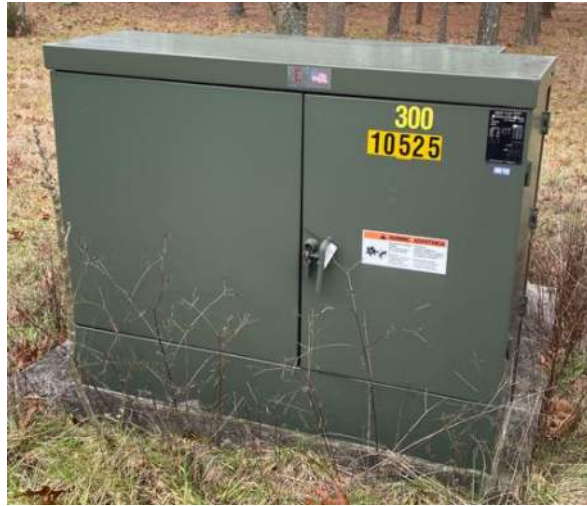
There is another pole within the fence, #VE 10082 where the medium voltage cable continues underground to a 300kVA transformer bringing the voltage down to 208/120V.

Figure 5.2 - 300kVA Transformer

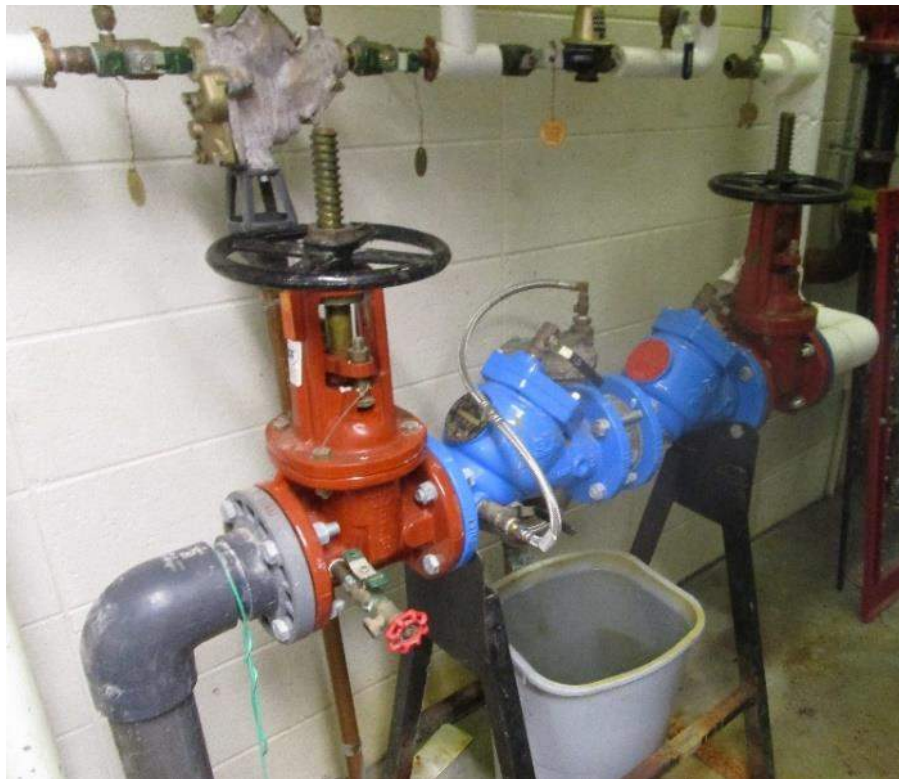
Figure 6.1 - PRZ Backflow Preventer

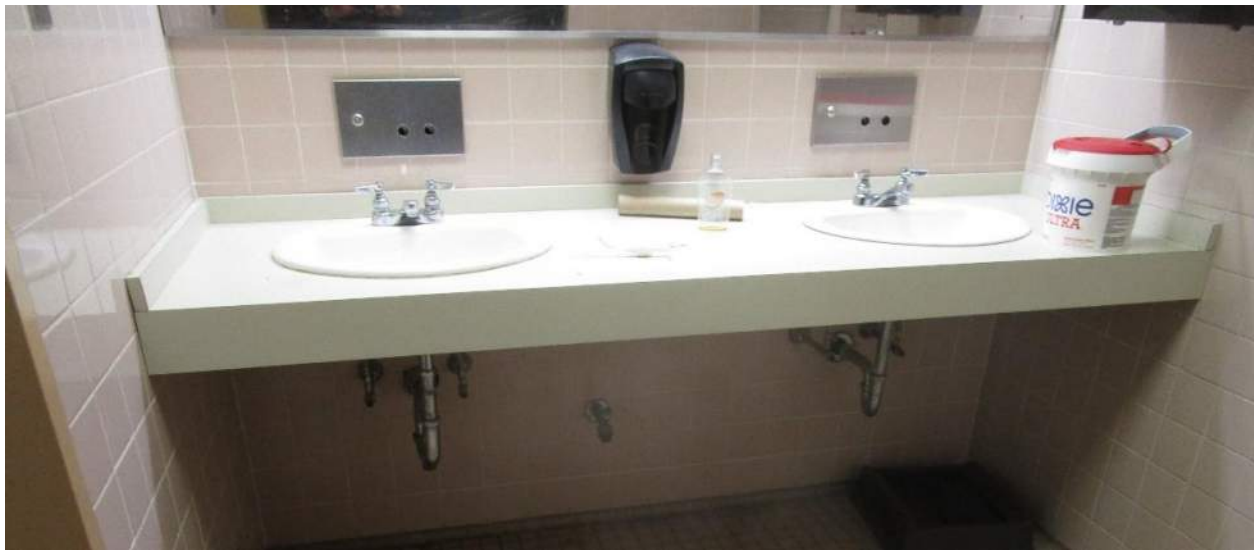
Figure 6.2 - Plumbing Fixtures, Lavatories

There is a 3 " Domestic water service with a RPZ backflow preventer (Figure 6.1) in the Mechanical Equipment Room. Hot and cold-water piping is distributed to the plumbing fixtures throughout the building. The plumbing fixtures are in satisfactory condition (Figures 6.2 to 6.8). The electric water heater (120 gal, 36 kW) is in good condition (Figure 6.9). Based on as-built drawing P-2 (Oct 1977), there is a buried 5" sanitary line that connect to the site

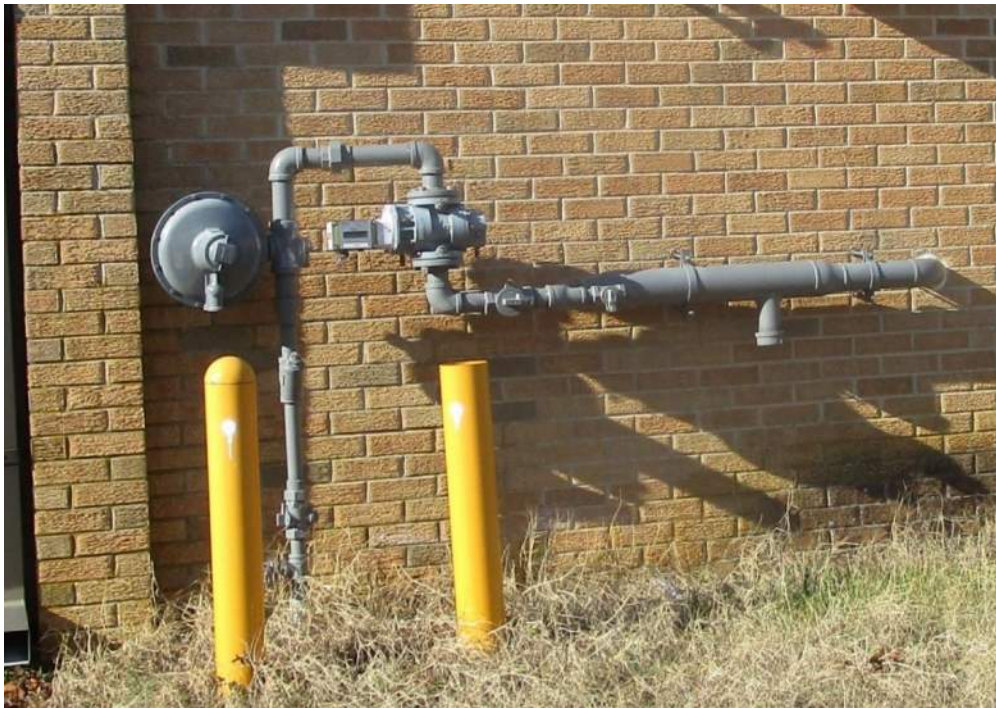
utilities on the north east side of the building. There is a 3" natural gas service in the Mechanical Room that supplies the boilers. The gas meter is located on the south east side of the building (Figure 6.10). There are roof drains in the flat roof above the Gymnasium (Figure 6.11). Based on as-built drawing P-2 (Oct 1977), the 8" storm leaders connect to the site system on the west side on the building.

Figure 6.10 - Natural Gas Meter and Regulator

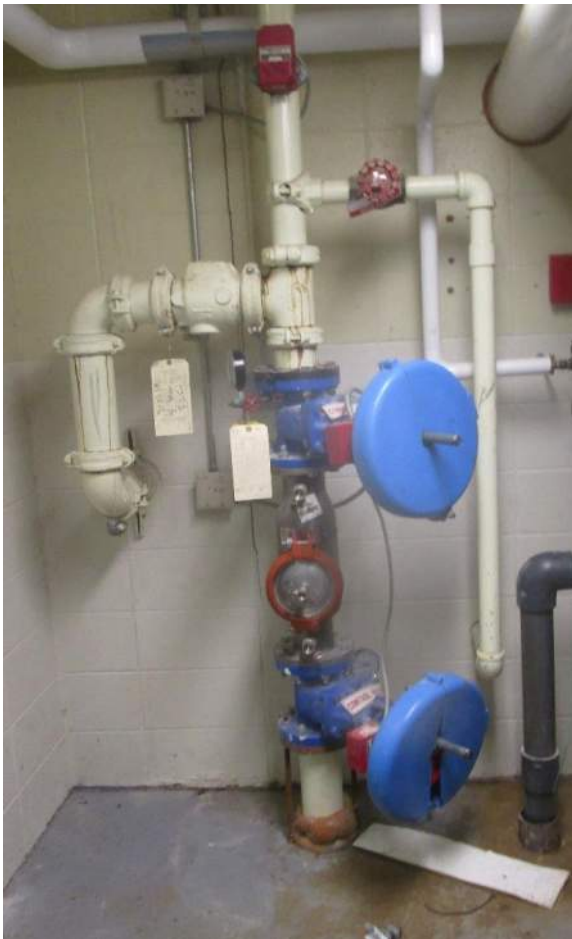
The TLC has a 4" fire service with a backflow preventer in the Mechanical Equipment room (figure 7.1). As indicated on the pressure gages, the static pressure is 50 psi (figure 7.2). The fire service supplies a limited area sprinkler system (figure 7.3) and a class II standpipe system. There are sprinklers in the Gymnasium stage and the Mezzanines that are adjacent to the Gymnasium. There is a Fire Department connection near entrance on the south side of the building (figure 7.4).

Figure 7.1 - Fire Protection Backflow Preventer Gage

Consistent with the Change of Use evaluation, the structure shall be fully sprinklered. Although the Feasibility Study refers to a Fire Pump and Fire Pump Room, it shall be noted that no flow testing (residual and static) was done to verify/validate the need for a fire pump. The agency (DOH) will be securing a flow test from the nearest hydrant for use by the Design Consultant to determine if a fire pump and/or an upgraded fire service line (from the street to the facility) is required based upon a fully sprinklered building, and as the basis of design.

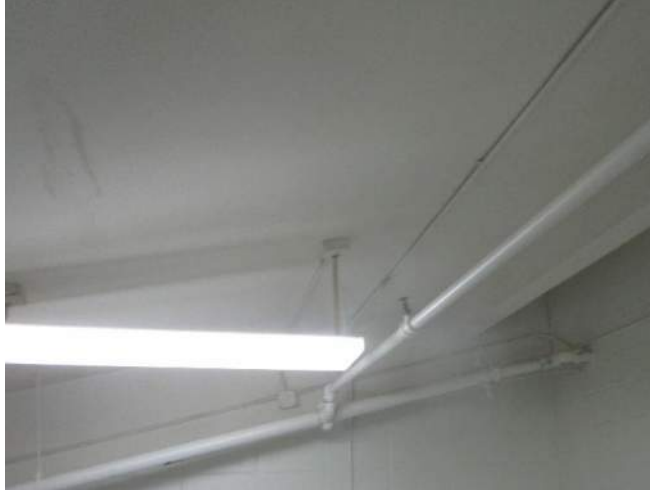
Figure 7.3 - Sprinkler Piping

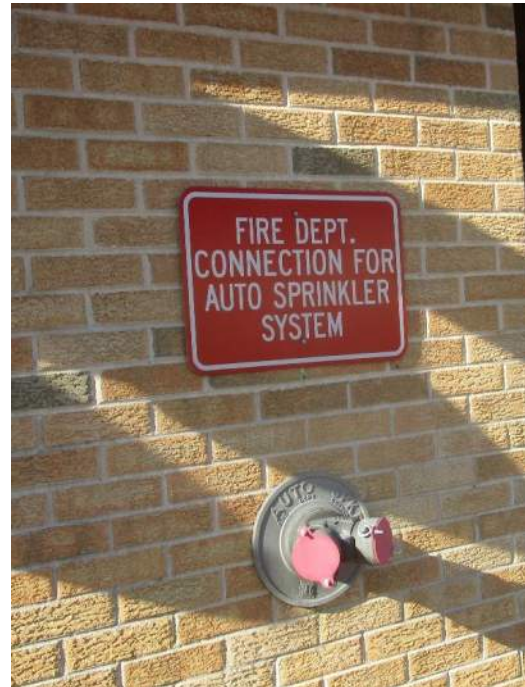
Figure 7.4 - Fire Department Connection

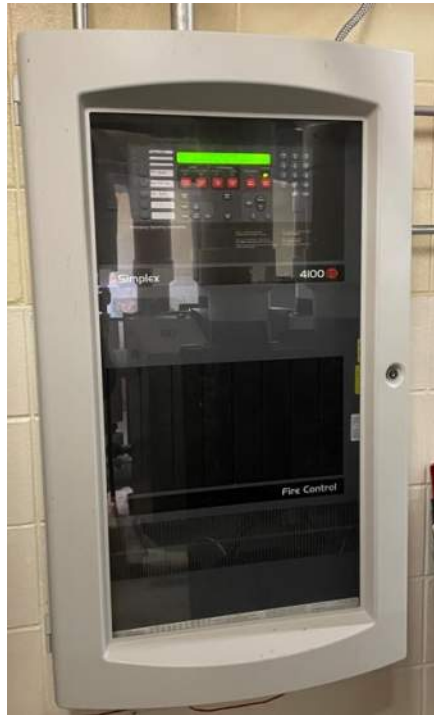
There is an existing Fire Alarm system in the building. The main control panel is located in the mechanical room next to the electrical equipment. It is a digital addressable system in relatively good condition, including all existing devices including speaker/strobes, detectors, pull stations, etc.

Figure 8.1 - Main Fire Alarm Control Panel

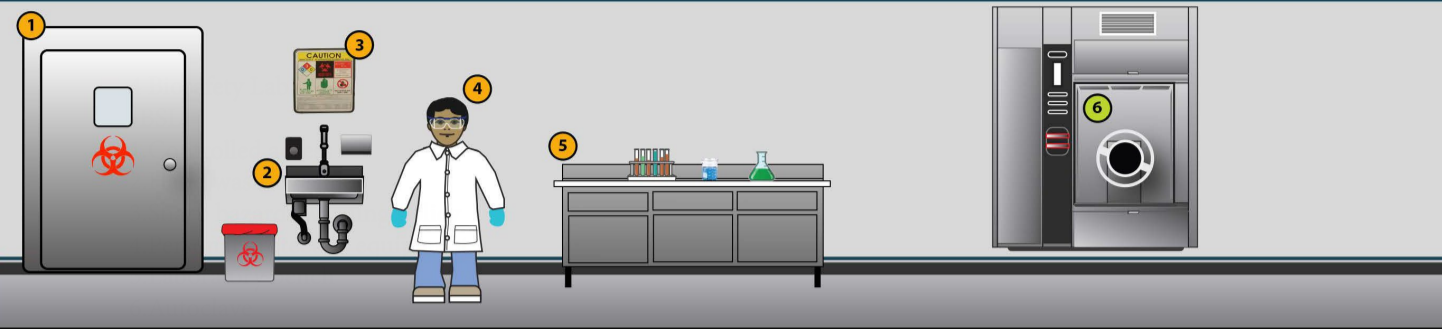
BSL 2

- 1 controlled access
- 2 hand washing sink
- 3 sharp hazards warning policy
- 4 physical containment device
- 5 personal protective equipment
- 6 laboratory bench
- 7 autoclave
