## DEP TAKES ACTION TO REMOVE UNSAFE DAM

Brisbane Lake Dam is located in Wall Township, Monmouth County, New Jersey. The lake and dam are located within the Allaire State Park. Traversing the crest of the dam is County Route 524. The dam is an earthen embankment dam approximately 18 feet high and 200 feet long. The lake impounded by the dam is approximately 7 acres in size. The spillway is a concrete spillway approximately 14 feet high. The spillway is located on the downstream side of the County bridge structure. According to the plaque on the bridge, the structure was built in 1926. The dam is classified as a significant hazard dam due to the existence of the county roadway across its crest and the existence of the historic Allaire Village immediately downstream.

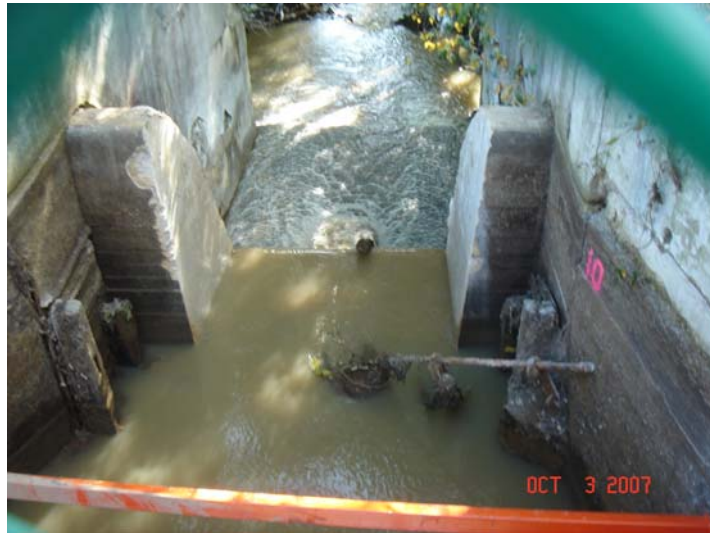
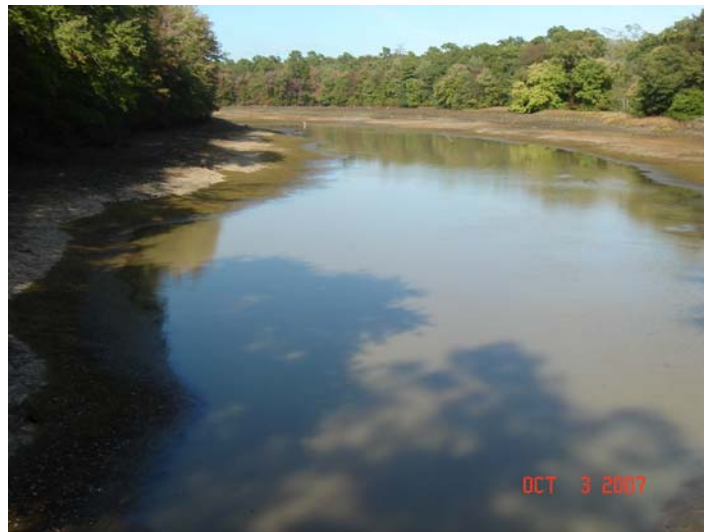
Lateral braces were placed across the channel to account for any loss of lateral support provided by the spillway. Some of the impoundment still remains which will help in controlling sedimentation as a channel develops through the upper reaches of the lake bed. The removal project was completed with no detrimental impacts to the environment. Sediment control measures were in place throughout construction to minimize the impacts of sediment release. The presence of the egret in the lake bed on a continuous basis during the work indicated that the lake was still alive and well. The final product resulted in a safe structure until such time as the plans can be completed for the reconstruction of the dam.
