Mullica River Watershed Stormwater Basin Assessment Project

September 2005

New Jersey Pinelands Commission
P.O. Box 7, New Lisbon, N.J. 08064

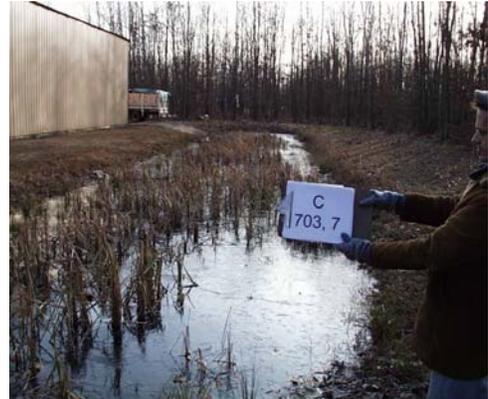
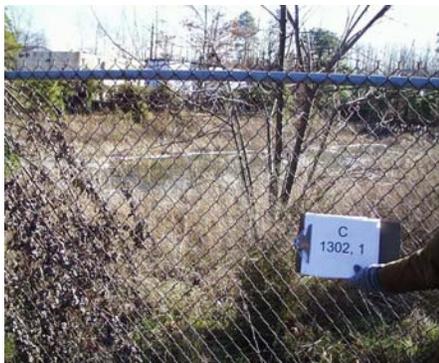
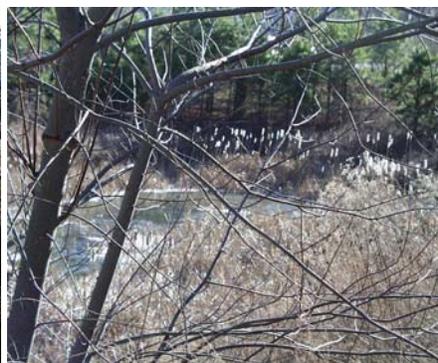
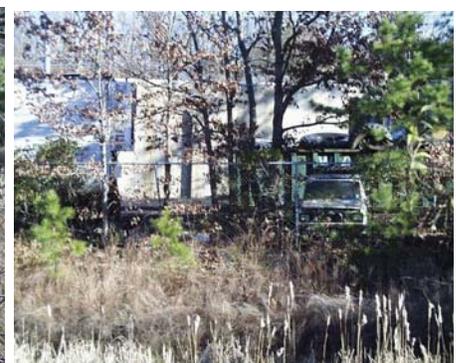
Other observations: This basin is located directly adjacent to a parking lot on one side and a road on the other, with a wooded area adjacent to a third side. It appears relatively shallow and completely filled with water. A trench is visible which appears to conduct water from the road into one corner of the basin.

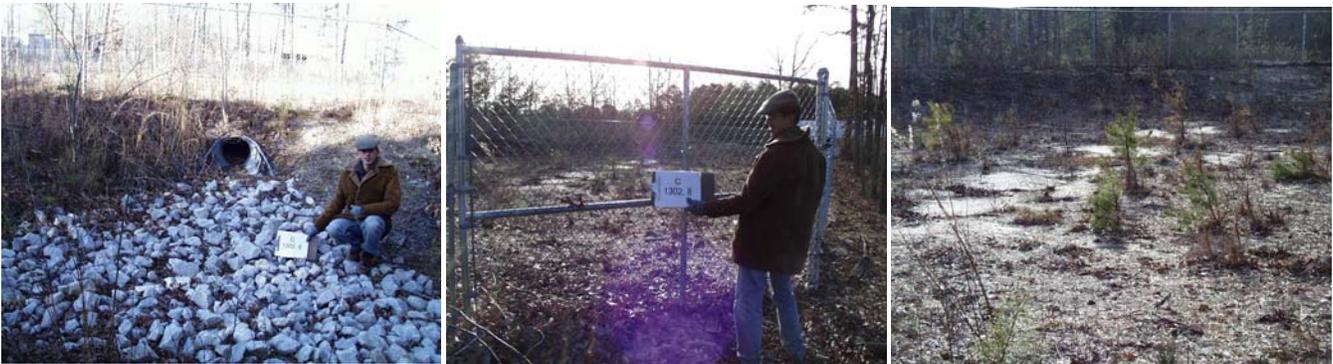
Other observations: This basin contained shrubs, tall grasses and 15-20-foot trees. There was no evidence of recent maintenance/mowing. The basin had shallow, vegetated side slopes. Evidence of dumping was observed outside of basin.

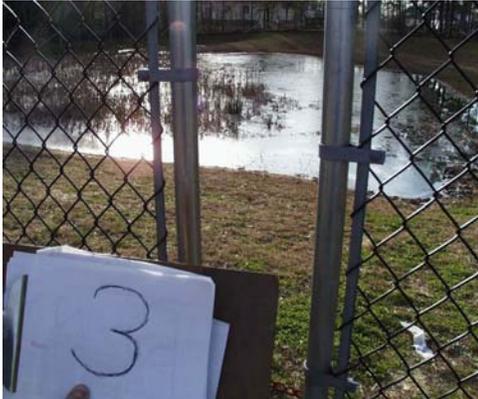
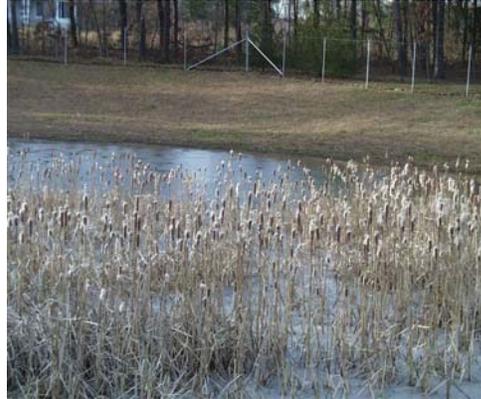
Other observations: The basin floor and sides appear overgrown with weeds, especially at the single visible inlet.

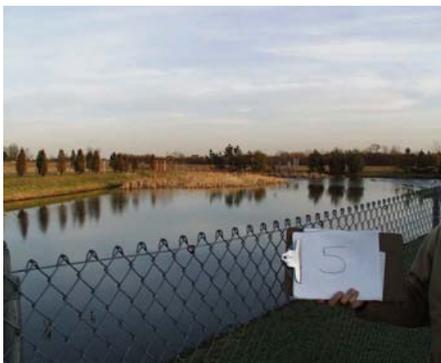
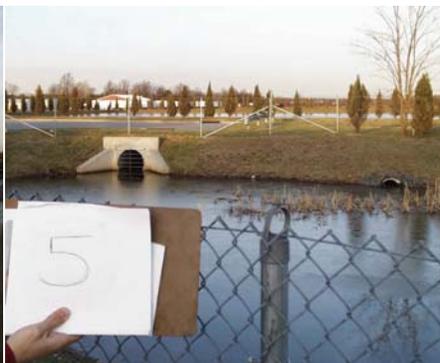
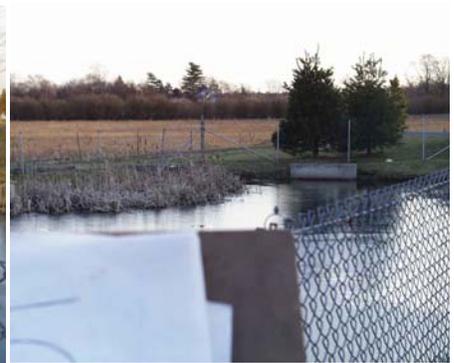
Other observations: This basin appeared to be entirely filled with standing water. Approximately 45% of the basin floor appeared to be covered with cattails. A grate was visible between the basin and the street; this grate apparently provides a connection to a submerged (not visible) inlet.

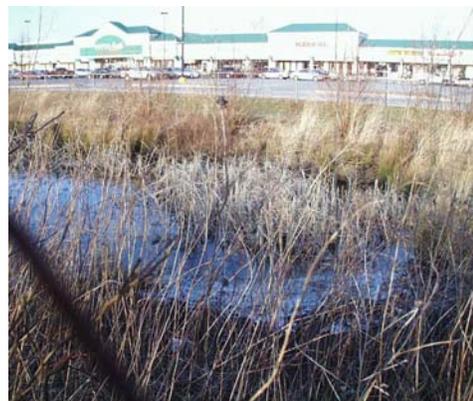
Other observations: This basin appears abandoned and completely overgrown on floor and sides with weedy vegetation approximately 2-4 feet high. A significant amount of street litter was observed around the outside of the basin fence. The entire basin floor appears to be either submerged or covered with tall vegetation.

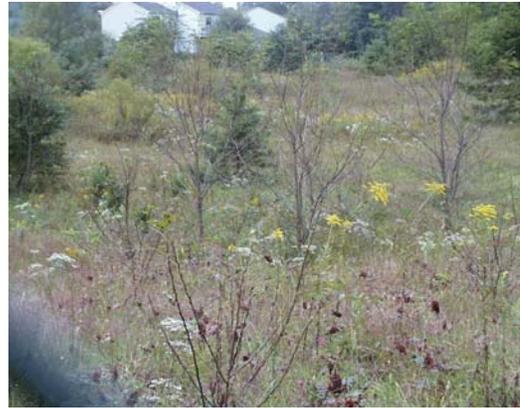
Other observations: This basin appeared to be dry and completely vegetated with tall grasses and a variety of trees (apparently all upland species). It did not appear to have been mowed for some time.

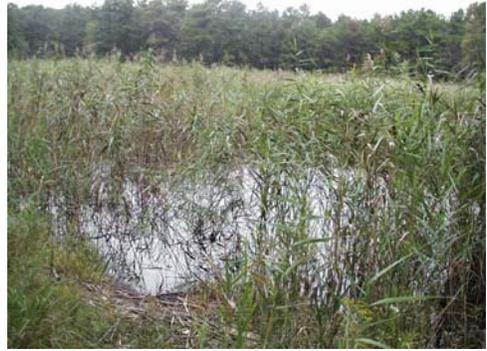
Other observations: This basin appeared to be almost completely filled with vegetation, but there appeared to be a clear area of deeper water in the middle. Redwing blackbirds and frogs were heard.

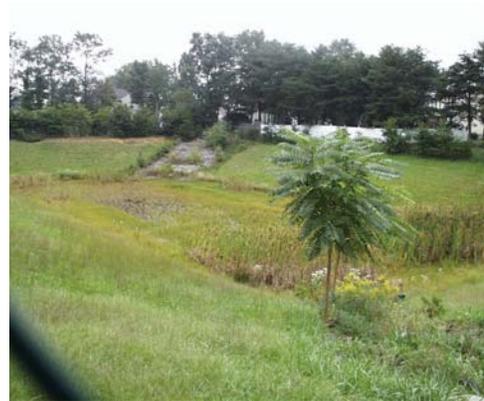
Other observations: The basin is L-shaped. A portion of this basin is behind townhouses and not visible from the access point on the cul-de-sac. Several ducks were observed in the visible portion of the basin.

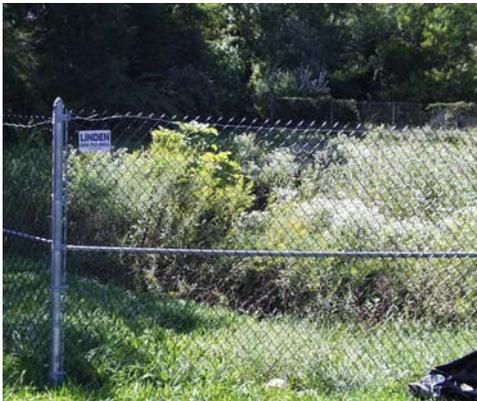
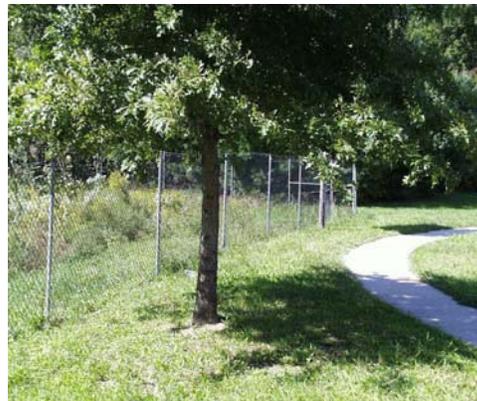
Basin ID#: W-30

Emergent wetland vegetation observed: 7 to 8' phragmites, 15' willows, milkweed covering center of basin

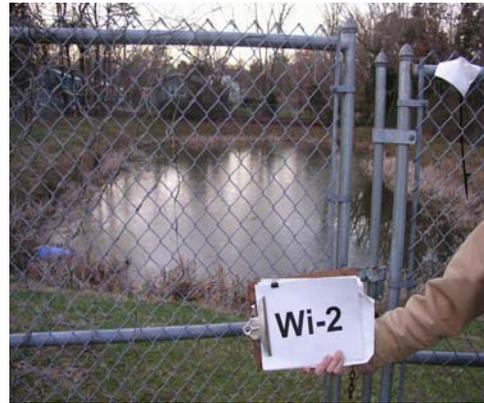
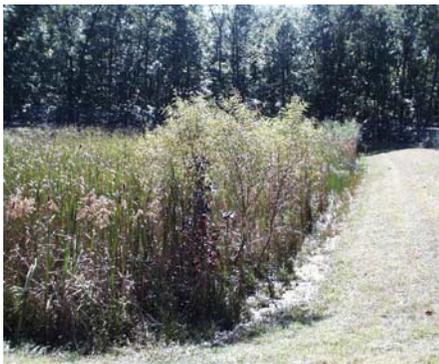
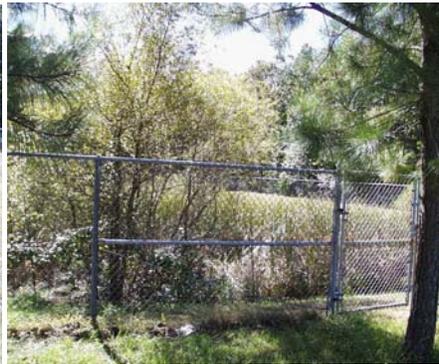
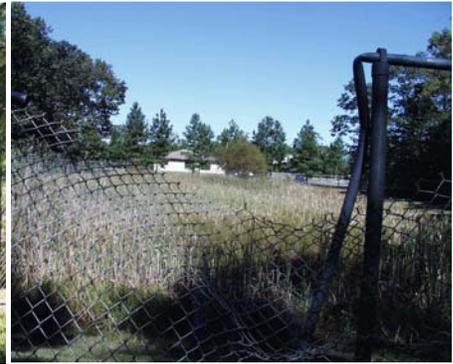
Basin ID#: Wi-4

Emergent wetland vegetation observed: carex, cattails, phragmites, willows

Other observations: This basin appeared to be entirely filled with tall herbaceous vegetation and tree. The sides of the basin appear to have been recently mowed to a height of approximately 4 inches. Significant sediment buildup was observed at the inlet pipe. Damage to the back side of the chain-link fence was observed.

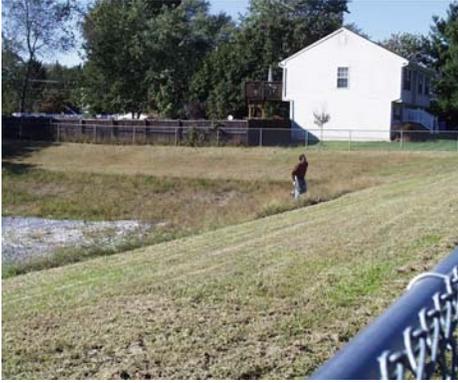
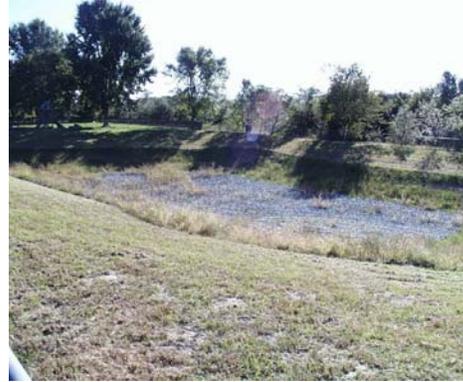
Basin ID#: Wi-5

Other observations: This basin appeared to be entirely dry, with a layer of gravel over the floor and sides mowed to a height of approximately 3-4 inches. One cement access point that appears to admit sheet flow from the street was observed.

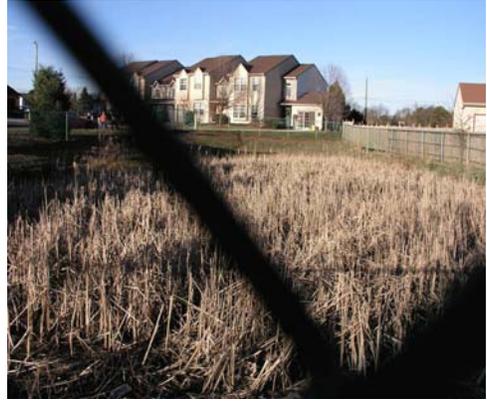
Basin ID#: Wi-17

Location: Lakeside Court, off Coopers Folly Rd. (Tally Hoe)
Block, Lot: 2410.01, 16
Development type: Residential subdivision
Date assessed: 12/23/03
Previous 24-hour rainfall (in): 0.00
Previous 72-hour rainfall (in): 0.00
Basin size: 0.296 ac
Estimated portion of basin floor covered by water: 2
Dominant soil hydrogroup: B
Dominant soil type: Downer loamy sand, 0-5% slopes
Emergent wetland vegetation observed: cattails, willows, rushes
Basin sides appear recently mowed: N
Debris in basin: few pieces street litter, three basketballs
Chain link fence: Y
Other observations: Basin appeared entirely covered by wetland vegetation (mostly cattails).

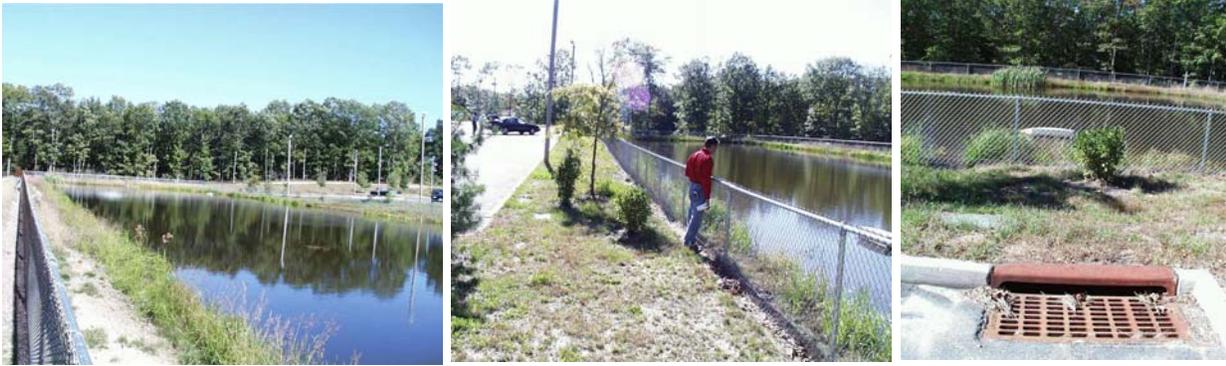
Location: Oakton Dr., near corner of Hayes Mill Rd.
Block, Lot: 2402.01, 1.06
Development type: Residential subdivision
Date assessed: 10/3/03
Previous 24-hour rainfall (in): 0.00
Previous 72-hour rainfall (in): 0.00
Basin size: 0.280 ac
Estimated portion of basin floor covered by water: >75%
Dominant soil hydrogroup: B
Dominant soil type: Downer loamy sand, 0-5% slopes
Emergent wetland vegetation observed: cattails, rushes, phragmites
Basin sides appear recently mowed: N
Debris in basin: few pieces street litter
Chain link fence: Y
Other observations: The majority of the basin floor appeared to be covered by open water, with clumps of vegetation at the edges. The sides of this basin do not appear to have been recently mowed (2-4 foot tall grass). The gate was unlocked. Some muck/sediment was visible on basin floor. The inlet appeared to be obscured by a large stand of phragmites. One

eroded strip was visible on one side at the rear of the basin. Several frogs were observed within the basin.

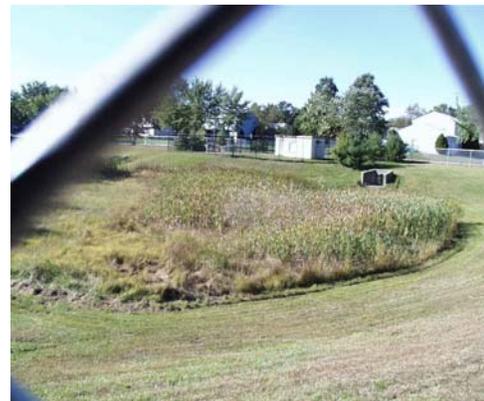
Other observations: The sides of this basin appear to have been recently mowed to a height of approximately 3-4 inches. Sedimentation was observed in front of one of the two inlets.

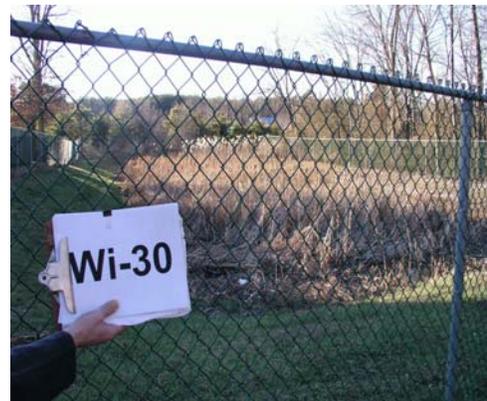
Basin ID#: Wi-30

Location: Baker Ave. (Waterford Green)
Block, Lot: 3102.04, 29
Development type: Residential subdivision
Date assessed: 12/23/03
Previous 24-hour rainfall (in): 0.00
Previous 72-hour rainfall (in): 0.00
Basin size: 0.317 ac
Estimated portion of basin floor covered by water: >75%
Dominant soil hydrogroup: A
Dominant soil type: Lakewood sand, 0-5% slopes
Emergent wetland vegetation observed: phragmites, cattails, rushes
Basin sides appear recently mowed: Y
Debris in basin: few pieces street litter
Chain link fence: Y
Other observations: The sides of this basin are covered with turfgrass, with several patches of bare earth. The basin floor appeared to be completely covered with phragmites, cattails and rushes.
