**STATE OF NEW JERSEY**  
**Board of Public Utilities**  
44 South Clinton Avenue, 9<sup>th</sup> Floor  
Post Office Box 350  
Trenton, New Jersey 08625-0350  
[www.nj.gov/bpu/](http://www.nj.gov/bpu/)

| IN THE MATTER OF THE BOARD'S INVESTIGATION | ) | SPECIAL RELIABILITY |
| INTO RELIABILITY ISSUES RELATED TO JERSEY | ) | MASTER REPORT AND |
| CENTRAL POWER & LIGHT COMPANY'S | ) | ANALYSIS |

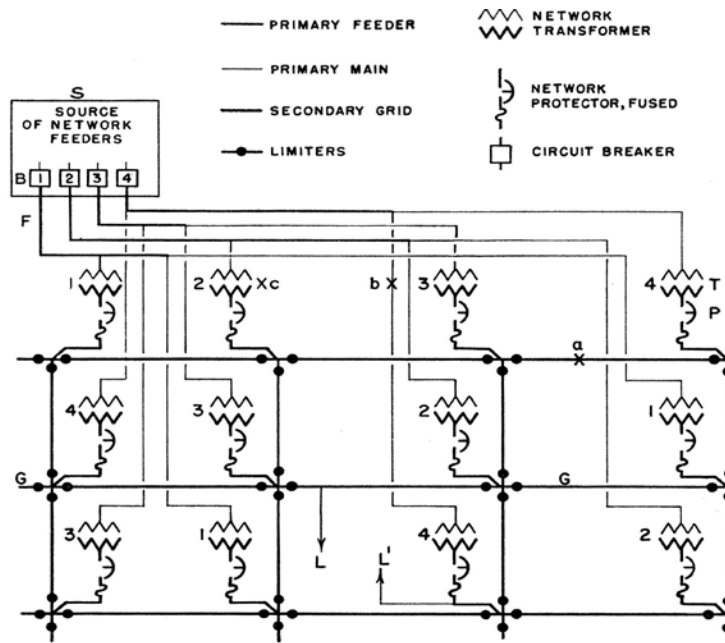
**Figure 1**

Although the network has five circuits, they are not as symmetrical as the text book case shown in Figure 1. This means that under some conditions the ends of the network act more like a three circuit network, but service remains for all n-1 conditions.

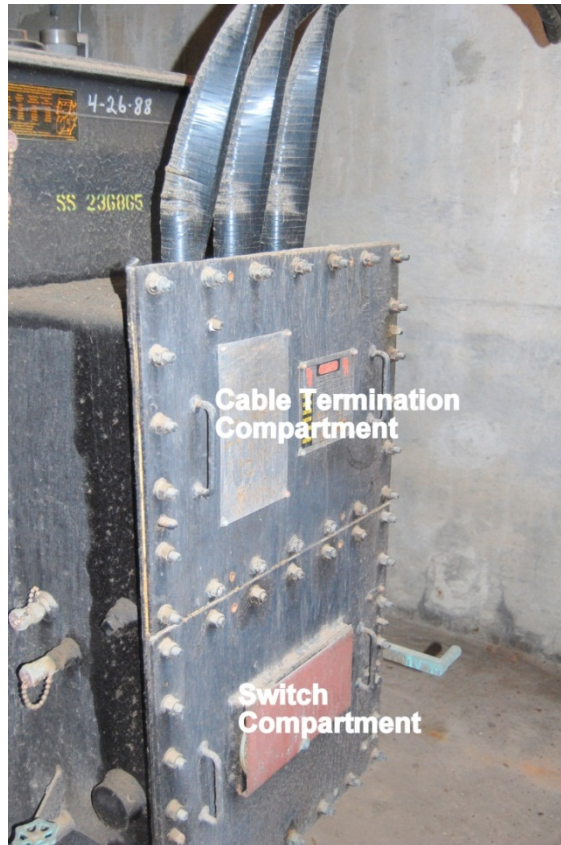
**Photograph # 1**

1. The cable termination compartment or the exterior cable connection using elbow connectors as the points where the transformer is connected to the primary circuit as shown in Photographs # 1 and # 2.
2. The switch compartment contains an electrical switch in an oil filled compartment. The switch can be used to isolate the transformers and ground the primary electric cable to allow work to be performed safely on the cable and transformer. The switch is shown in Photograph # 1.
3. The main transformer tank contains the electrical winding in a sealed compartment under oil. It too is shown in Photographs # 2 and # 4.
4. The network protector is shown in Photograph # 3 and # 4.
