# Essex Hudson Greenway Structures Report

# Arup USA, Inc 77 Water Street

Final 2 | September 28, 2020

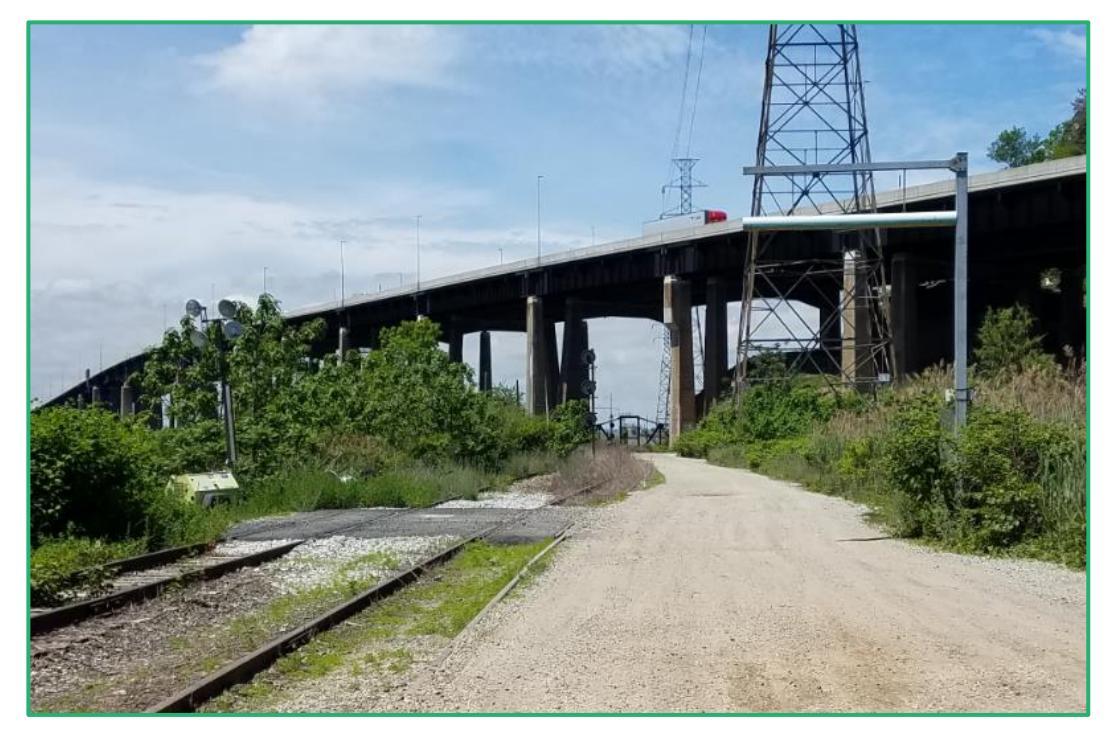
Figure 11 – MP 4.05 NJ Turnpike Eastern Spur

- Sufficient clearance for greenway under the existing structure.
- ٠ the overhead power lines.

Access road on north side of the greenway corridor connects to Laurel Hill Road and Laurel Park. This access road will need to be maintained adjacent to the greenway for access by NJTransit and PSG&E for

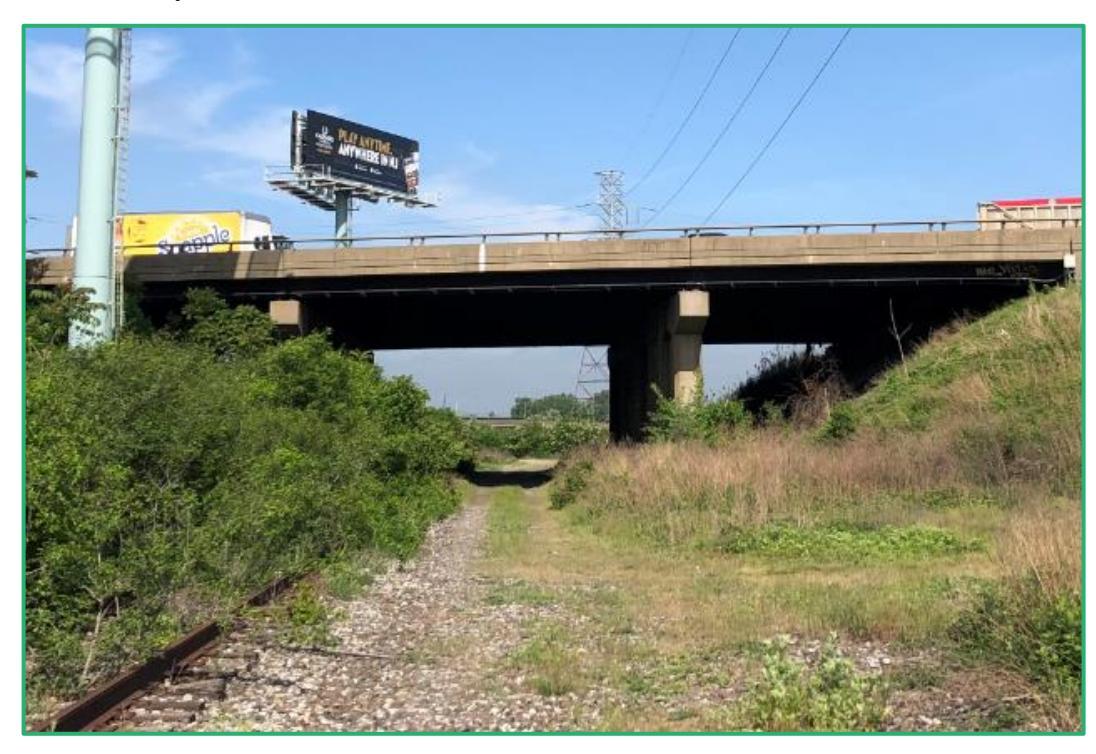
Figure 12 – MP 5.39 NJ Turnpike Western Spur

- Sufficient clearance for greenway under the existing structures.
- Graffiti removal may be desired for aesthetic reasons.

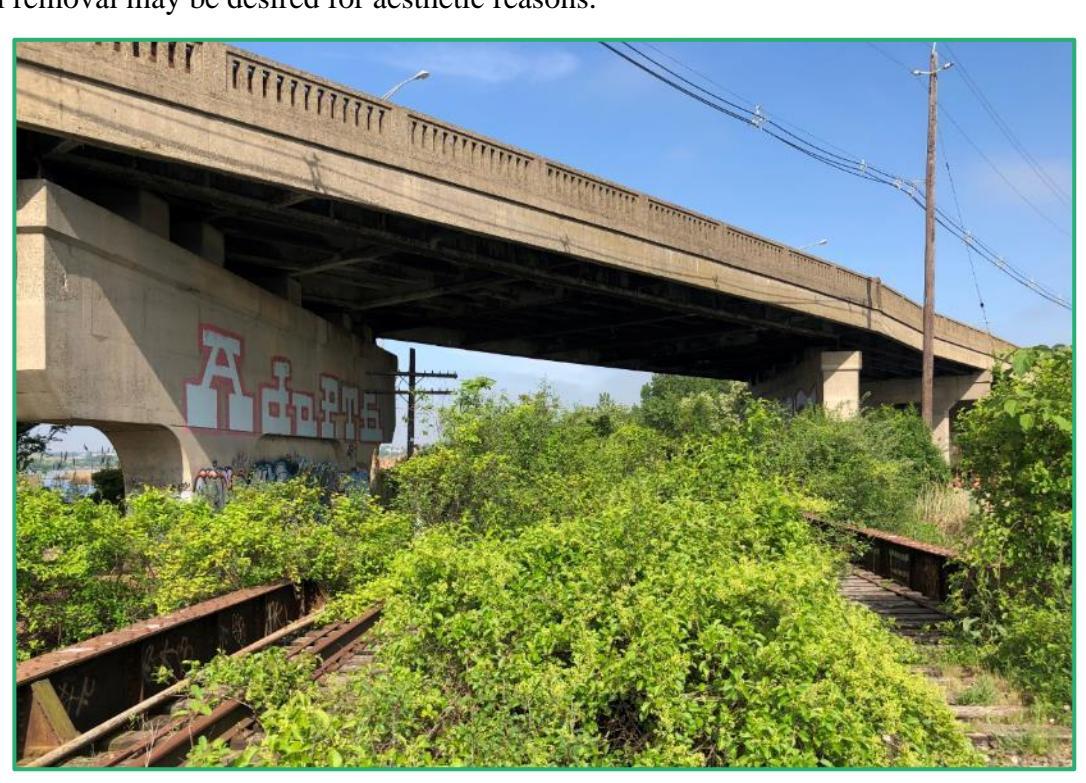
Figure 13 – MP 5.65 Belleville Turnpike

- Sufficient clearance for greenway under the existing structures.
- Graffiti removal may be desired for aesthetic reasons.

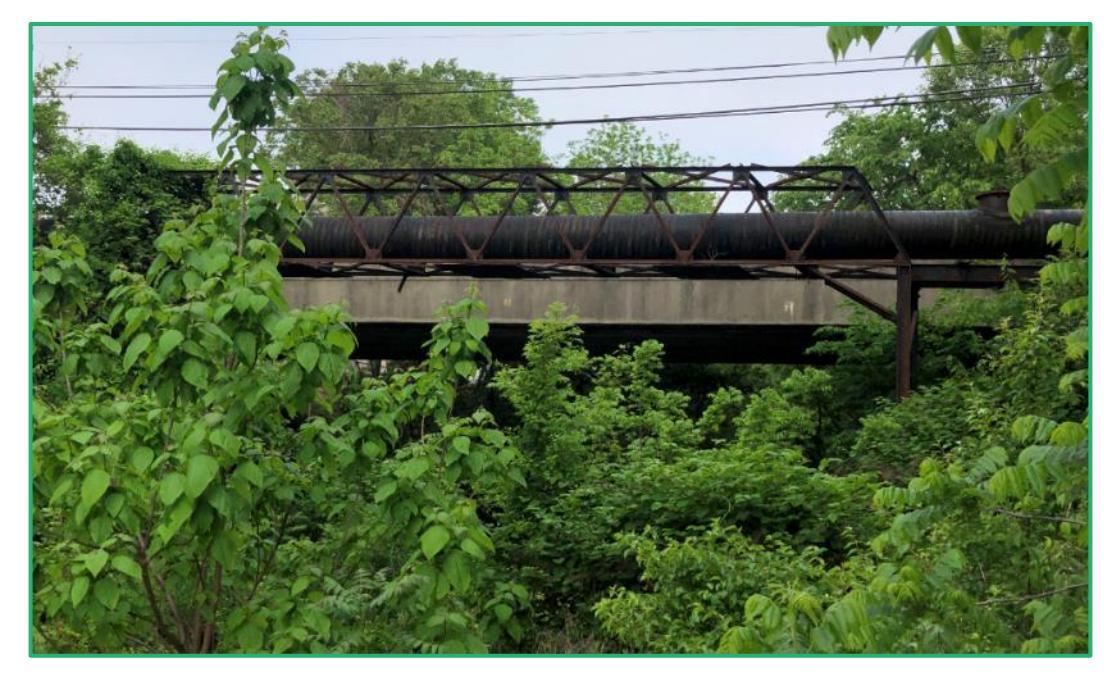
Figure 14 – MP 6.69 Schuyler Water Pipes

• Sufficient clearance for greenway under the existing structures.

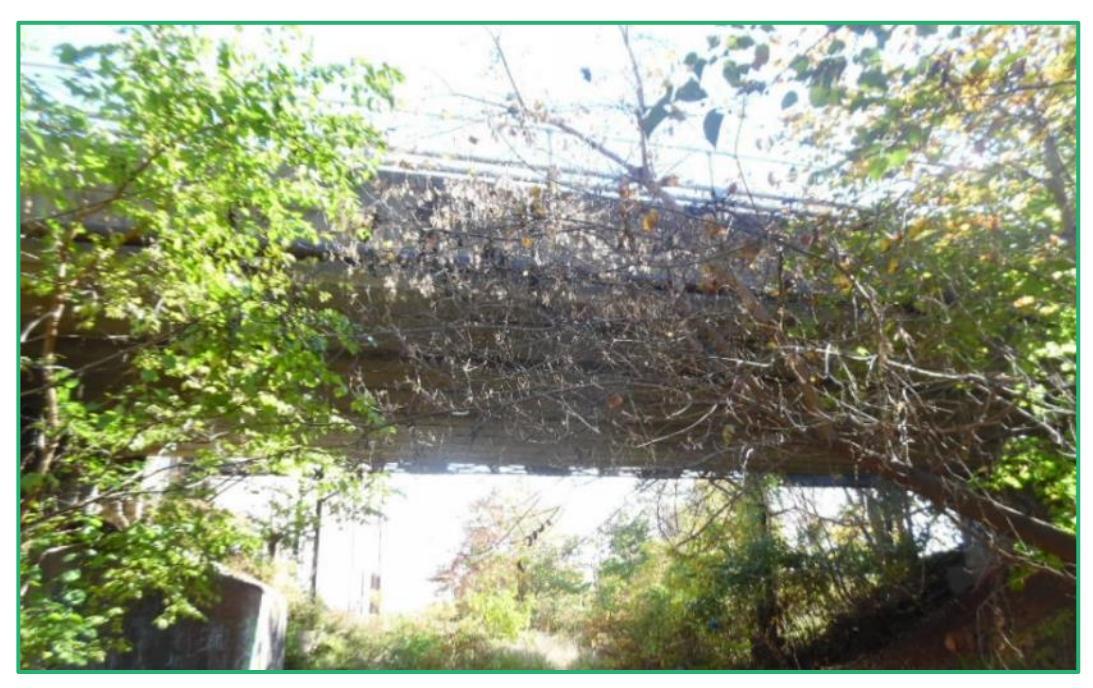
Figure 15 – MP 6.71 Schuyler Ave

- Sufficient clearance for greenway under the existing structures.
- Graffiti removal may be desired for aesthetic reasons.

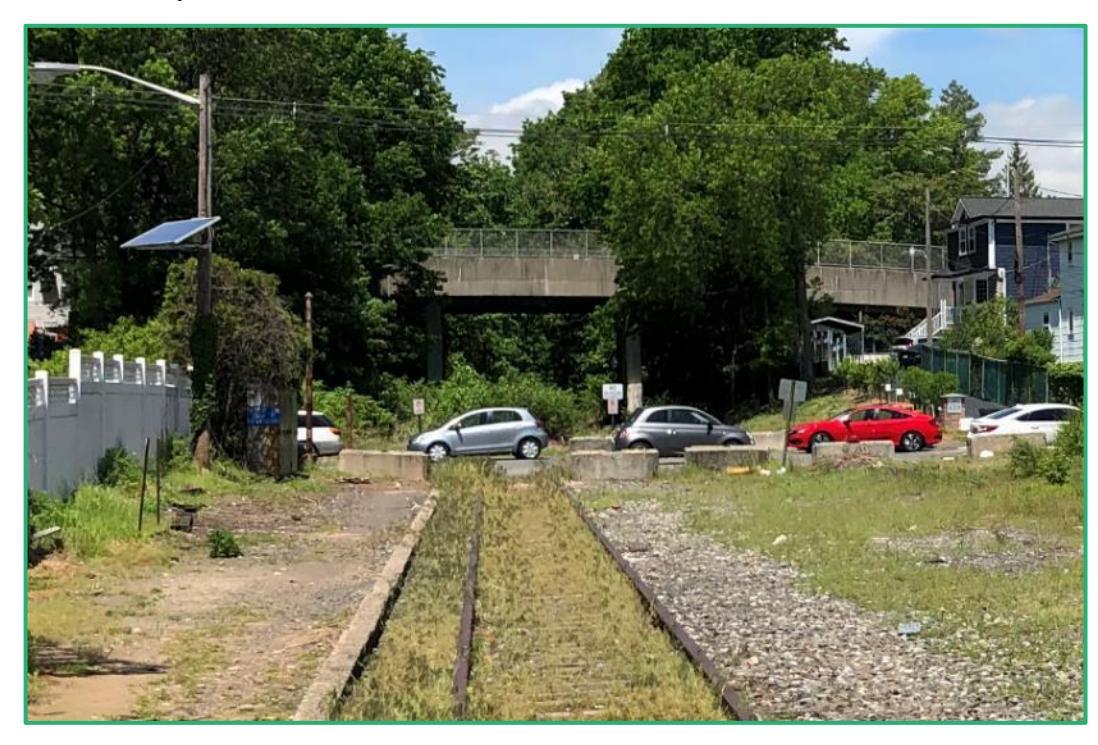
Figure 16 – MP 7.02 Chestnut St

- Sufficient clearance for greenway under the existing structures.
- Graffiti removal may be desired for aesthetic reasons.

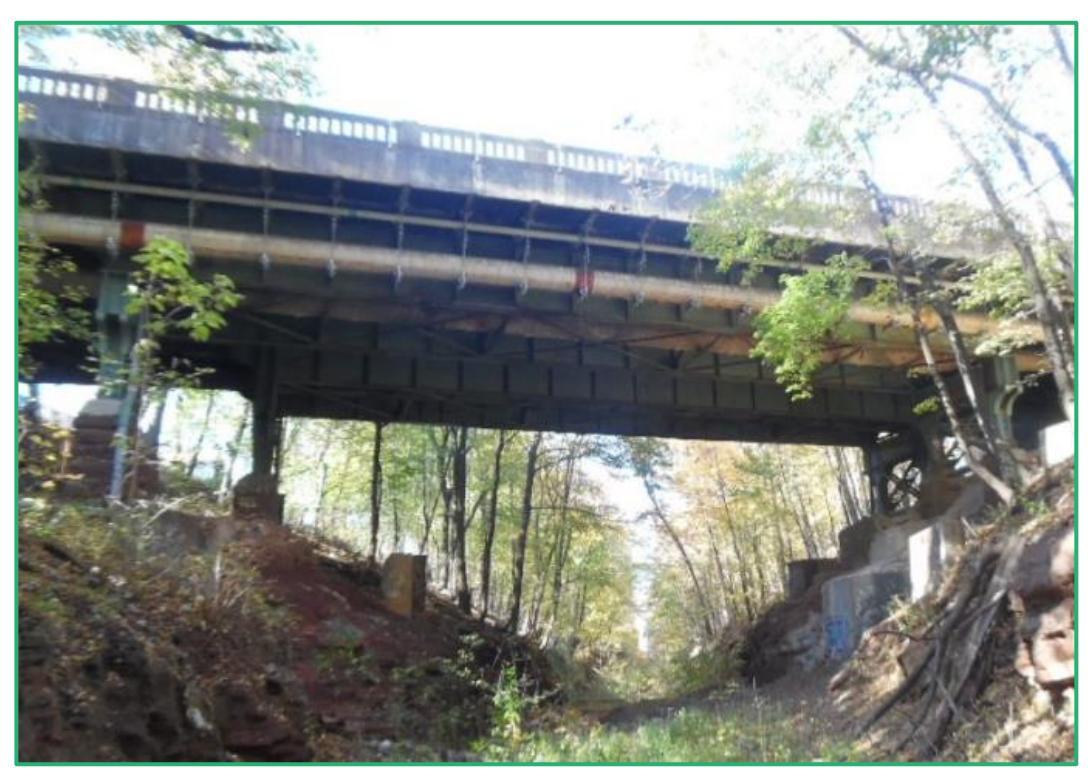
Figure 17 – MP 7.18 Kearny Pipelines

- Sufficient clearance for greenway under the existing structures.
- Note that the pipelines are supported off the Kearny Avenue bridge

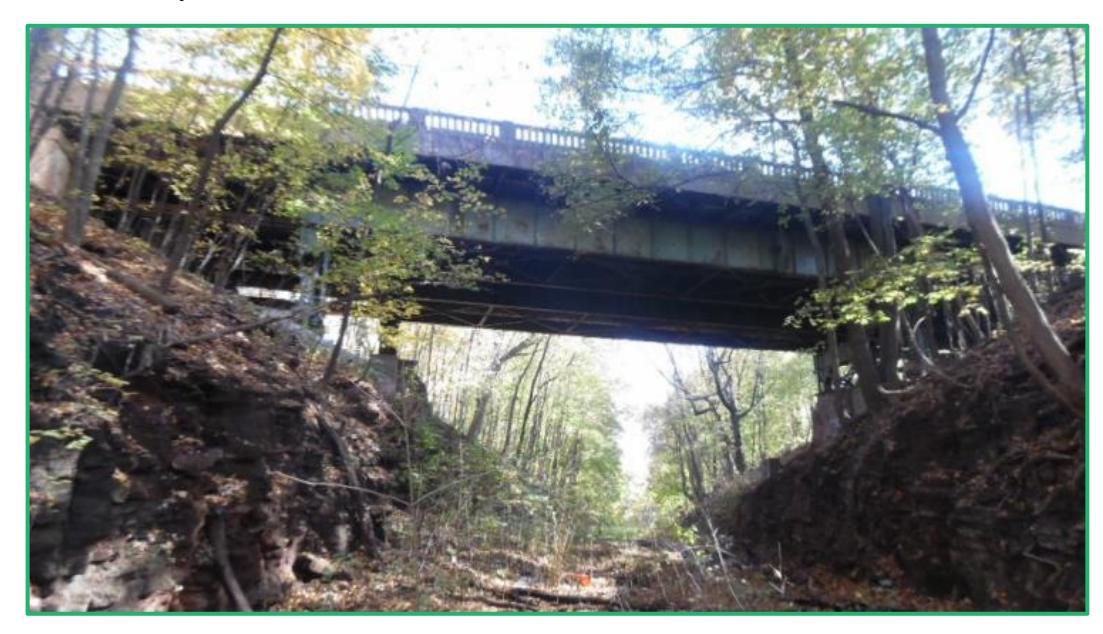
Figure 18 – MP 7.19 Kearny Ave

- Sufficient clearance for greenway under the existing structures.
- Graffiti removal may be desired for aesthetic reasons.

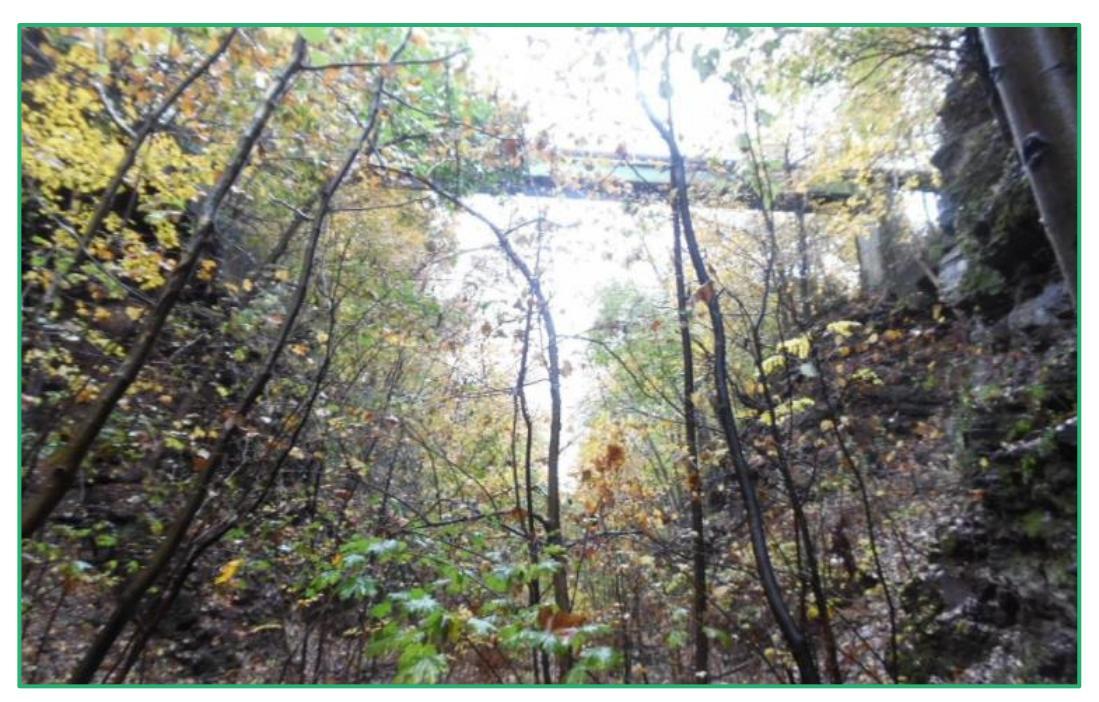
Figure 19 – MP 7.34 Hillcrest Pipeline

• Sufficient clearance for greenway under the existing structures.

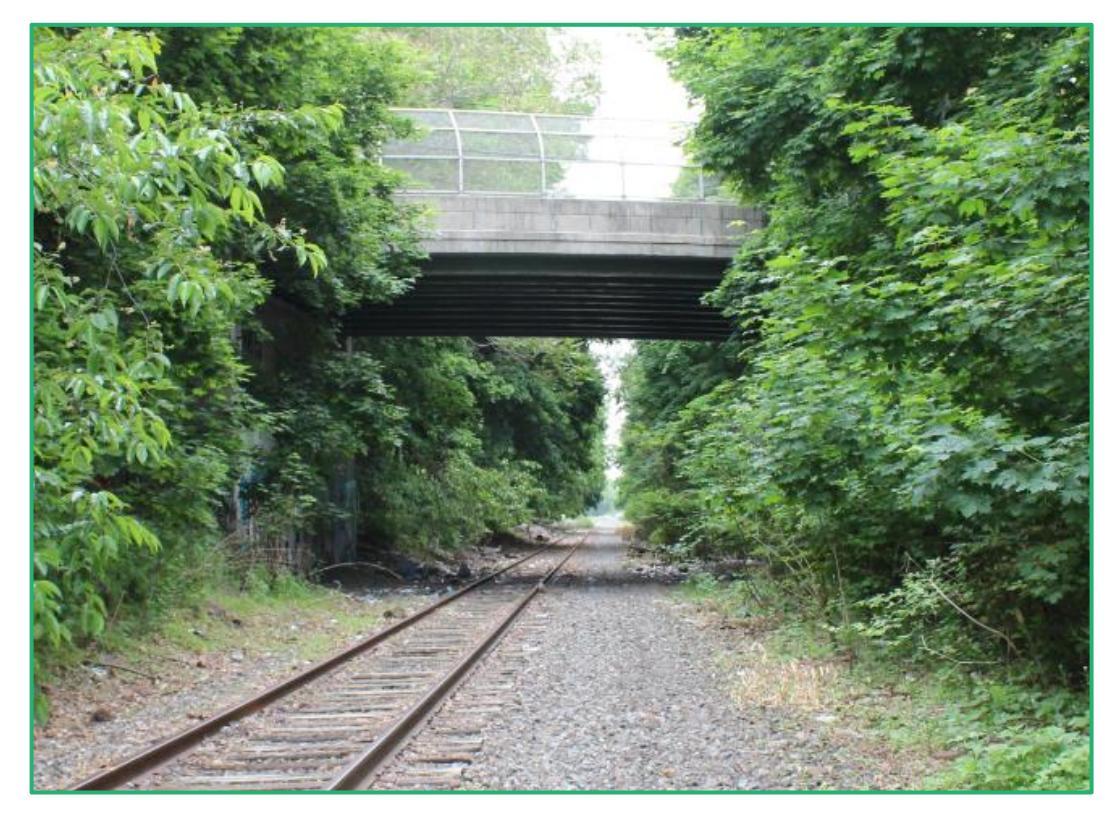
Figure 20 – MP 10.14 Williamson Ave

- Sufficient clearance for greenway under the existing structures.
- Graffiti removal may be desired for aesthetic reasons.

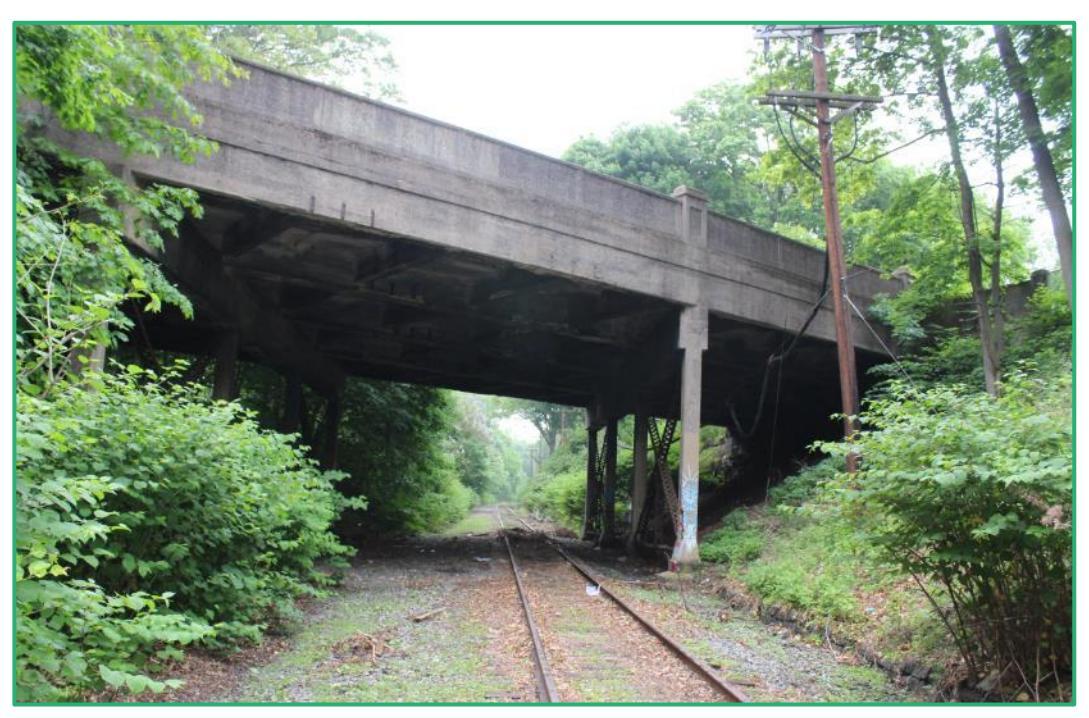
Figure 21 – MP 11.06 Ridgewood Ave

- Sufficient clearance for greenway under the existing structures.
- Graffiti removal may be desired for aesthetic reasons.

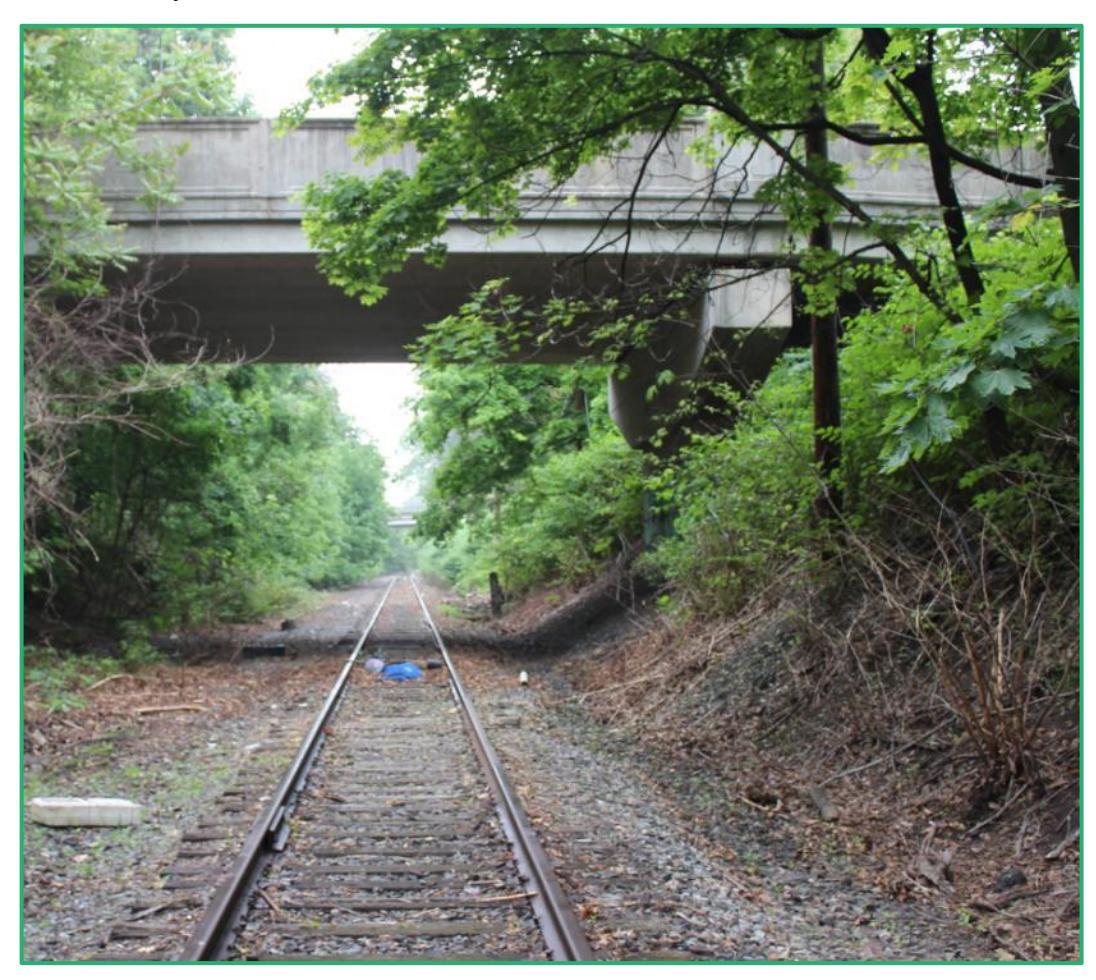
Figure 22 – MP 11.33 Highland Ave

- Sufficient clearance for greenway under the existing structures.
- Graffiti removal may be desired for aesthetic reasons.

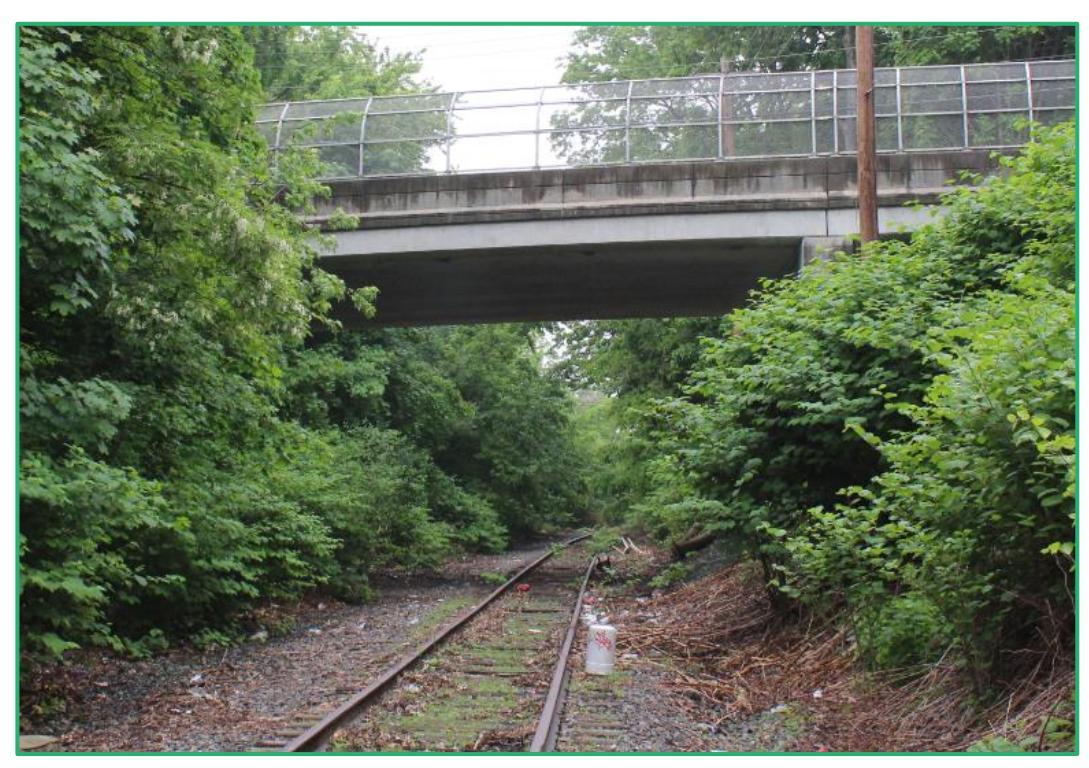
Figure 23 – MP 11.44 Bay Street

- Sufficient clearance for greenway under the existing structures.
- Graffiti removal may be desired for aesthetic reasons.

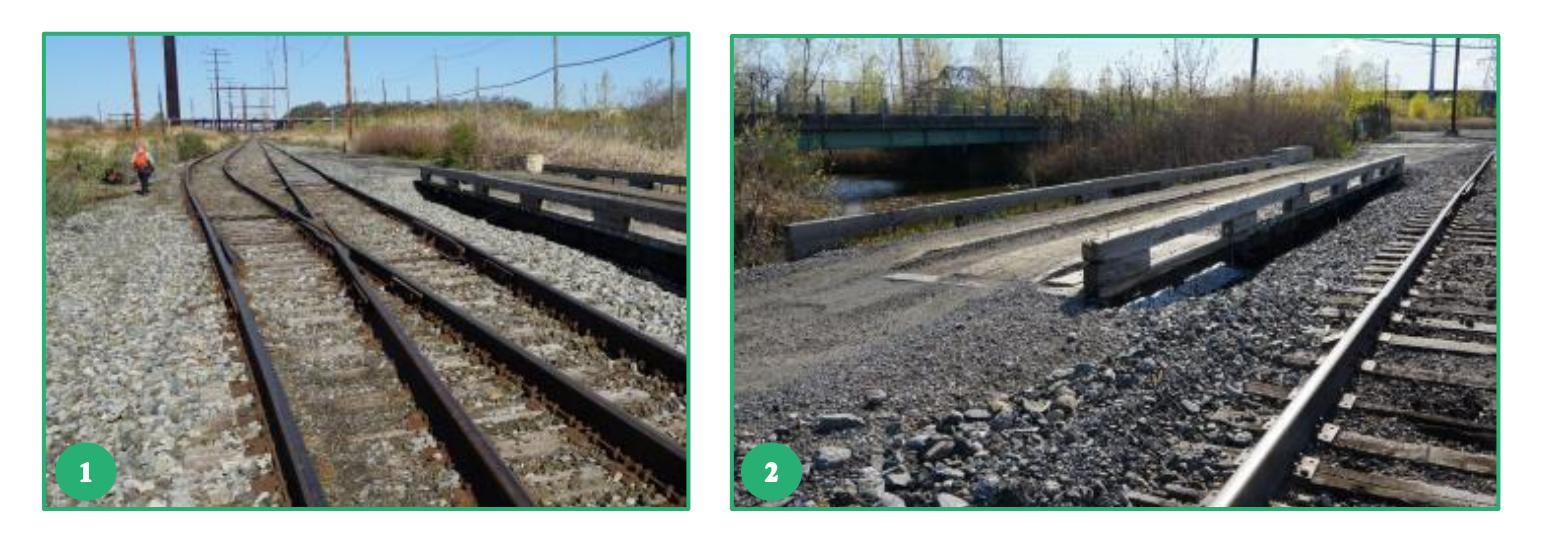
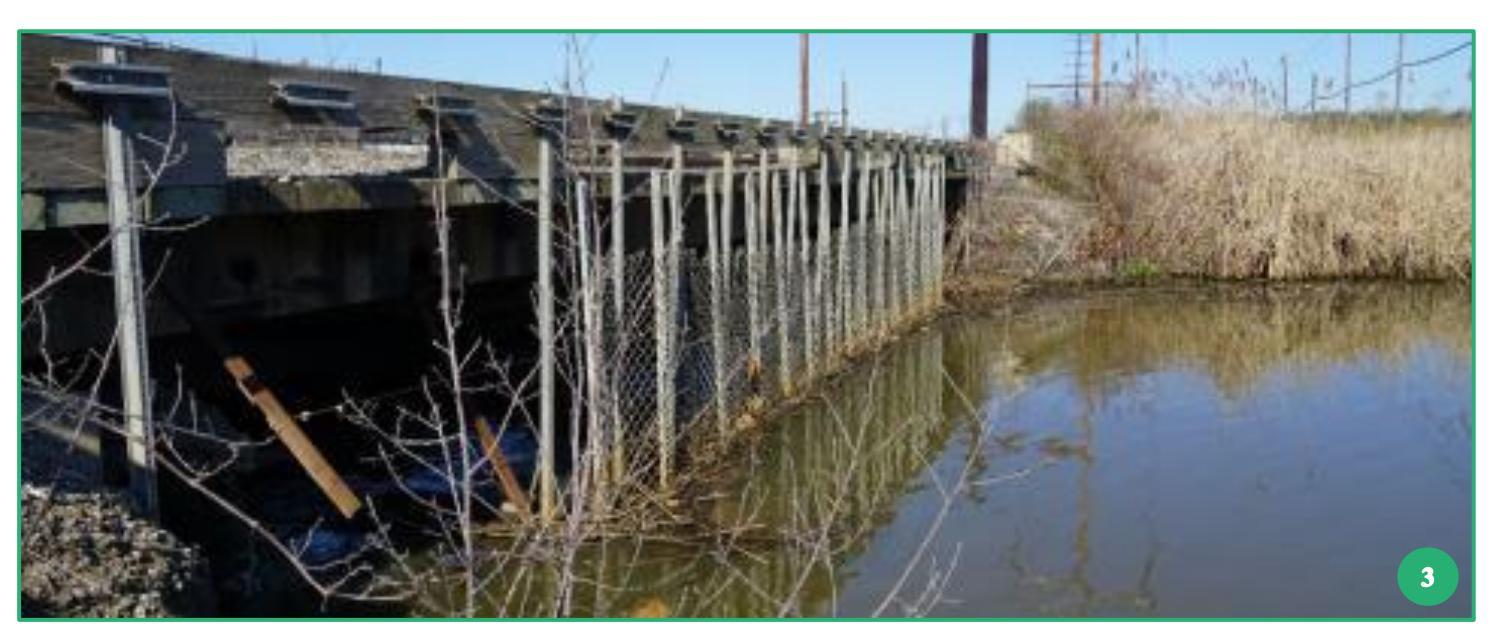
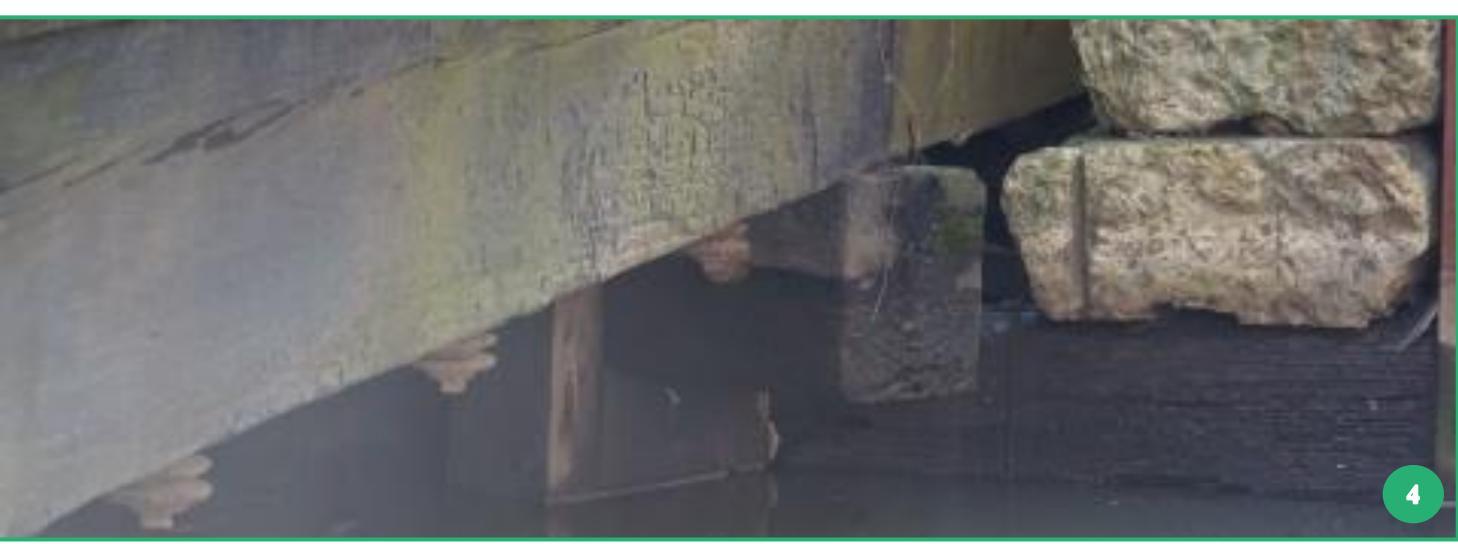
The Naik report indicated that the timber piles of the bridge are crushing. However, it is not clear if these piles were supporting the access road or the railroad trestle. Without more information, it is difficult to determine exactly what rehabilitation measures would need to be taken.

- 1. Looking west
- 2. Looking east
- 3. Looking south
- 4. East timber pile foundation and south timber fascia

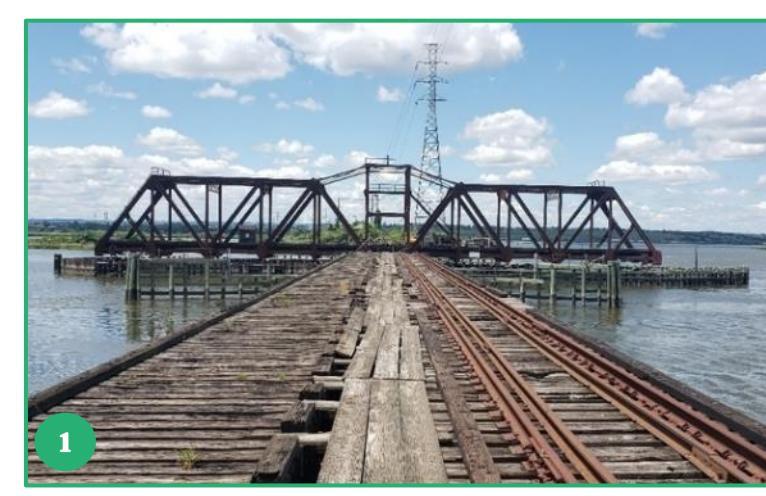
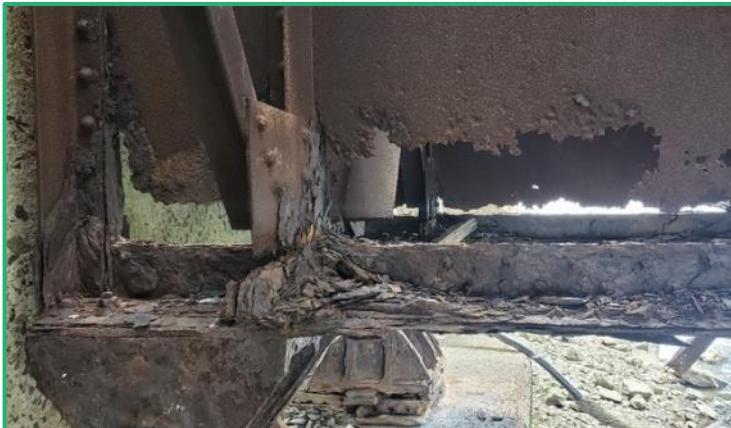
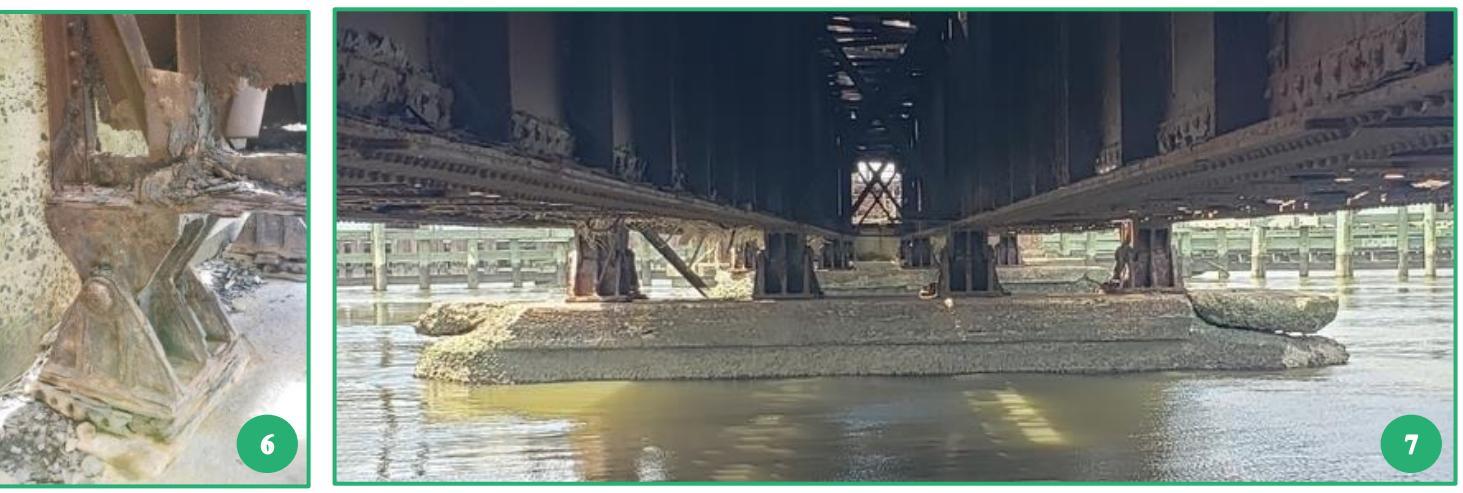
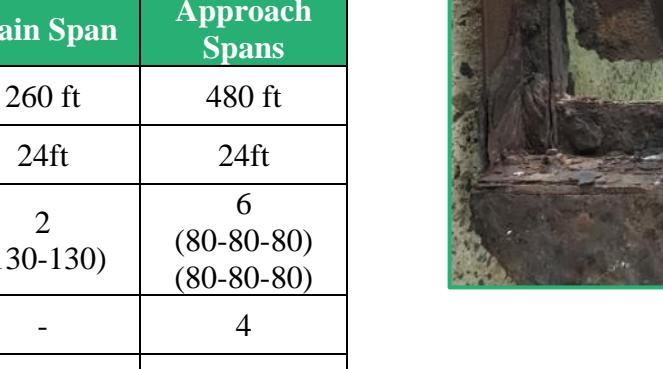
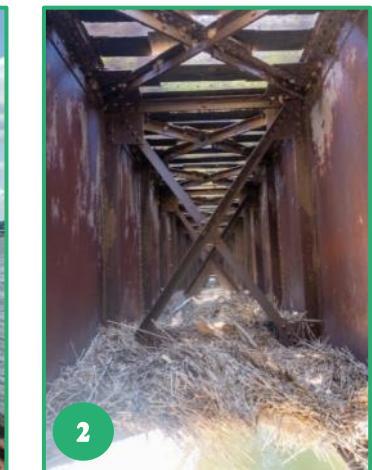
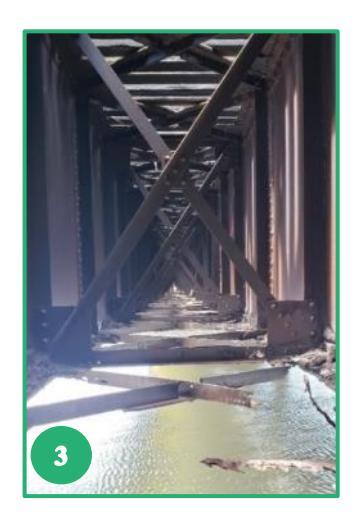
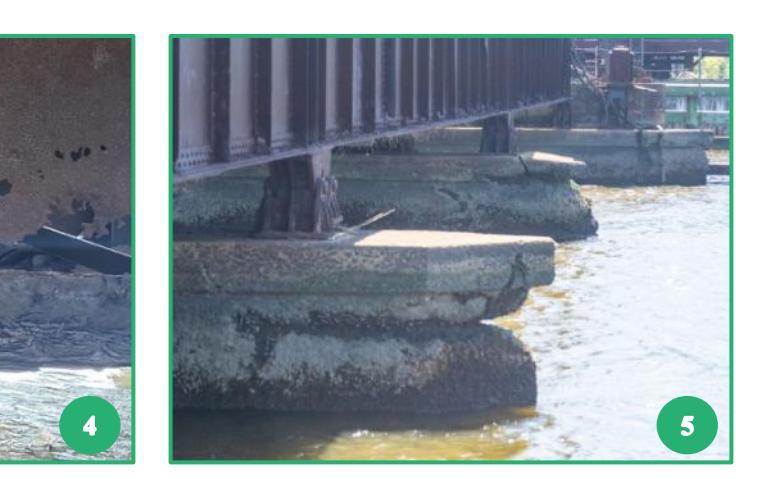
Factor	Sub Factor	Key Observations
	Type of bridge	<ul> <li>Riveted steel girder approach spans</li> <li>Truss swing span</li> <li>Mass concrete substructure pile caps</li> <li>Unknown foundations</li> </ul>
	Feature crossed	Hackensack River
Existing Conditions	Deterioration	<ul> <li>Areas of 100% section loss on approach girders</li> <li>Corroded bearings</li> <li>Concrete spalling at substructure pile caps</li> <li>Inoperable movable span</li> <li>Deteriorated and rotten deck ties</li> </ul>
	Design Standards	AASHTO LRFD Pedestrian Bridge Design Code
	Load carrying capacity	• See comparison in Section 3.2.3
	Redundancy	<ul> <li>Potential risk – approach structures likely redundant. Swing truss potentially non-redundant.</li> </ul>
Structural Integrity	Seismic	• Potential risk – swing span requires review
	Collision	• Potential risk – bridge crosses navigable waterway
	Hydraulics	• Potential risk – requires further investigation

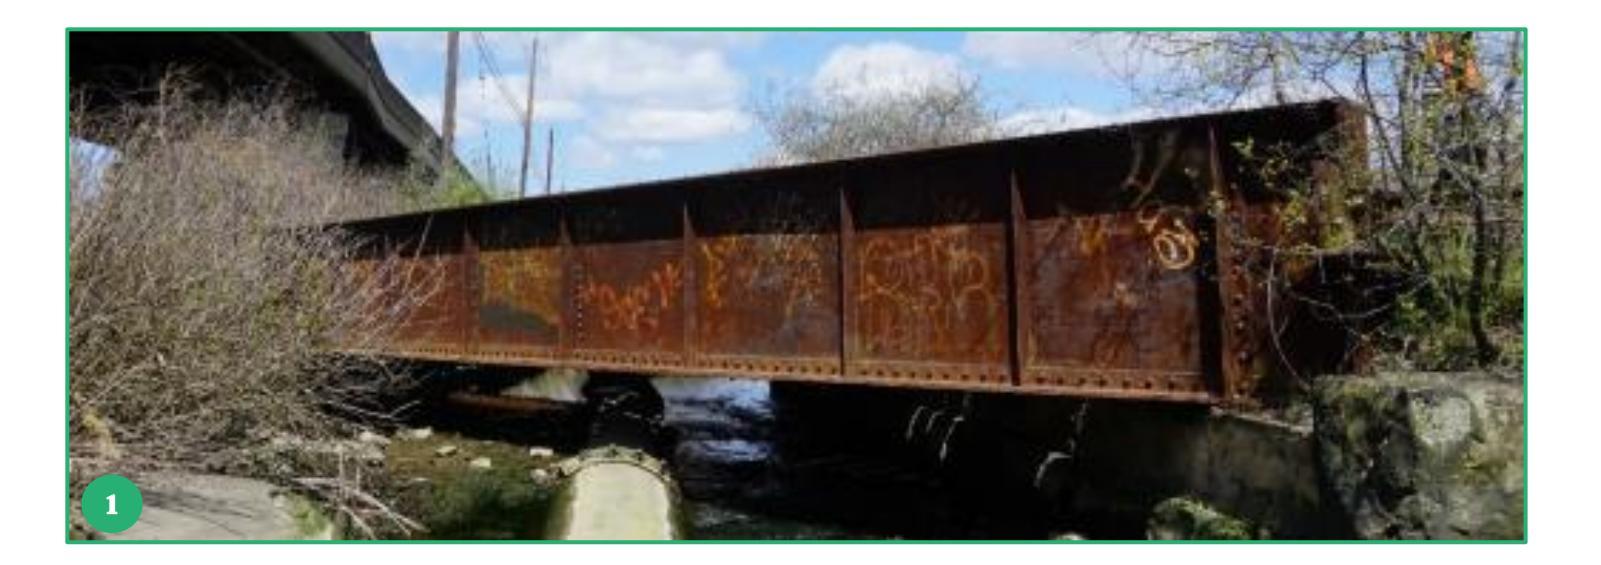
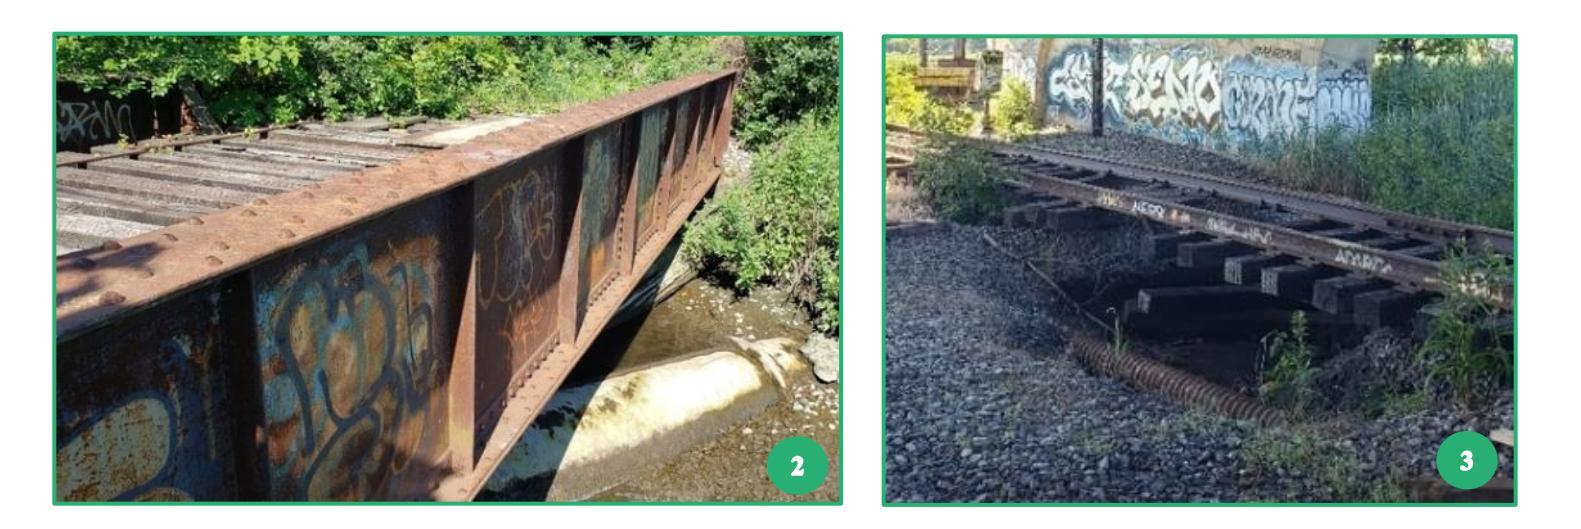
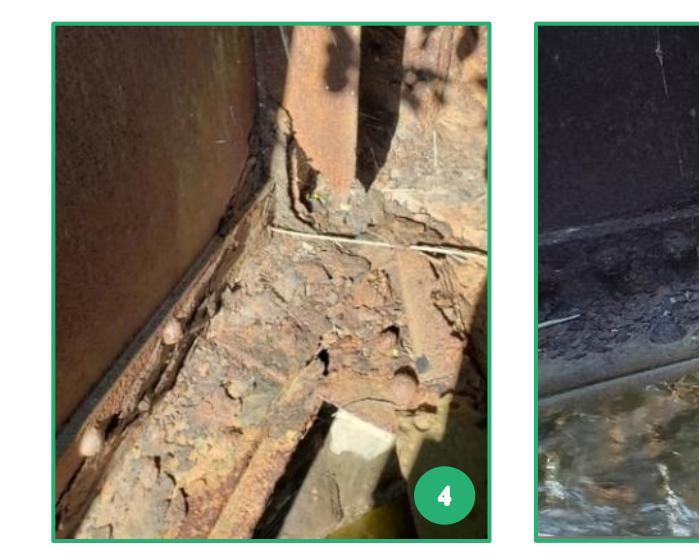
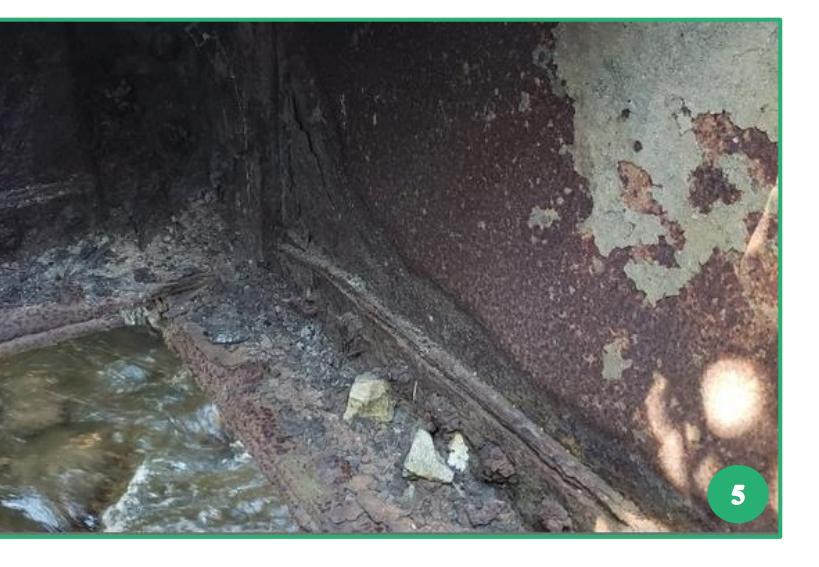
The bridge at MP 5.63 is a 26-foot-long, single span steel girder bridge that crosses a pipe line at a low clearance. Despite the low clearance, there is only minor corrosion on the girders, with moderate corrosion of secondary elements that may require replacement. The abutments appear to be in good condition. However, there is evidence of washout in the area surrounding the bridge. This may need to be addressed.

- 1. Looking north
- 2. Looking south
- 3. The ground approximately 300 feet west of the bridge is washed out
- 4. Corrosion on the girders
- 5. Corrosion on the girders

Factor	Sub Factor	Key Observations	
	Type of bridge	Steel through girders	
Existing Conditions	Feature crossed	Wetlands and pipe lines	
	Deterioration	<ul><li>Minor to moderate corrosion of steel</li><li>Deteriorated and rotten deck ties</li></ul>	
	Design Standards	AASHTO LRFD Pedestrian Bridge Design Code	
	Load carrying capacity	• See comparison in Section 3.2.3	
	Redundancy	Potentially non-redundant	
Structural Integrity	Seismic	• Low risk – single span structure	
	Collision	• No risk – no vessel traffic	
	Hydraulics	Potential – evidence of nearby washouts	
Safety	Geometry	<ul> <li>Adequate width and height for trail</li> <li>Note through girder at centerline of bridge, essentially dividing the bridge into two halves.</li> </ul>	
	Horizontal and Vertical Clearances	• N/A	
	Railings and Fences	Railing required at both edges	
	Emergency Vehicle Access	Adequate access available	
	Construction Methods	• Assume conventional construction methods can be used with land-based equipment
