# Essex Hudson Greenway Structures Report

# Arup USA, Inc 77 Water Street

Final 2 | September 28, 2020

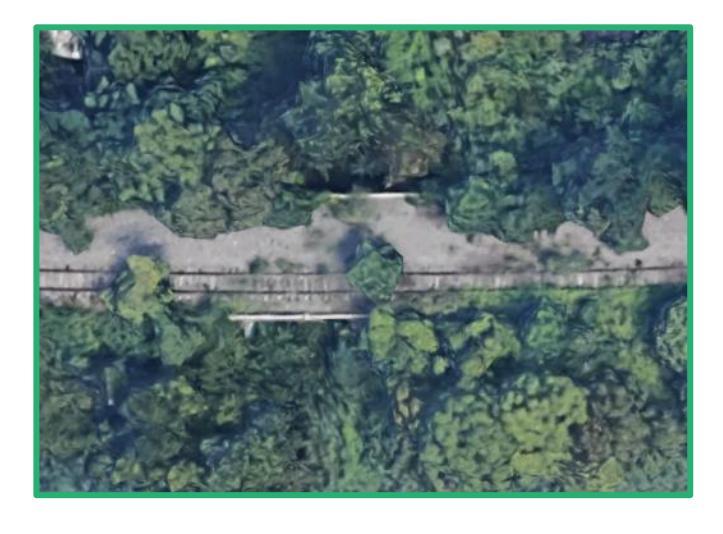
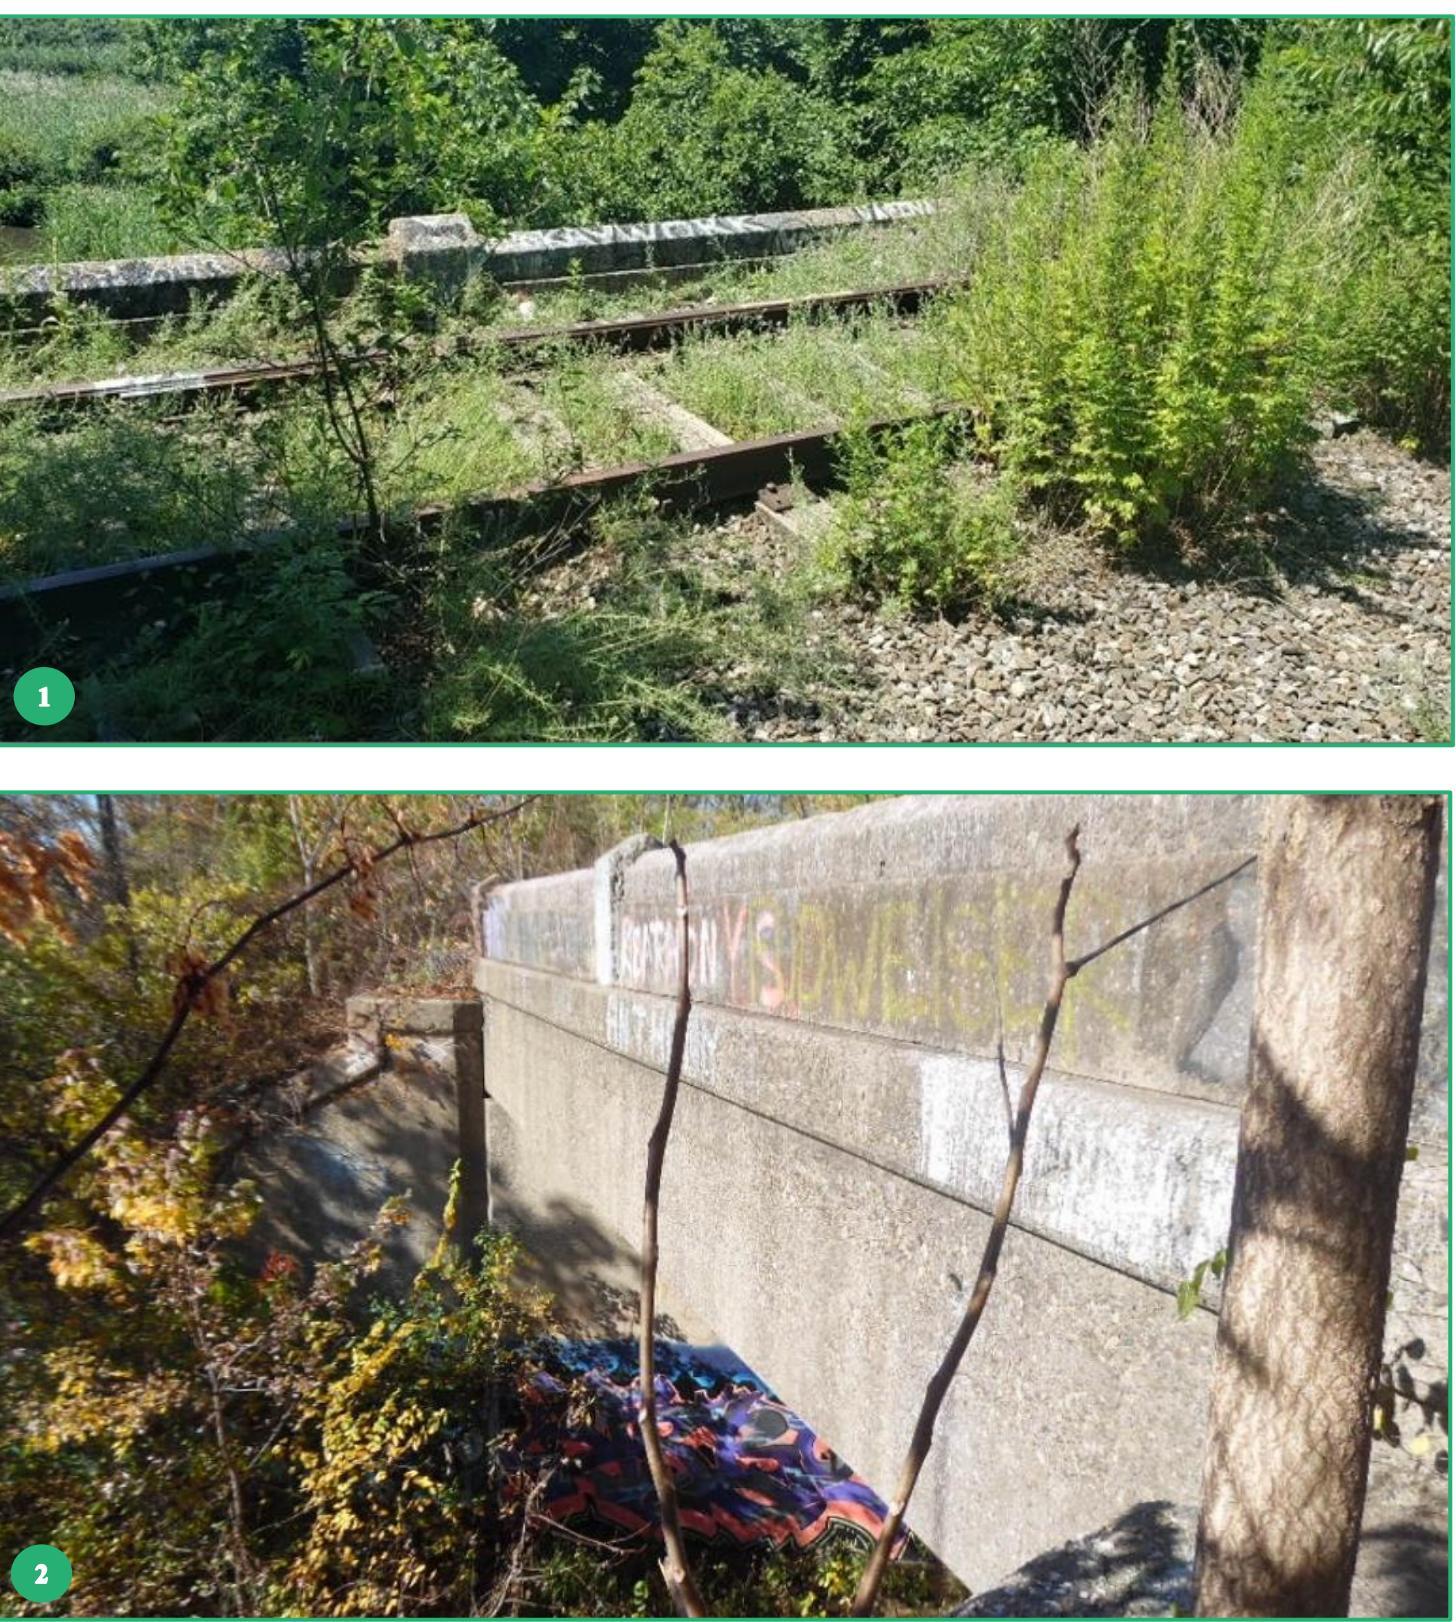
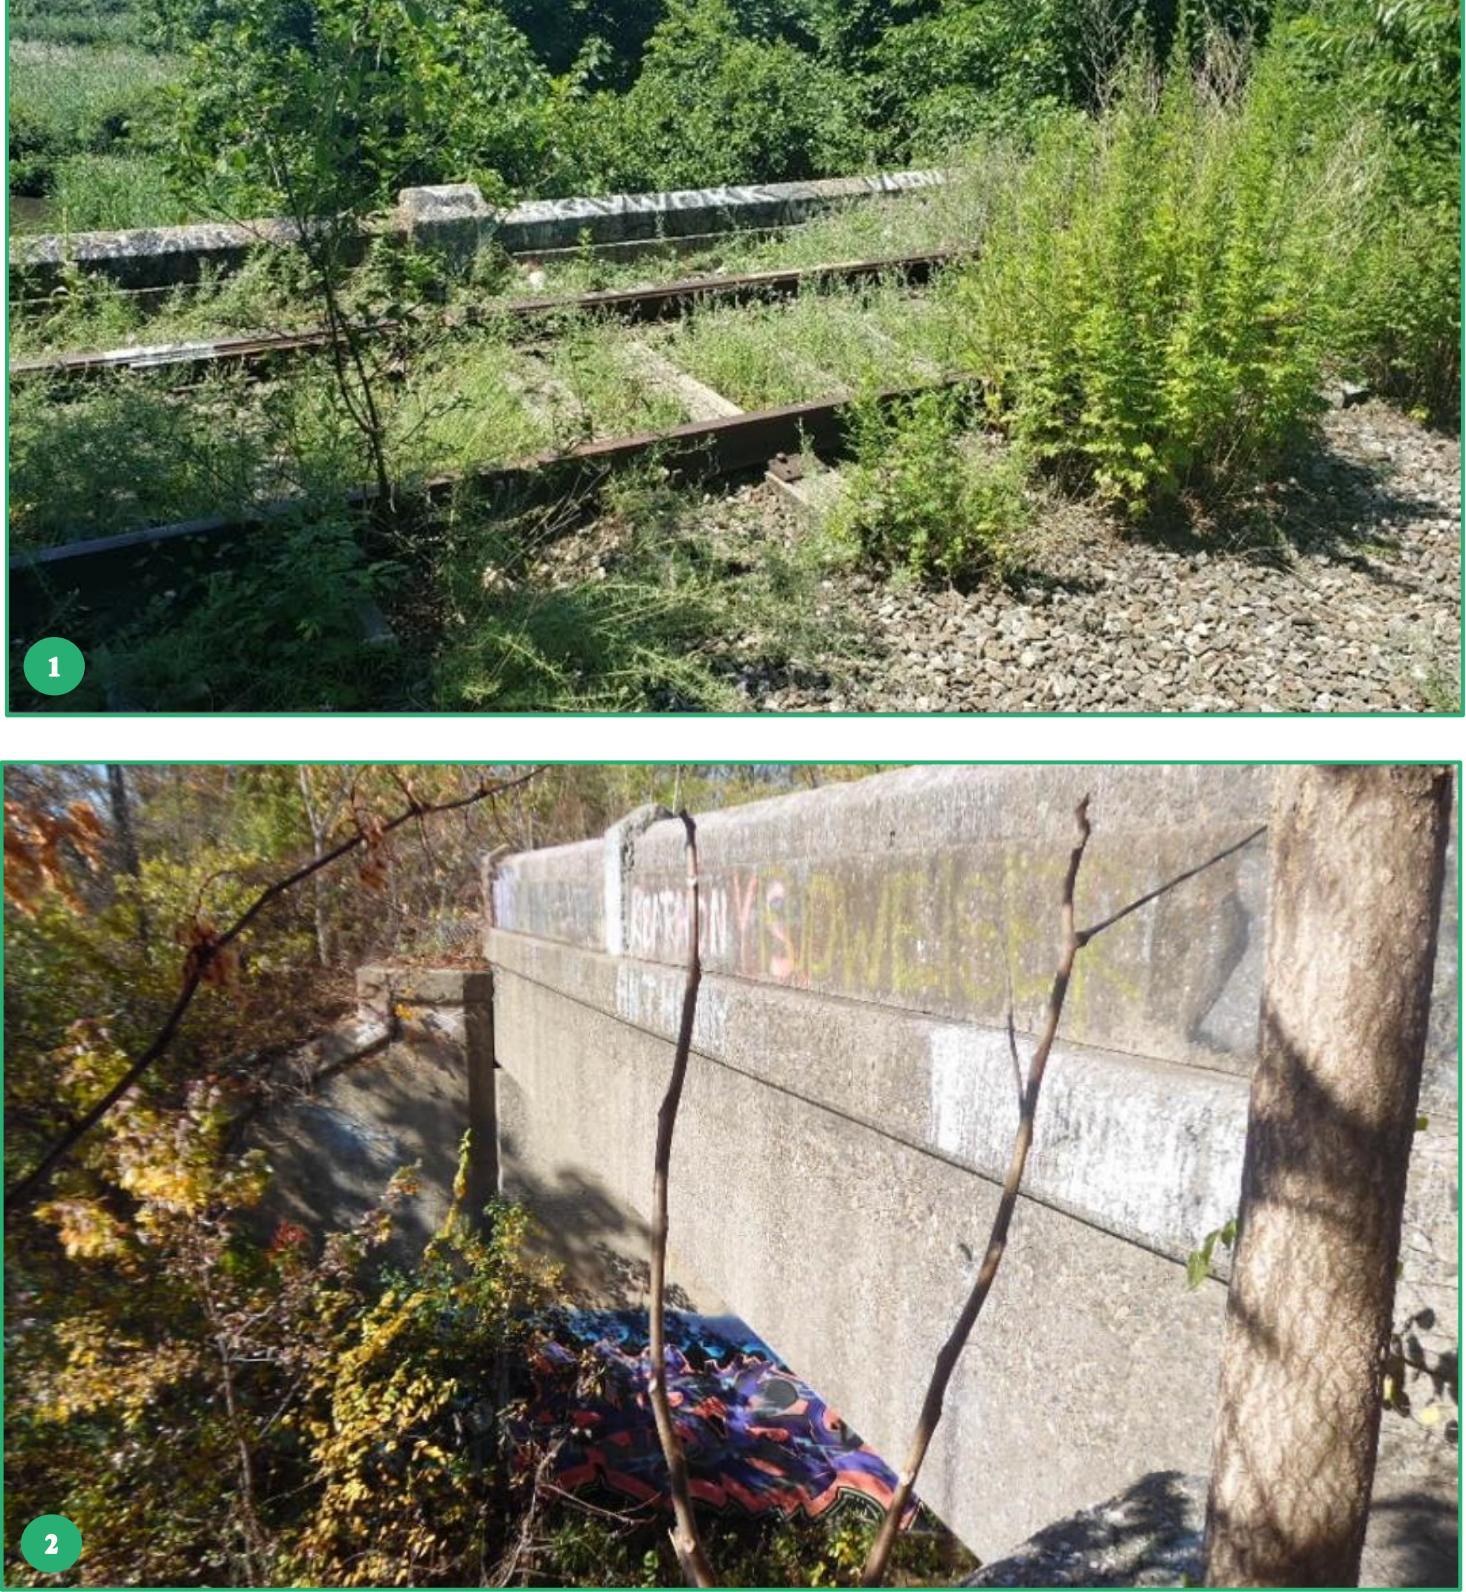
This structure is a single span, 33-foot-long concrete bridge crossing a stream. Since this bridge crosses private property (potentially another abandoned rail line), observations during site visits were unable to verify the condition of the underside of the superstructure and the substructure. It does appear that the superstructure and the abutments are in good condition where they were visible.

This bridge does not appear to have damage or deterioration that significantly reduces the load carrying capacity of the bridge.

- 1. Looking south
- 2. Looking northwest

• Obtain and evaluate existing bridge drawings and maintenance/repair history, and perform load rating

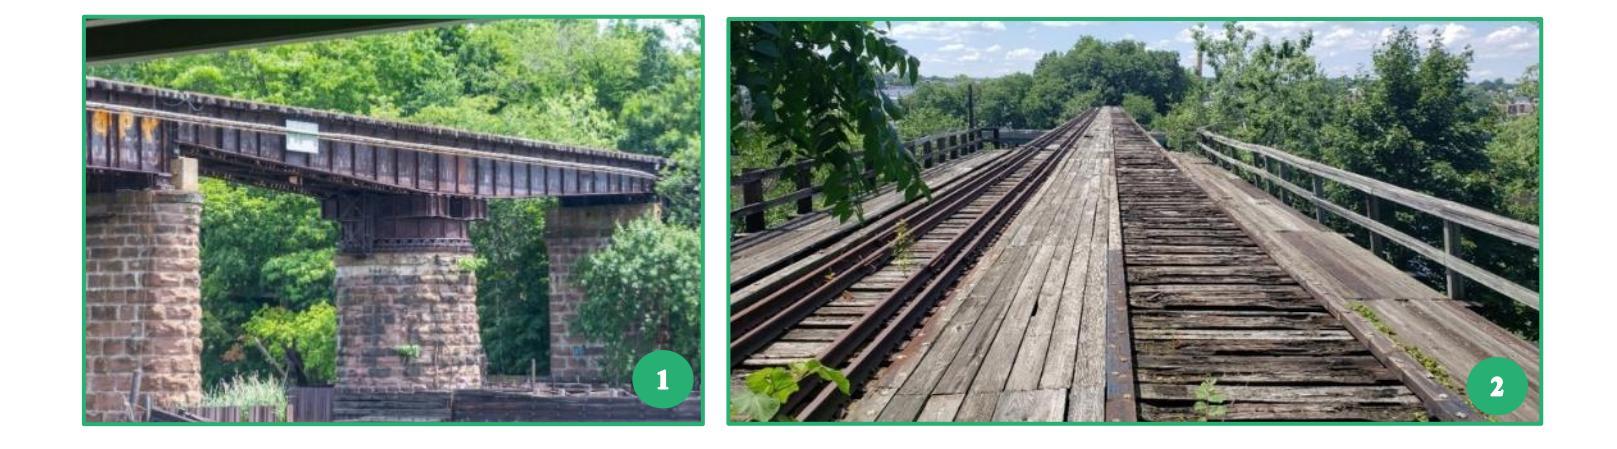
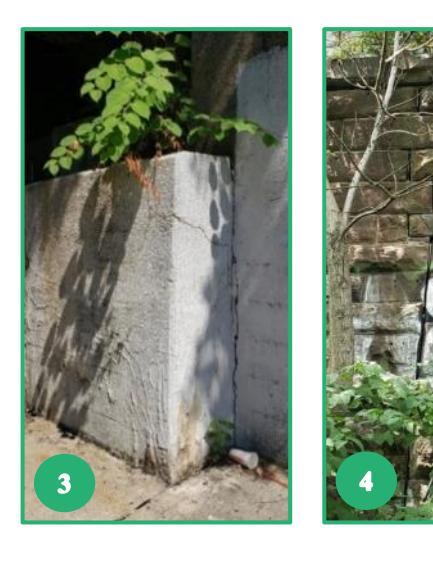
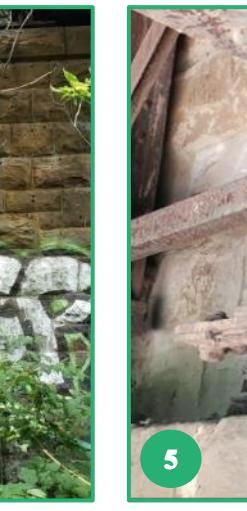
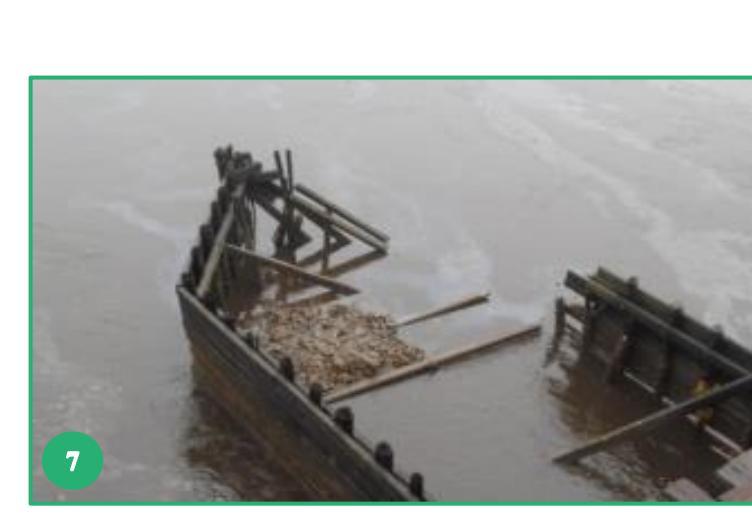
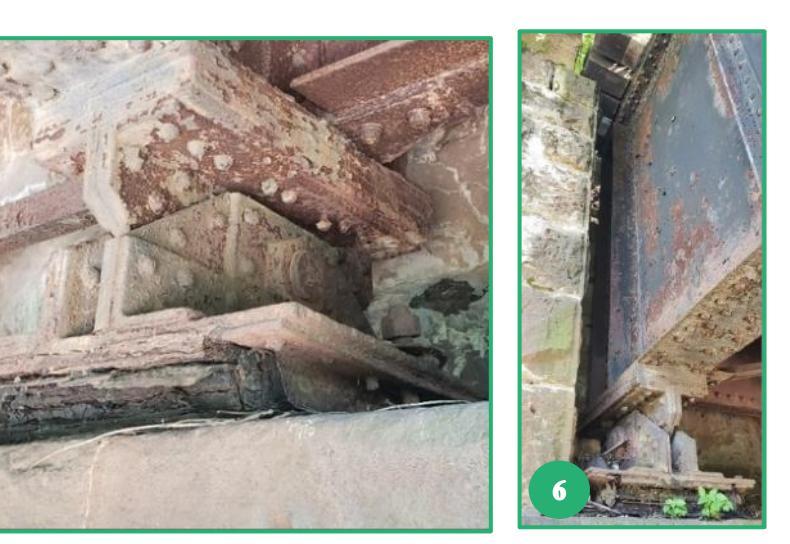
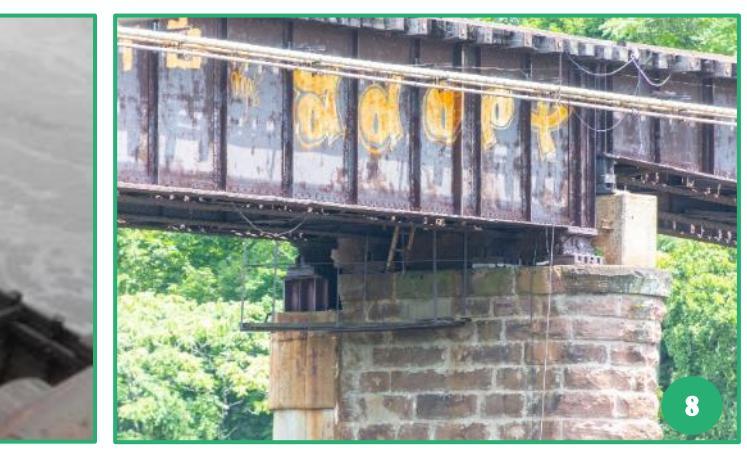
The superstructure appeared to be in relatively good condition with some minor corrosion. The bearings at the abutments are also exhibiting corrosion. The piers for the outermost spans appear to be in good condition and the abutment on the eastern side exhibits only minor cracking. The abutment on the western side exhibits more severe cracking which appears to be associated with a past widening or repairs to the original abutment. The substructure in the river was more difficult to assess based on accessibility and visibility. The components that were visible appeared to be in fair condition and to have been rehabilitated in the past. Where the masonry abutments needed rehabilitation in the past it was carried out using concrete. The river fender system, however, exhibits severe deterioration.

- 1. Moveable span looking north
- 2. Looking west
- 3. East concrete abutment exhibiting some cracking
- 4. West masonry abutment has a major crack due to past expansion of the abutment
- 5. Corrosion of bearings at the eastern side of the bridge
- 6. Corrosion in girders and bearings
- 7. Deterioration of fender system
- 8. Evidence of past rehabilitation measures used on the bearings at one of the piers

In order to convert this bridge to a greenway, the condition of the substructure in the water will have to be verified. It would be beneficial to have more information on the design and materials of the masonry piers, the moveable superstructure, and the foundations in the river.

- Obtain and evaluate existing bridge drawings and maintenance/repair history, in particular the measures taken to close the movable span and previous repairs made to masonry piers
- Evaluate the vessel collision risk to determine the extent of repair required for the fender system
- Detailed inspection of structure to identify locations and extent of deterioration across the structure, including an underwater inspection to review the condition of the substructure below the waterline and condition
- Perform load rating calculations based on the drawings to verify load capacity

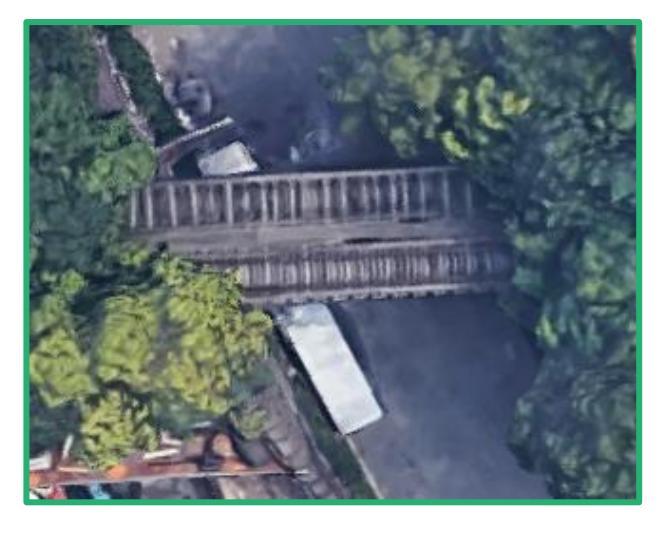
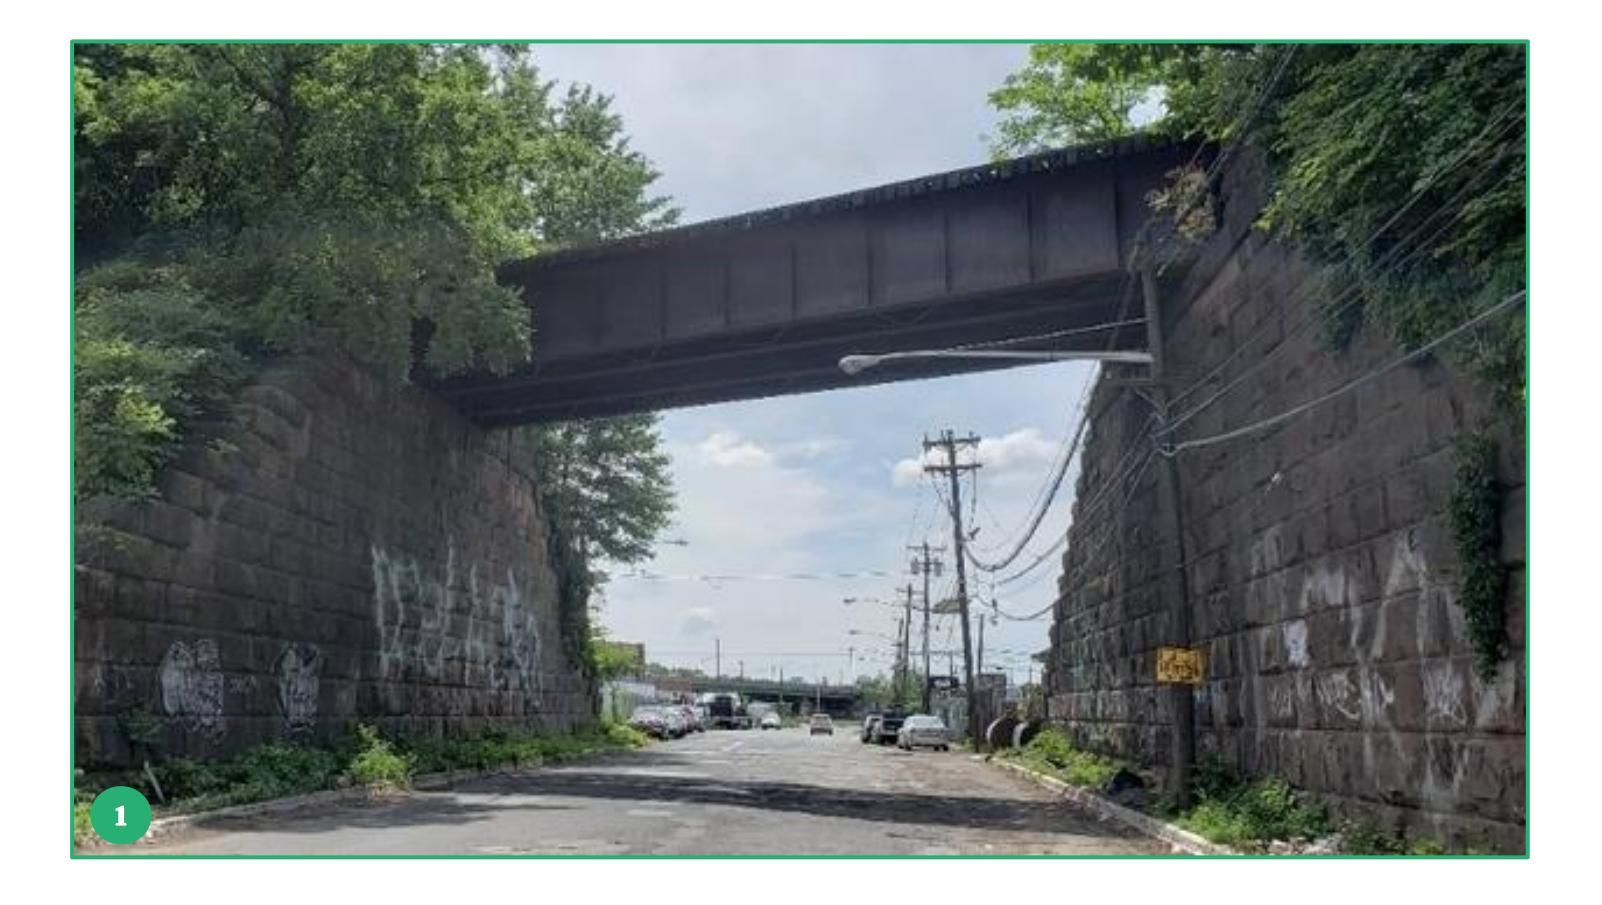
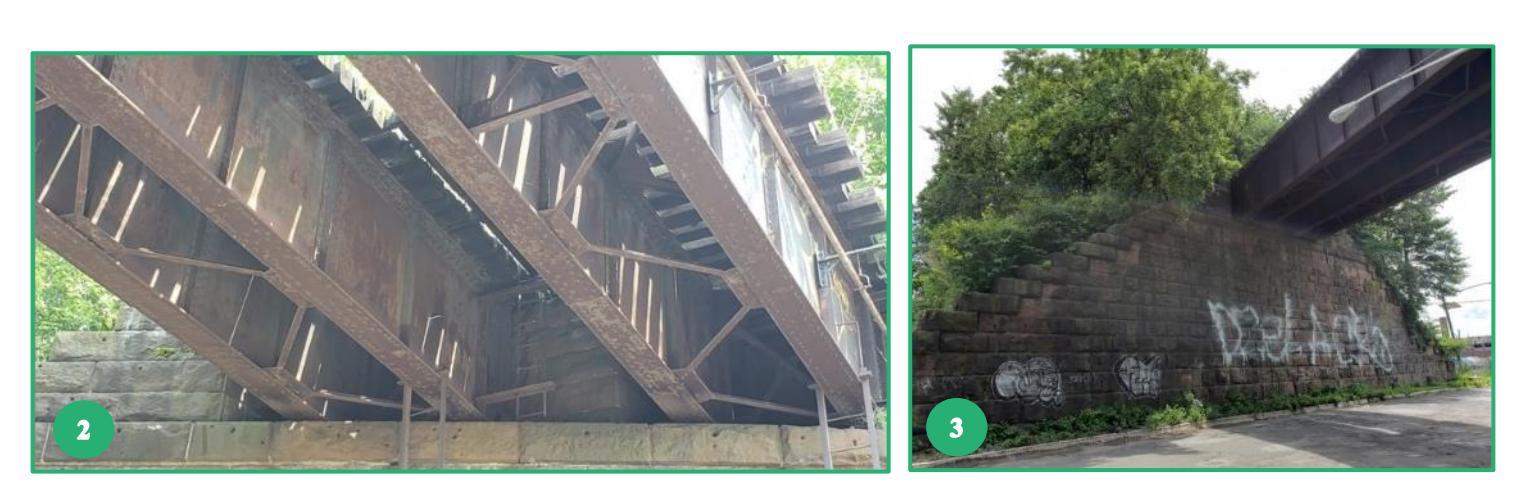
The bridge crossing McCarter Highway is a 66-foot-long, single span bridge with steel girders and masonry abutments. While the superstructure exhibits some corrosion, the overall condition of the bridge is good.

This bridge does not appear to have damage or deterioration that significantly reduces the load carrying capacity of the bridge.

- 1. Looking south
- 2. Minor corrosion on the underside of the girders
- 3. Looking east

• Obtain and evaluate existing bridge drawings and maintenance/repair history, and perform load rating

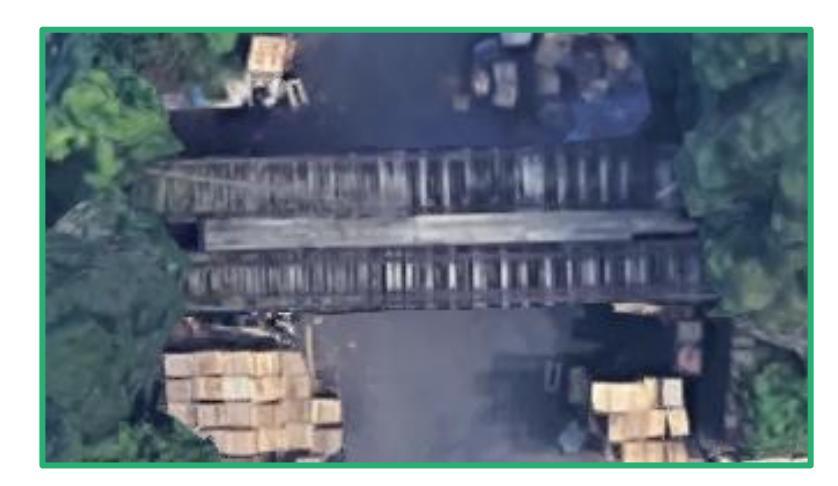
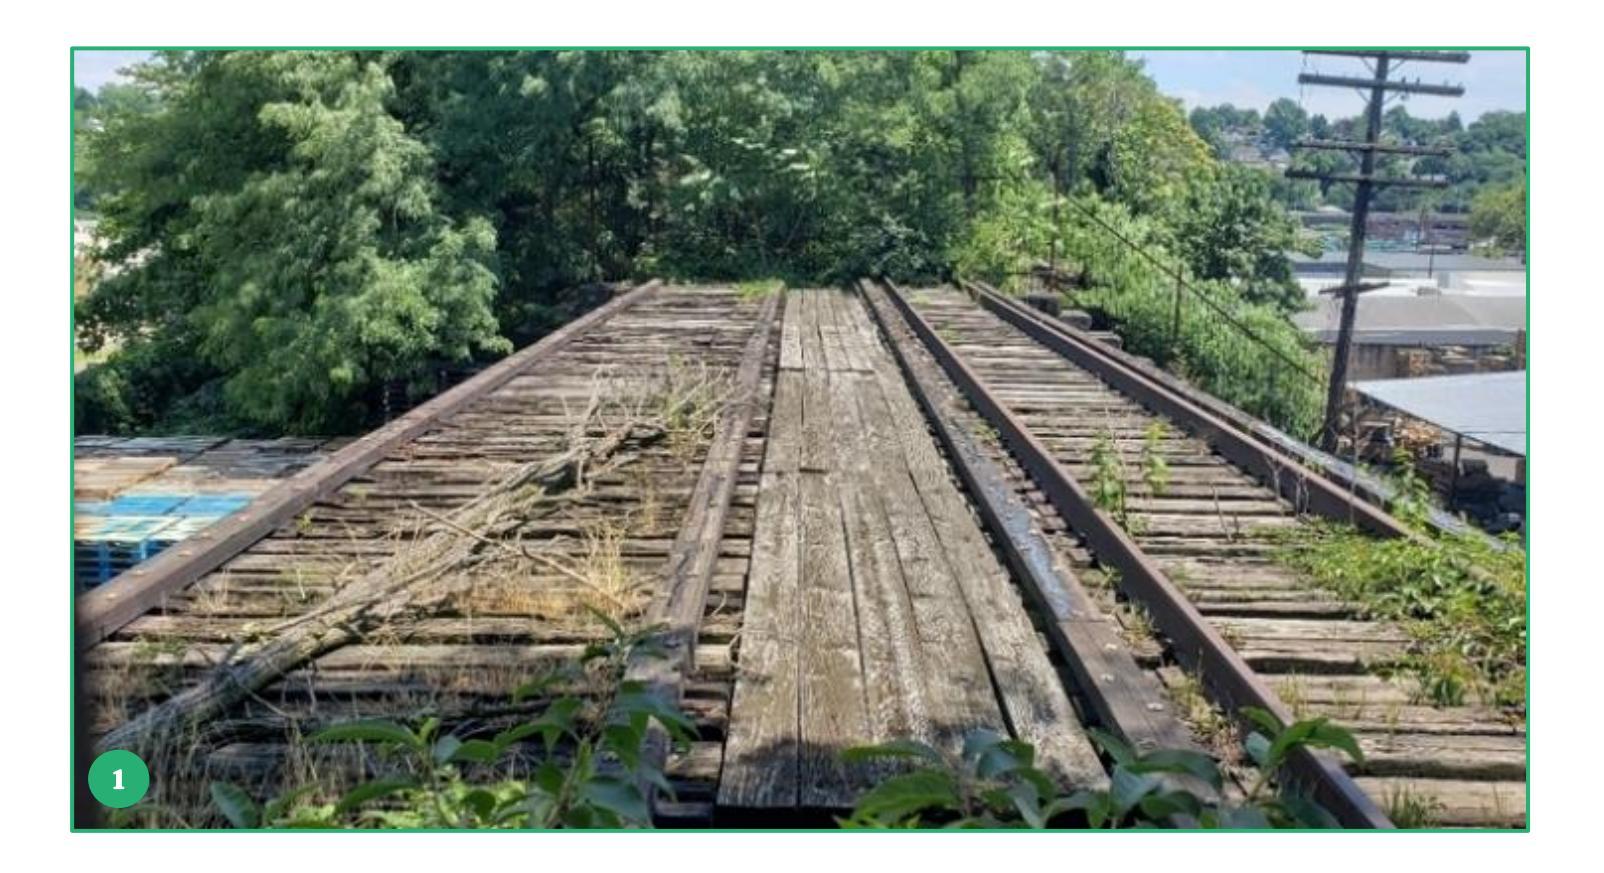
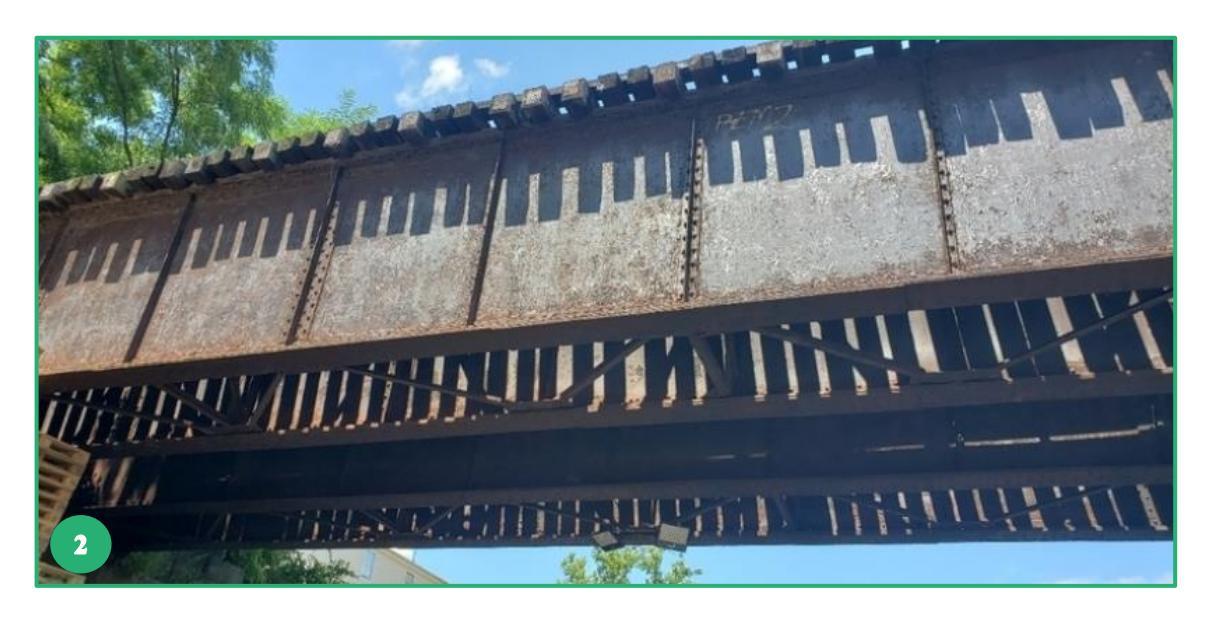
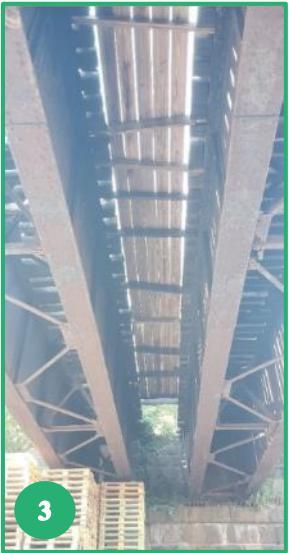
The structure at MP 7.88 crosses a private lot. It is an 85-foot-long, single span bridge with steel girders and masonry abutments. The steel girders show some corrosion but generally appear to be in fair condition.

This bridge does not appear to have damage or deterioration that significantly reduces the load carrying capacity of the bridge depending on the condition of the substructure.

- 1. Looking east
- 2. Looking north
- 3. Minor corrosion on the underside of the girders

• Obtain and evaluate existing bridge drawings and maintenance/repair history, and perform load rating

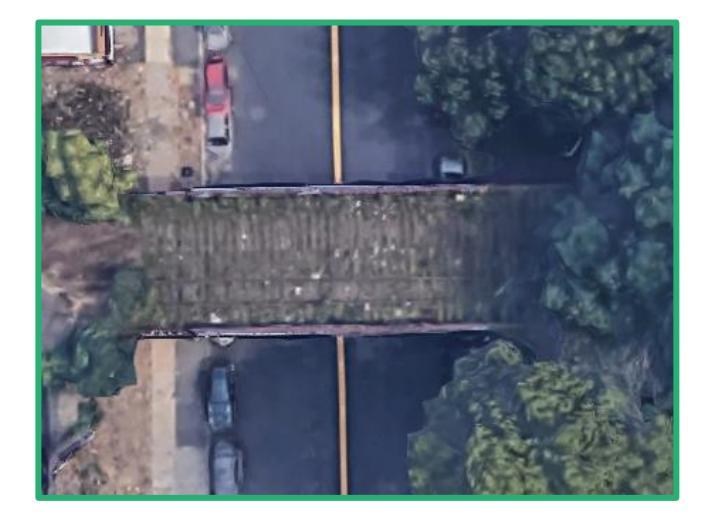
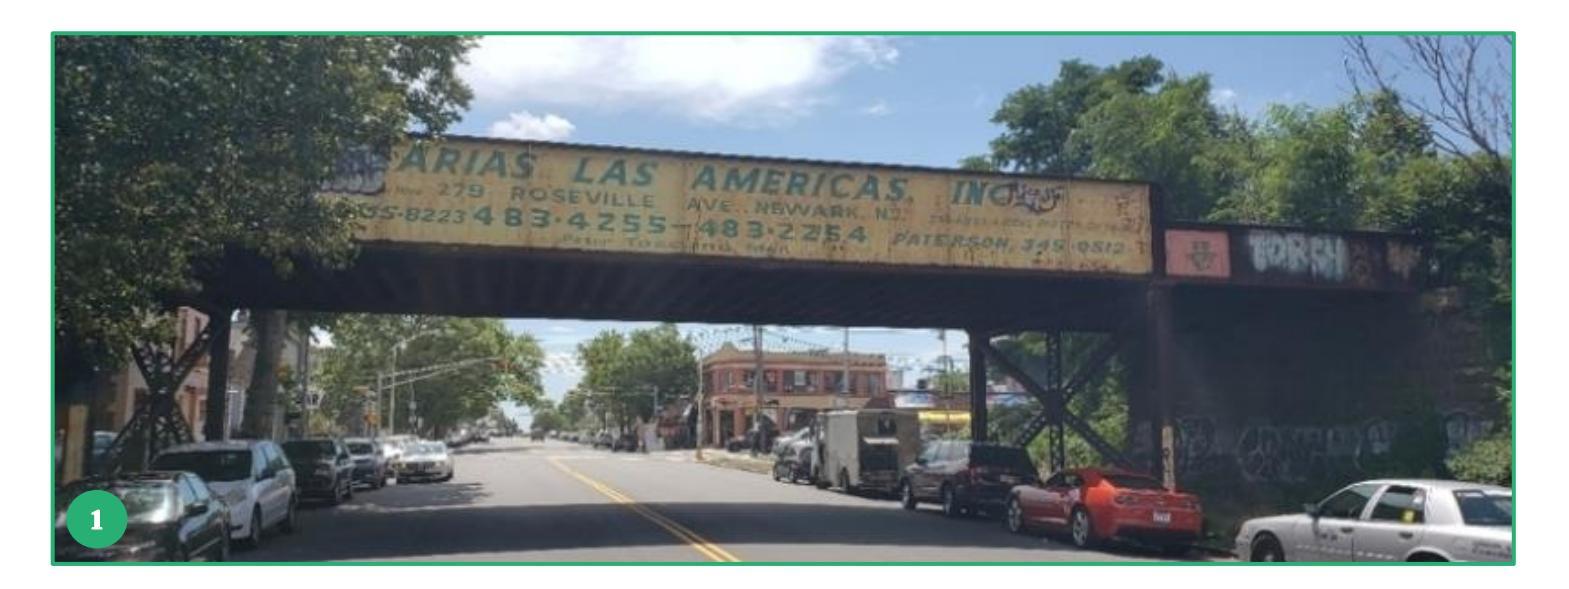
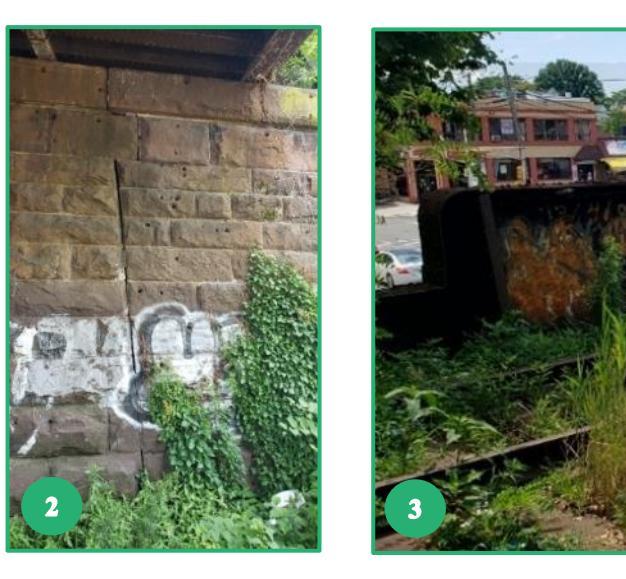
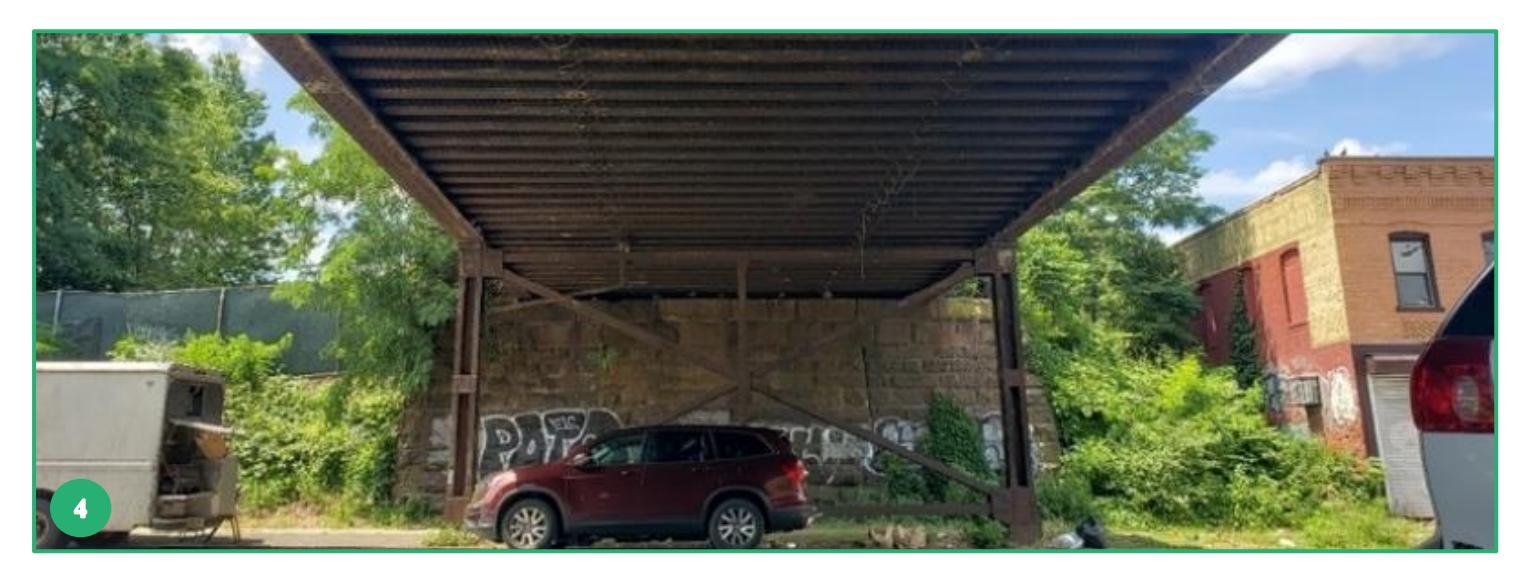
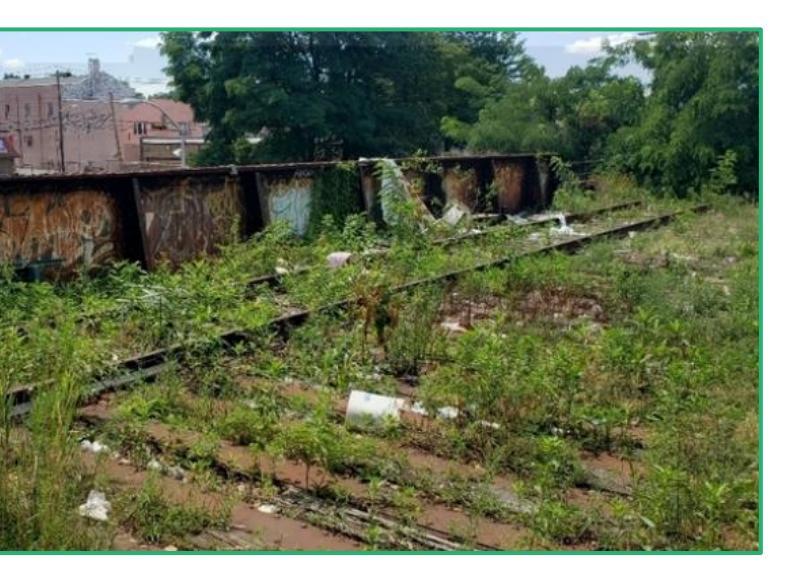
The bridge crossing Broadway is a 100-foot-long, three span bridge with steel girders and masonry abutments. The superstructure exhibits some minor corrosion and there is a crack in the western abutment. There is also a significant amount of vegetation growing on top of the deck.

While there are some minor issues in the superstructure and substructure, this bridge does not appear to have damage or deterioration that significantly reduces the load carrying capacity of the bridge.

- 1. Looking north
- 2. Crack in the western masonry abutment
- 3. Vegetation present on the deck
- 4. Looking east

• Obtain and evaluate existing bridge drawings and maintenance/repair history, and perform load rating

• If substandard vertical and horizontal clearances are not desired, the bridge could be replaced with a prefabricated truss pedestrian bridge in order to achieve the required height. Ramps and embankments would need to be constructed at each end. This option could potentially leave the existing abutments in place with the new bridge spanning above, but this would need to be studied to ensure they remain stable in

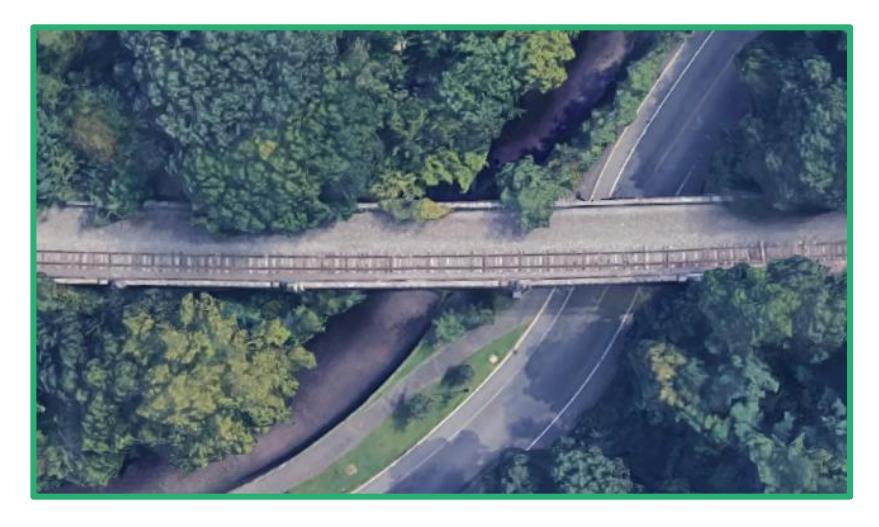
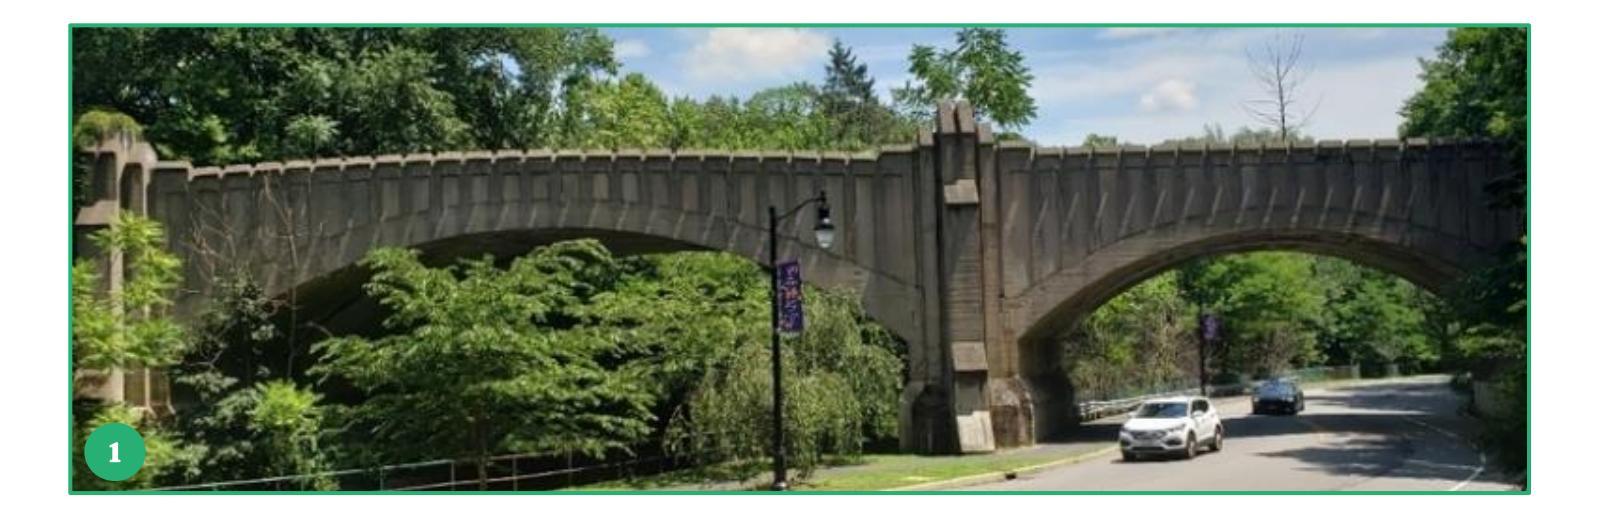
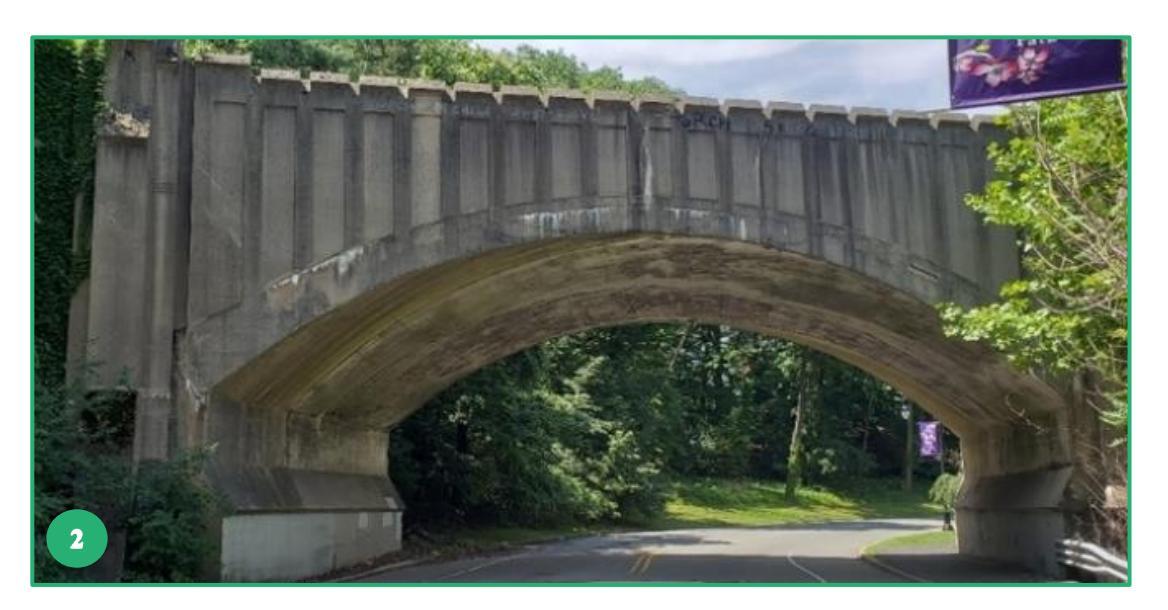
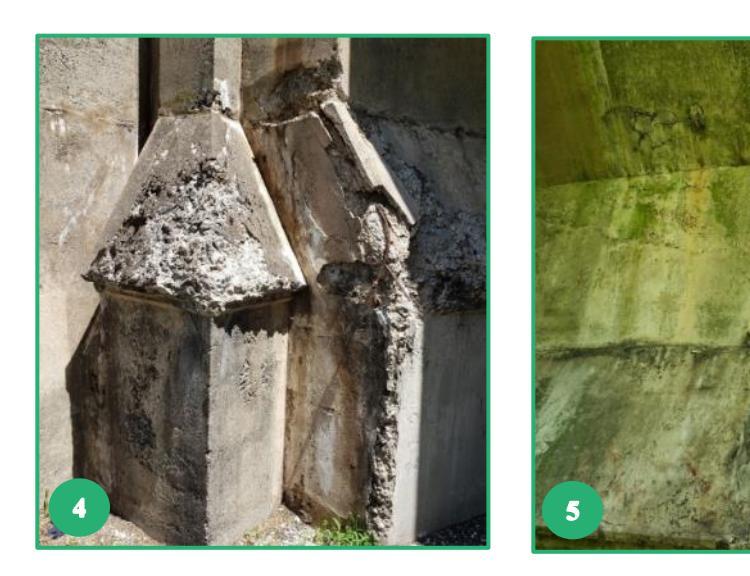
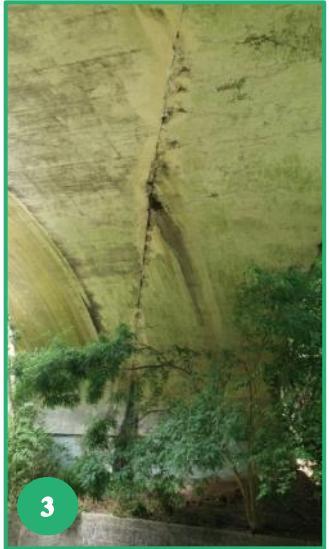
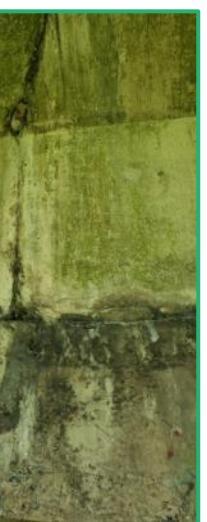
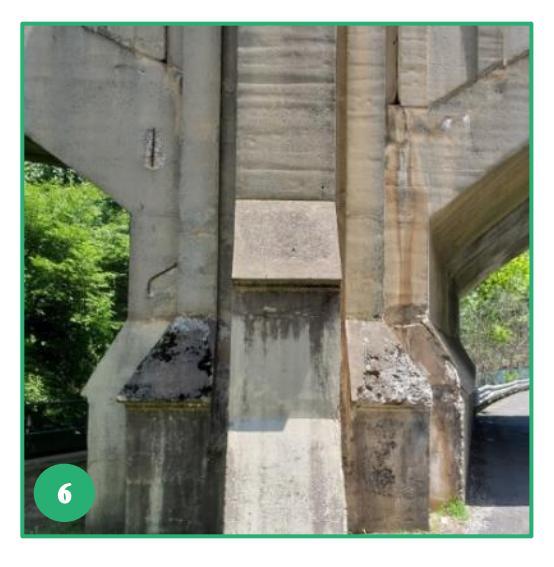
The structure at MP 8.85 is a 175-foot-long, three span concrete arch bridge that crosses Branch Brook Park Drive, Second River, and a path through the park. There is some localized spalling on one of the piers, as well as minor cracking and discoloration at the construction joint underneath the deck. Overall, however, the bridge is in good condition.

This bridge does not appear to have damage or deterioration that significantly reduces the load carrying capacity of the bridge.

- 1. Looking northeast
- 2. Spalling and discoloration seen looking southwest
- 3. Spalling of concrete at construction joint under southern most span
- 4. Spalling at the base of one of the piers
- 5. Spalling and discoloration on the side of one of the piers
- 6. Spalling at the base of one of the piers

• Obtain and evaluate existing bridge drawings and maintenance/repair history, and perform load rating calculations based on the drawings to verify load capacity
