# Essex Hudson Greenway Structures Report

# Arup USA, Inc 77 Water Street

Final 2 | September 28, 2020

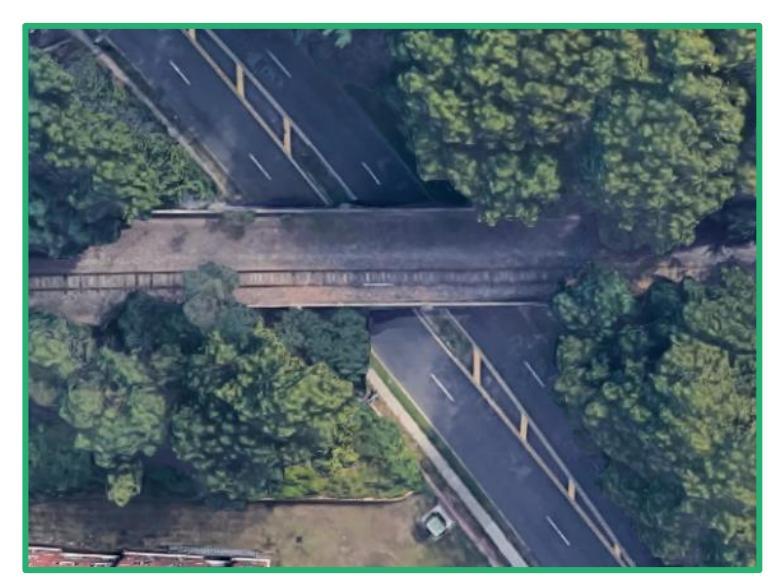
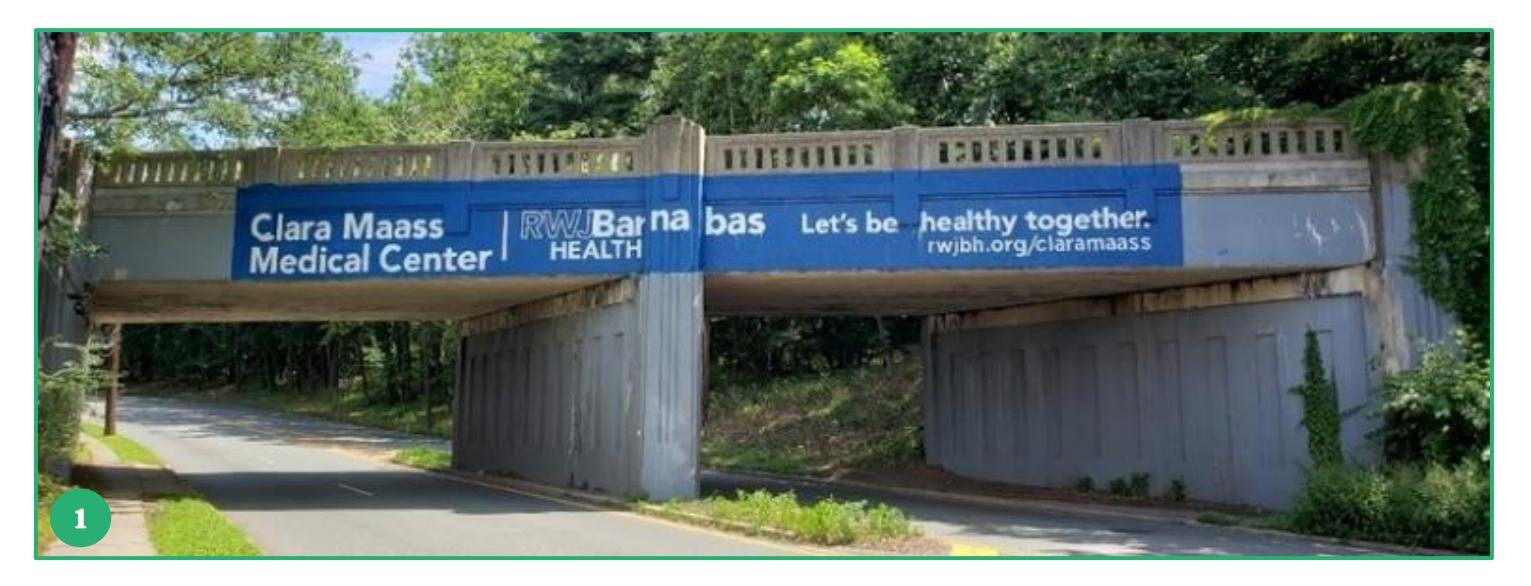
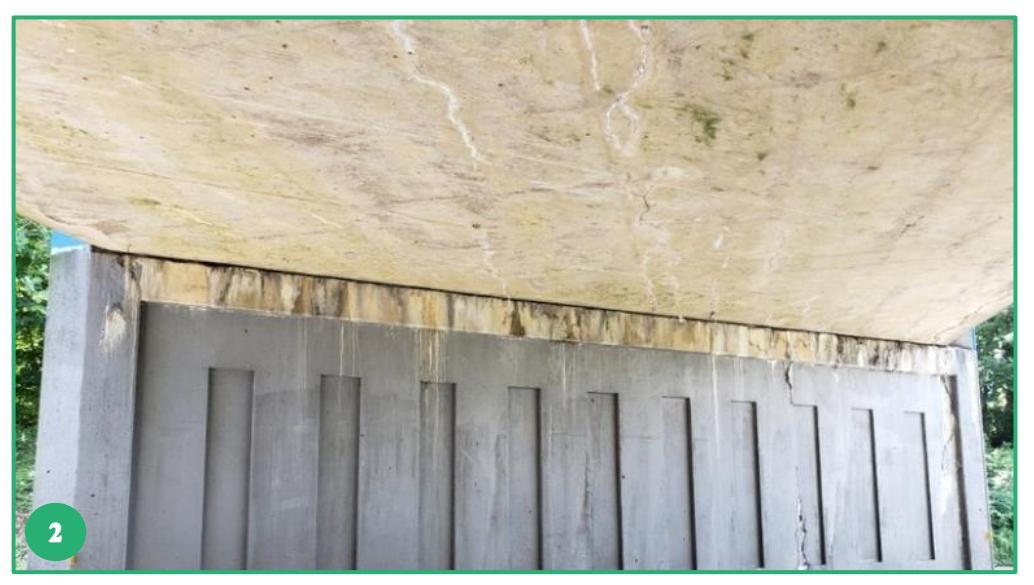
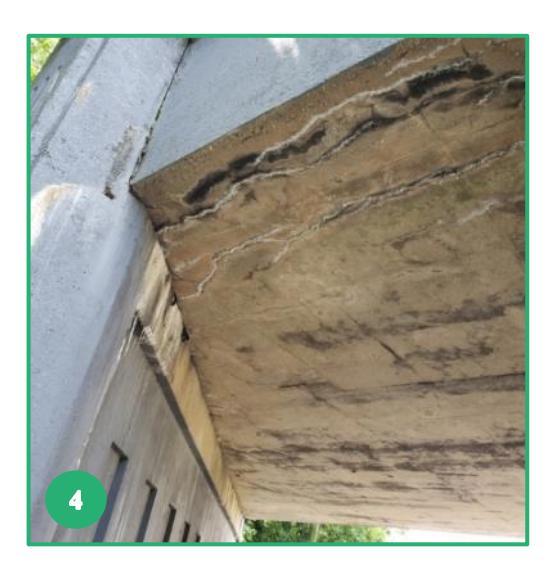
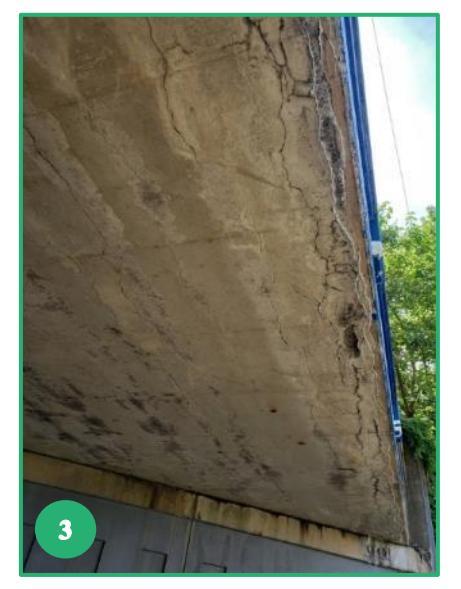
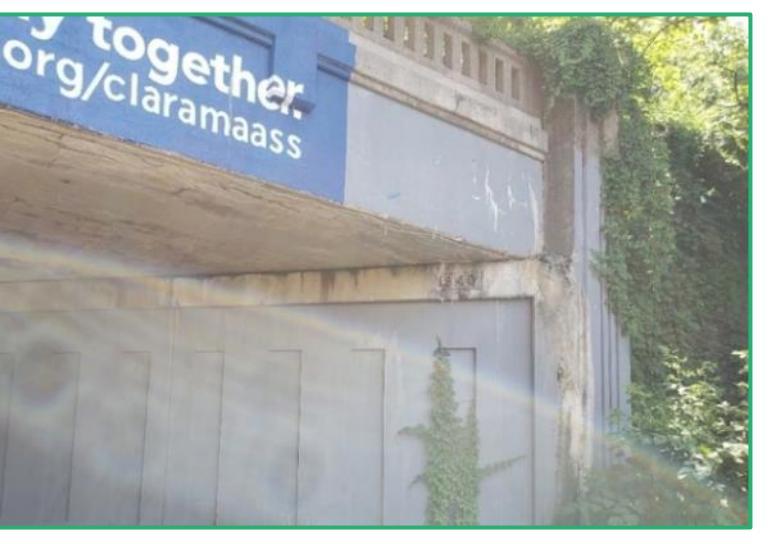
The bridge crossing Franklin Ave is an 86-foot-long, two span concrete structure. There is some damage to one of the abutments that may be evidence of an impact and the underside of the deck exhibits longitudinal cracking. However, overall the bridge is in fair condition.

This bridge does not appear to have damage or deterioration that significantly reduces the load carrying capacity of the bridge.

- 1. Looking east
- 2. Cracking underneath the deck and discoloration at the top of the pier
- 3. Cracking underneath the deck
- 4. Cracking and discoloration underneath the deck
- 5. Spalling at the southern abutment and cracking in the superstructure

• Obtain and evaluate existing bridge drawings and maintenance/repair history, and perform load rating

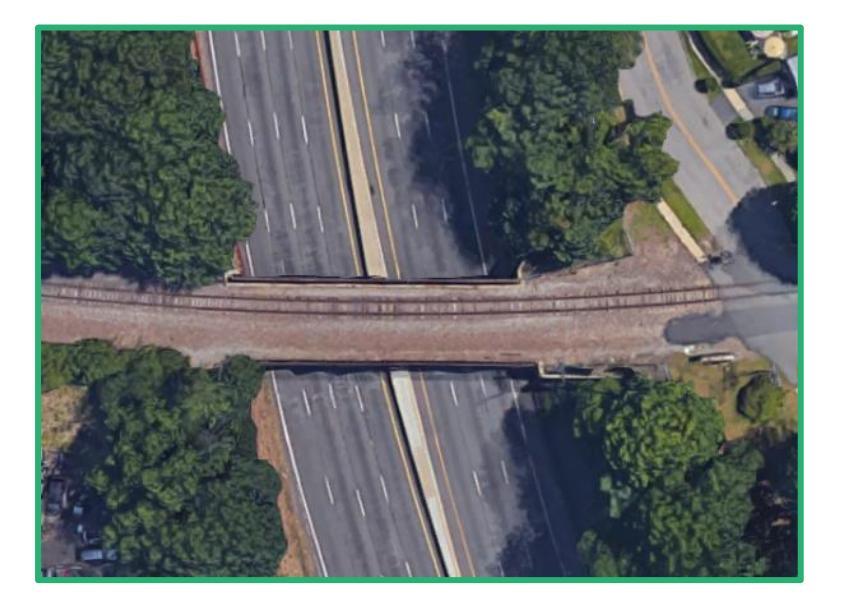
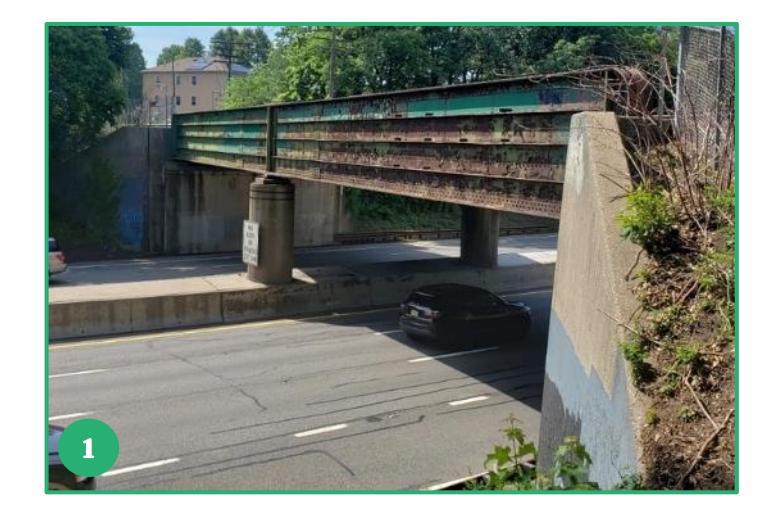
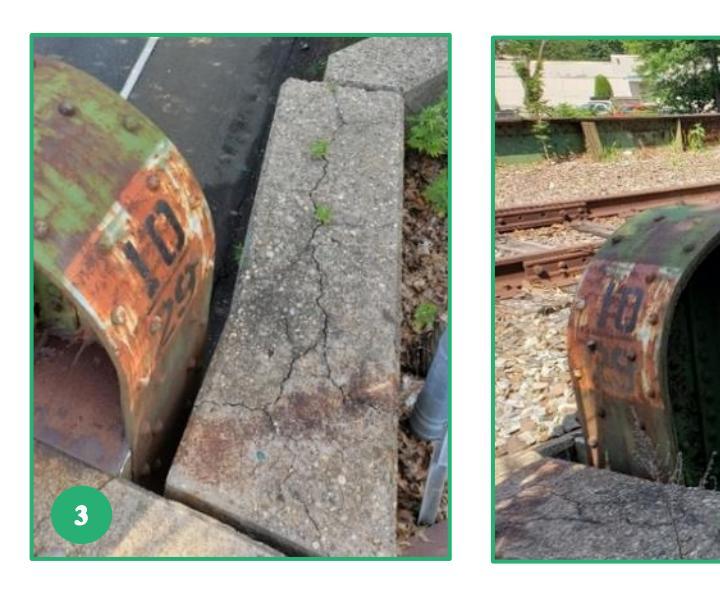
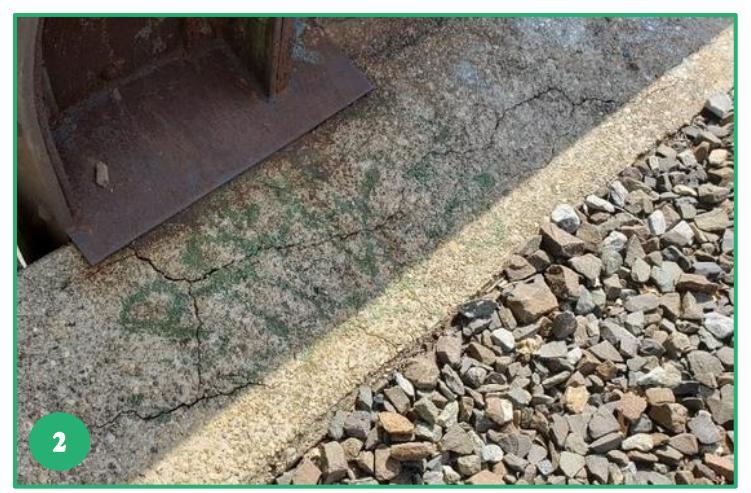
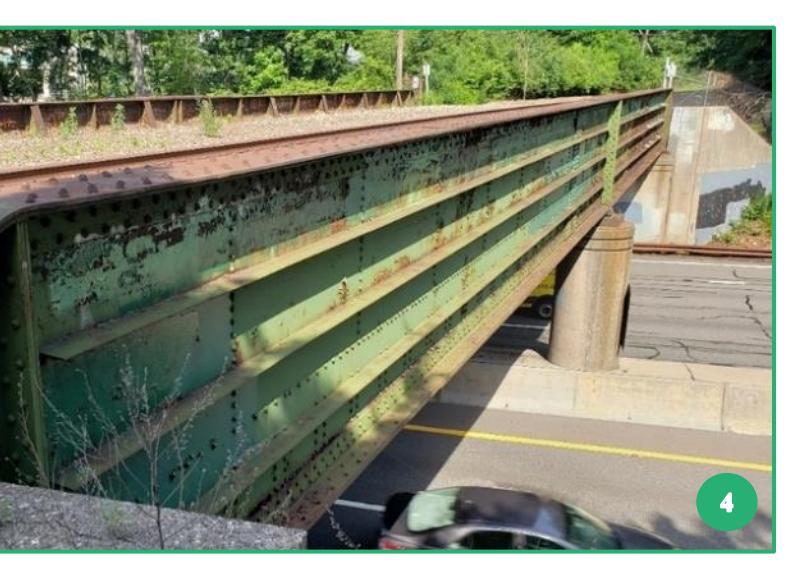
The bridge crossing the Garden State Parkway is 120-foot-long, two span structure with two steel girders and a concrete substructure. The superstructure is in good condition despite some minor corrosion. The abutments have been repaired in the past and are also in good condition. There is some cracking above the wingwalls.

This bridge does not appear to have damage and deterioration that significantly reduces the load carrying capacity of the bridge.

- 1. Corrosion on the girders looking south
- 2. Cracking in the concrete above the abutment
- 3. Cracking in the concrete above the wingwall
- 4. Looking north

• Obtain and evaluate existing bridge drawings and maintenance/repair history, and perform load rating calculations based on the drawings to verify load capacity

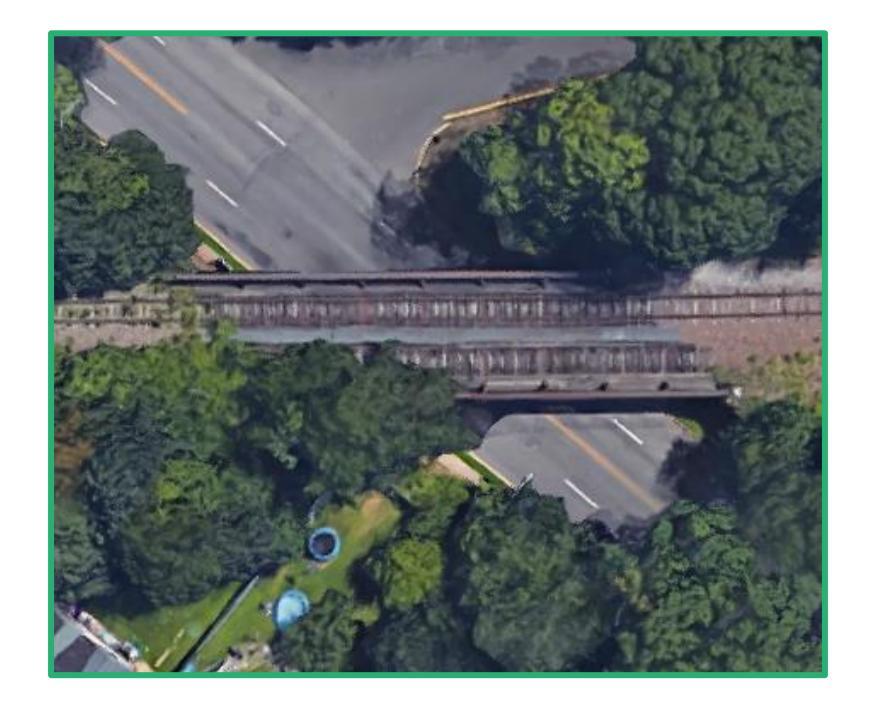
The bridge crossing JFK Drive is a 110-foot-long, one span structure with steel girders and masonry abutments. Despite some superficial rust, the bridge is in good condition. This bridge is a historic structure, originally spanning the Morris Canal, which traversed through New Jersey. Therefore, there is historic value in rehabilitating and retaining this bridge.

There is no obvious deterioration or damage that will significantly reduce the load carrying capacity of the bridge, and it can likely be rehabilitated using typical construction methods.

- 1. Looking north
- 2. Crack running horizontally in masonry under bearing
- 3. Looking east
- 4. Western masonry abutment
- 5. Corrosion and graffiti on girder

• Obtain and evaluate existing bridge drawings and maintenance/repair history, and perform load rating calculations based on the drawings to verify load capacity

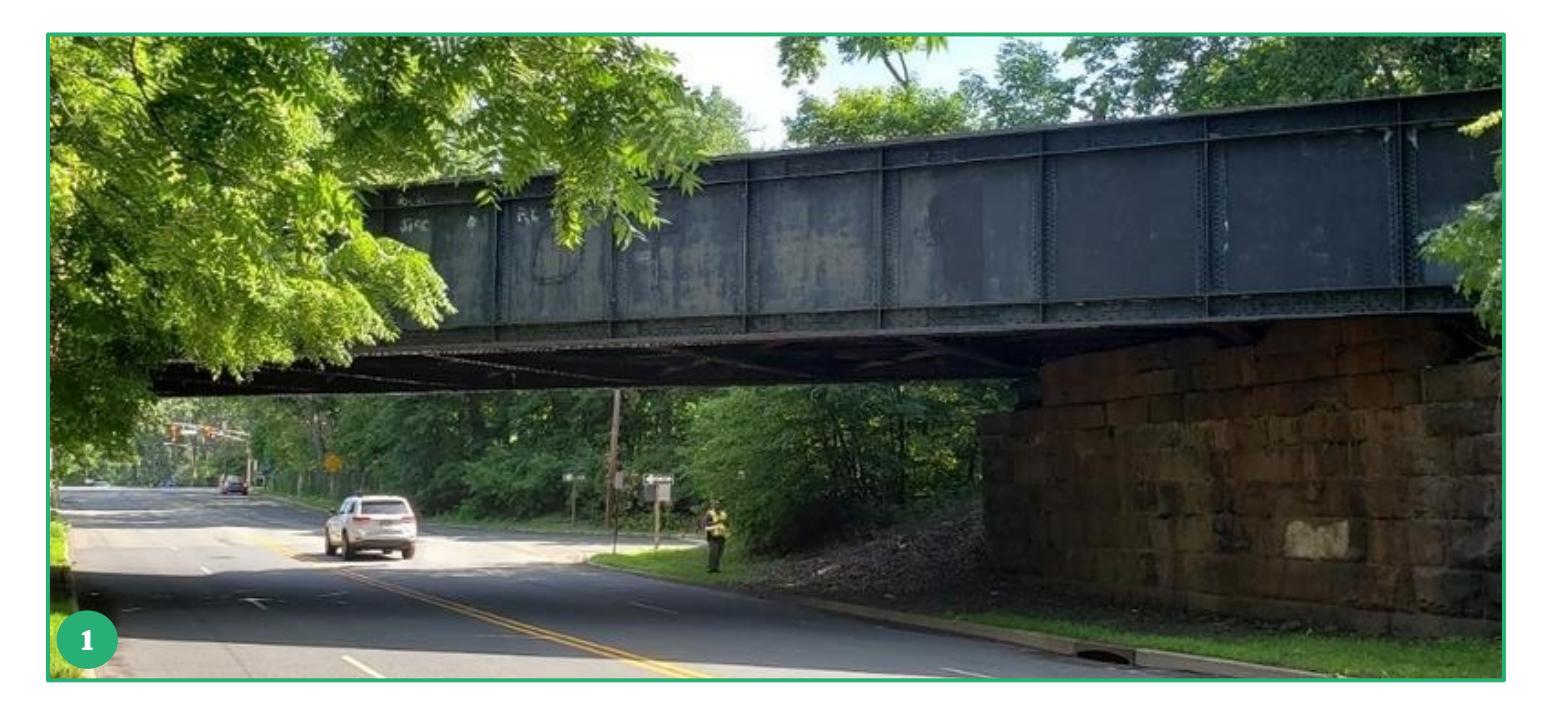
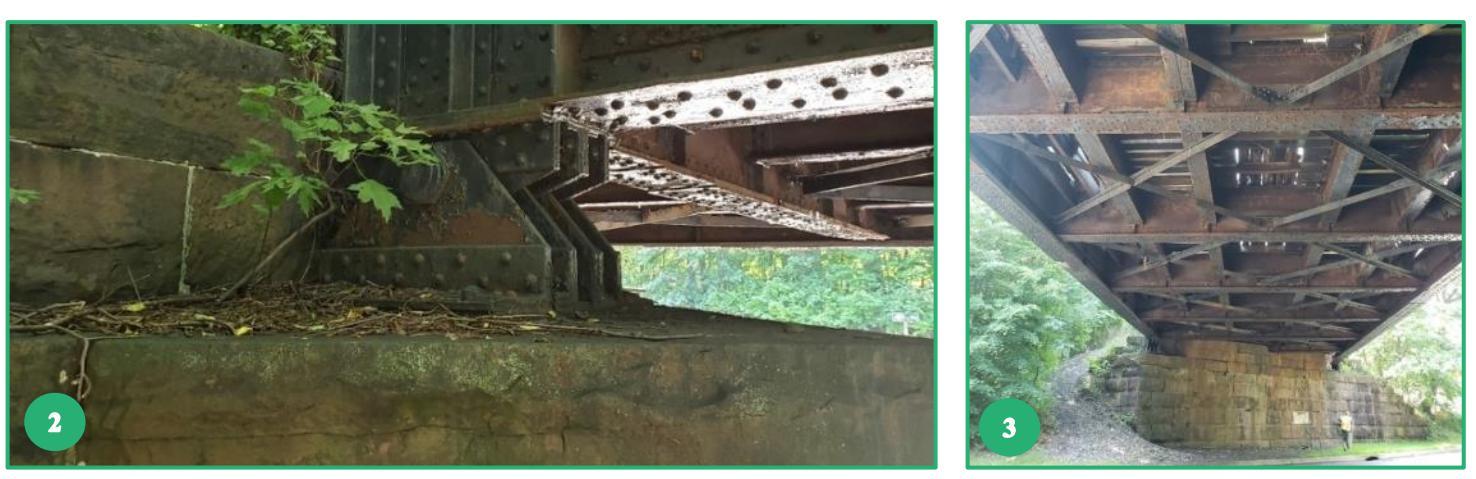
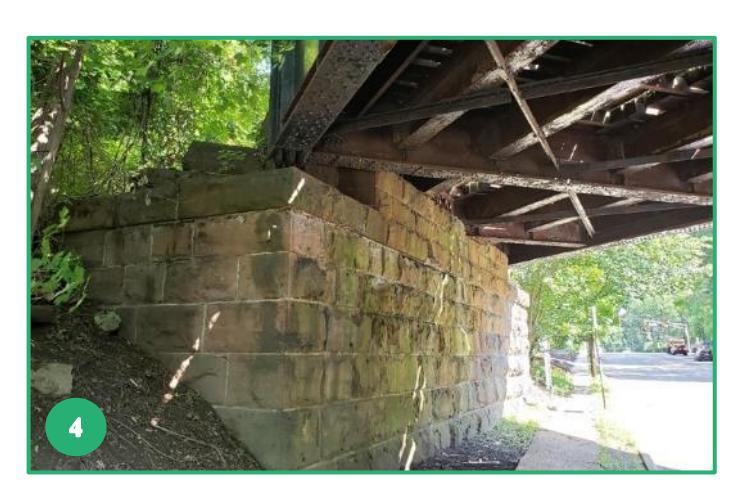
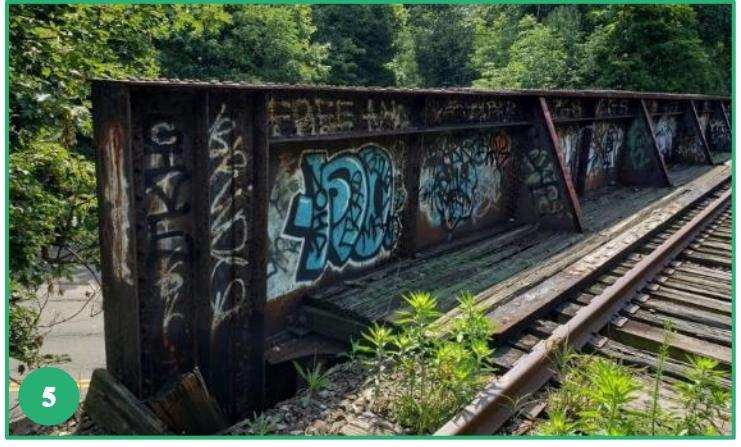
#### Table 17 – Review of MP 10.36 JFK Drive

Factor	Sub Factor	Key Observations	
	Type of bridge	Steel girders with masonry abutments	
Existing Conditions	Feature crossed	JFK Drive	
	Deterioration	<ul> <li>Minor deterioration in steel girders, cracking in masonry abutment bearing stones</li> <li>Deteriorated and rotten deck ties</li> </ul>	
	Design Standards	AASHTO LRFD Pedestrian Bridge Design Code	
	Load carrying capacity	• See comparison in Section 3.2.3	
	Redundancy	Potential – non-redundant through girders	
Structural Integrity	Seismic	Potential risk	
	Collision	• No risk – no vessel traffic	
	Hydraulics	• No risk – not in a waterway	
Safety	Geometry	• Adequate width and height for trail	
	Horizontal and Vertical Clearances	Adequate clearance over roadway	
	Railings and Fences	<ul><li>Railing required at both edges</li><li>Require fences over roadway</li></ul>	
	Emergency Vehicle Access	Adequate access available	
	Construction Methods	• Assume conventional construction methods can be used with land-based equipment

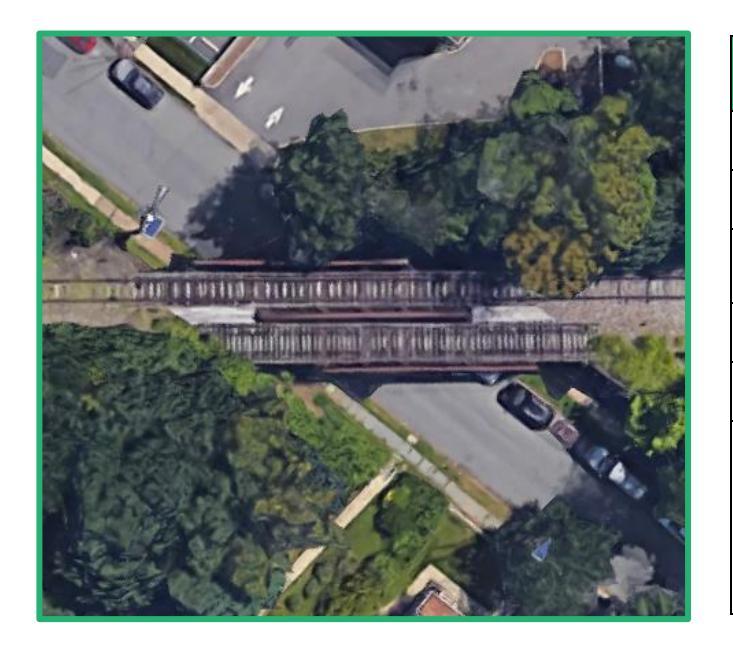
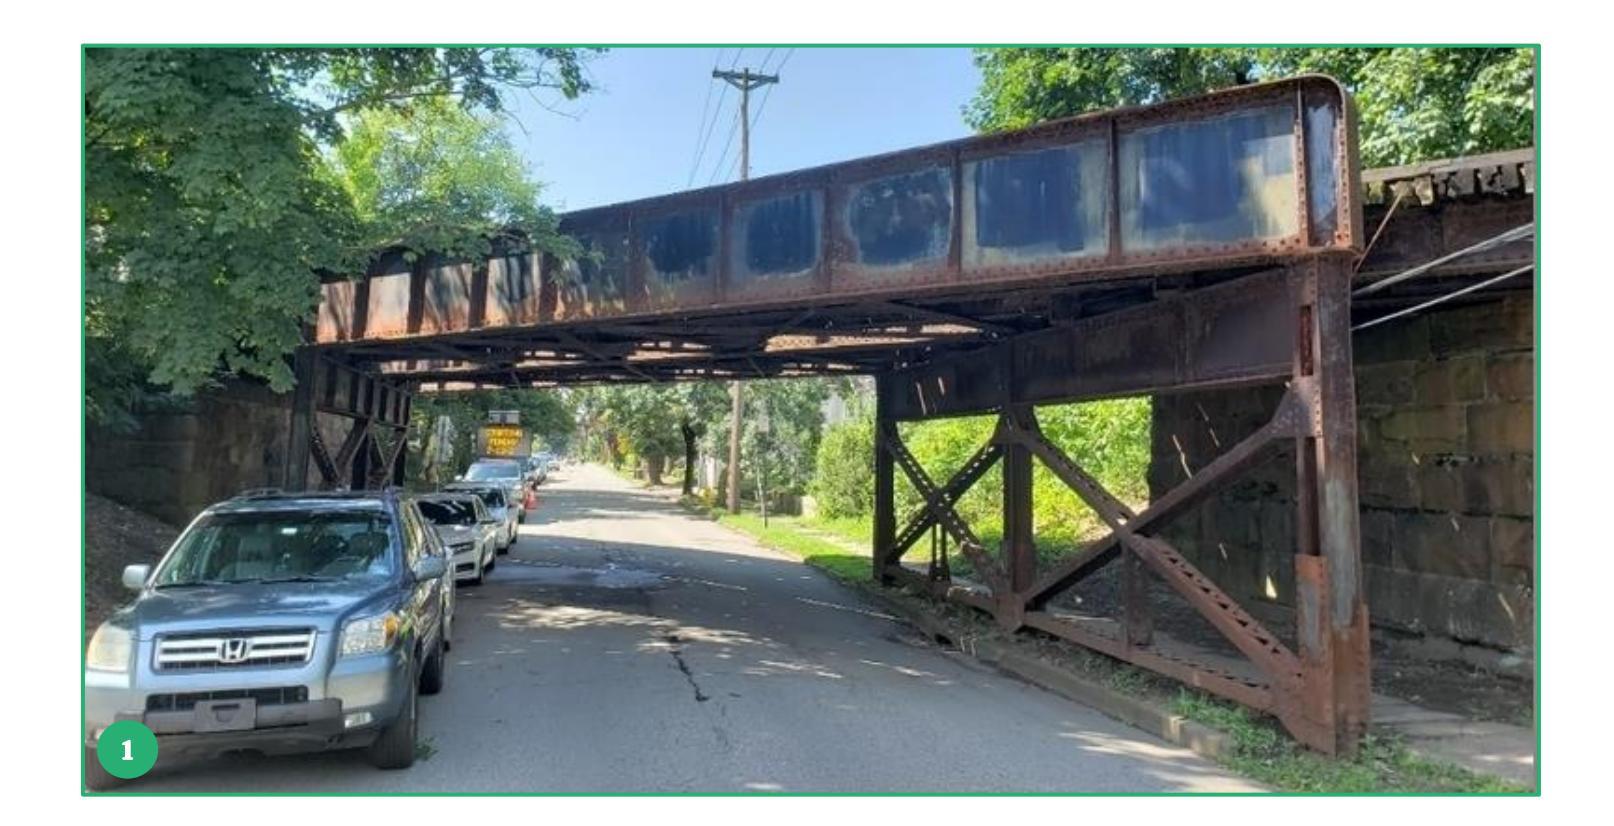
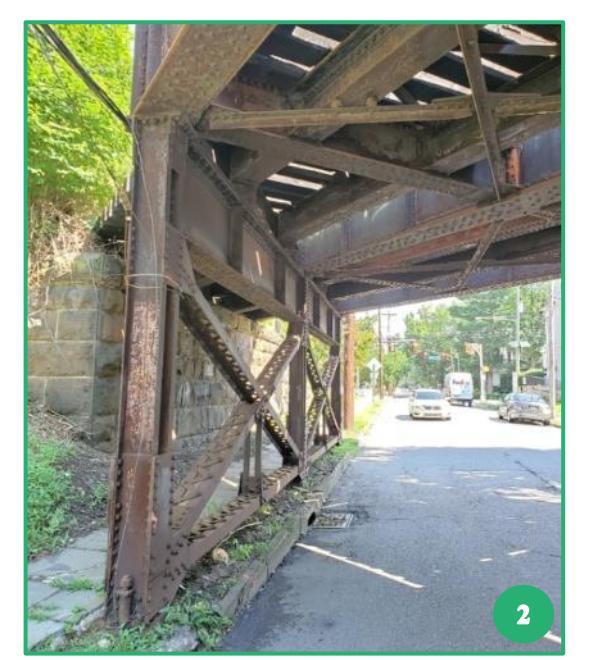
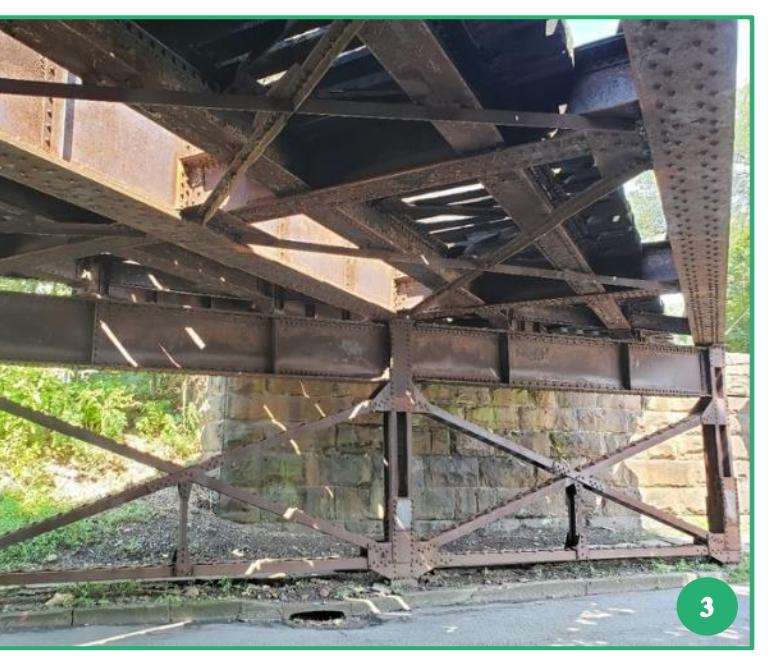
#### Table 18 – Review of MP 10.46 Spruce Street

The bridge that crosses Spruce St is an 80-foot-long, three span structure with a steel superstructure, steel piers, and masonry abutments. The structure exhibits minor corrosion but is otherwise in good condition.

This bridge does not appear to have damage or deterioration that significantly reduces the load carrying capacity of the bridge.

- 1. Looking north
- 2. Western abutment and pier
- 3. Western abutment and pier

Factor	Sub Factor	Key Observations
	Type of bridge	Steel girders with masonry abutment
Existing Conditions	Feature crossed	Spruce Street – local roadway
	Deterioration	<ul><li>Minor deterioration</li><li>Deteriorated and rotten deck ties</li></ul>
	Design Standards	AASHTO LRFD Pedestrian Bridge Design Code
	Load carrying capacity	• See comparison in Section 3.2.3
	Redundancy	• Potential – non-redundant through girders
Structural Integrity	Seismic	Potential risk
	Collision	• No risk – no vessel traffic
	Hydraulics	• No risk – not in a waterway
Safety	Geometry	<ul> <li>Adequate width and height for trail</li> <li>Note through girder at centerline of bridge, essentially dividing the bridge into two halves.</li> </ul>
	Horizontal and Vertical Clearances	• Potential risk – substandard vertical and horizontal clearances
	Railings and Fences	<ul><li>Railing required at both edges</li><li>Require fences over roadway</li></ul>

- Obtain and evaluate existing bridge drawings and maintenance/repair history, and perform load rating calculations based on the drawings to verify load capacity
- Consult with local transportation departments on nonstandard vertical and horizontal clearances

• If substandard vertical and horizontal clearances are not desired, the bridge could be replaced with a prefabricated truss pedestrian bridge in order to achieve the required height. Ramps and embankments would need to be constructed at each end. This option could potentially leave the existing abutments in place with the new bridge spanning above, but this would need to be studied to ensure they remain stable in

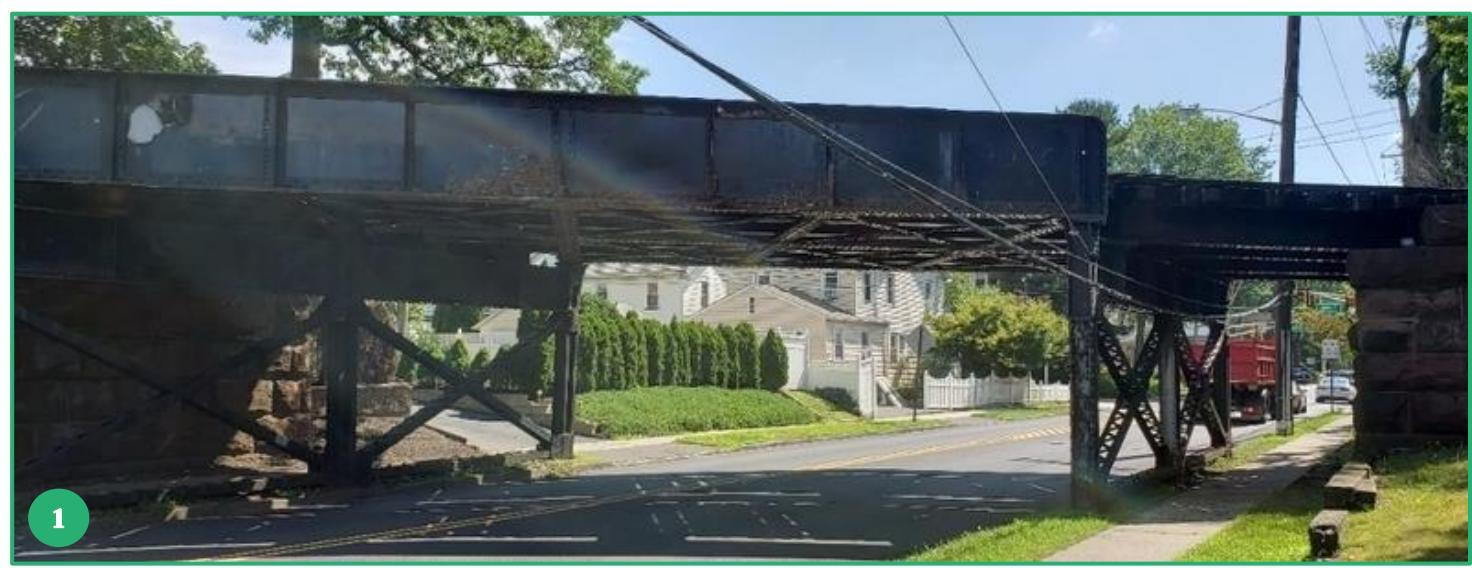
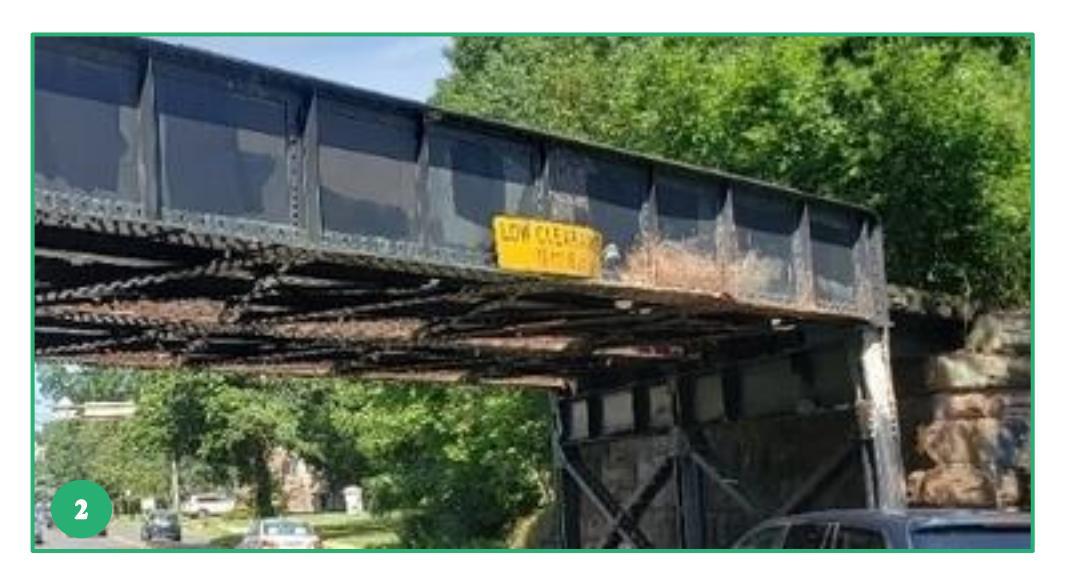
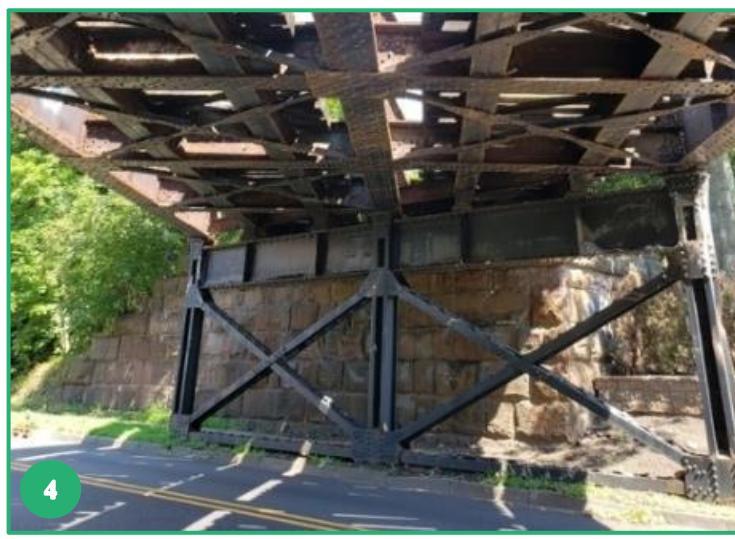
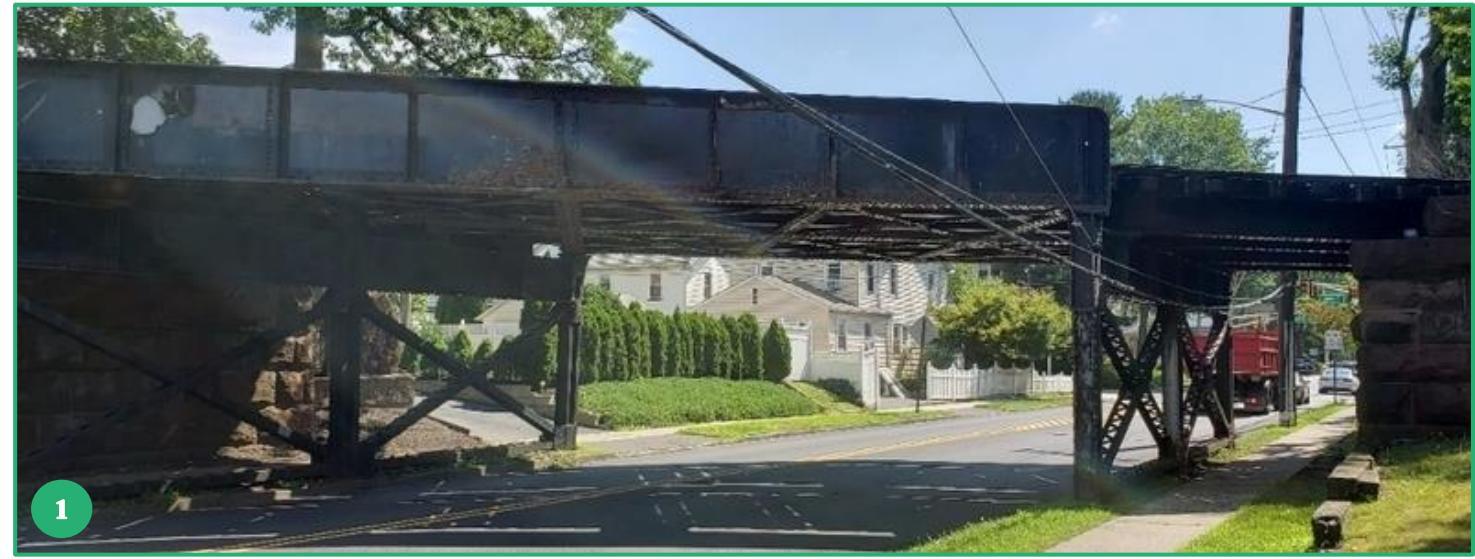
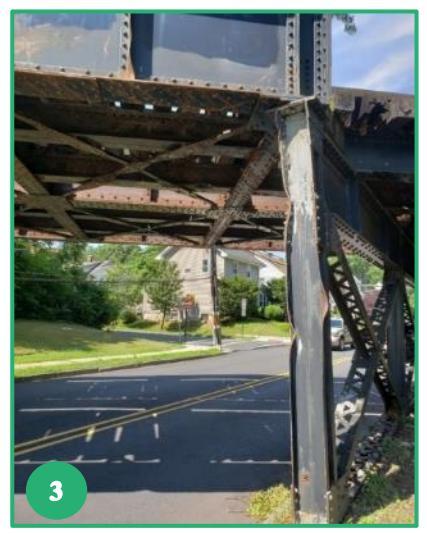
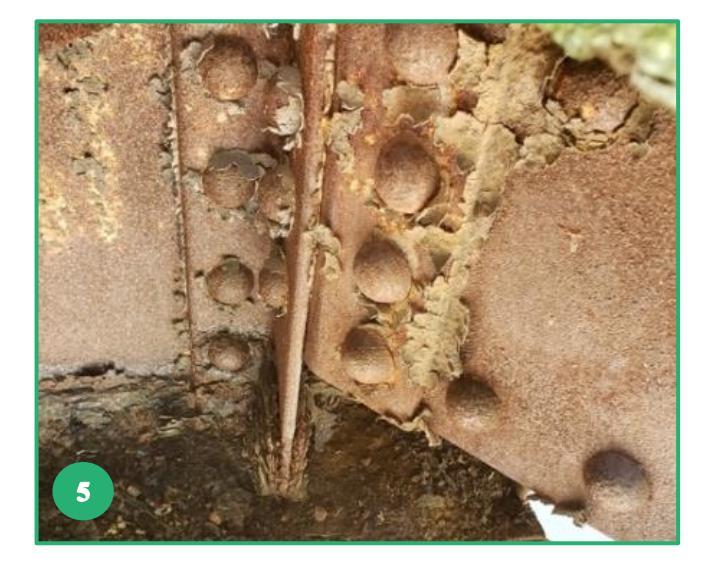
#### Table 19 – Review of MP 10.47 Belleville Ave

The bridge crossing Belleville Ave is an 80-foot-long, three span structure with steel girders, steel piers, and masonry abutments. The vertical clearance of the bridge is substandard at 11'-8". The bottom flanges and web stiffeners of one of the fascia girders and the flanges of one of the piers exhibit severe damage from impacts. The superstructure exhibits some corrosion.

- 1. Looking east
- 2. Damage to the fascia girder due to vehicular impact

- 3. Damage to the pier column due to vehicular impact
- 4. Looking north
- 5. Corrosion at a connection on the superstructure

Factor	Sub Factor	Key Observations
	Type of bridge	• Steel girders with masonry abutment
	Feature crossed	Belleville Ave – local roadway
Existing Conditions	Deterioration	<ul> <li>Minor deterioration, significant vehicle impact damage</li> <li>Deteriorated and rotten deck ties</li> </ul>
	Design Standards	AASHTO LRFD Pedestrian Bridge Design Code
	Load carrying capacity	• See comparison in Section 3.2.3
	Redundancy	• Potential – non-redundant through girders
Structural Integrity	Seismic	Potential risk
	Collision	• No risk – no vessel traffic
	Hydraulics	• No risk – not in a waterway
	Geometry	<ul> <li>Adequate width and height for trail</li> <li>Note through girder at centerline of bridge, essentially dividing the bridge into two halves.</li> </ul>
Safety	Horizontal and Vertical Clearances	<ul> <li>Potential risk – substandard vertical and horizontal clearances</li> </ul>
	Railings and Fences	<ul><li>Railing required at both edges</li><li>Require fences over roadway</li></ul>

While the structure is safe to be converted into a pedestrian bridge, it is recommended that the substandard vertical geometry be addressed through improved signage or raising the structure.

• Obtain and evaluate existing bridge drawings and maintenance/repair history, and perform load rating

• If substandard vertical and horizontal clearances are not desired, the bridge could be replaced with a prefabricated truss pedestrian bridge in order to achieve the required height. Ramps and embankments would need to be constructed at each end. This option could potentially leave the existing abutments in place with the new bridge spanning above, but this would need to be studied to ensure they remain stable in The bridge crossing New St is a 100-foot-long, three span structure with steel girders, steel piers, and masonry abutments. The vertical clearance of the bridge is substandard at 11'-6". The bottom flange of the northern fascia girder is slightly damaged and may have been hit by a vehicle.

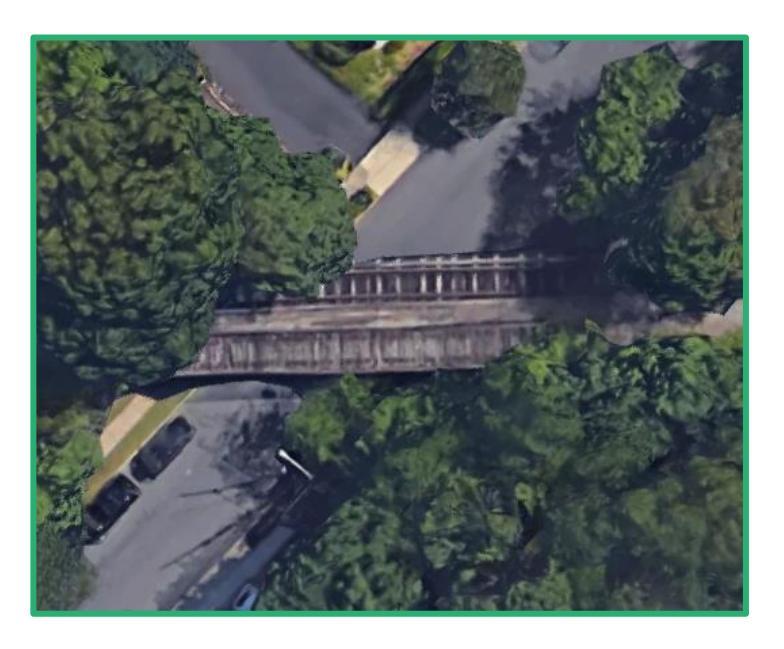
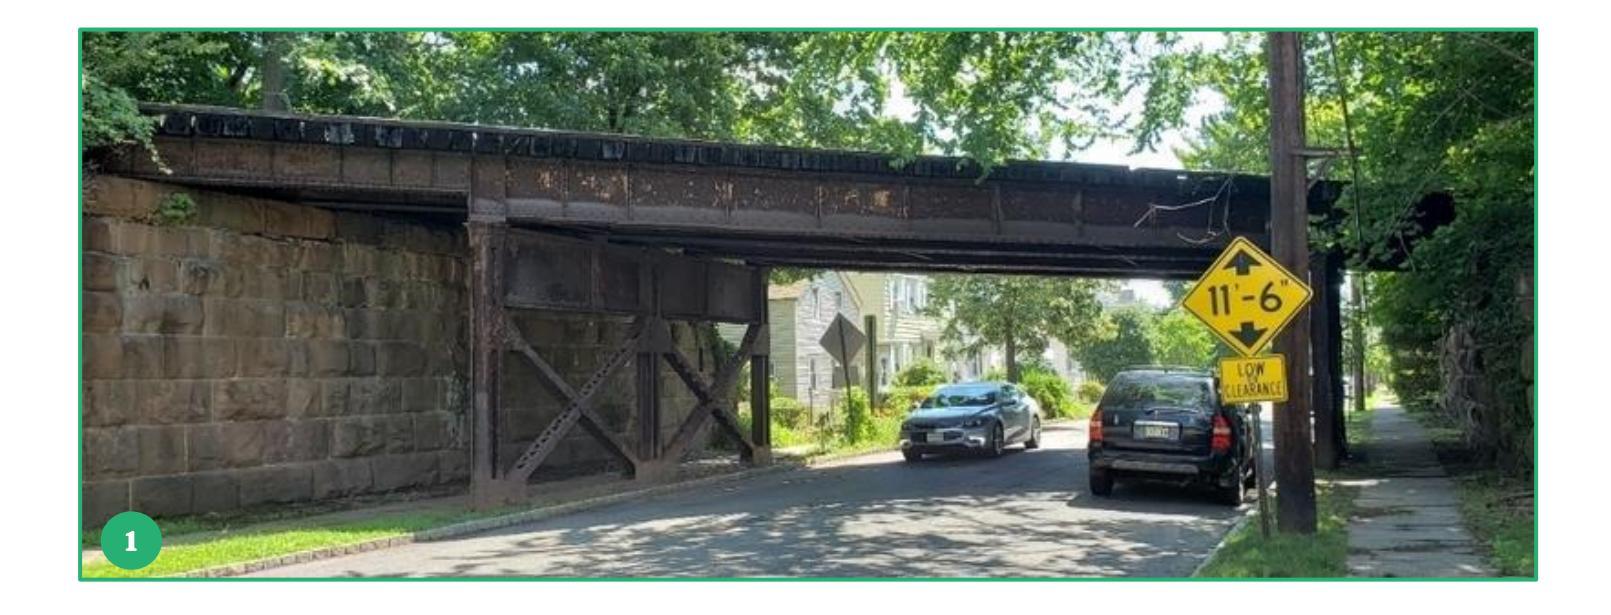
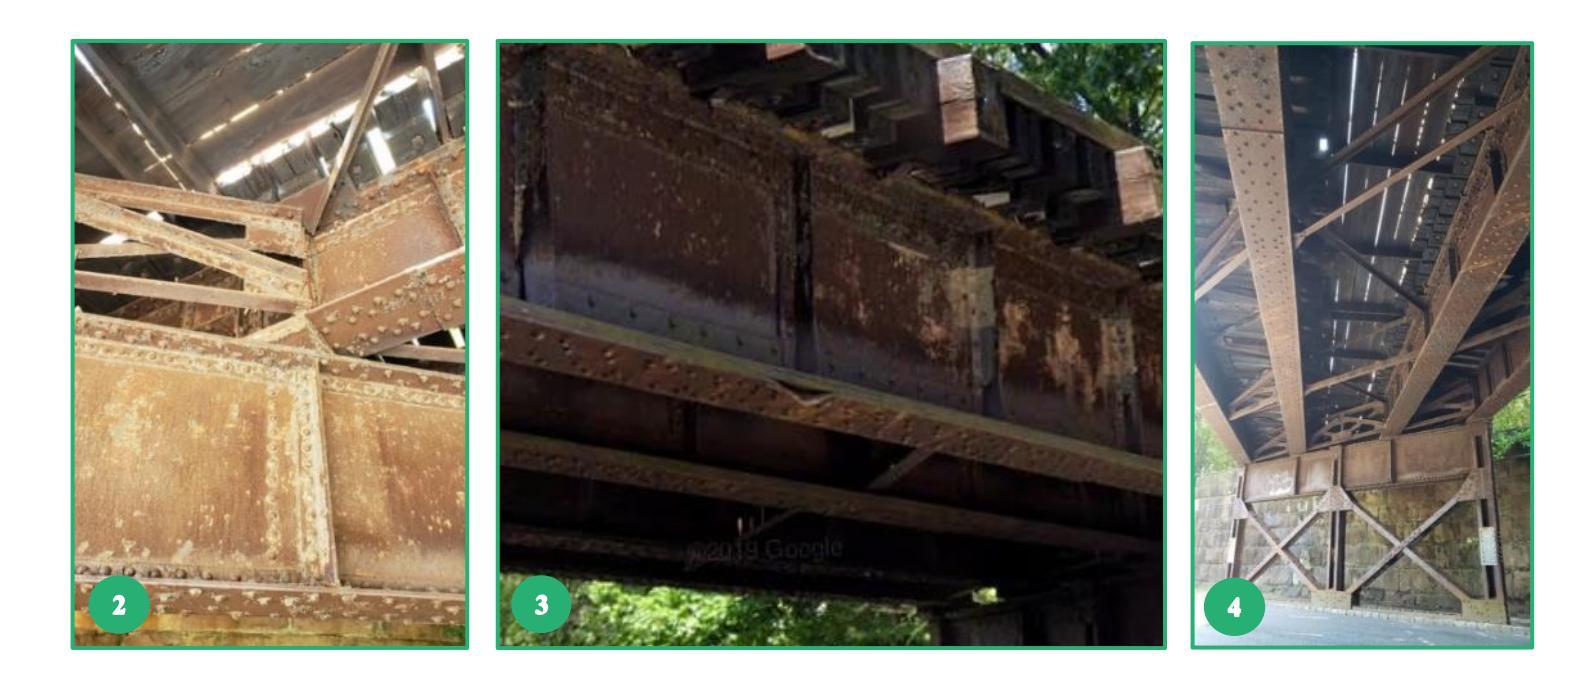
#### Table 20 – Review of MP 10.58 New Street

Despite its low clearance this bridge does not appear to have damage or deterioration that significantly reduces the load carrying capacity of the bridge.

- 1. Looking east
- 2. Corrosion in superstructure
- 3. Damage to bottom flange of fascia girder, potentially due to vehicle impact
- 4. Underside of bridge looking north

Factor	Sub Factor	Key Observations		
Existing Conditions	Type of bridge	• Steel girders with masonry abutment		
	Feature crossed	• New Street – local roadway		
	Deterioration	<ul><li>Minor deterioration, minor vehicle impact damage</li><li>Deteriorated and rotten deck ties</li></ul>		
	Design Standards	AASHTO LRFD Pedestrian Bridge Design Code		
Structural Integrity	Load carrying capacity	• See comparison in Section 3.2.3		
	Redundancy	Potential – non-redundant through girders		
	Seismic	Potential risk		
	Collision	• No risk – no vessel traffic		
	Hydraulics	• No risk – not in a waterway		
Safety	Geometry	• Adequate width and height for trail		
	Horizontal and Vertical Clearances	• Potential risk – substandard vertical and horizontal clearances		
	Railings and Fences	<ul><li>Railing required at both edges</li><li>Require fences over roadway</li></ul>		
	Emergency Vehicle Access	Adequate access available

- Obtain and evaluate existing bridge drawings and maintenance/repair history, and perform load rating calculations based on the drawings to verify load capacity
- Consult with local transportation departments on nonstandard vertical and horizontal clearances

• If substandard vertical and horizontal clearances are not desired, the bridge could be replaced with a prefabricated truss pedestrian bridge in order to achieve the required height. Ramps and embankments would need to be constructed at each end. This option could potentially leave the existing abutments in place with the new bridge spanning above, but this would need to be studied to ensure they remain stable in
