# Essex Hudson Greenway Structures Report

# Arup USA, Inc 77 Water Street

Final 2 | September 28, 2020

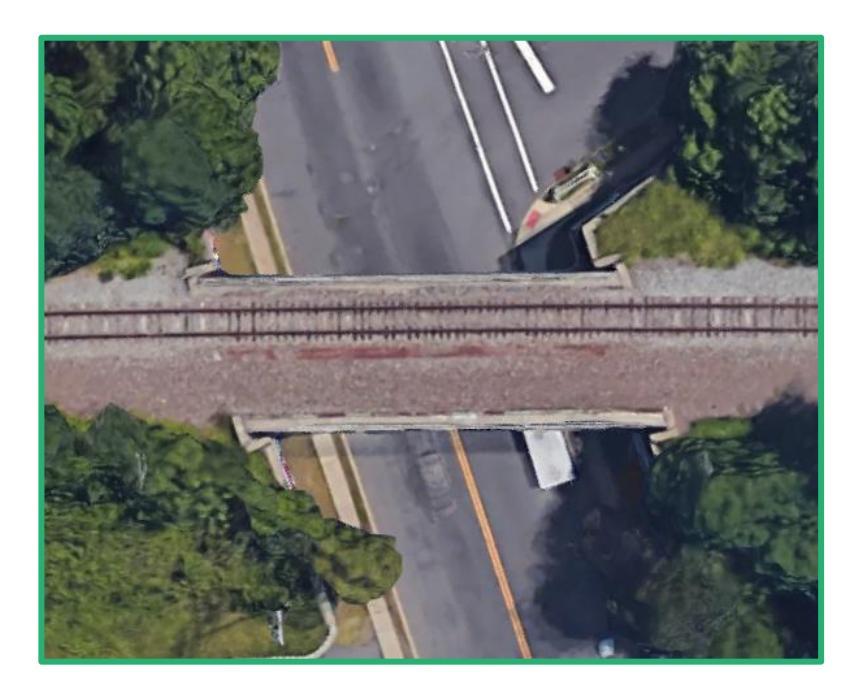
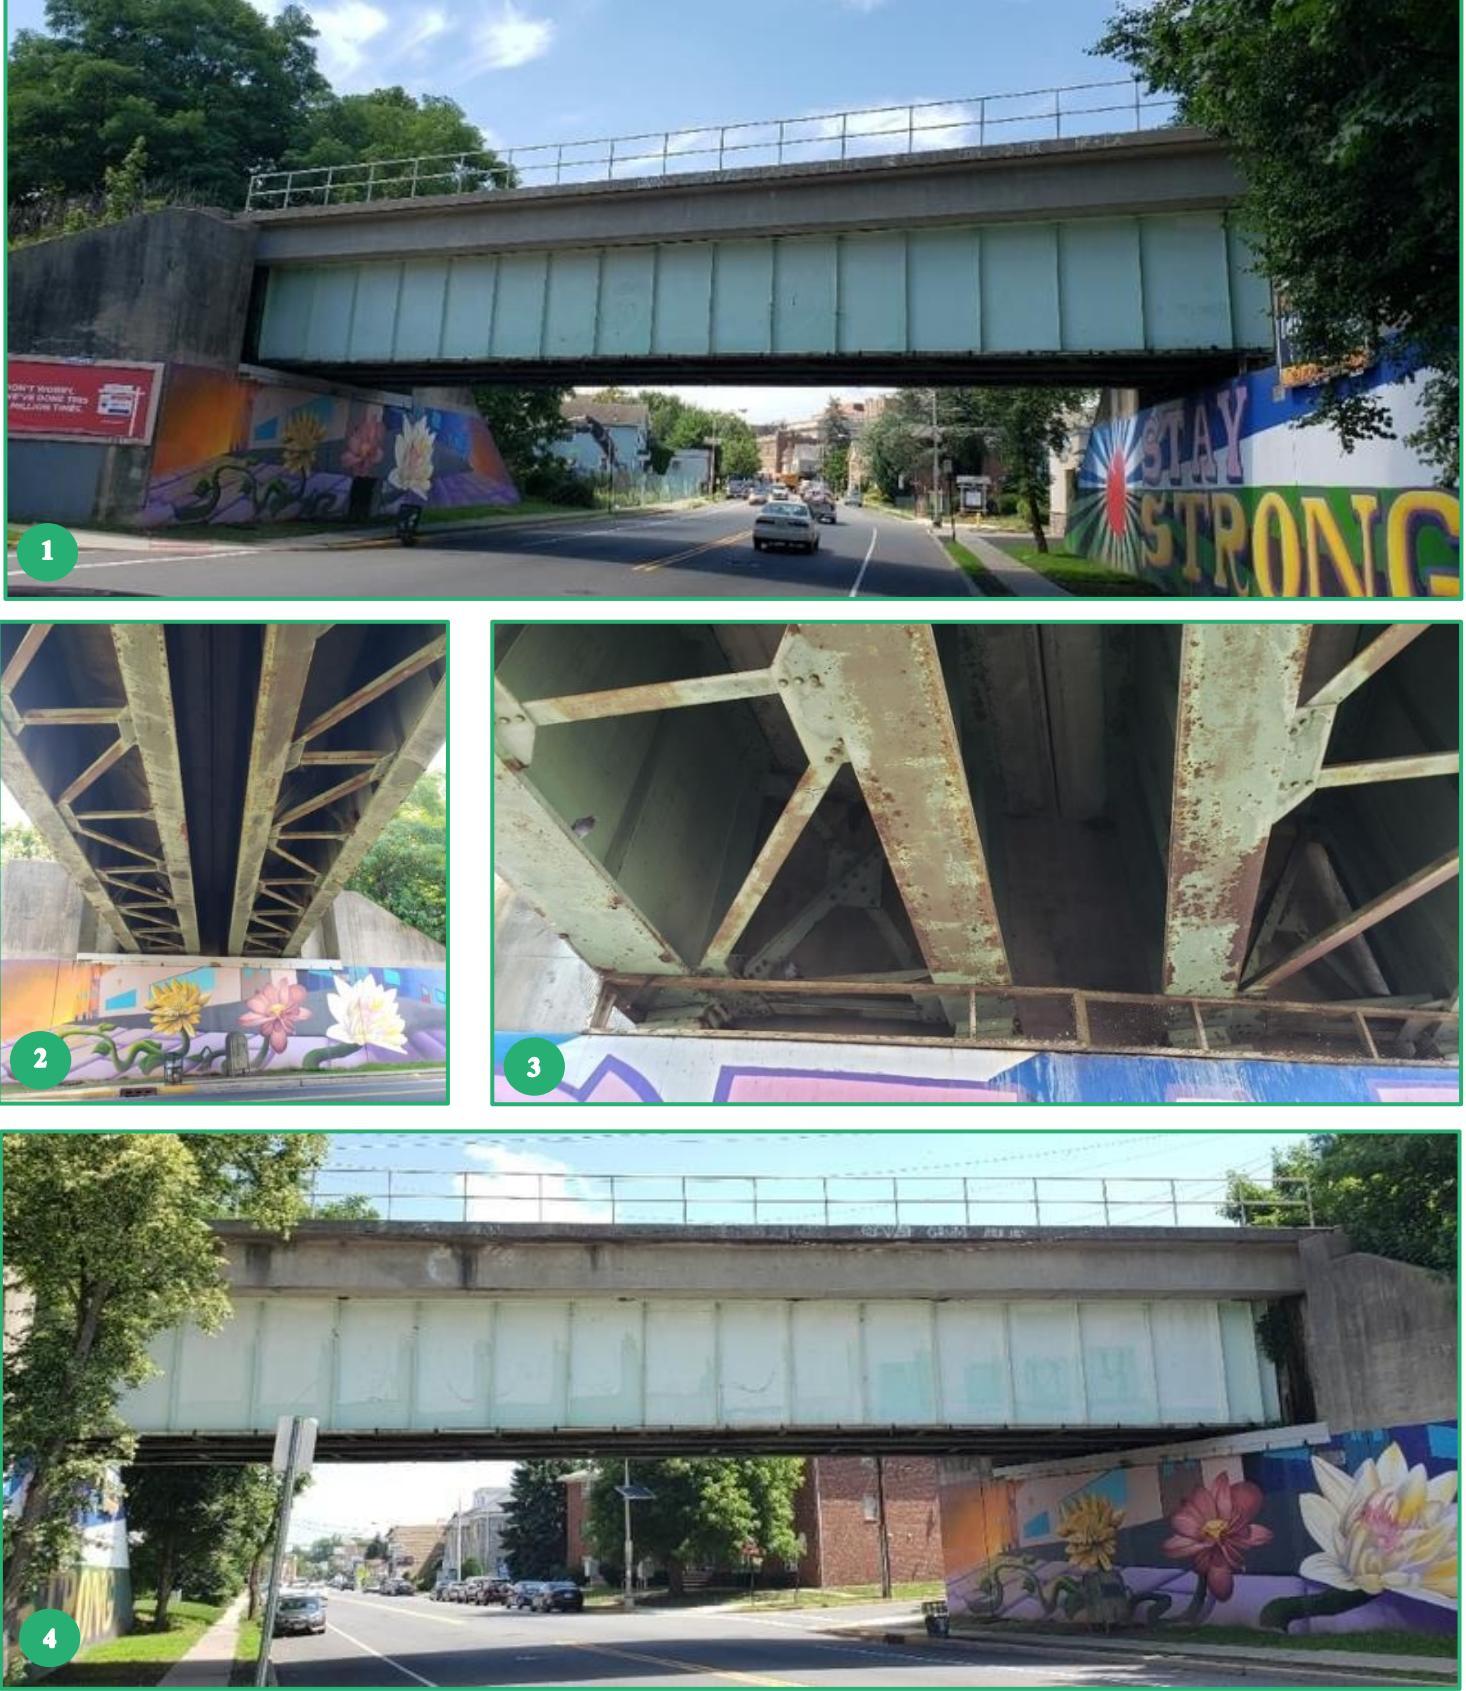
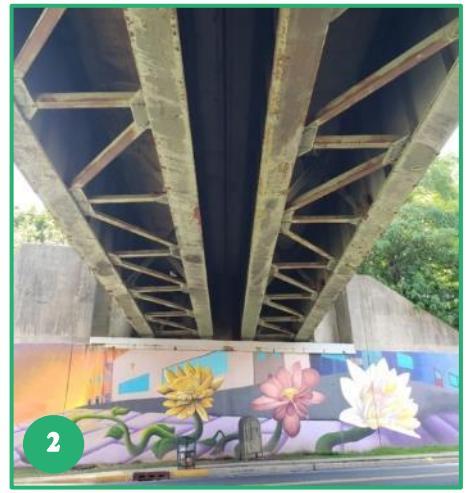
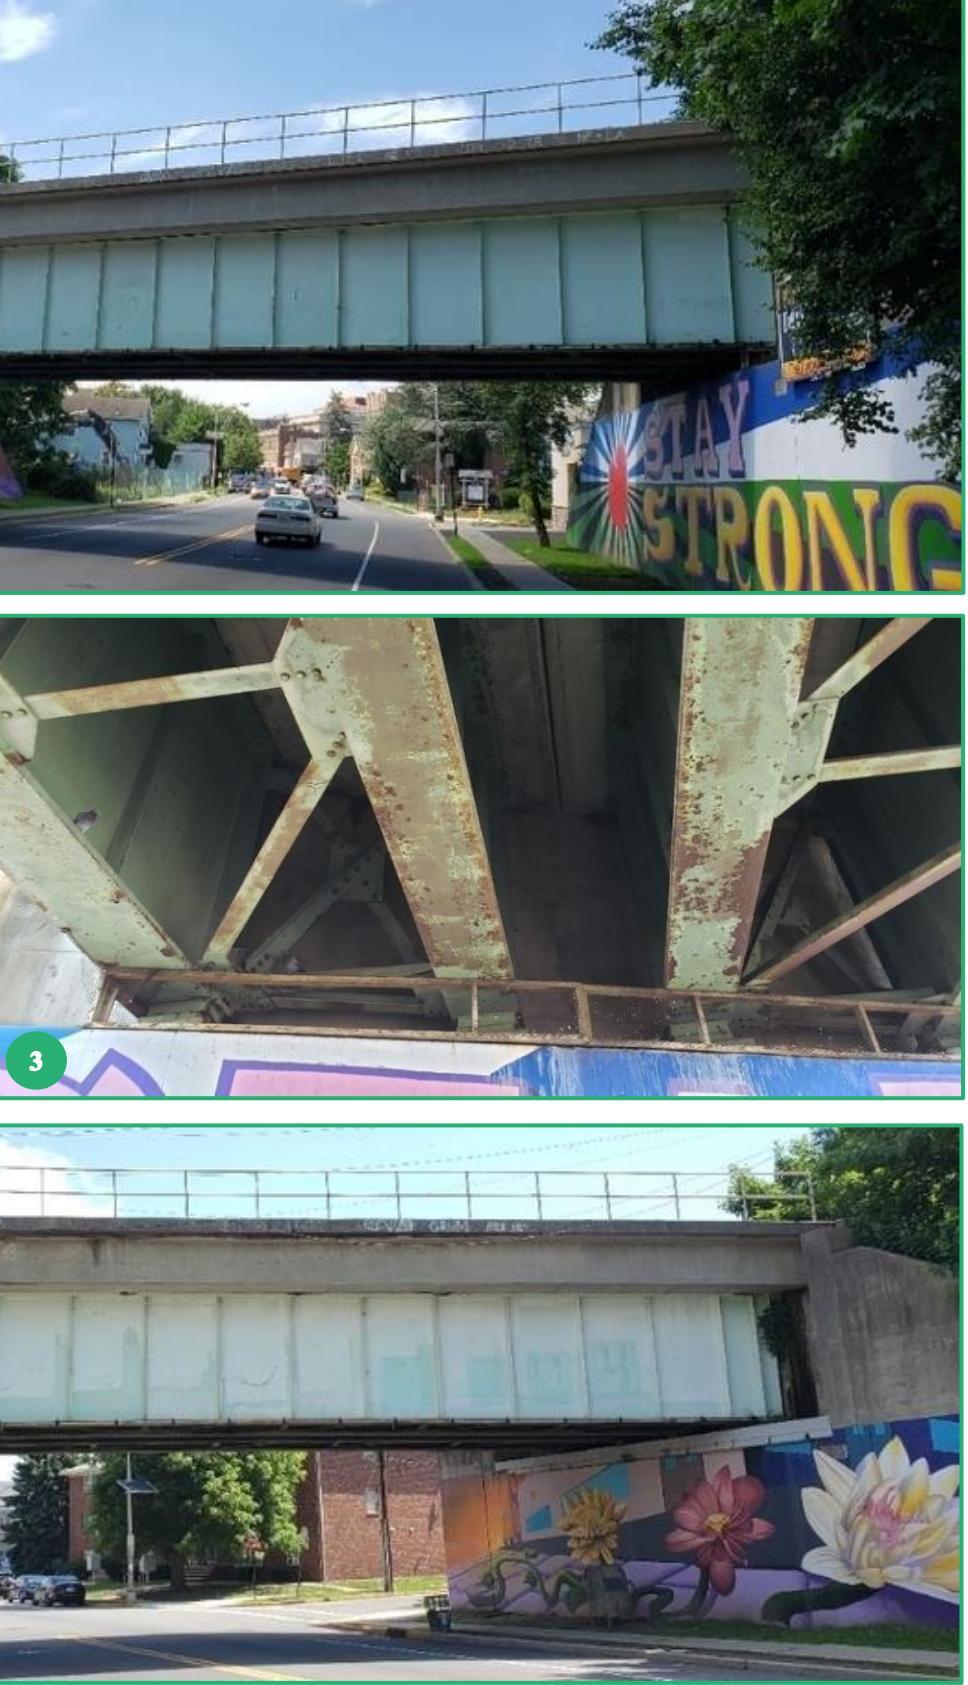
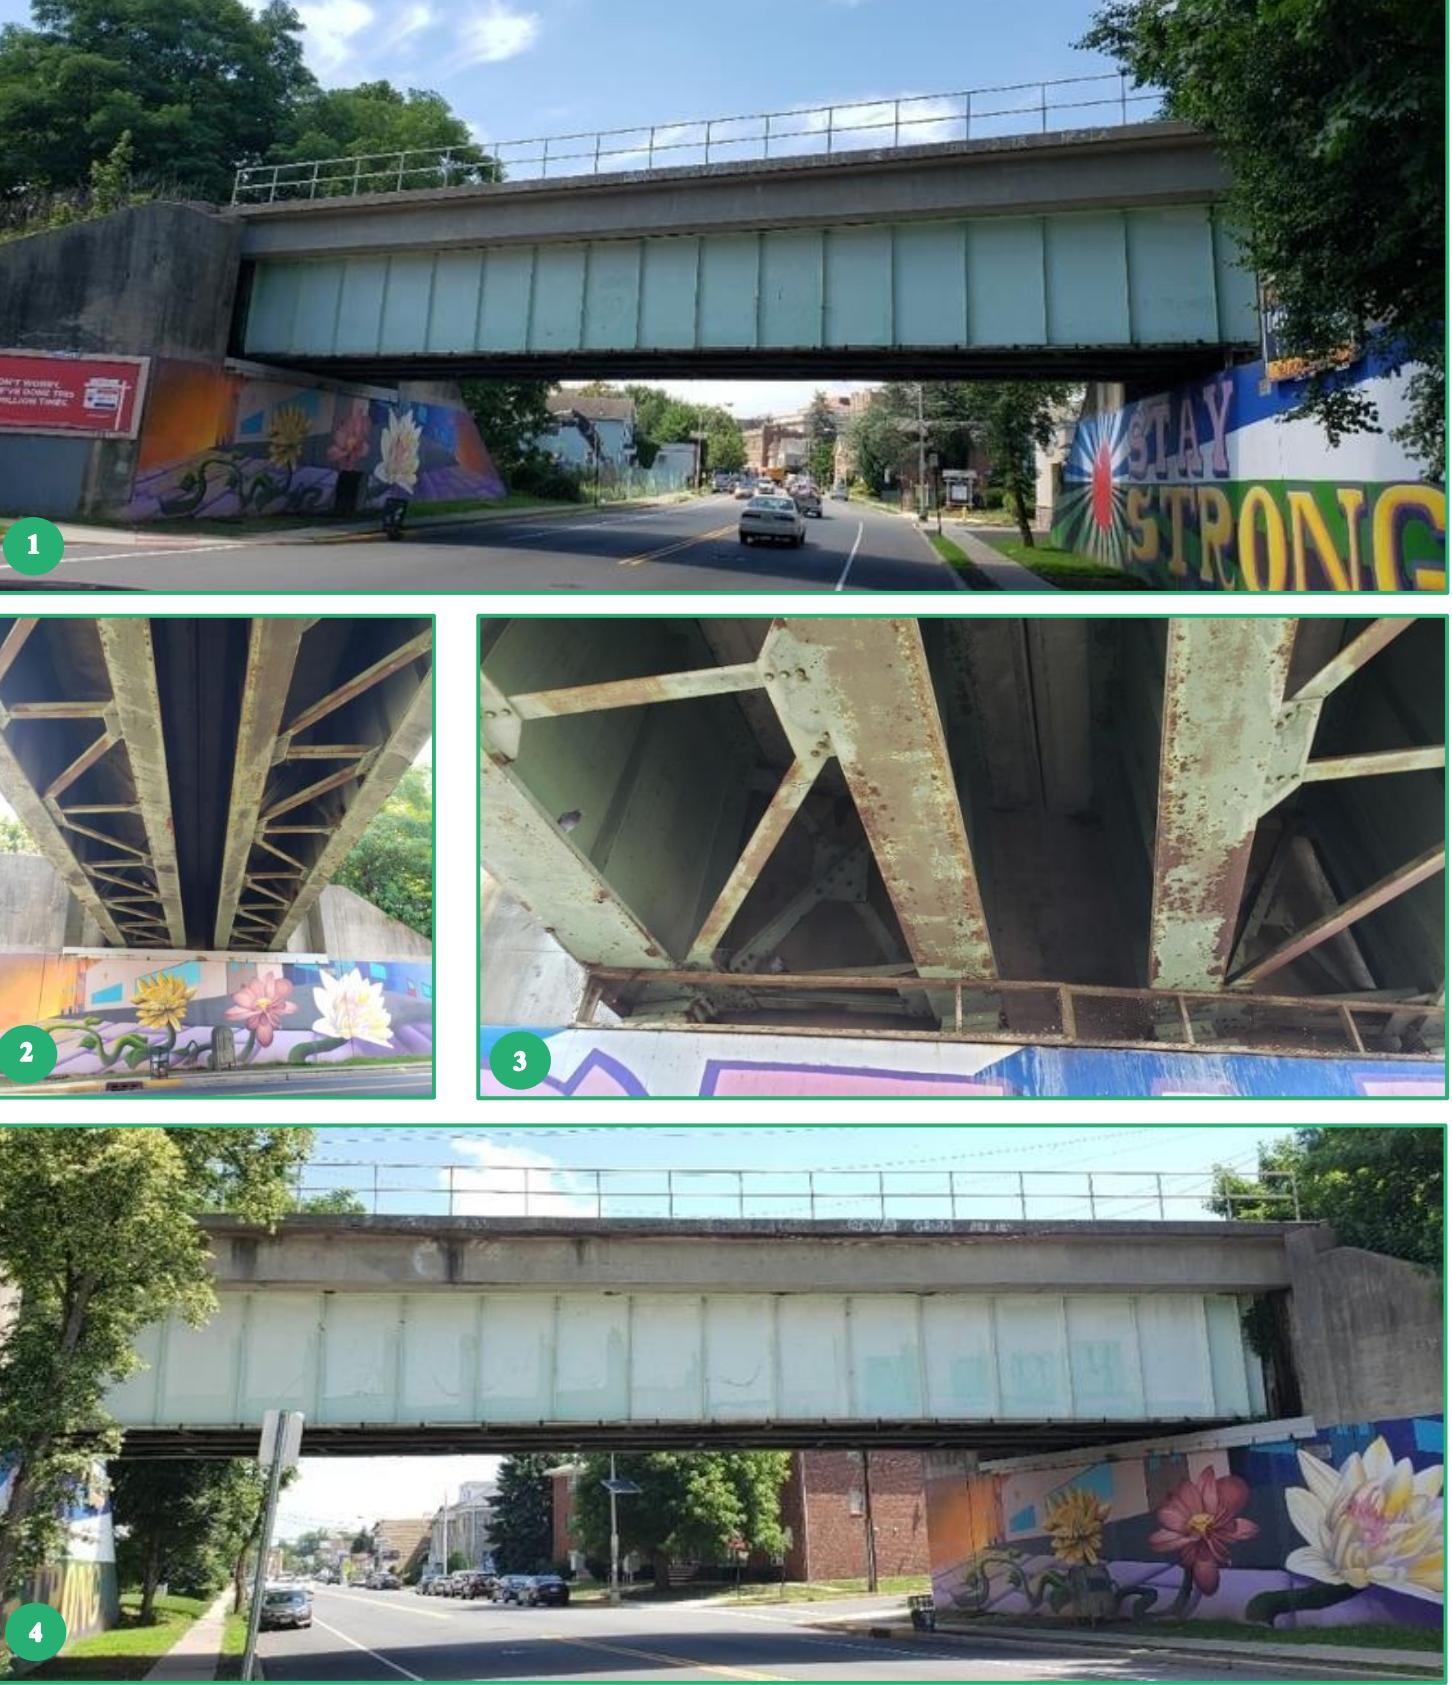
The bridge crossing Broad St is a 60-foot-long, single span structure with steel girders and concrete abutments. This bridge appears to be a relatively new structure, compared with others on the corridor, and is in good condition.

This bridge does not appear to have damage or deterioration that significantly reduces the load carrying capacity of the bridge.

- 1. General view of bridge, looking south
- 2. Underside of bridge looking east, in generally good condition
- 3. Western abutment
- 4. Looking north

Factor	Sub Factor	Key Observations		
Existing Conditions	Type of bridge	• Steel girders with concrete abutment and ballasted concrete deck		
	Feature crossed	Broad Street – local roadway		
	Deterioration	• Little deterioration evident		
	Design Standards	AASHTO LRFD Pedestrian Bridge Design Code		
Structural Integrity	Load carrying capacity	See comparison in Section 3.2.3		
	Redundancy	• Low risk – structure appears to be redundant		
	Seismic	Low risk – modern structure		
	Collision	No risk – no vessel traffic		
	Hydraulics	No risk – not in a waterway		
Safety	Geometry	Adequate width and height for trail		
	Horizontal and Vertical Clearances	Adequate clearance over roadway		
	Railings and Fences	<ul><li>Railing required at both edges</li><li>Require fences over roadway</li></ul>		
	Emergency Vehicle Access	Adequate access available		
Constructability	Construction Methods	• Assume conventional construction methods can be used with land-based equipment

• Obtain and evaluate existing bridge drawings and maintenance/repair history, and perform load rating

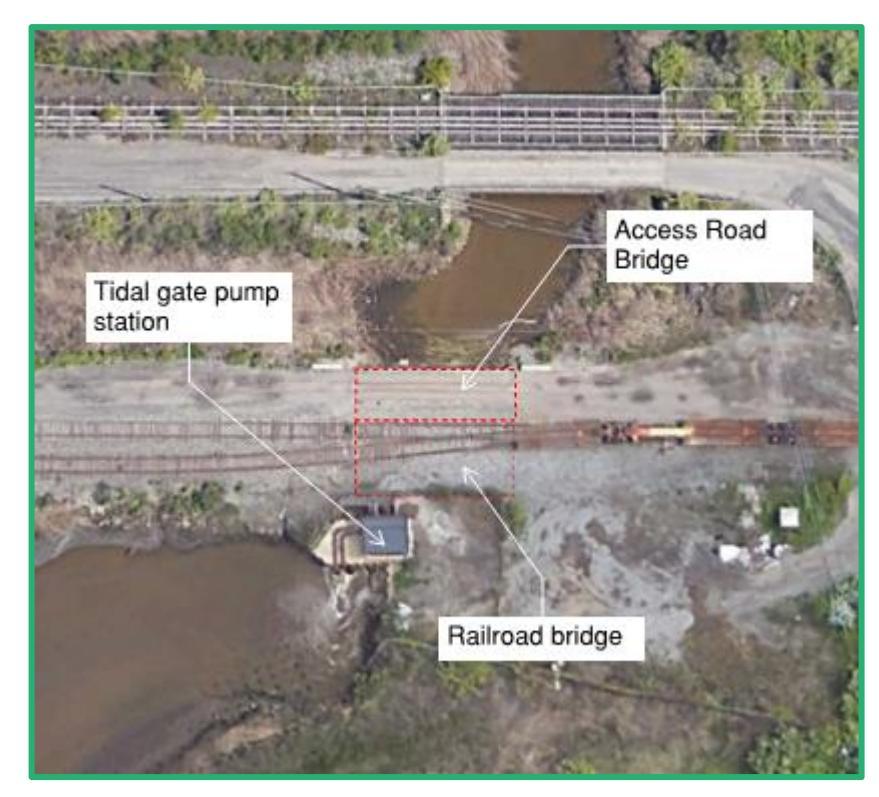
Figure 27 – Penhorn Creek Bridge Key Features

The NS inspection reports [3] state that the top of the piles are rotted and crushing on the north side. It is not evident if this is referring to the access road bridge or the railroad bridge. However, for the purpose of this study, it is assumed that timber piling needs to be replaced.

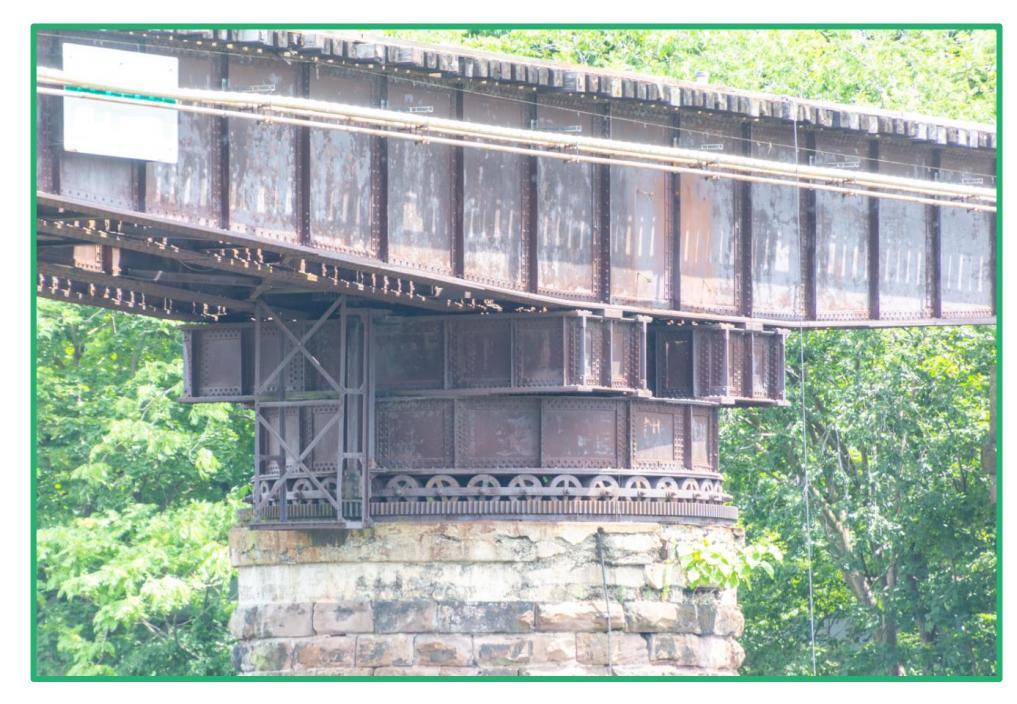
Figure 38 - Pivot pier and swing span on Passaic River bridge

The Passaic River bridge is a former swing bridge, which sits on a circular pivot pier offset to the east side of the river. The swing span comprises four plate girders supported on a rim-bearing. It is our understanding that the swing span has been closed for several years. However, the bridge opening procedure is still listed in 33 CFR 117.739, which governs the operation of movable bridges on the Passaic River.

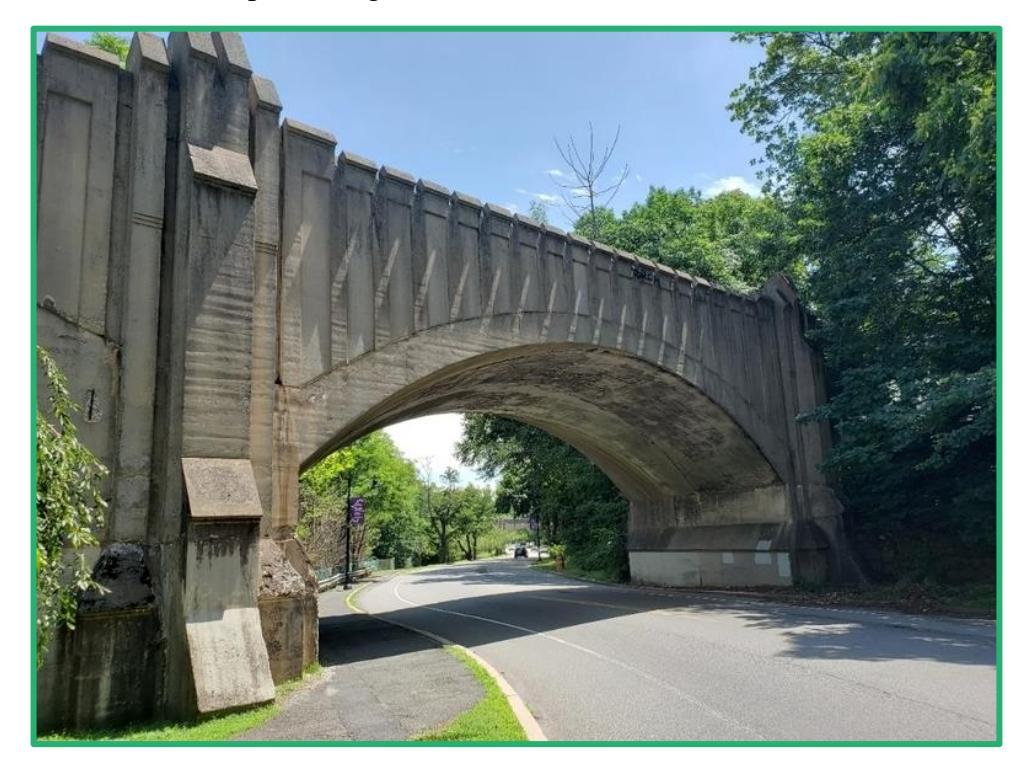
Figure 42 - MP 8.85 arch spanning over Branch Brook Park Drive
## 4.7 Garden State Parkway (MP 10.29)

The bridge over the Second River and Branch Brook Park Drive is unique along the greenway corridor, as it is the only concrete arch structure considered in this study. The arch structure is visually noteworthy, with unique architectural features that are worth preserving.
