SCOPE OF WORK

Trenton Office Complex Roof Restoration

MVC Central Headquarters Building
225 East State Street
Trenton, Mercer, NJ

Project No. A1382-00

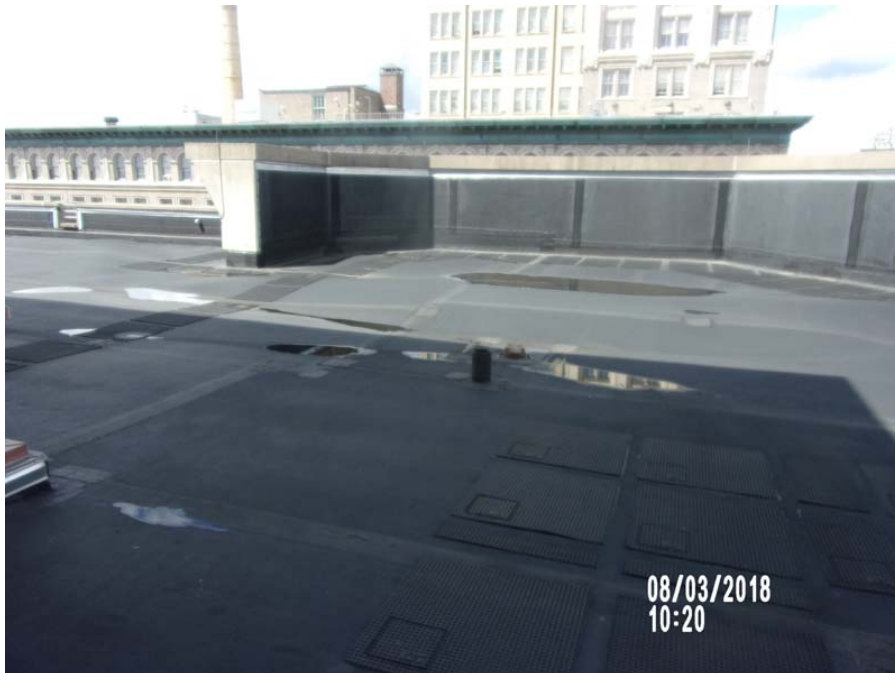
2. Roof Area B: Partial overall view of an area the insulation has delaminated from the concrete deck.

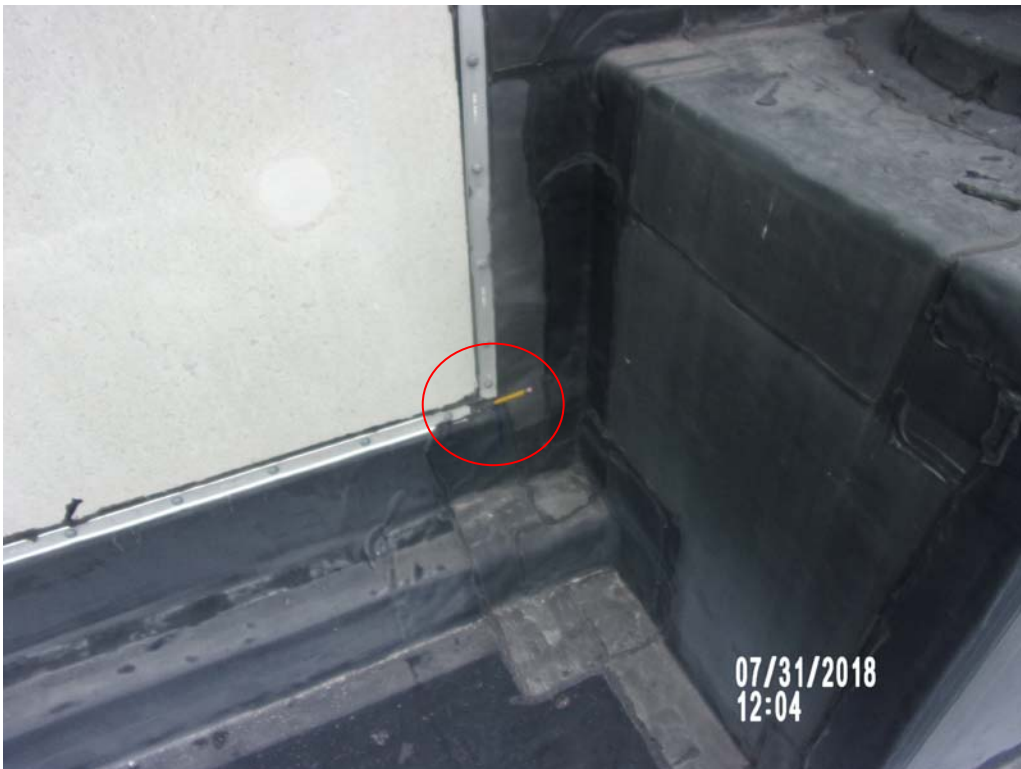
2. Roof Area D: Pencil indicating an opening.

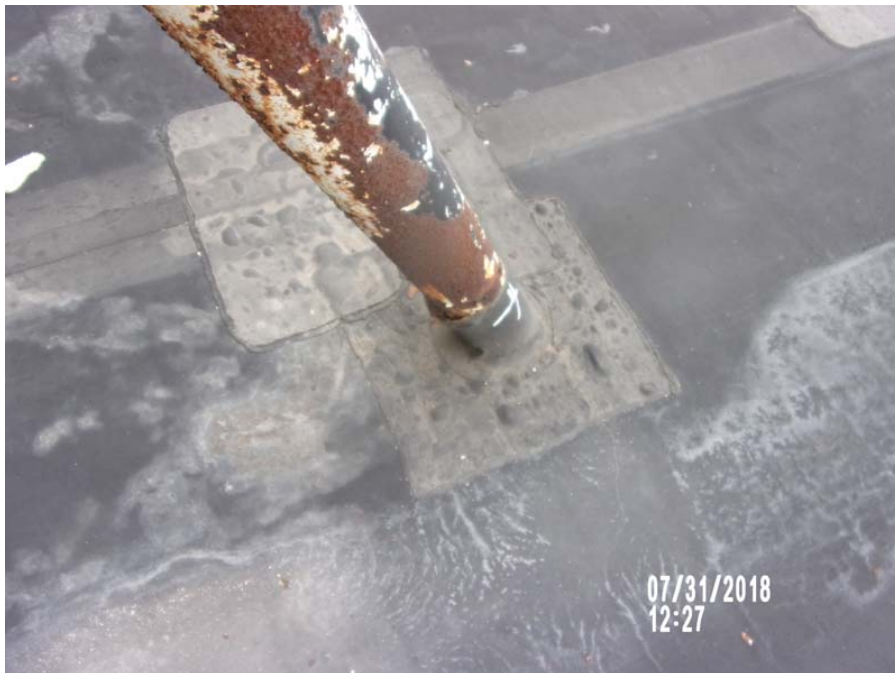
2. Roof Area D1: Typical open EPDM membrane wrap at the base of a curtain wall pipe support.

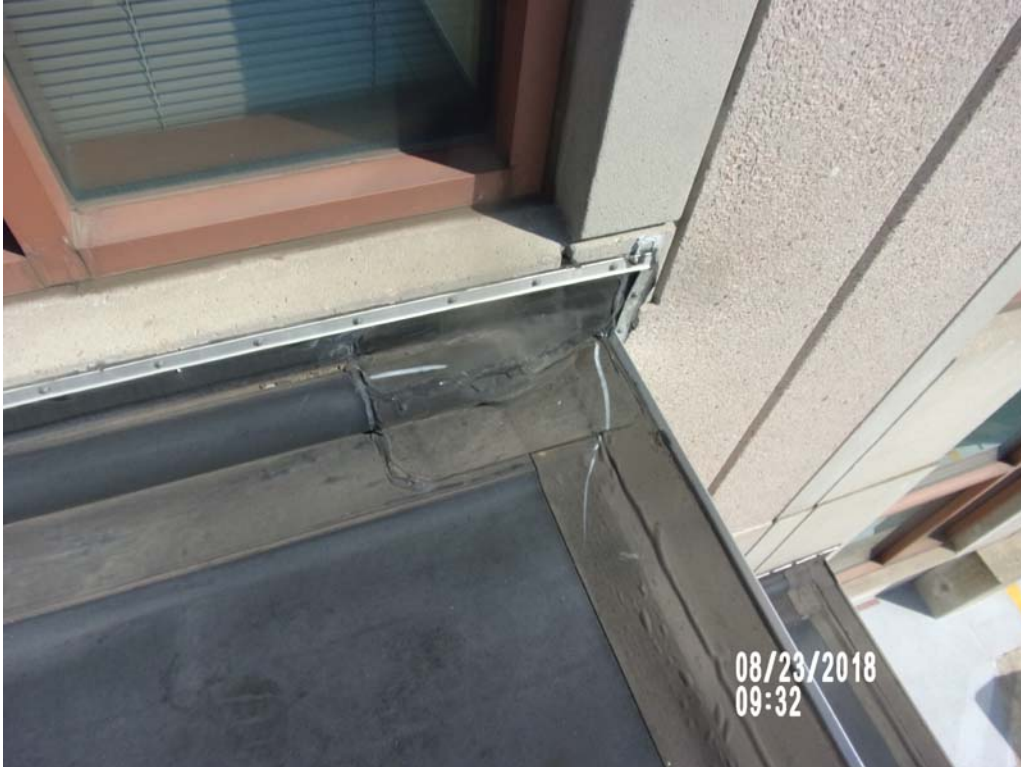
2. Roof Area R: Delaminating expansion joint end corner.

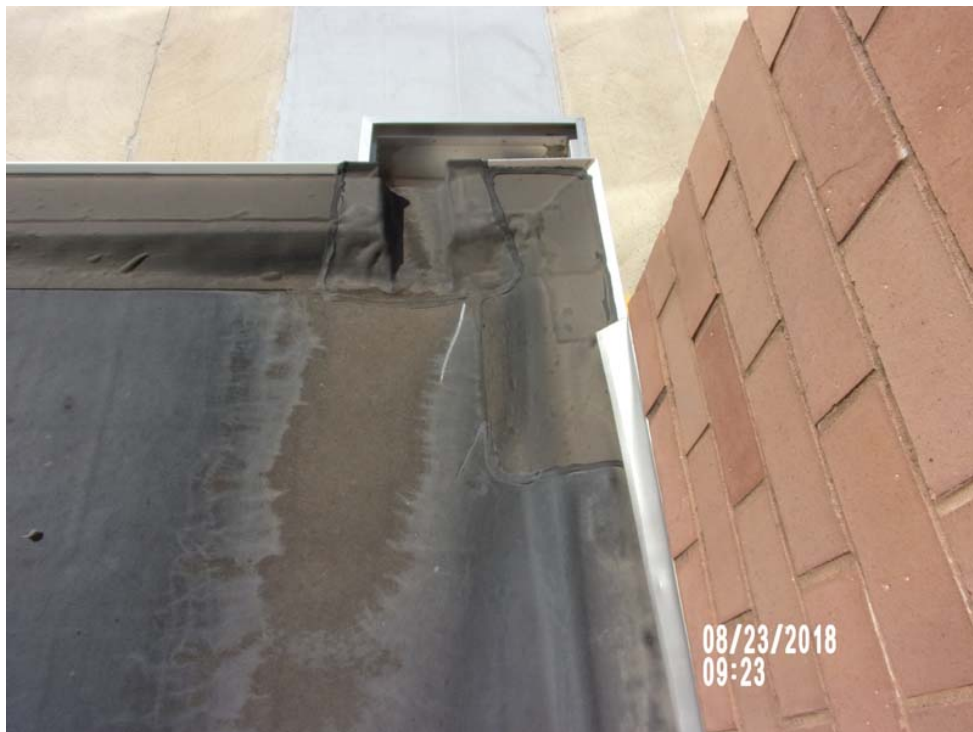
1. Roof Area S: Typical delaminating membrane.

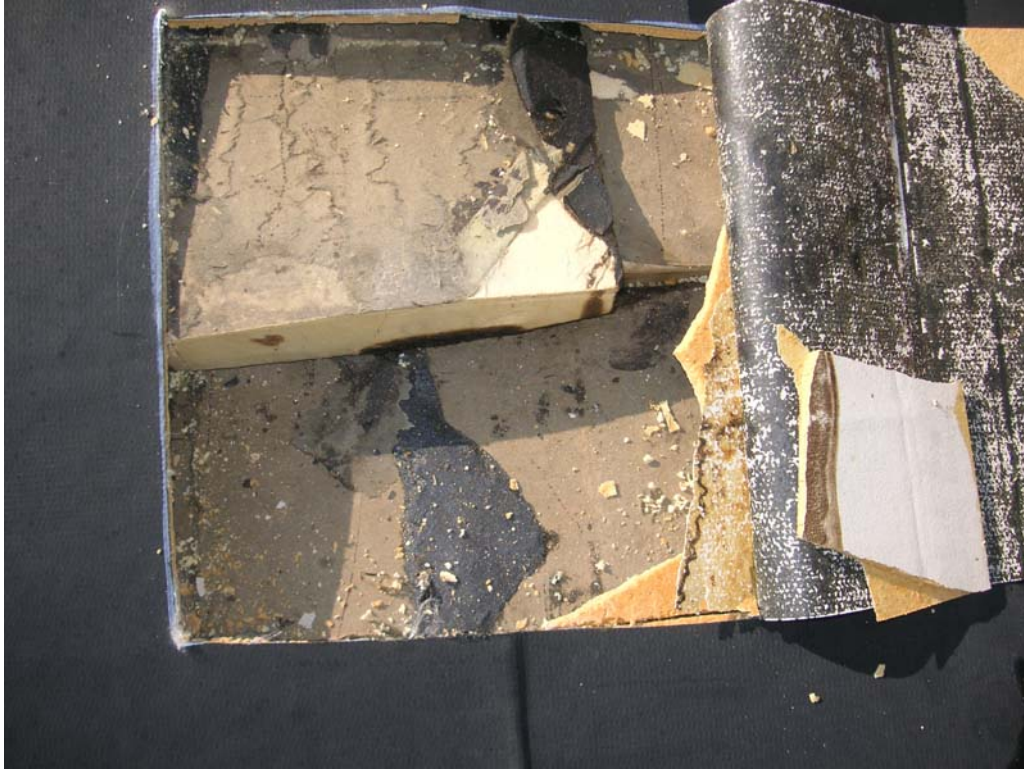
3. Top layer of insulation riding over the adjacent layer

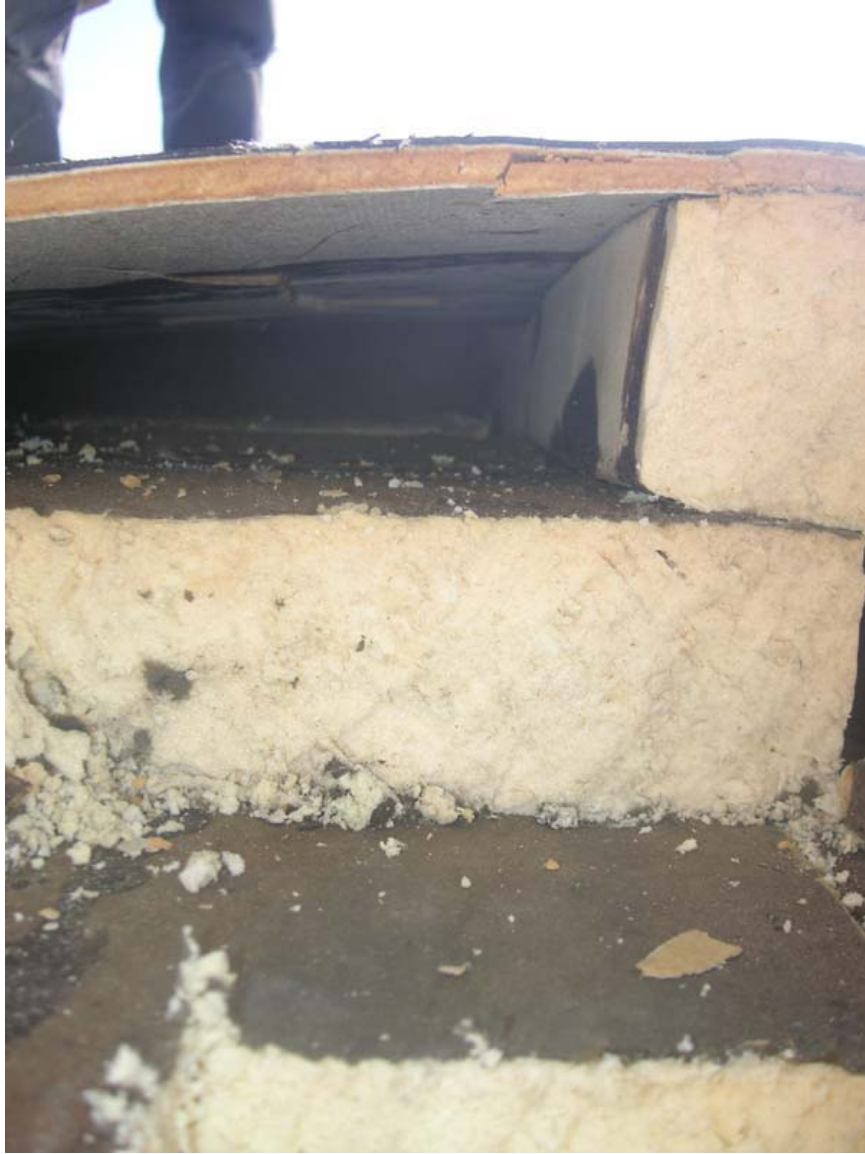
12. Open gap under board

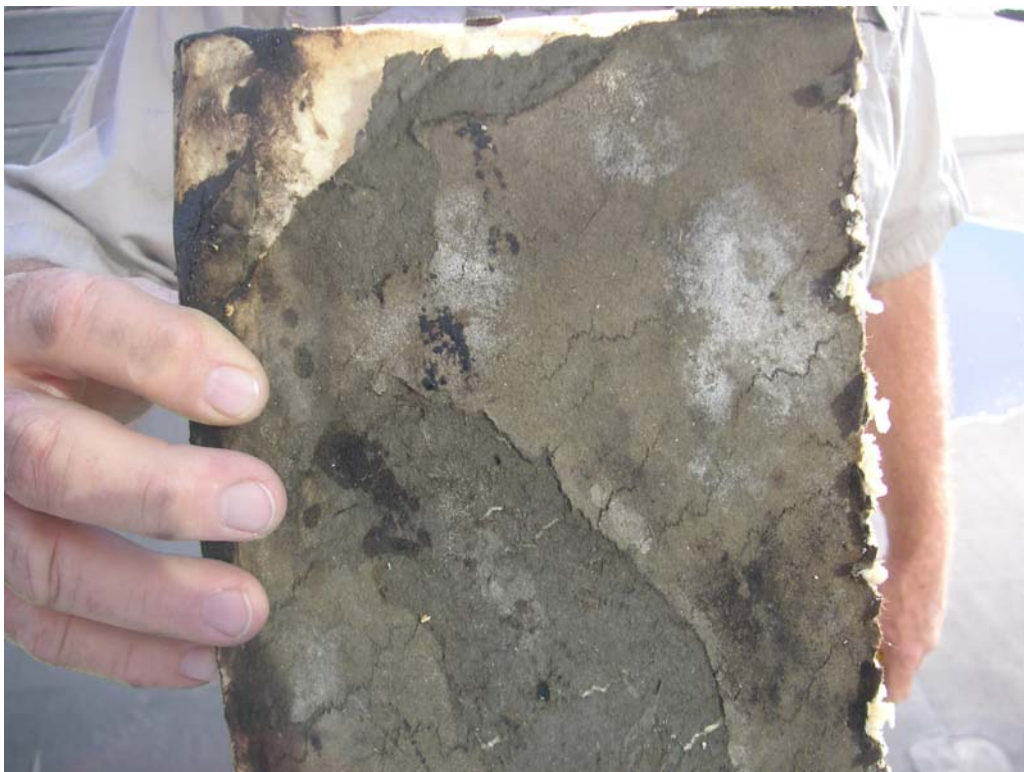
14. Mold growth on underside of top layer of insulation

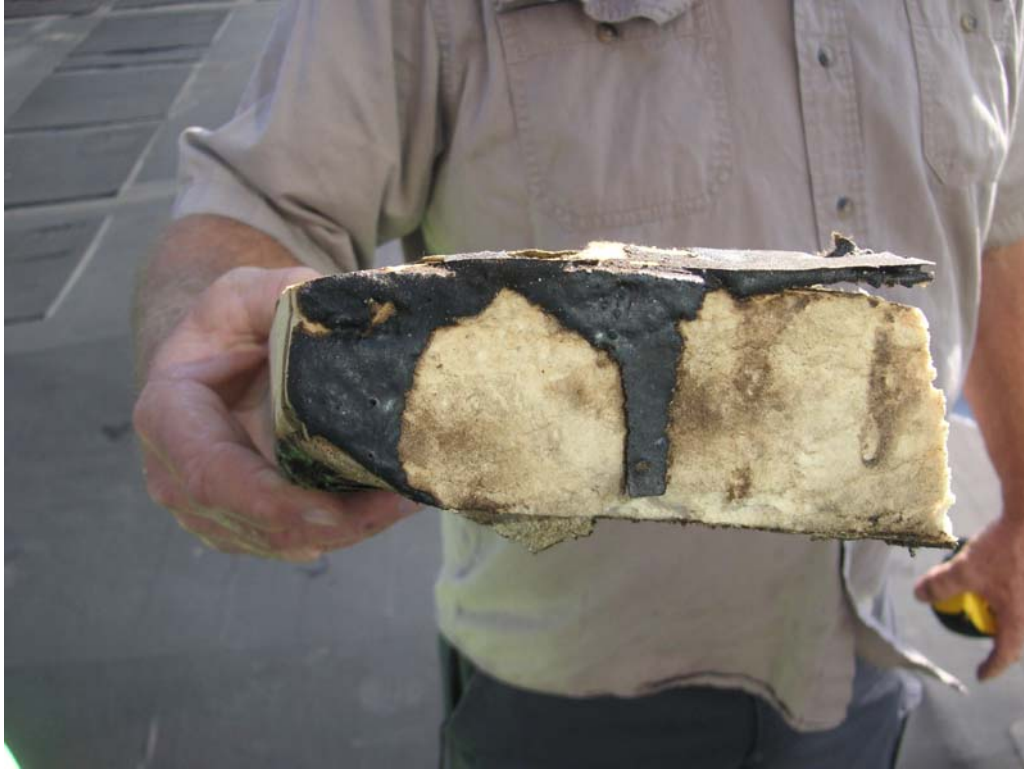
The roof cuts revealed there is thermal movement within the insulation stack. The overall application has a thermal condition which was induced by moisture that came from the wall systems and with the accumulation of moisture within the "insulation enclosed system" produced geometric movement within the insulation.

15. Board was deformed by thermal movement

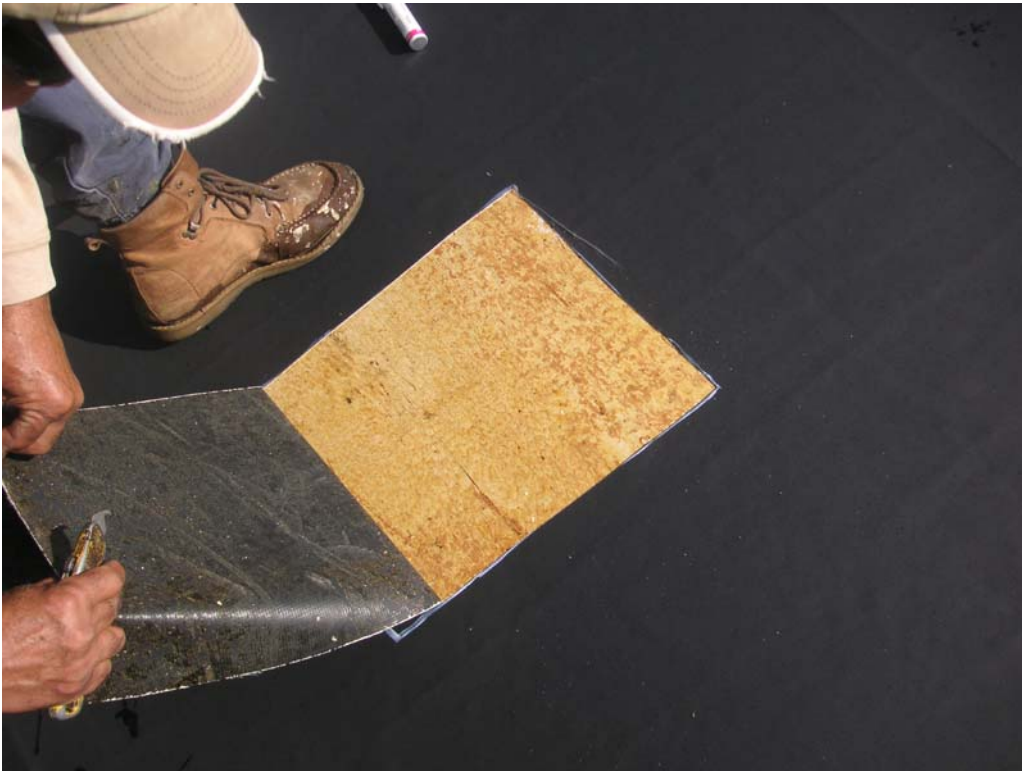
29. Good attachment of membrane to hard board

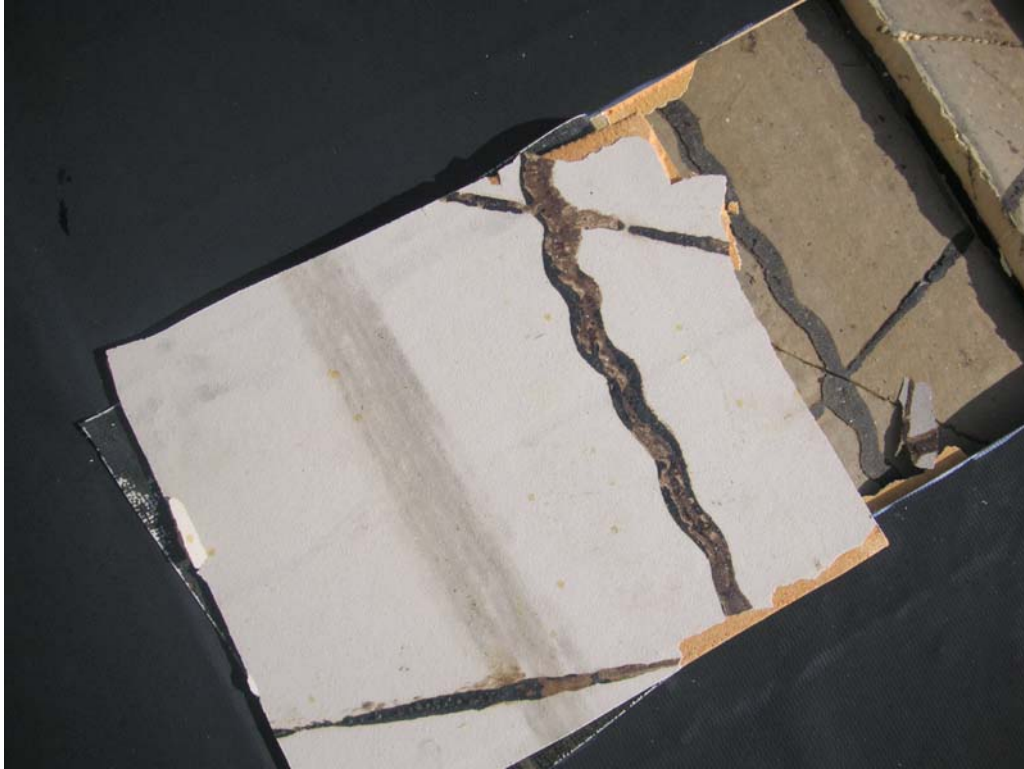
30. Bottom of hard board showing adhesive line – 8" apart

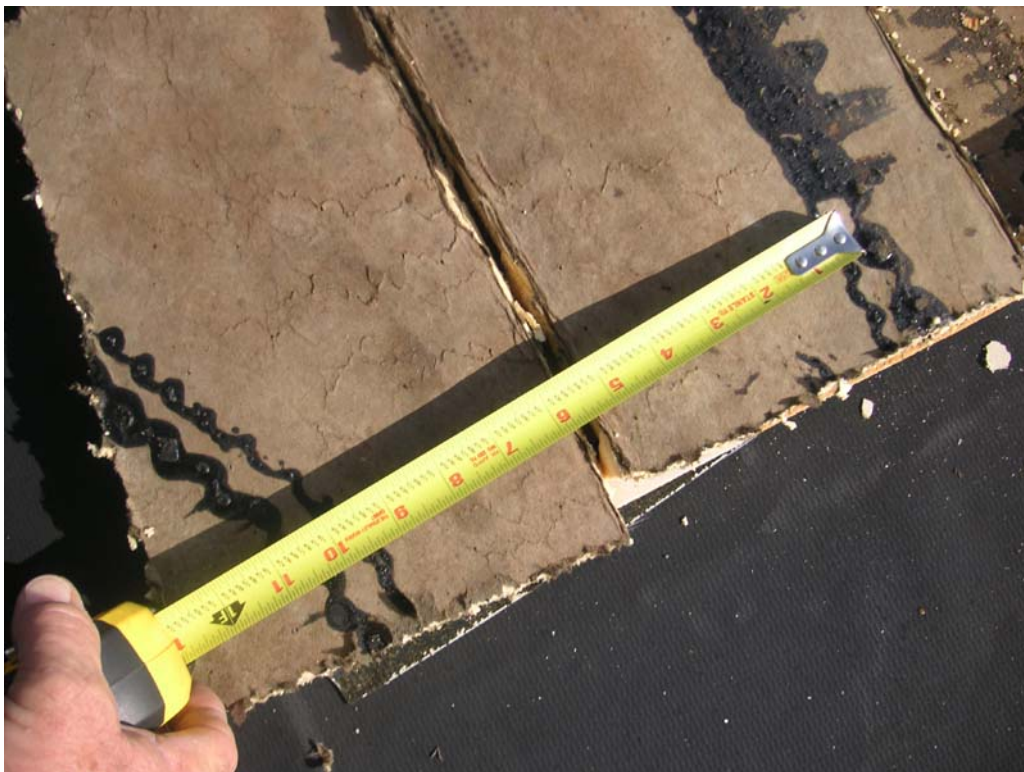
33. Full attachment as to manufacturer's recommendations at 10" for interface

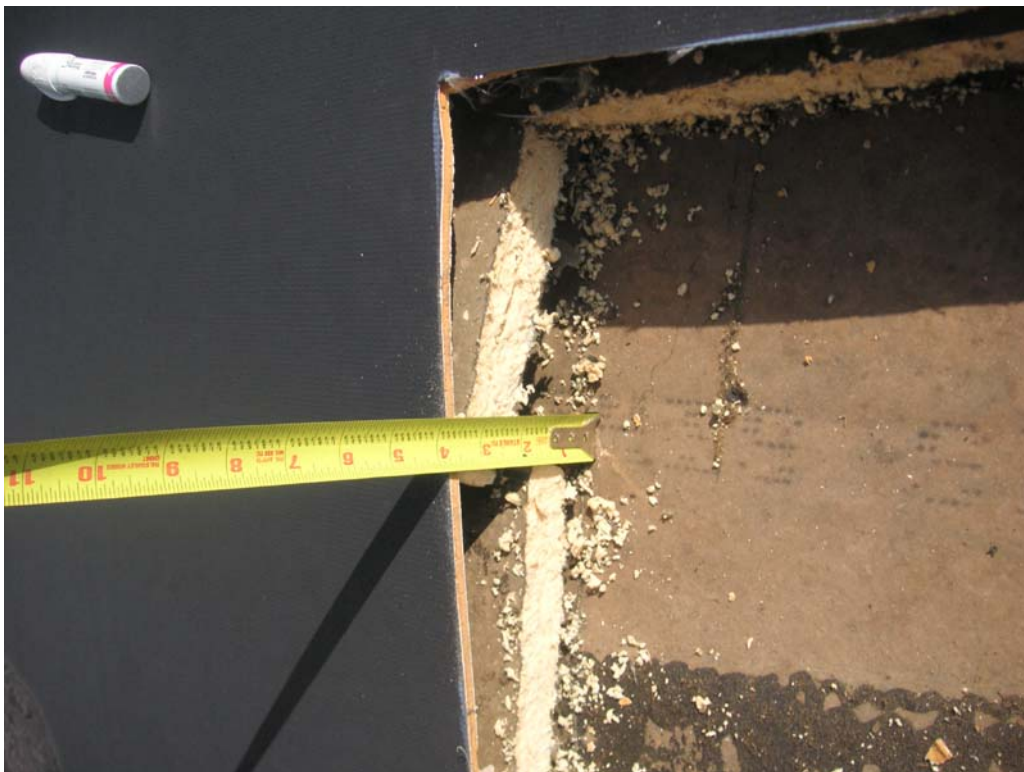
35. 4" rise of membrane and hard board

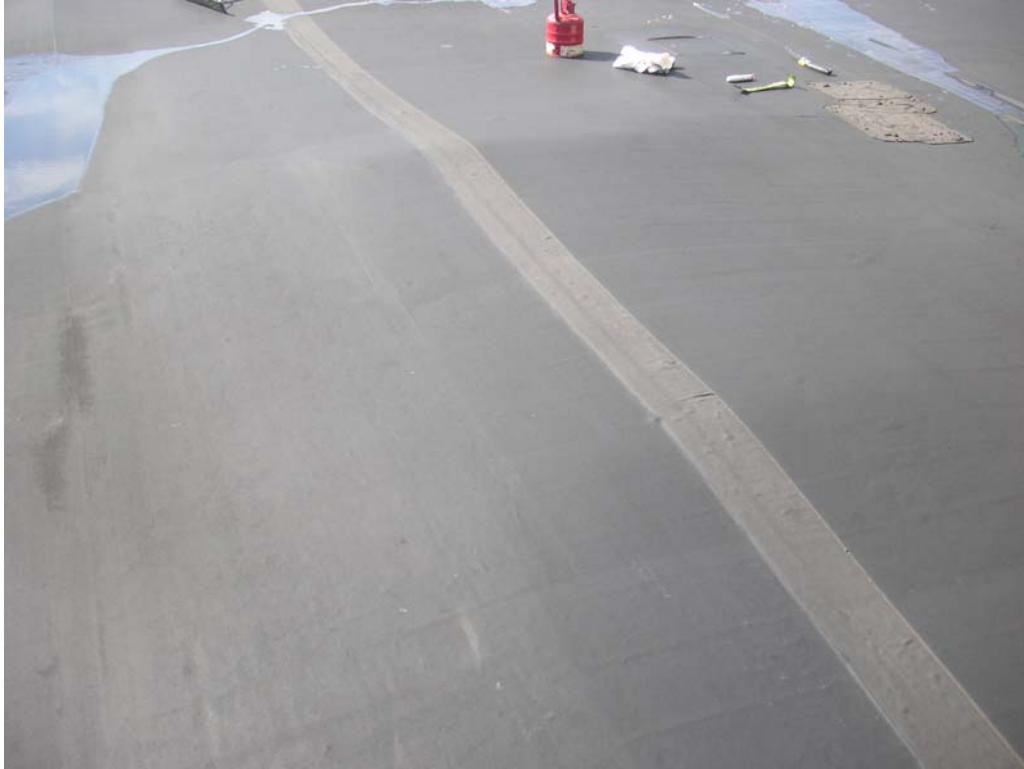
40. Large hump in the membrane

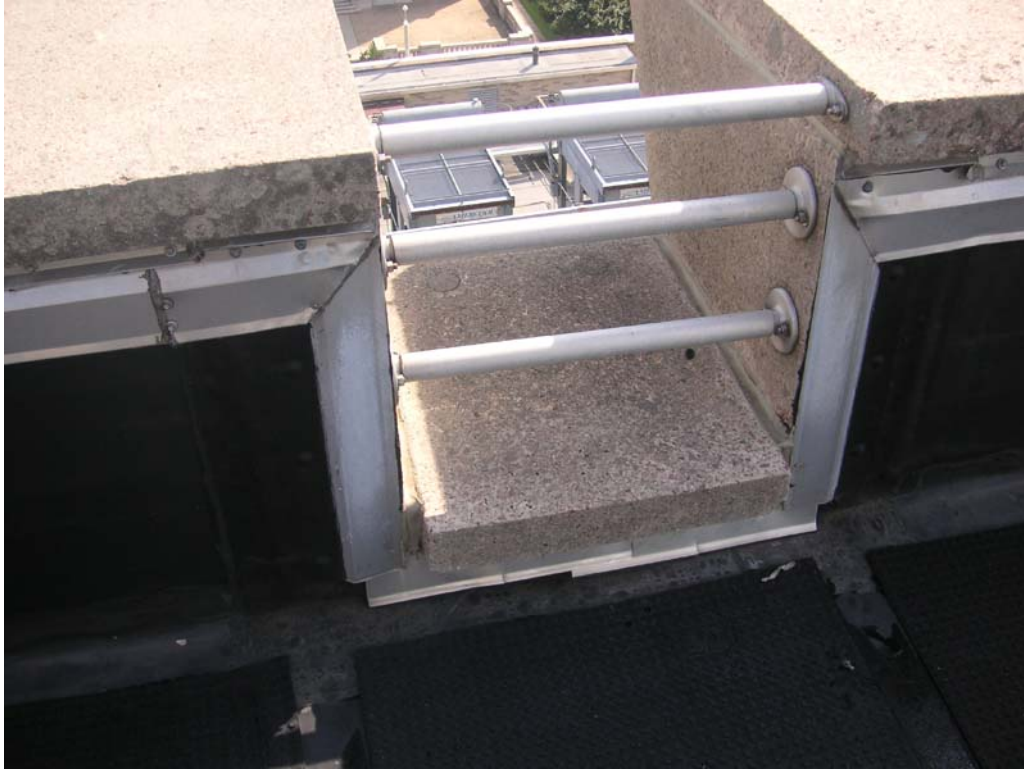
42. Cut-out is called a “crenel”, which is the bottom section of a merlon and crenel

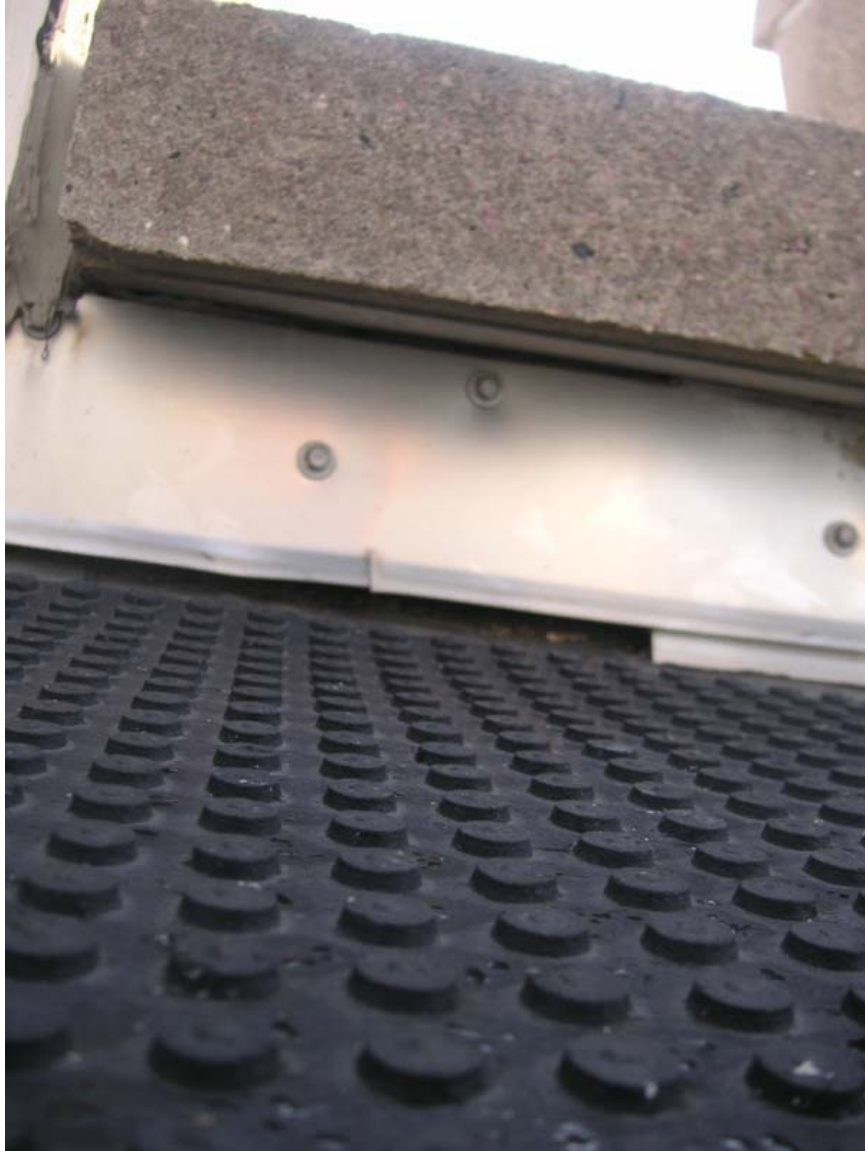
44. View of counterflashing detail at bottom of crenel

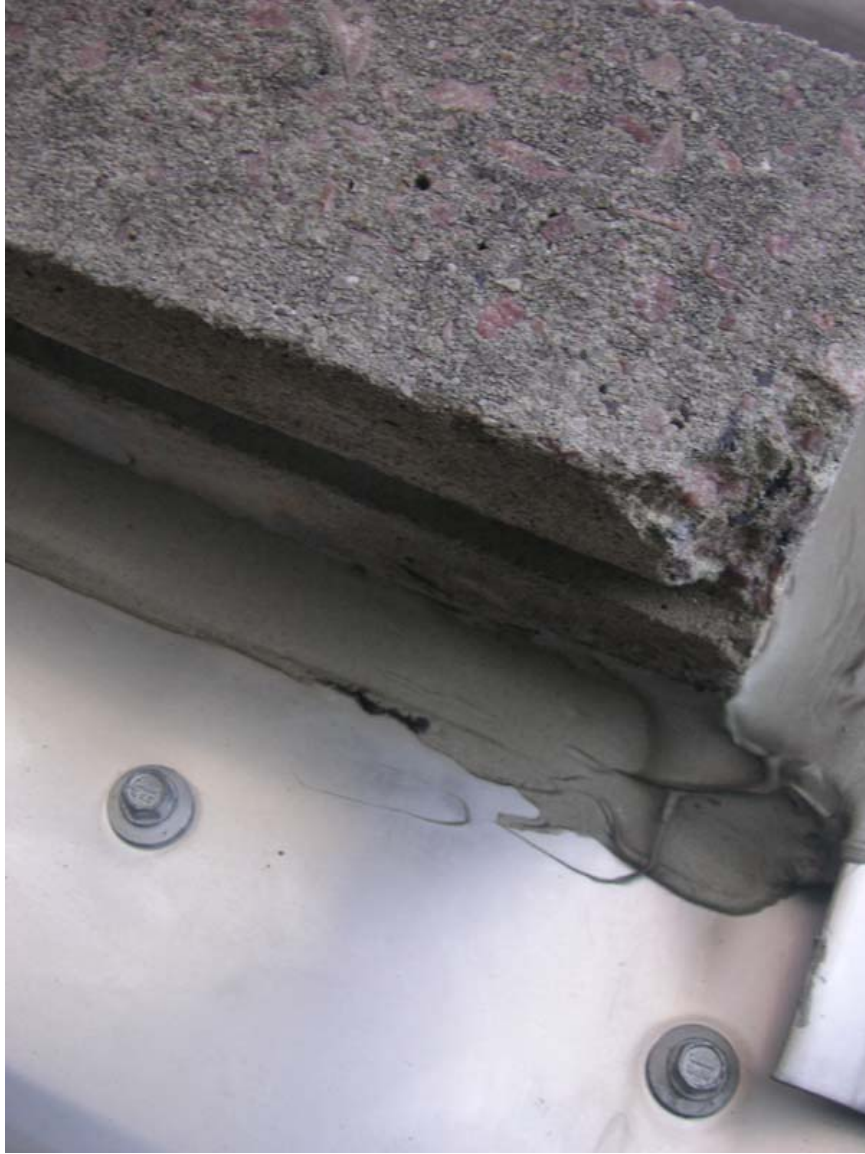
45. Caulk joint at crenel section

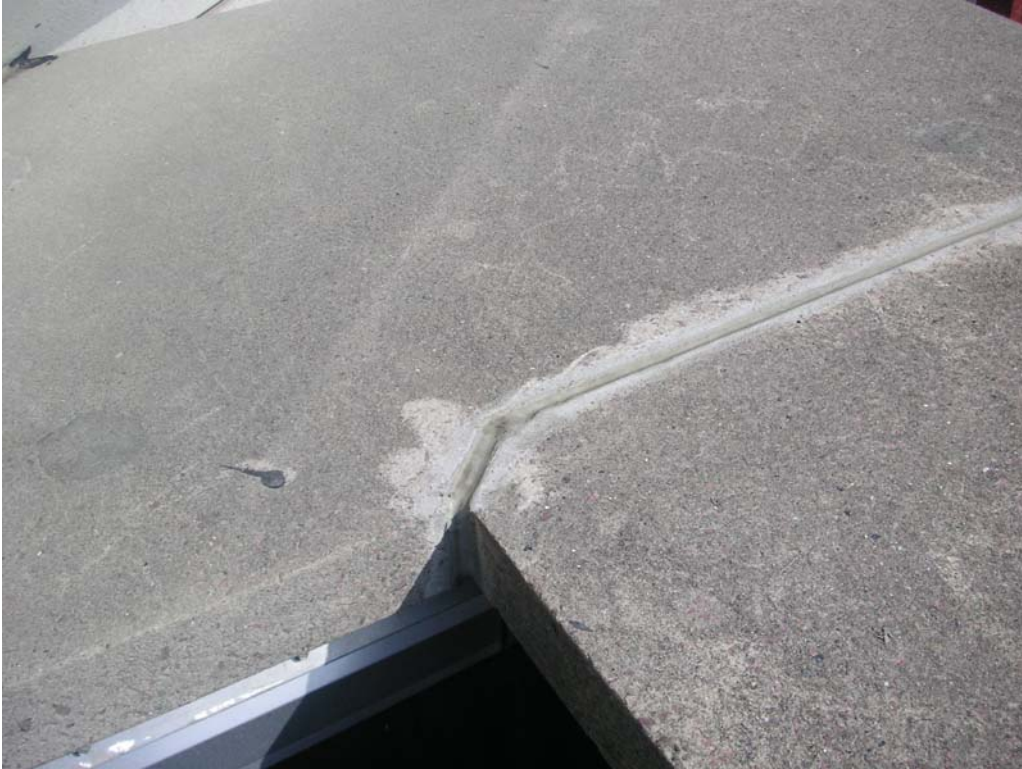
46. Top of caulking for cast stone

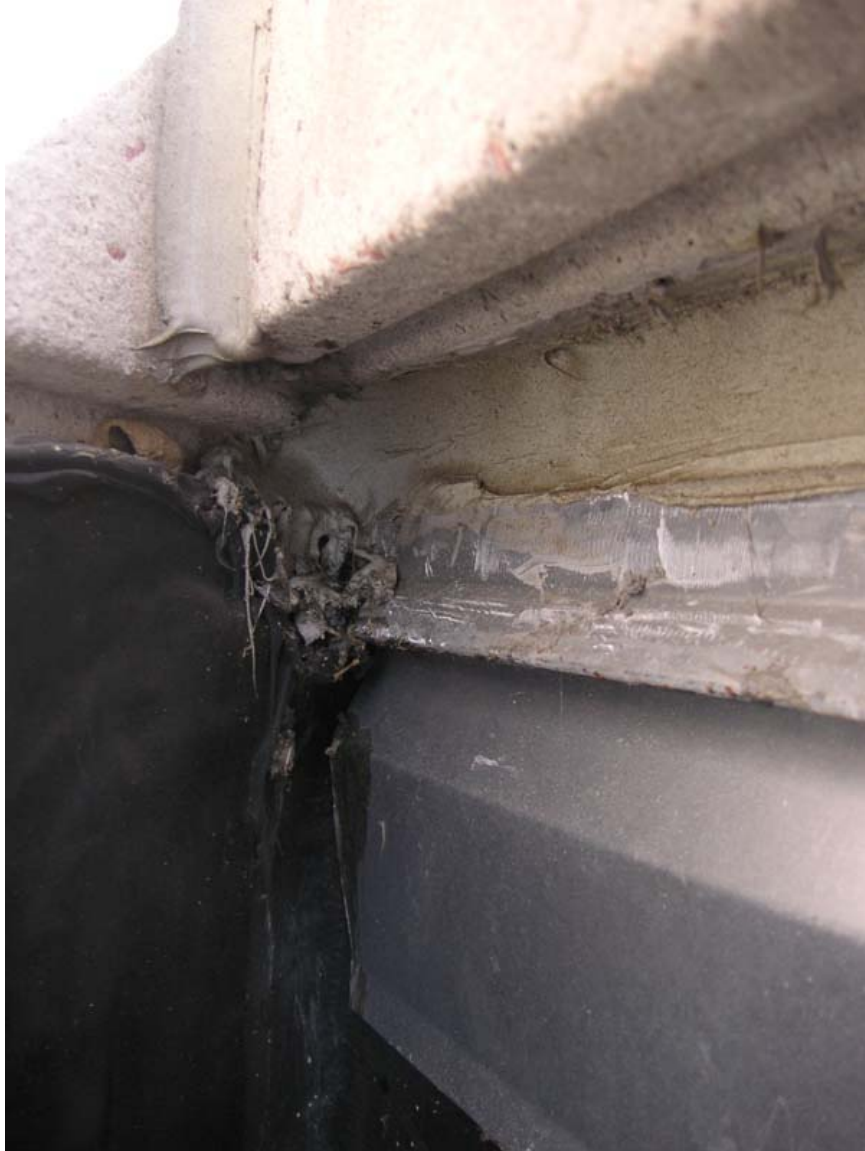
47. Caulking above cast stone and counterflashing

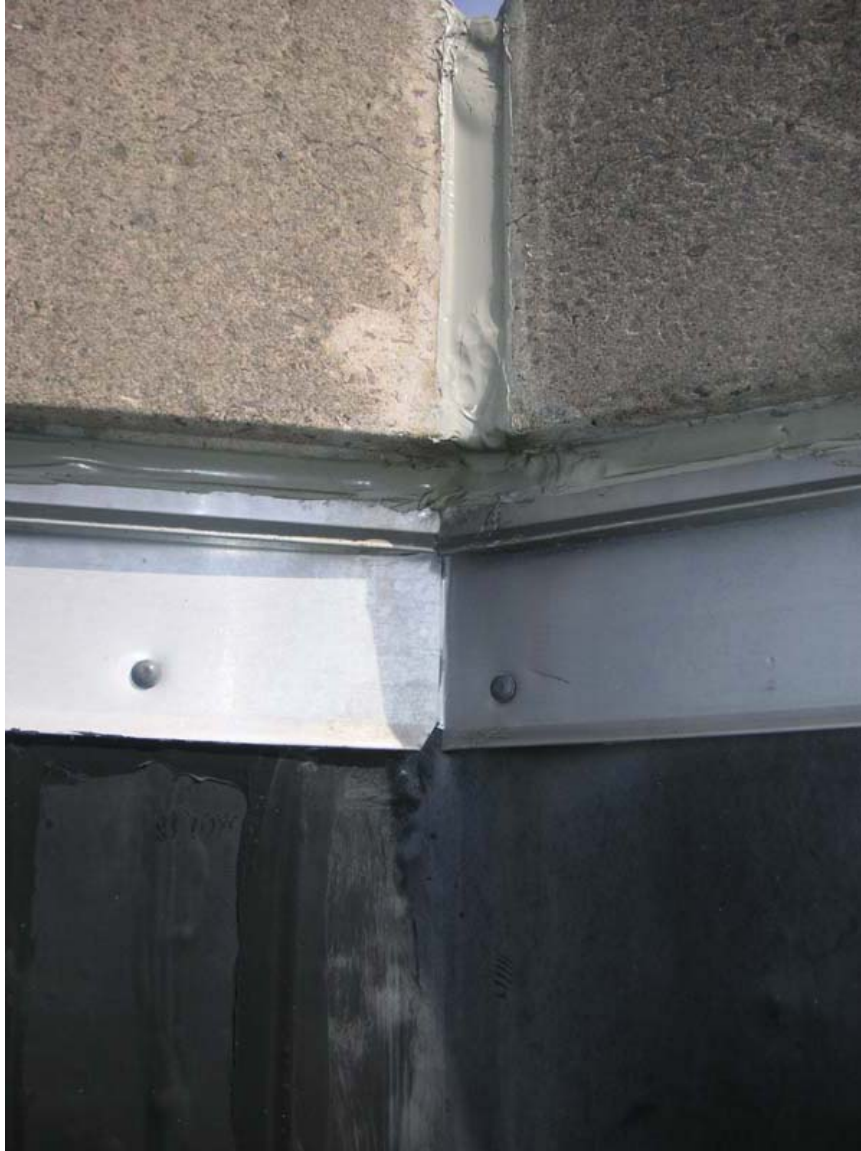
50. Constant overflow of water over counterflashing

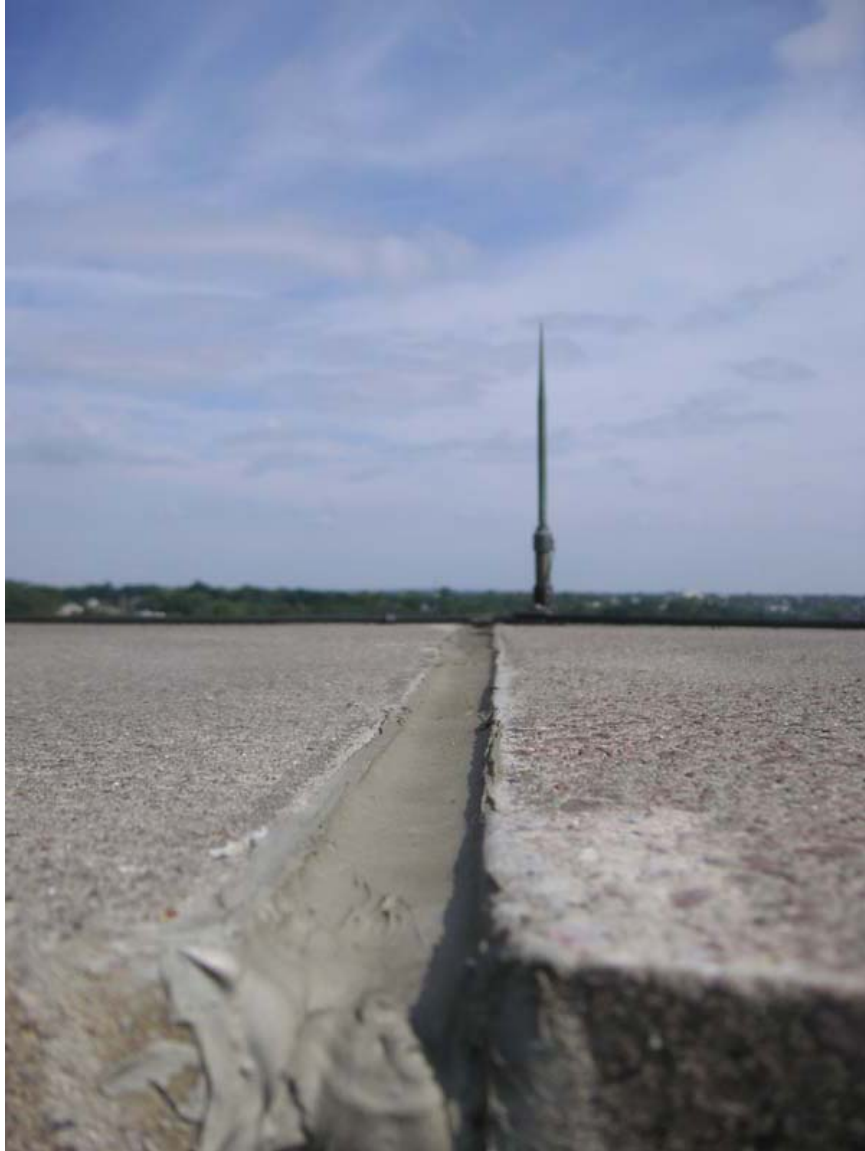
51. Top re-facing of stone for caulk

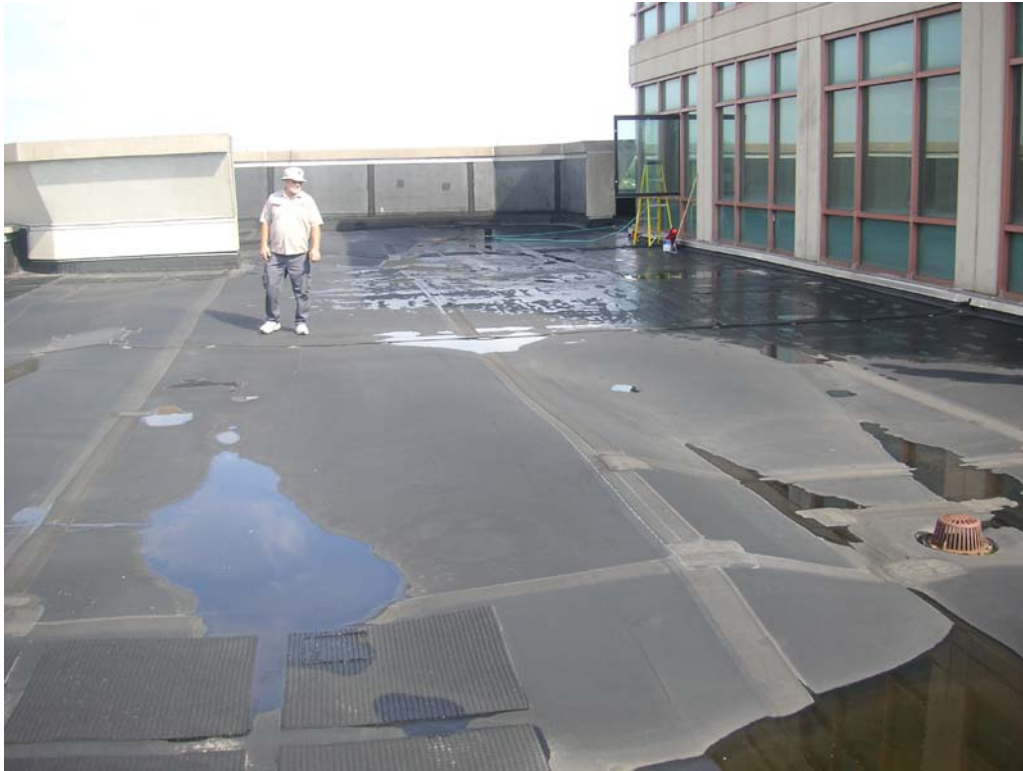
54. Large deformation in membrane

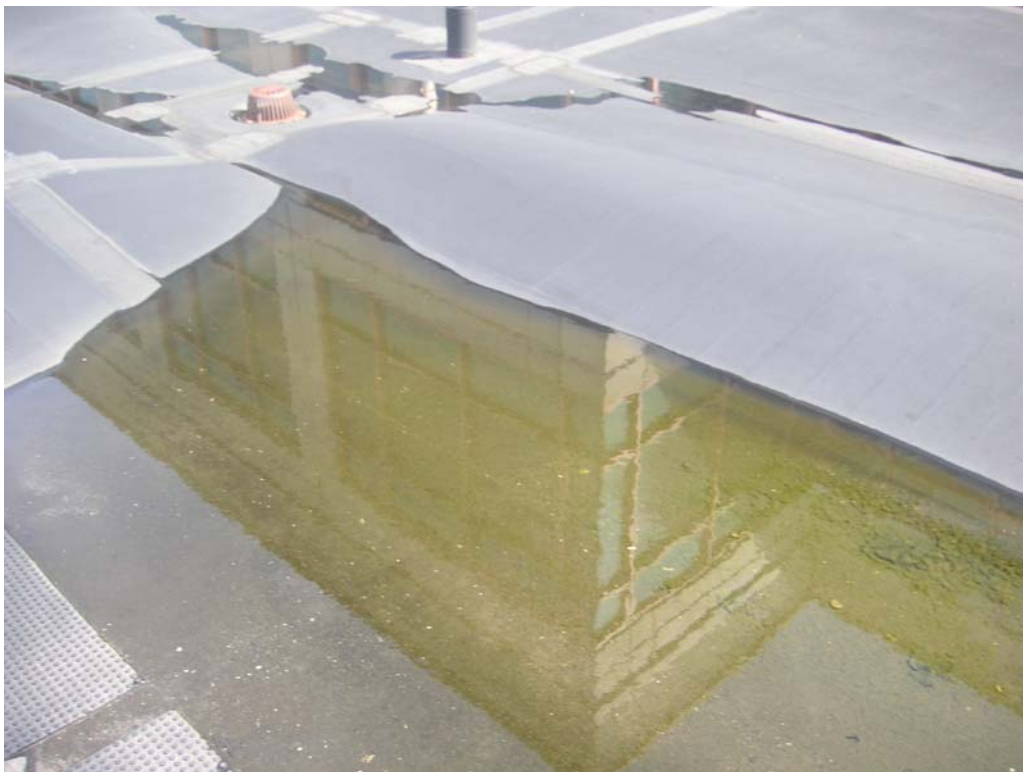
55. Ponding due to deformation

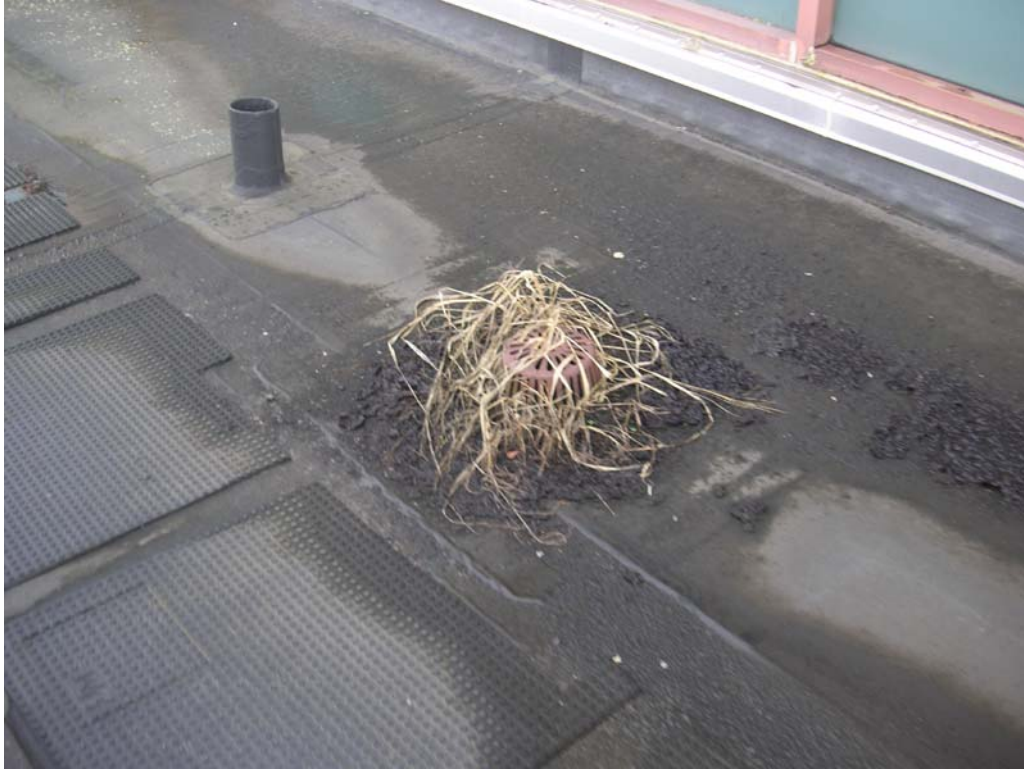
62. Lack of maintenance

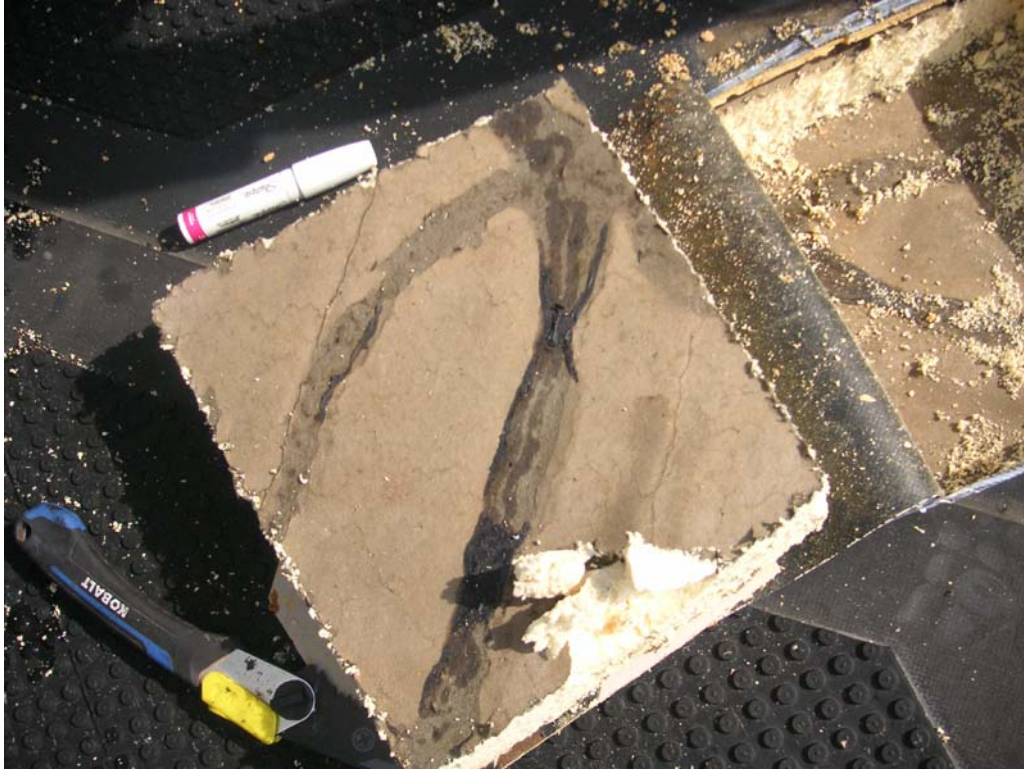
68. Shear top board of insulation

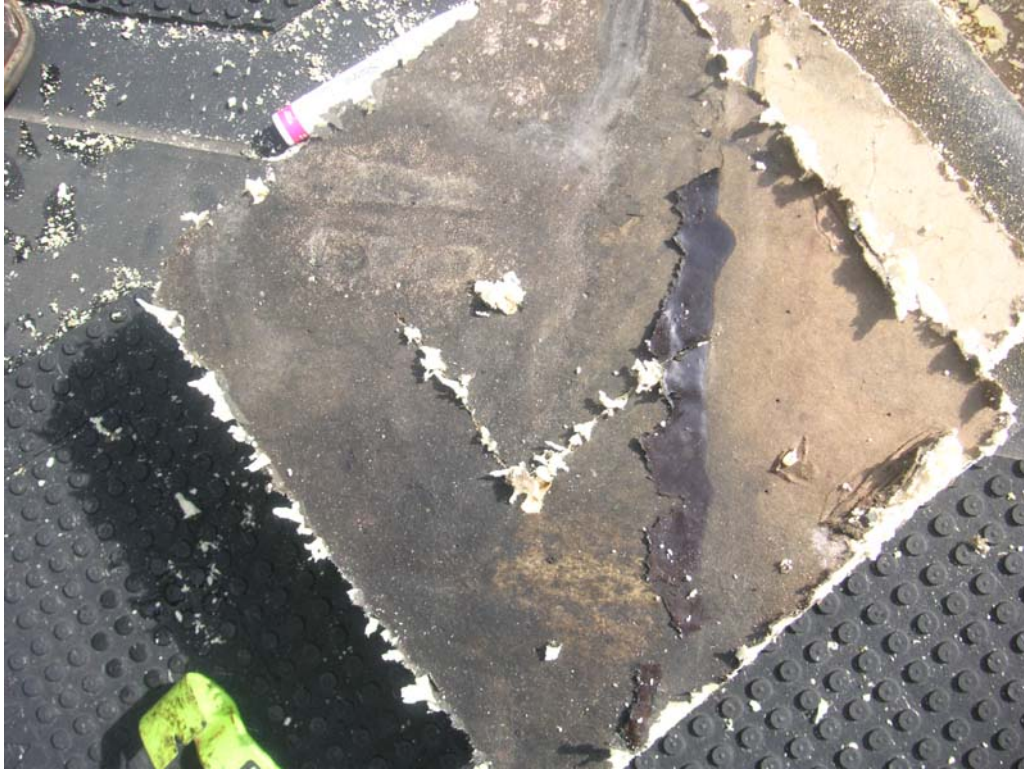
70. Underside of bottom layer of board

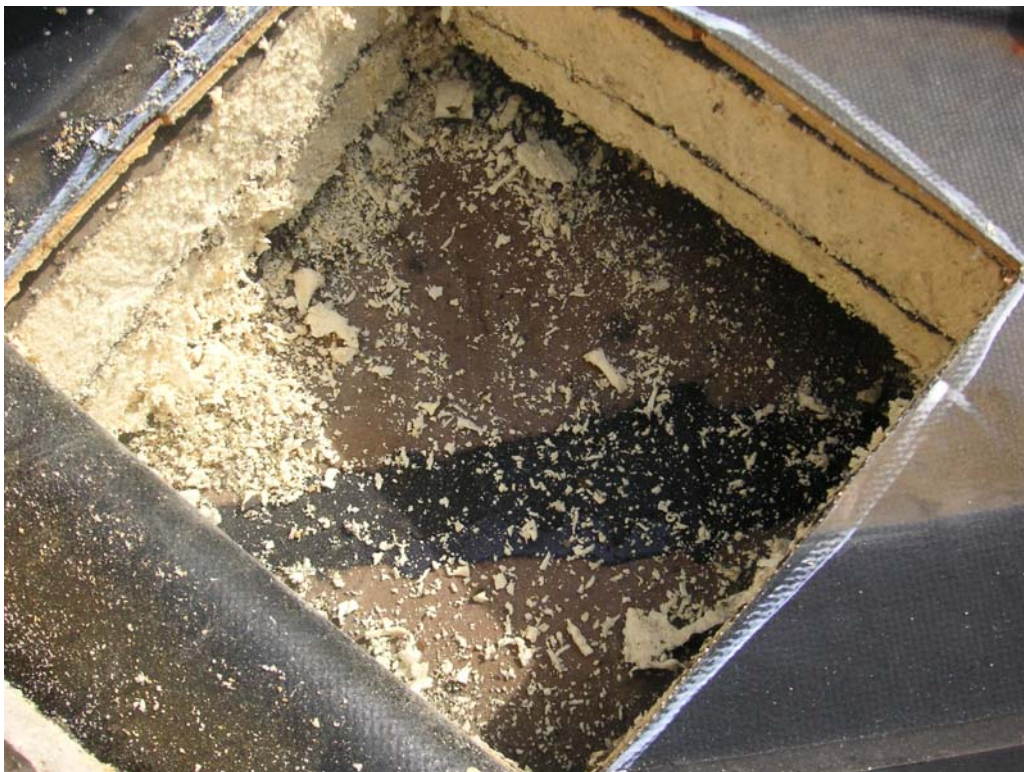
71. Saturated concrete deck

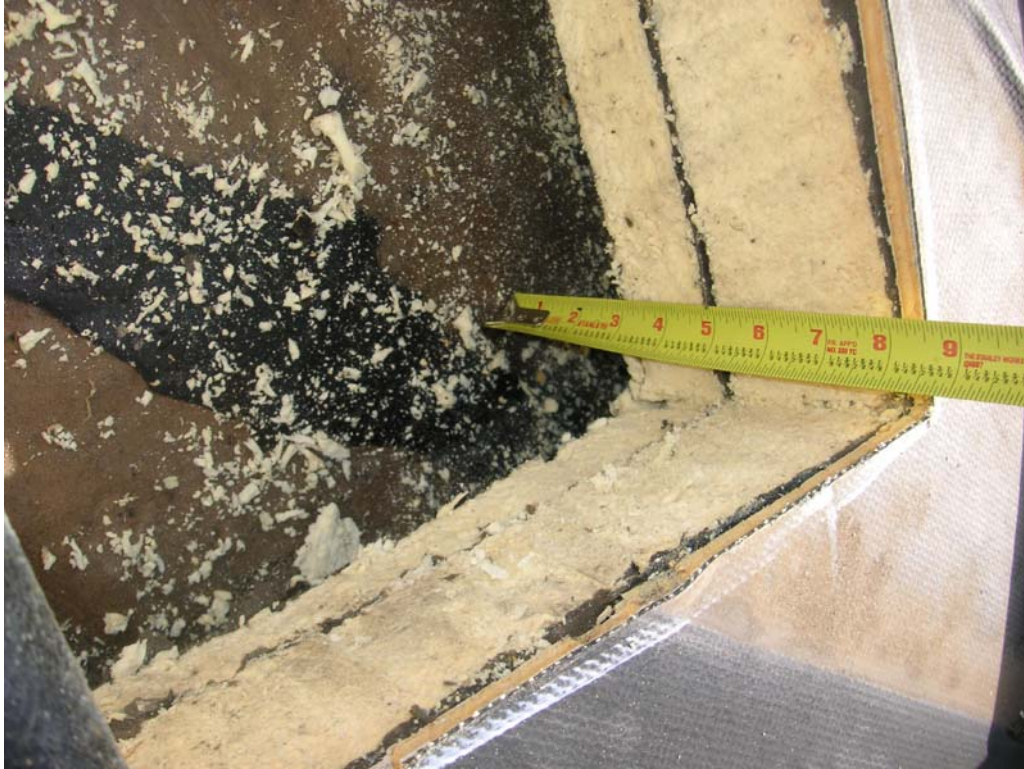
72. Total insulation with 3" delamination
