SCOPE OF WORK

Trenton Office Complex Roof Restoration

MVC Central Headquarters Building
225 East State Street
Trenton, Mercer, NJ

Project No. A1382-00

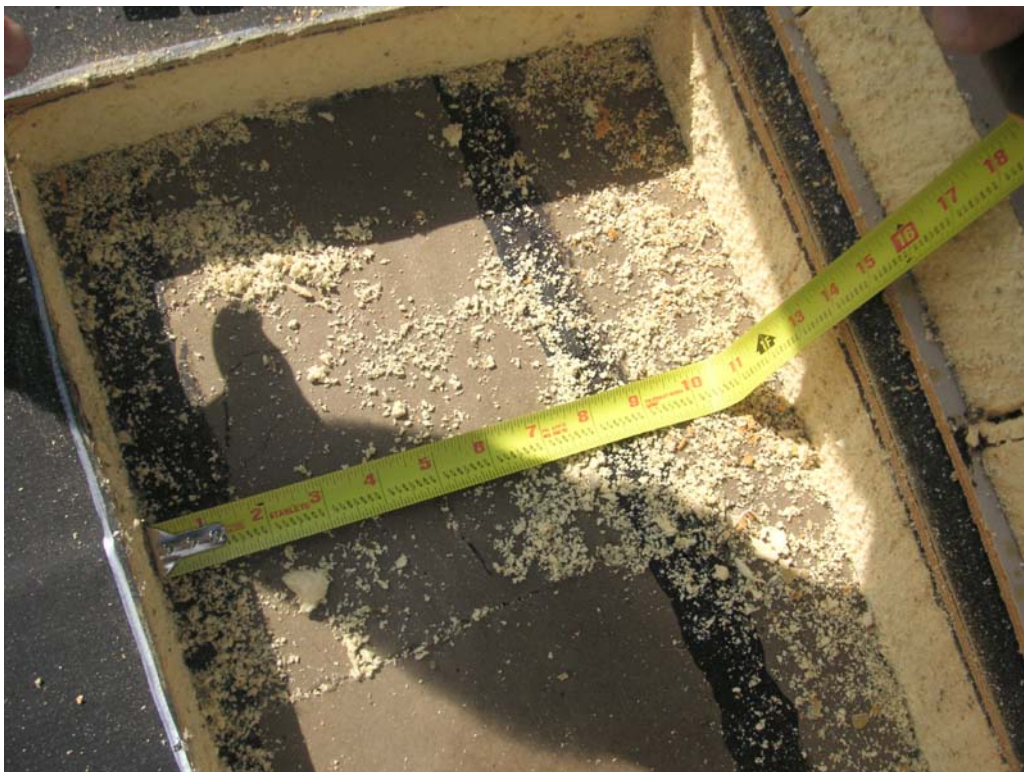
78. Wet facing sheet

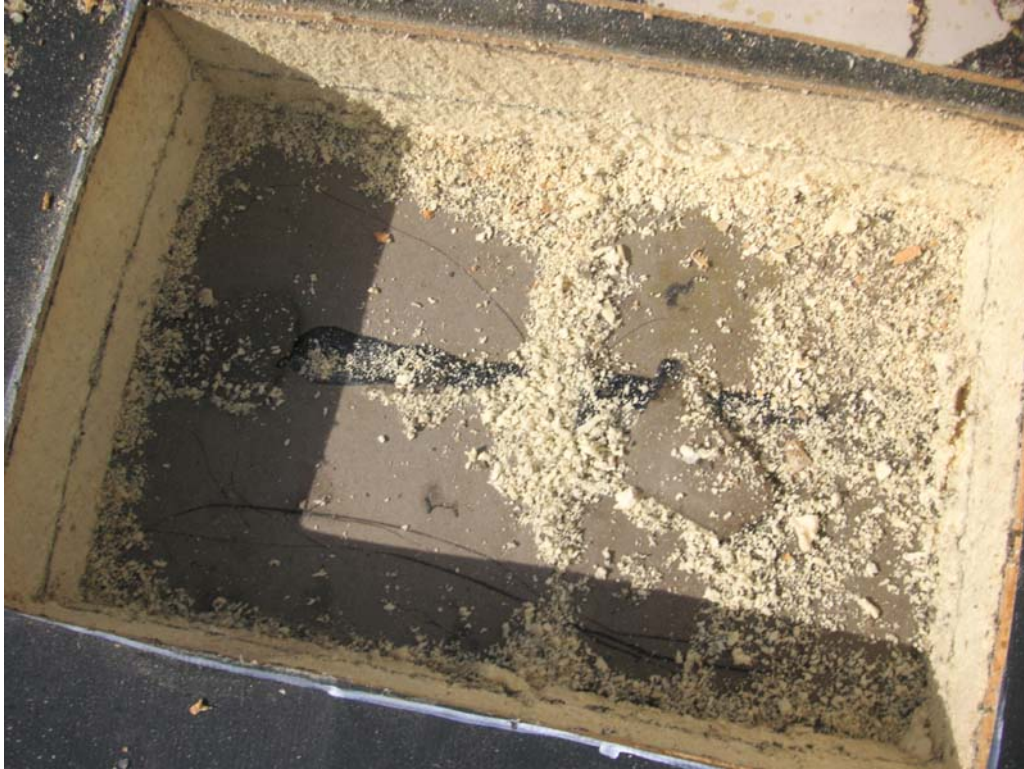
79. Good attachment of insulation layers

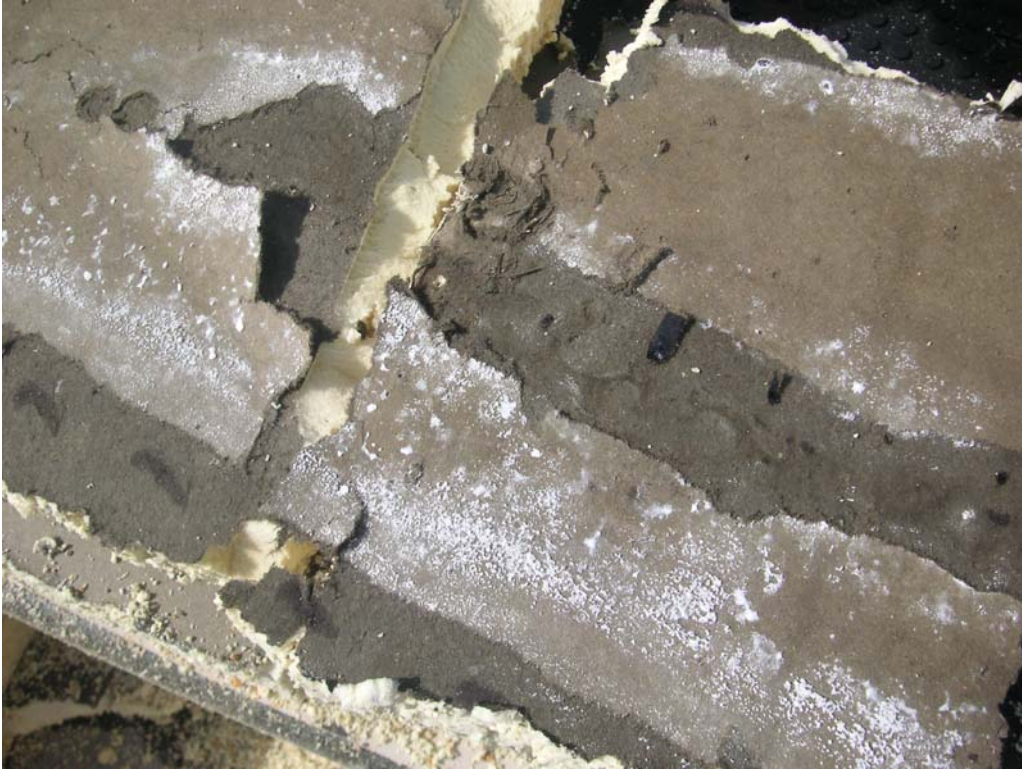
81. Concrete deck

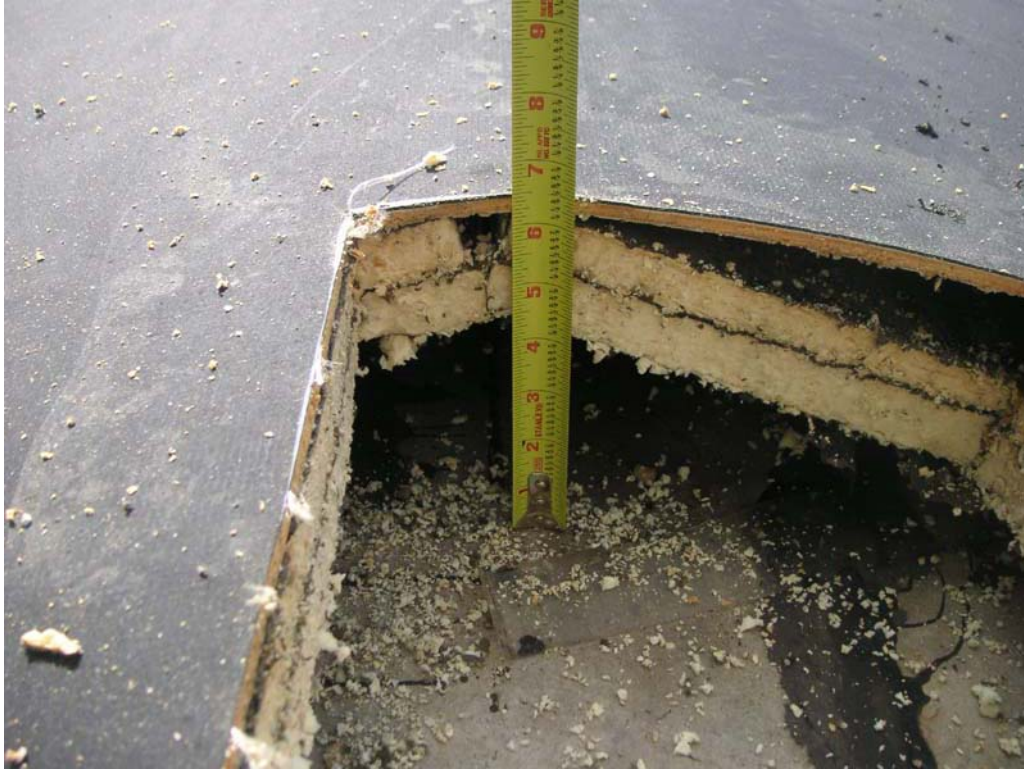
89. Bloated facing sheet of 2nd board

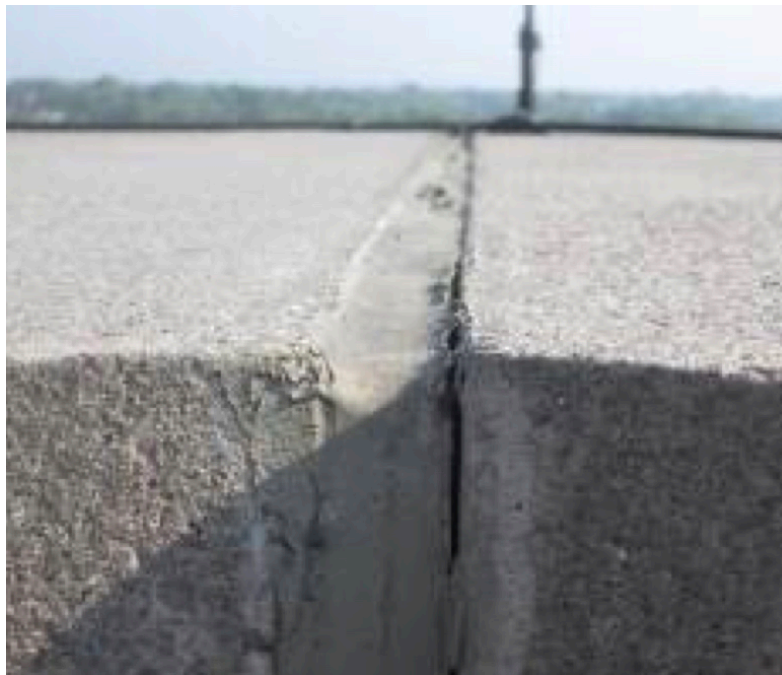
8. Coping
Split in caulk at shoulder of cast stone.

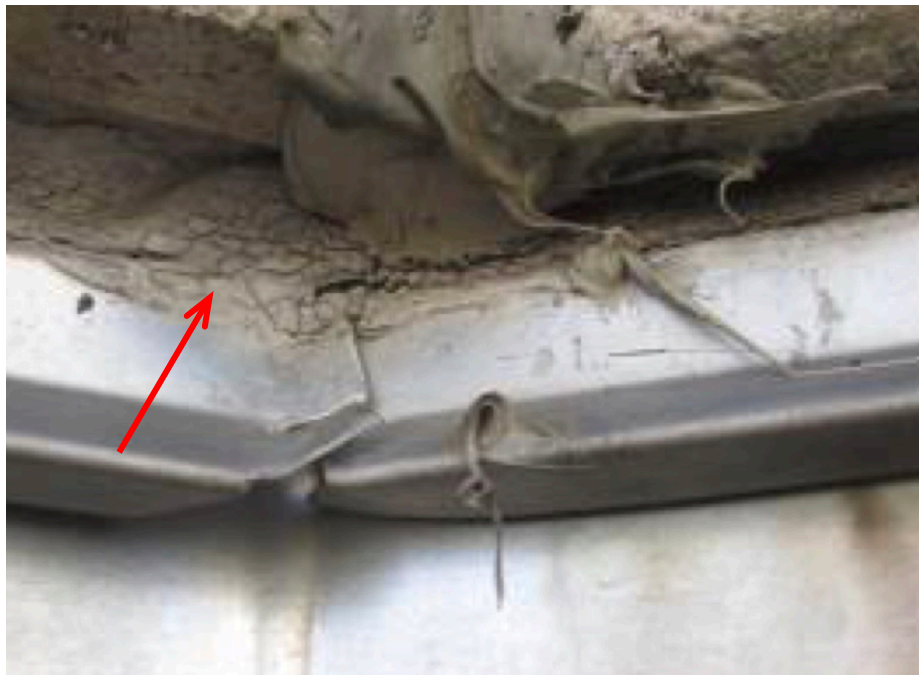
10. Caulking at Windows.
Original caulk 31 years ago never removed to allow water intrusion to base of system
