**N.J. PINELANDS COMMISSION
REQUEST FOR PROPOSAL (RFP)
RFP # 25-001
Cover Page**

HISTORIC FENWICK MANOR REHABILITATION

Historic Fenwick Manor Rehabilitation

HISTORIC PRESERVATION PLAN

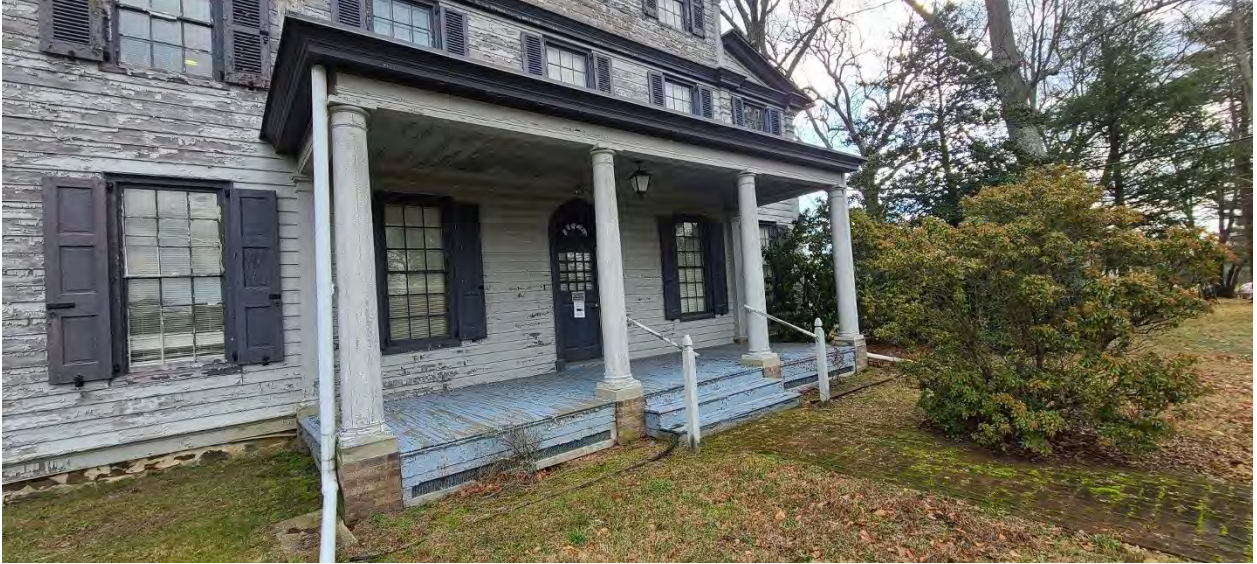
Photo S-1. View showing the front porch including the walk, which is barely visible due to the weeds and moss growth between the joints and on the surface of the brick. Note the grade is too high and there are two dead/dying bushes.

- Repair the walks and the side stairs including cleaning the brick of all biological growth. Allow for ten percent replacement of brick in-kind. (I)
- Investigate the condition of the abandoned underground drainage system on the north side of the building and determine its layout and condition. (I)
- Consider the installation/upgrading to create a new underground drainage system so all roof drainage goes underground and does not drain at grade. (I)
- Consider engaging a landscape architect to improve the foundation plantings and implement design. (IV – not in estimate)

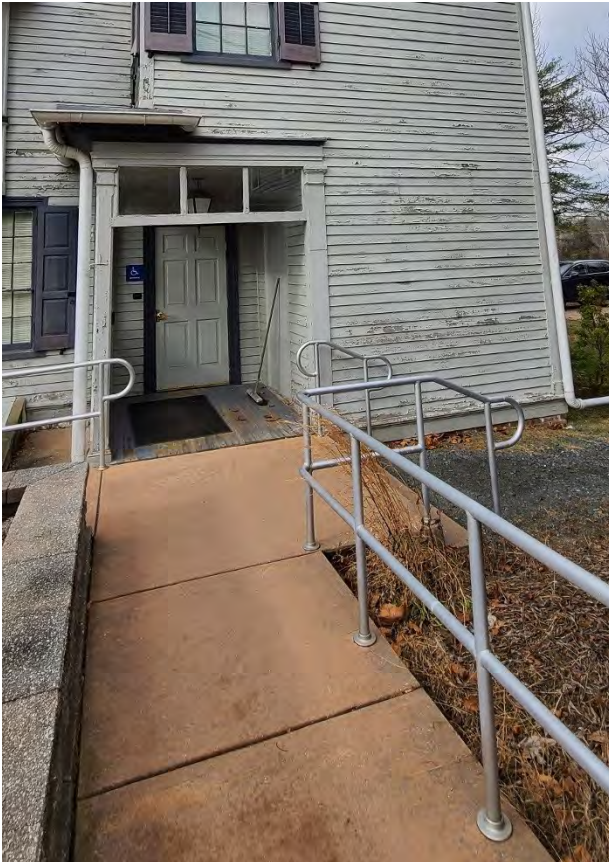
Photo S-2. View of the ramp and walk at the rear entrance, which serves as the primary entrance and is in good overall condition.

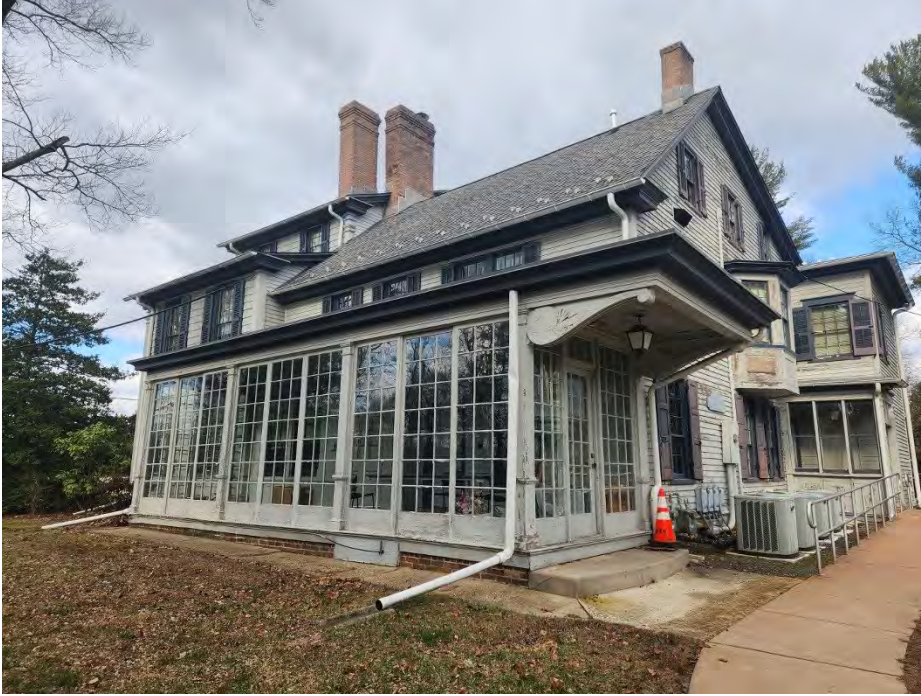
Photo S-3. View of the typical extension of the leaders to splashblocks.

The roof drains at grade via extensions to splash blocks, which is effective, but not necessarily an attractive approach to water management along the foundation.

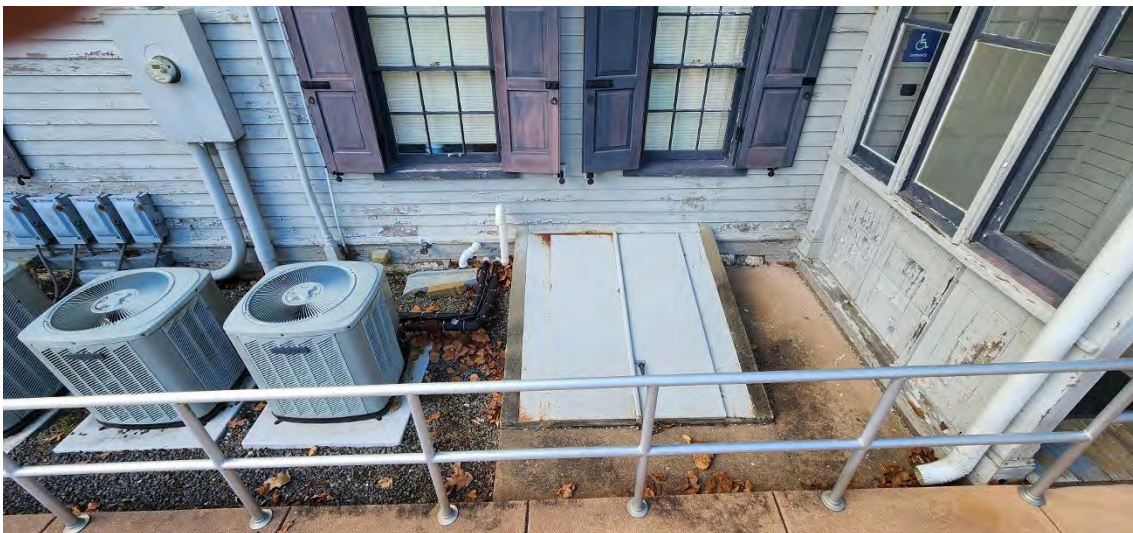
Photo S-4. View of the utility area at the rear of the building showing a mix of concrete and gravel surfaces.

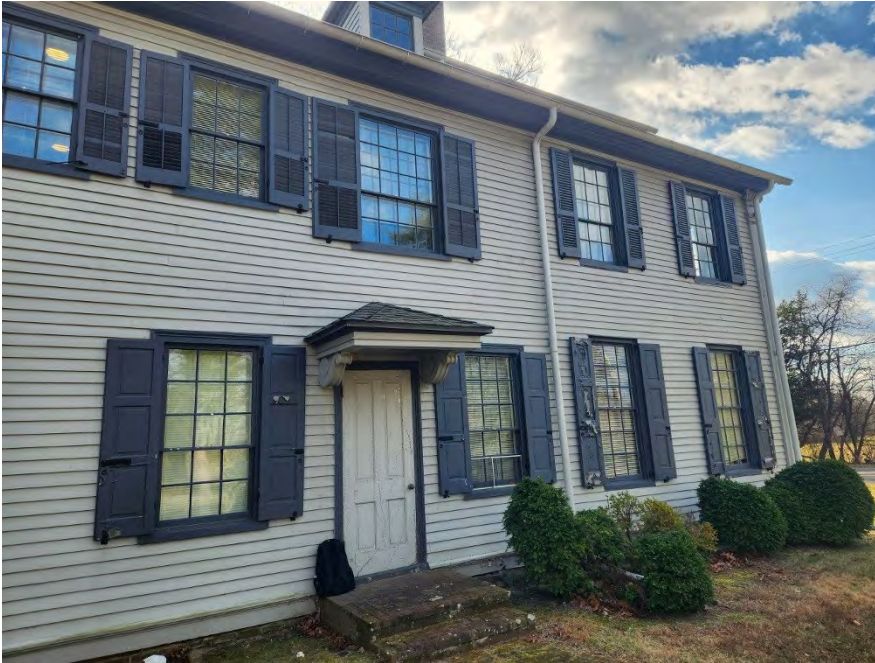
Photo S-5. View of the little-used side entrance showing biological growth on the side stairs and walk. The bushes and shrubs appear to be slightly haphazard.

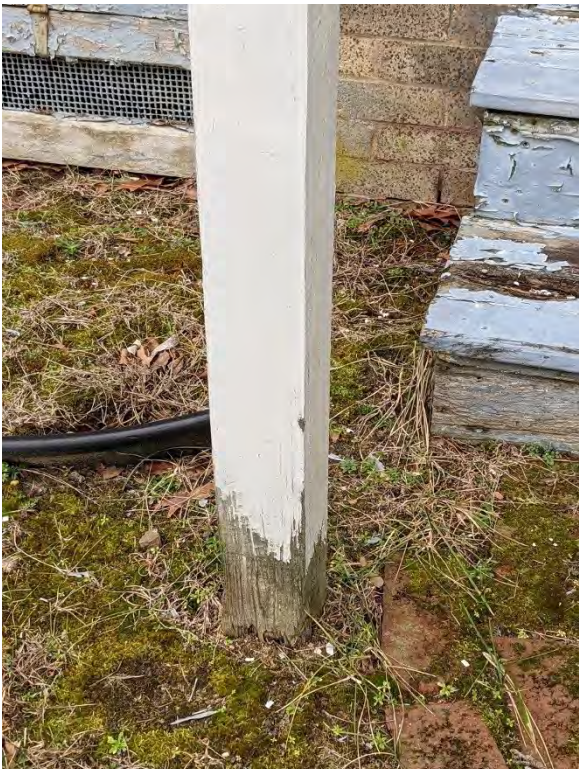
Photo S-6. Plastic edging indicates foundation plantings no longer present. The newel post for the railing at the front porch sits on grade and wood rot is evident at the lower few inches of the post.

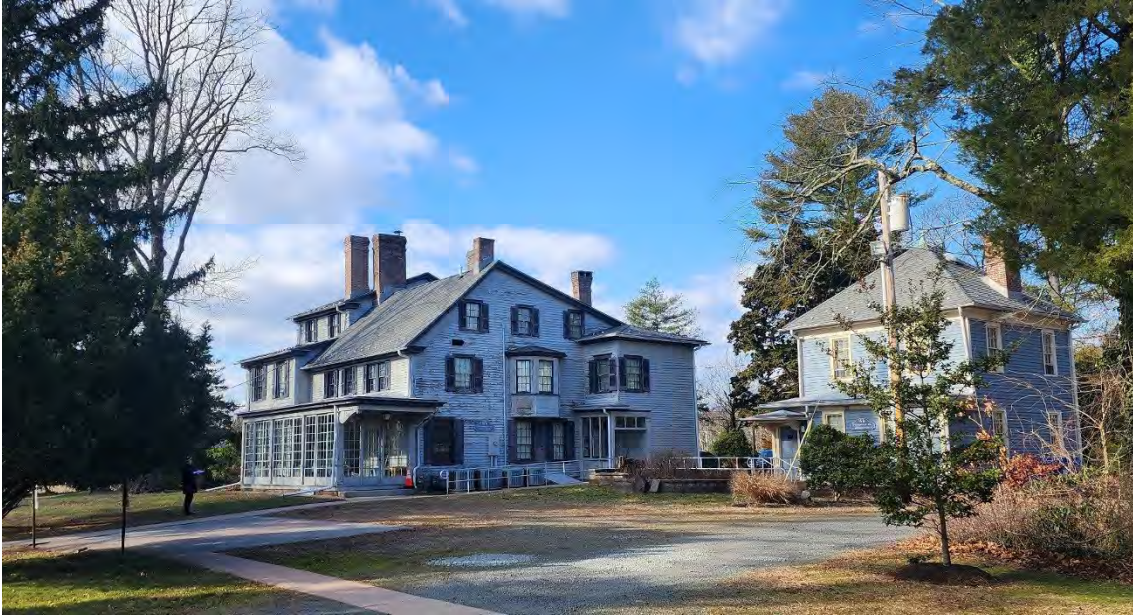
Photo E-5. Overall view of Fenwick Manor looking northwest at the south and east elevations. Note the evolution of the building as seen in the various rooflines and chimneys.

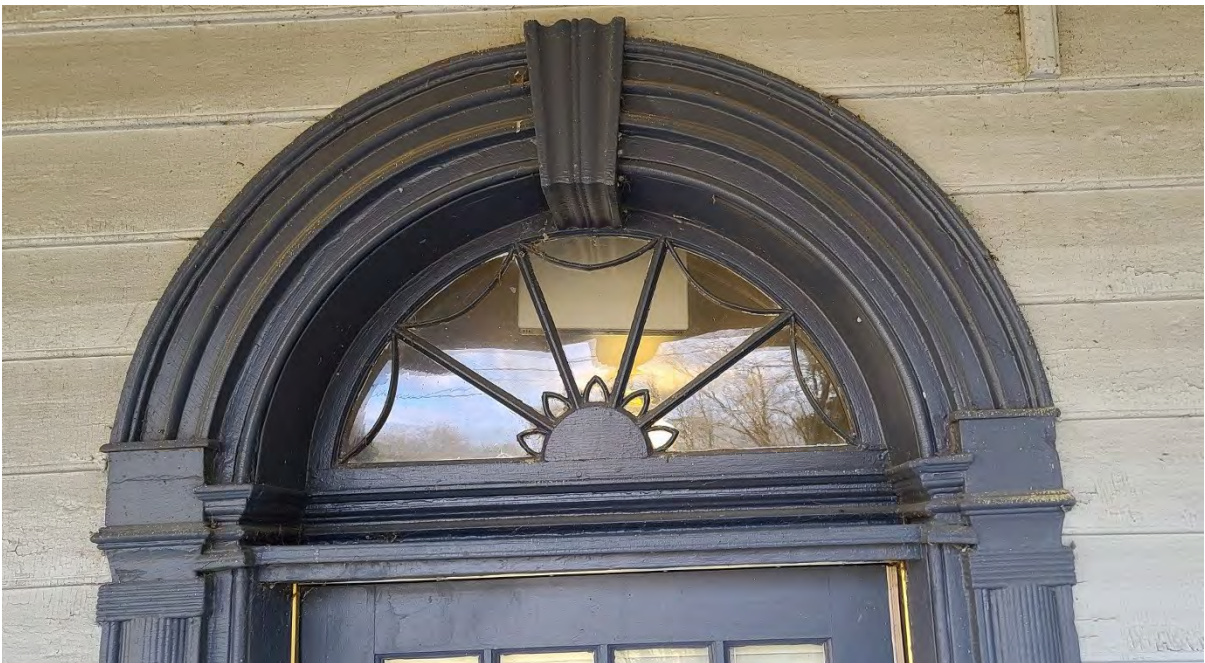
Photo E-8. Detail of the Federal style transom at the front entrance.

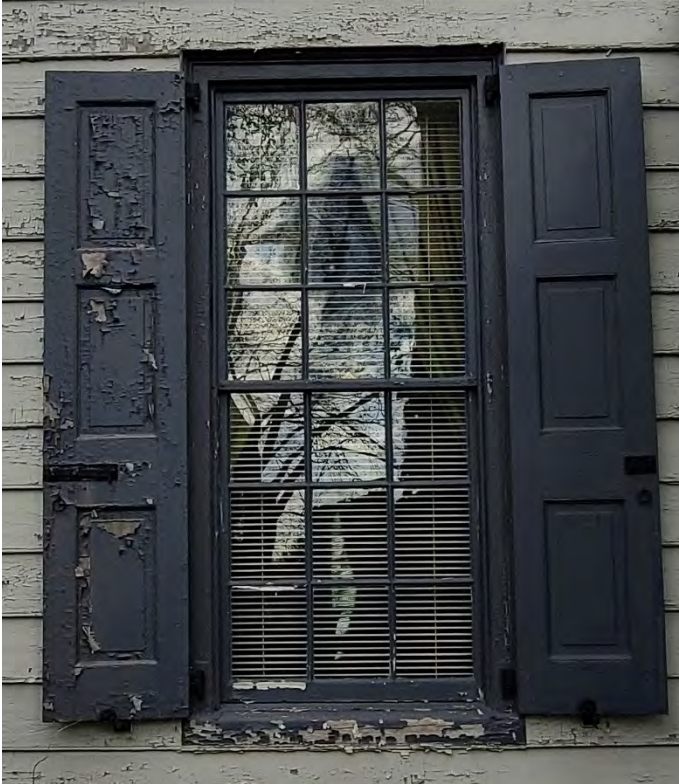
Photo E-9. View of a typical multi-light wood window with paneled shutters.

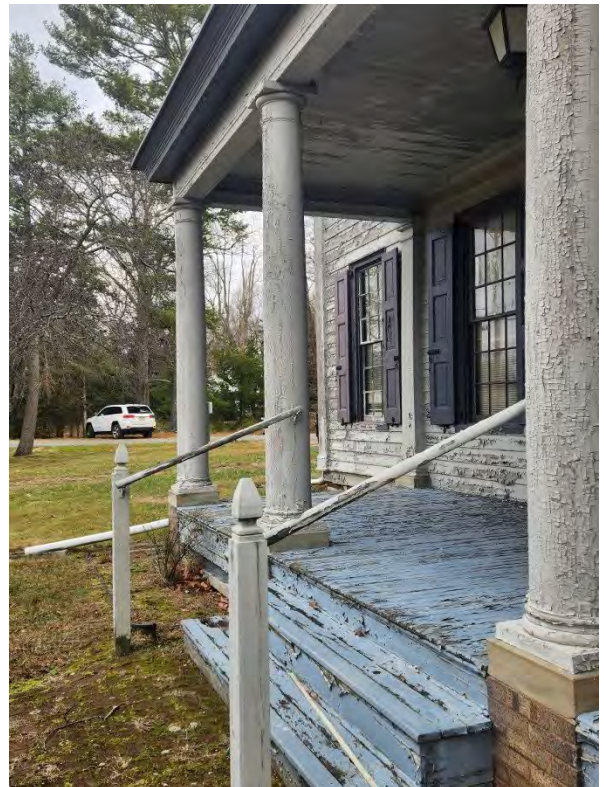
Photo E-10. Detail view of the front porch showing the Doric columns resting on limestone and brick piers. This image also shows the wholesale paint loss, which is throughout the painted porch elements.

All elements of the front porch exhibit wholesale paint loss including the wood decking. There is wood rot at the stairs as well as loss of nosing trim. At the south side of the porch the wood deck boards exhibit rot and about five of the wood boards have displaced. There is significant paint crazing at the columns and visible seams in the wood; the south column exhibits the worst conditions. The bottoms of the wood newel posts sit on the grade, and there is evidence that wood rot is beginning. The wood lattice, which has metal mesh infill, sits in the dirt and exhibits significant paint loss and rusted hinges. There is evidence at both ends of the porch that groundhogs are gaining access. The porch ceiling, which appears sound, exhibits paint loss and discoloration, which may be some biological growth.

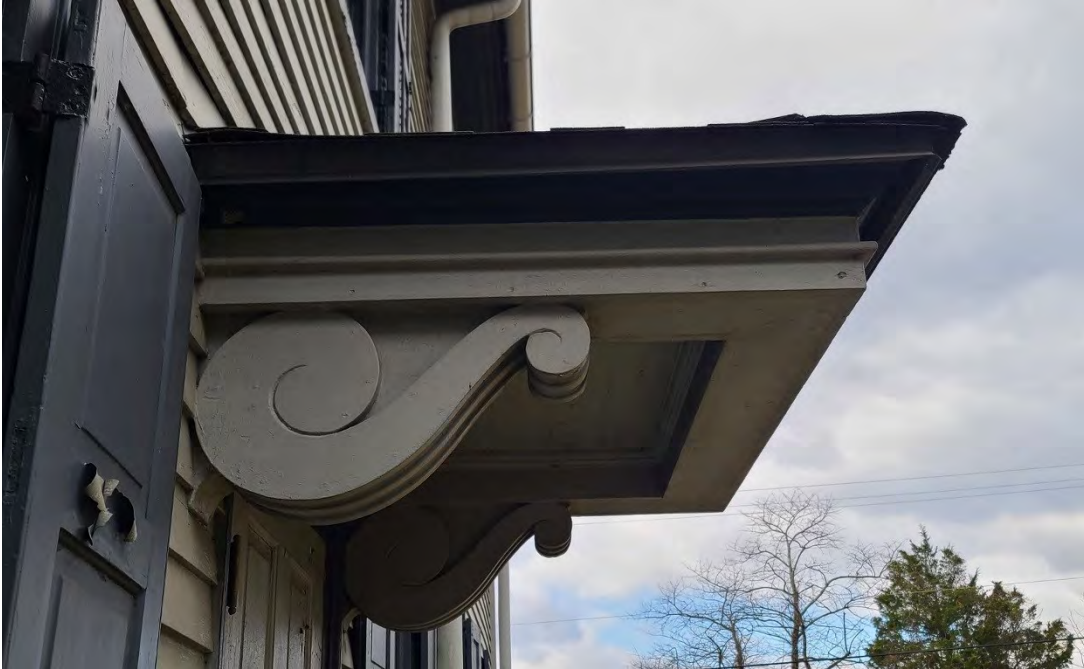
Photo E-11. Detail of the north side porch/stoop overhang showing the scroll detail that is also present over the rear entry to the enclosed south porch.

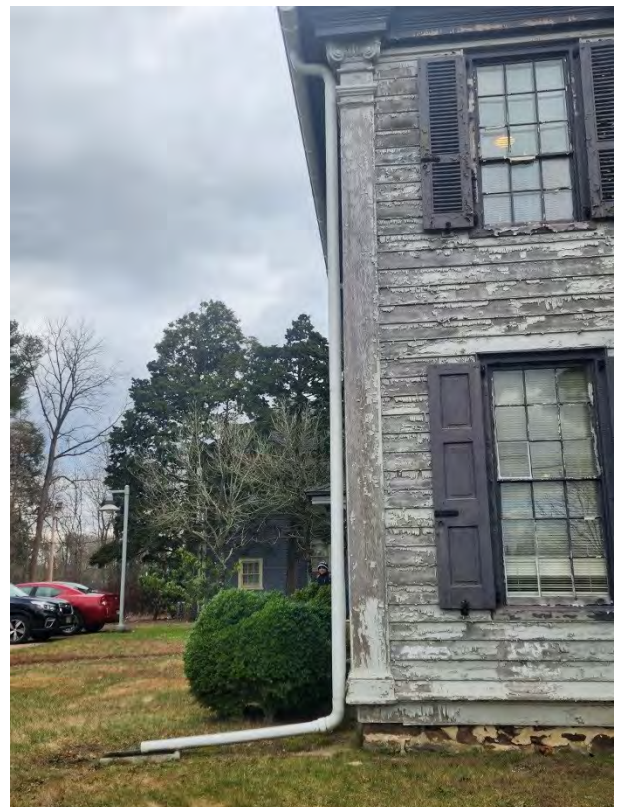
Photo E-12. Detail of the two-story pilasters at the Federal style section of the house. Note the wholesale paint loss on the siding and trim elements. Based on the manner in which the paint is peeling, the lower paint layers have failed causing the paint to check and alligator.

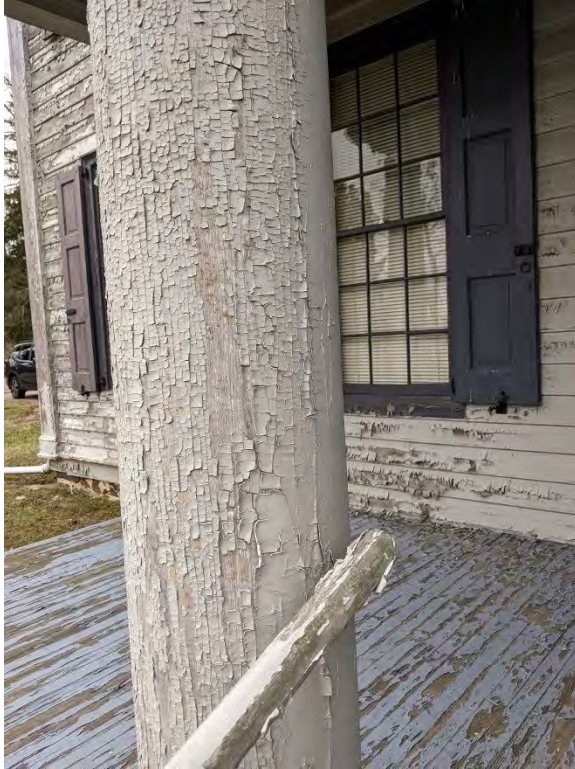
Photo E-13. Detail of alligatoring of the paint.

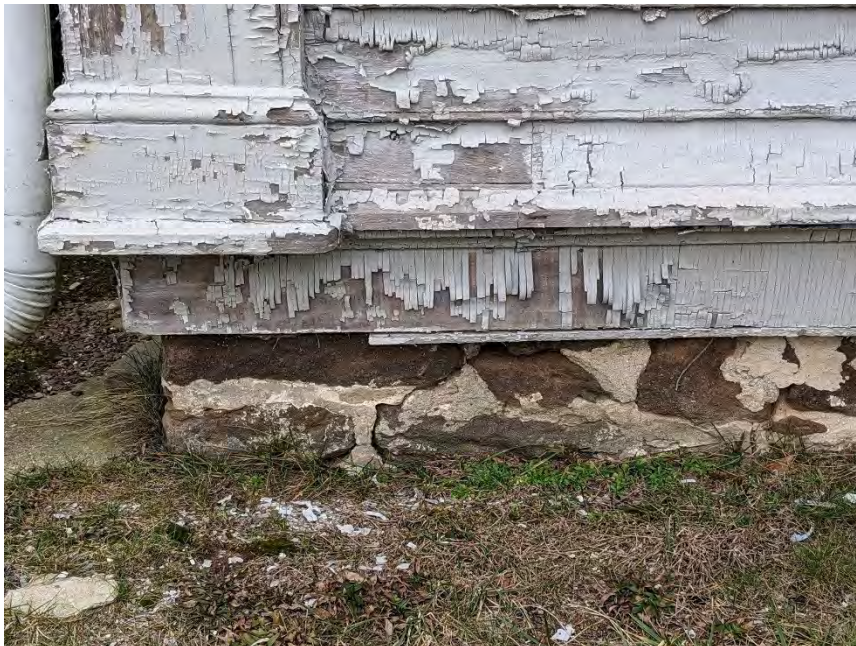
Photo E-14. Detail of paint that has checked, which is severe in many locations.

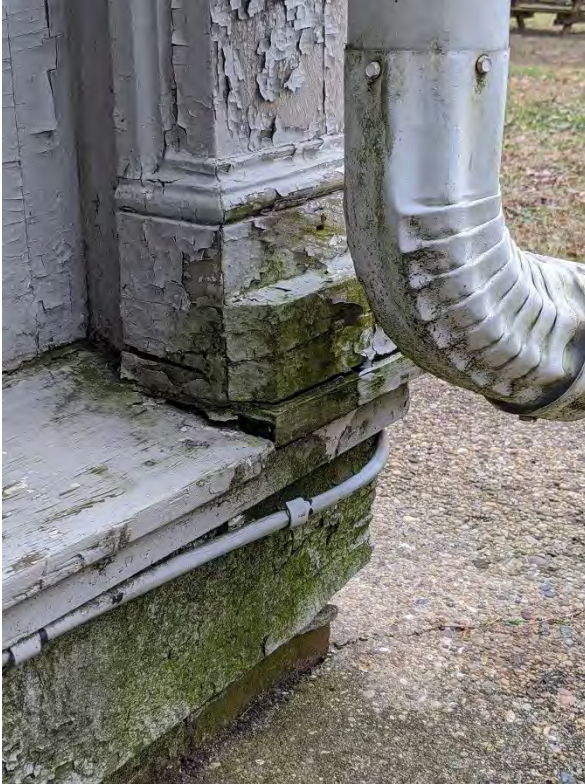
Photo E-15. Another exterior paint issue is heavy biological growth, as seen in this image probably caused by backsplash from concrete surface around the south enclosed porch.

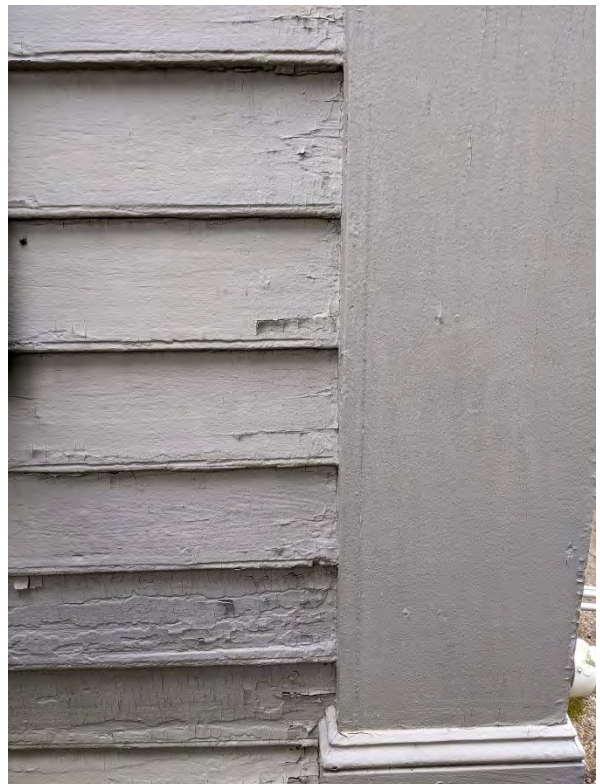
Photo E-16. This image shows heavy paint layers that were not properly sanded, and the build-up of paint is causing the paint to alligator and check.

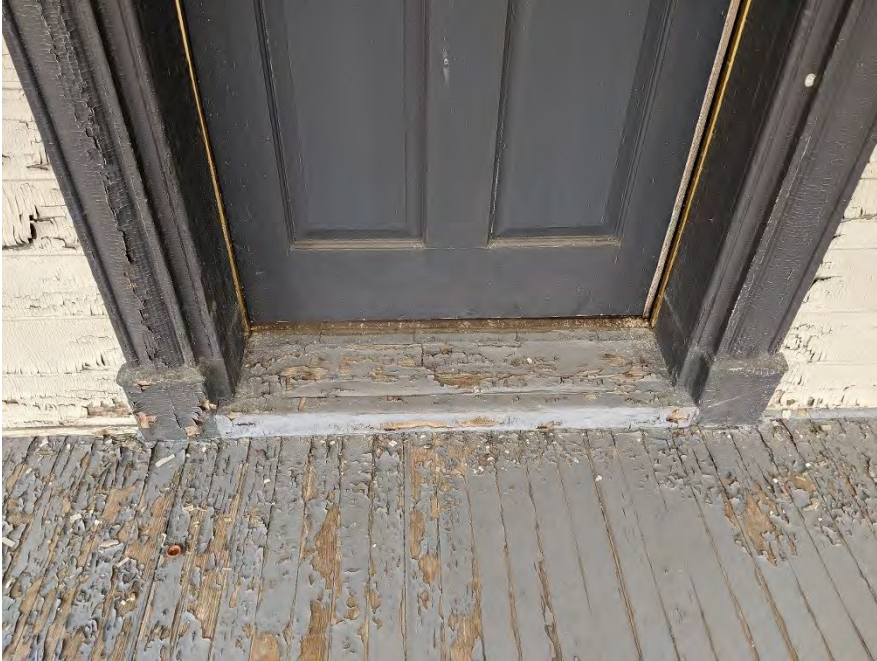
Photo E-17. View of paint failure at the front porch. Paint failure is unsightly but will also lead to wood rot and deterioration when the underlying substrate is exposed to moist and wet conditions.

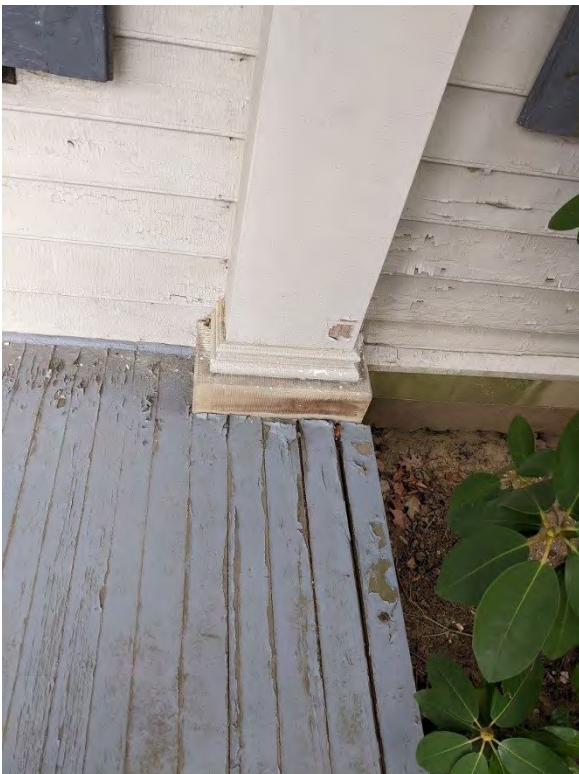
Photo E-18. View of wood rot and movement in the porch decking at the front porch.

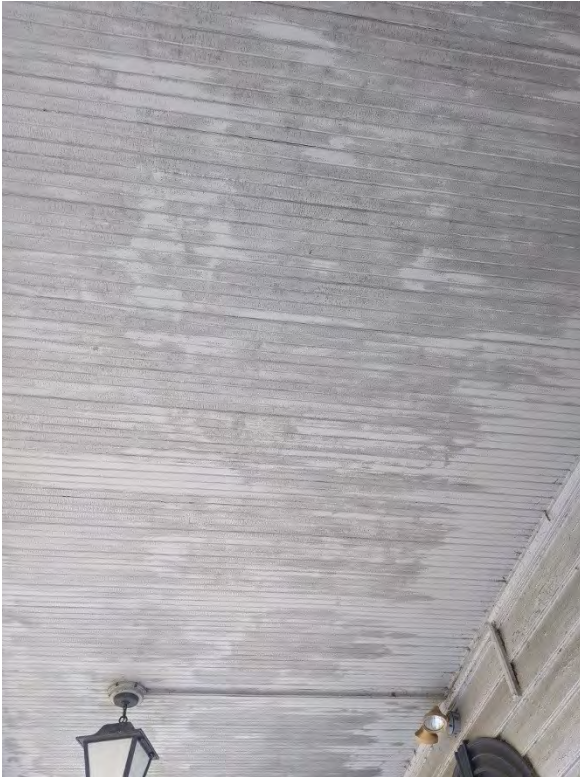
Photo E-19. Paint is alligatoring at the ceiling of the front porch.

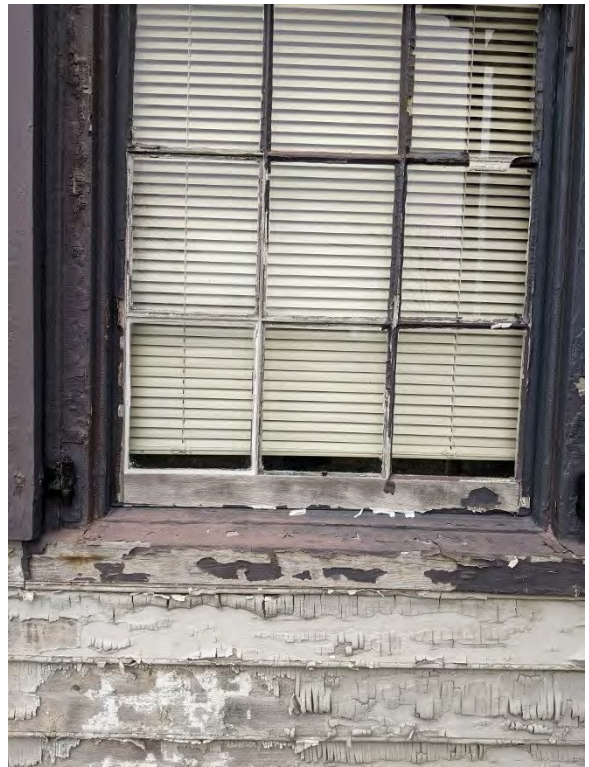
Photo E-20. Paint and glazing putty loss is prevalent at many of the wood-hung windows and frames.

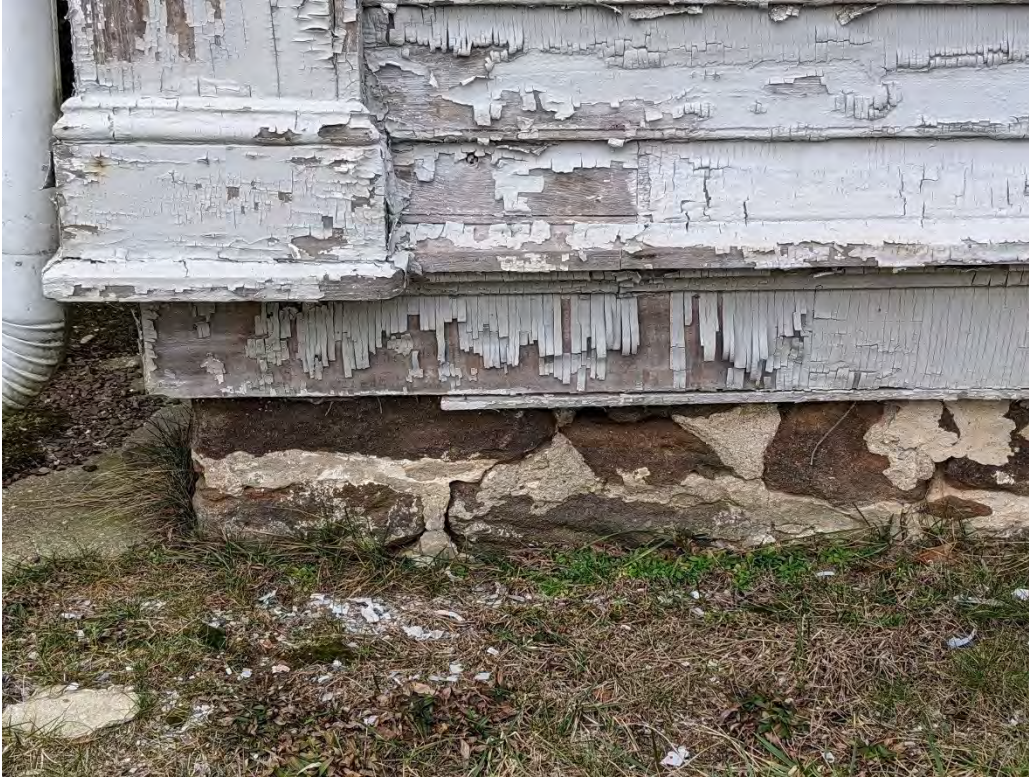
Photo E-21. View of mortar loss at the brownstone foundation. Foundations exhibit a mix of mortar and parging loss.

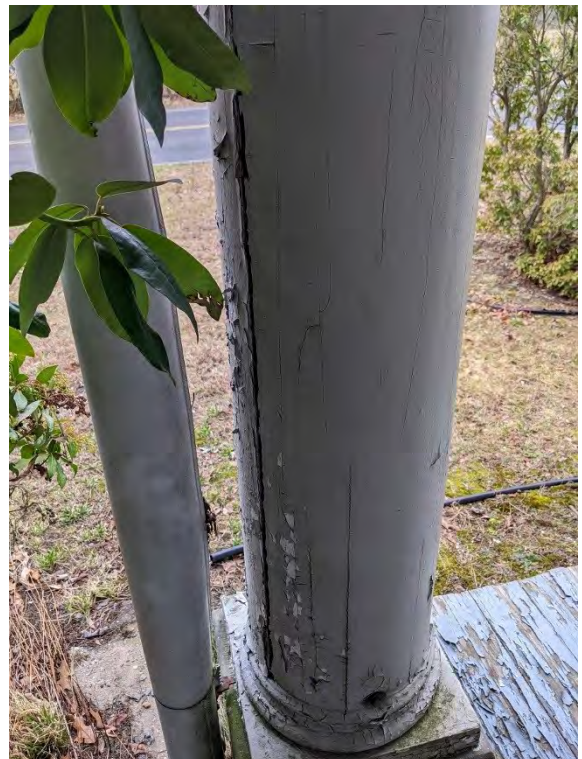
Photo E-22. Image shows a split in the south columns of the front porch.

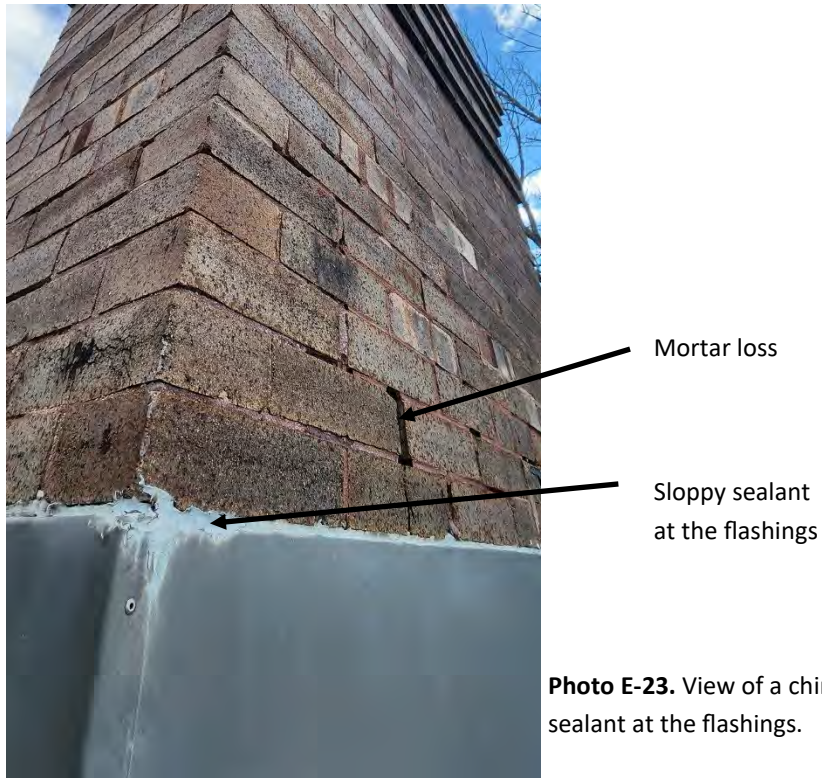
Photo E-23. View of a chimney showing mortar loss and sloppy sealant at the flashings.

The brick chimneys appear in overall good condition from afar, but upon closer examination each has a few areas where there is mortar loss and soiling. There is also a mix of colors used in the mortars from red to beige, and the red mortar appears to have just been laid over the beige mortar. The chimney belonging to the fireplace in the southwest parlor appears to lean slightly.

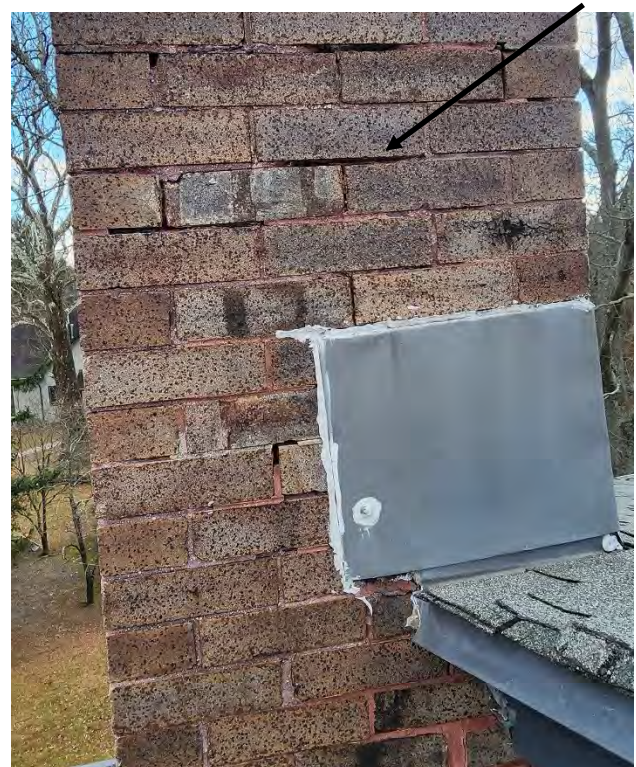
Photo E-24. View of flashings at chimney, which are generally poorly executed. Also noted in this image is mortar loss at the brick.

The asphalt shingle roof is a newer material fabric and appears in overall good condition. There is some edge loss of the material where it overhangs the drip edge too much. The aluminum flashings, in particular around the chimney, are poorly installed, the sealant is sloppy, and the poor workmanship makes one question their effectiveness in the long term. The aluminum hung gutters and smooth round leaders are newer and in good condition overall with some rusted fasteners; rusted fasteners indicate a mix of metals, which will shorten the lifespan of the leaders. The Project Team prefers a different type of gutter system where the gutter is supported from the bottom and top, as the clips used on the existing system fail within a few years.

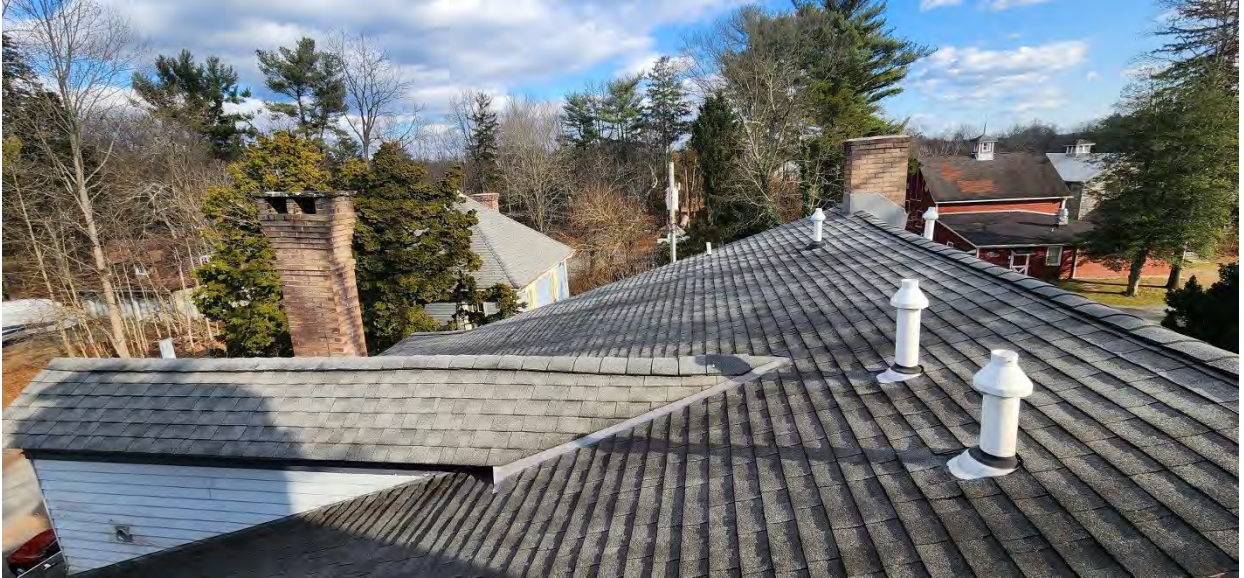
Photo E-25. Overall view of the asphalt shingle roof, which appears to be newer and in good condition overall.

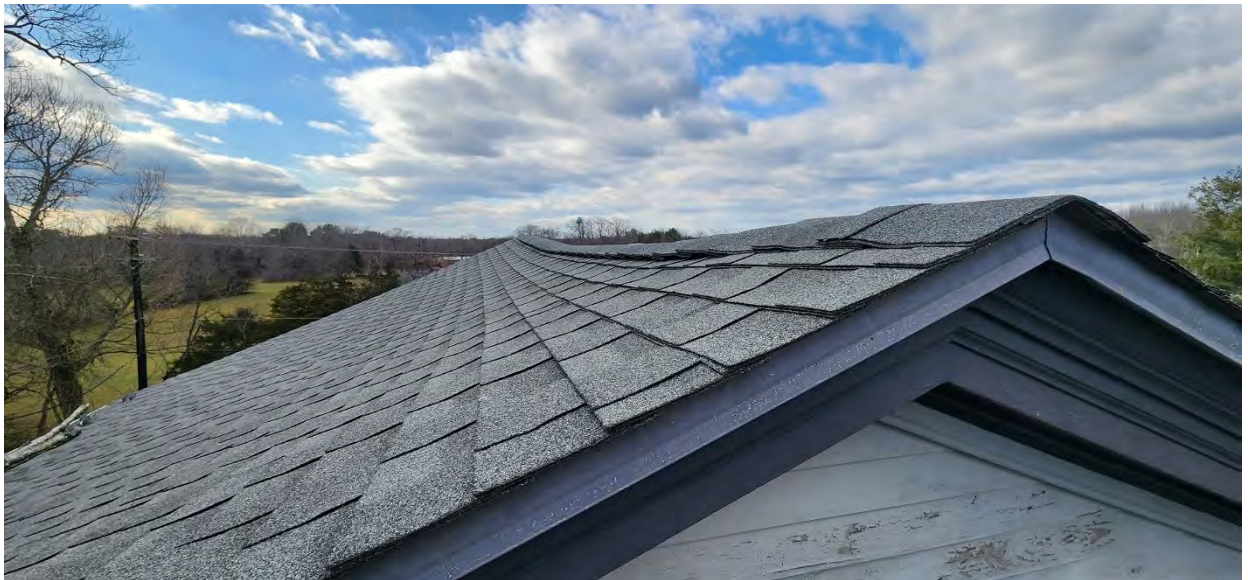
Photo E-26. This image shows a slight dip along the ridge of the west section.

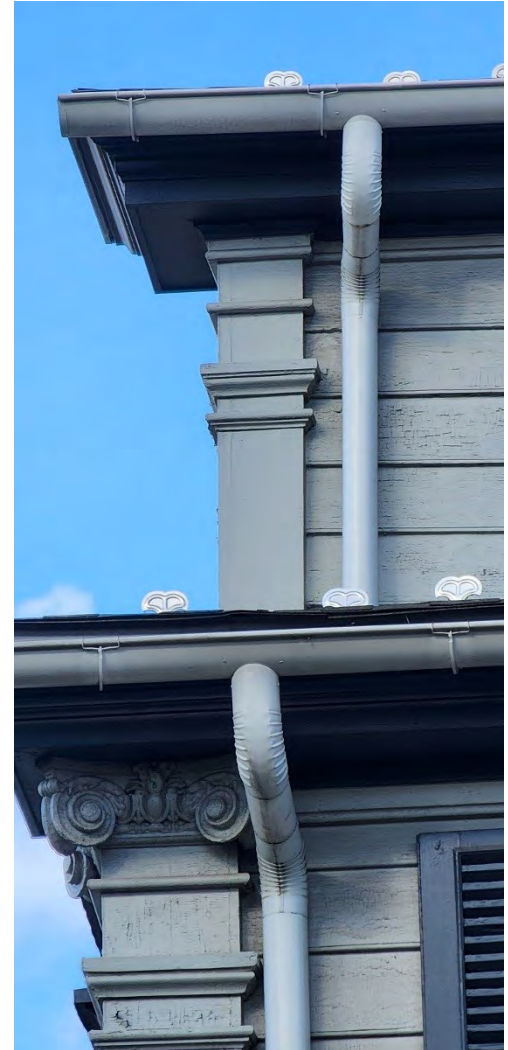
Photo E-27. View of the typical aluminum half-round gutters. These types of gutters are not durable due to the type of clips used, which fail after a few years.

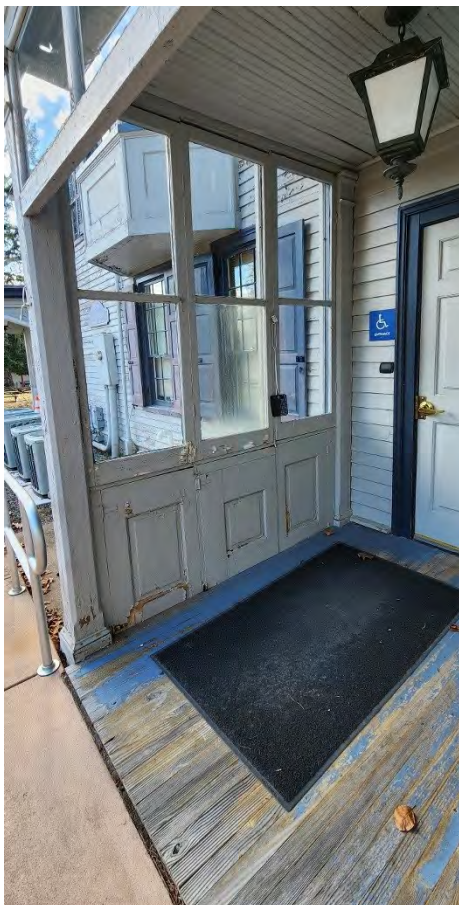
Photo E-28. View of the rear entrance showing finish loss and graining of the wood deck at the east (rear) entrance, which receives the most use.

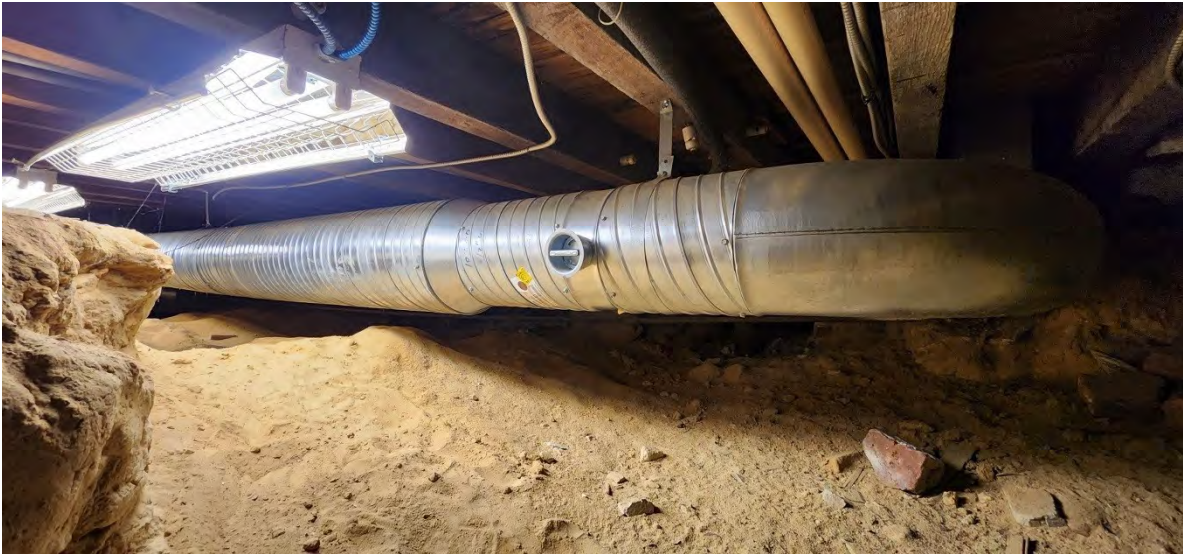
Photo I-3. View looking northwest into the north crawlspace. Note the sandy soil and the juxtaposition of the newer ductwork.

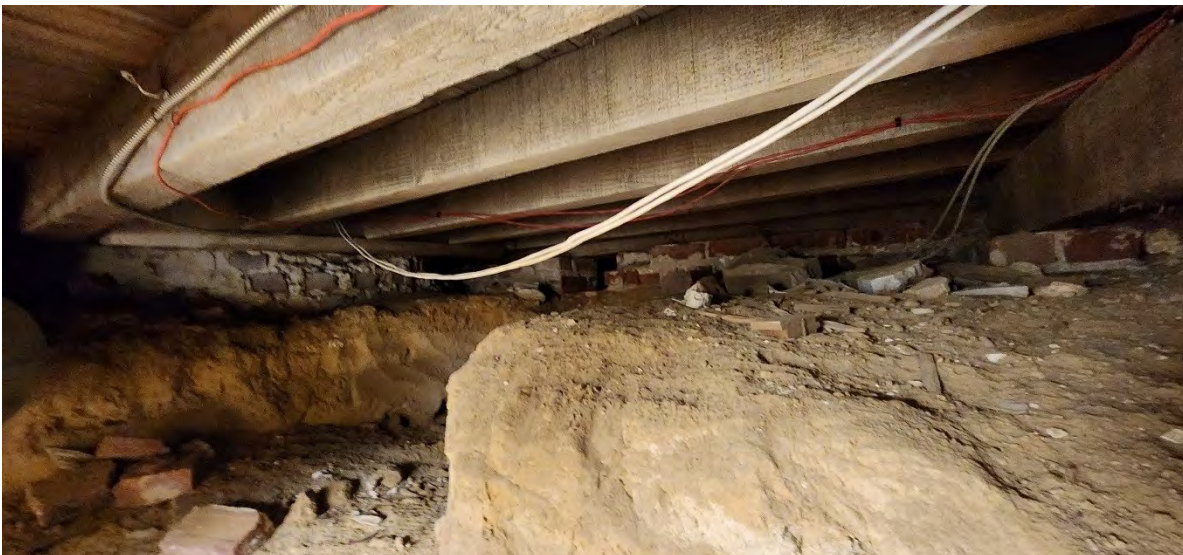
Photo I-4. View of the crawlspace looking northeast showing how portions of the crawlspace have been dug out.

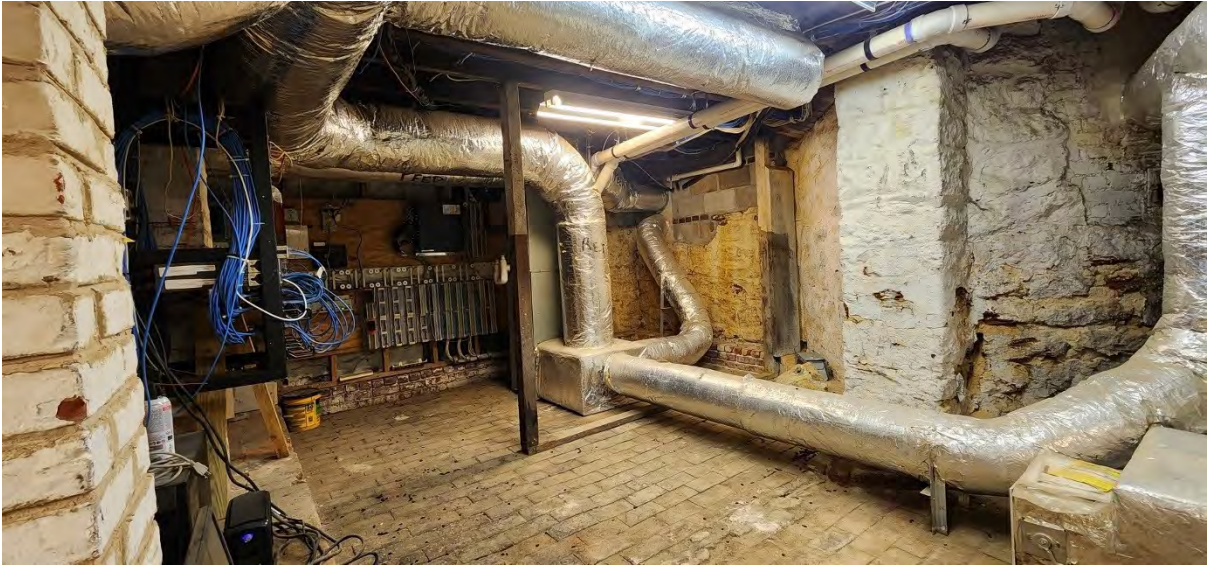
Photo I-5. View looking southwest in the basement at the corner fireplace support.

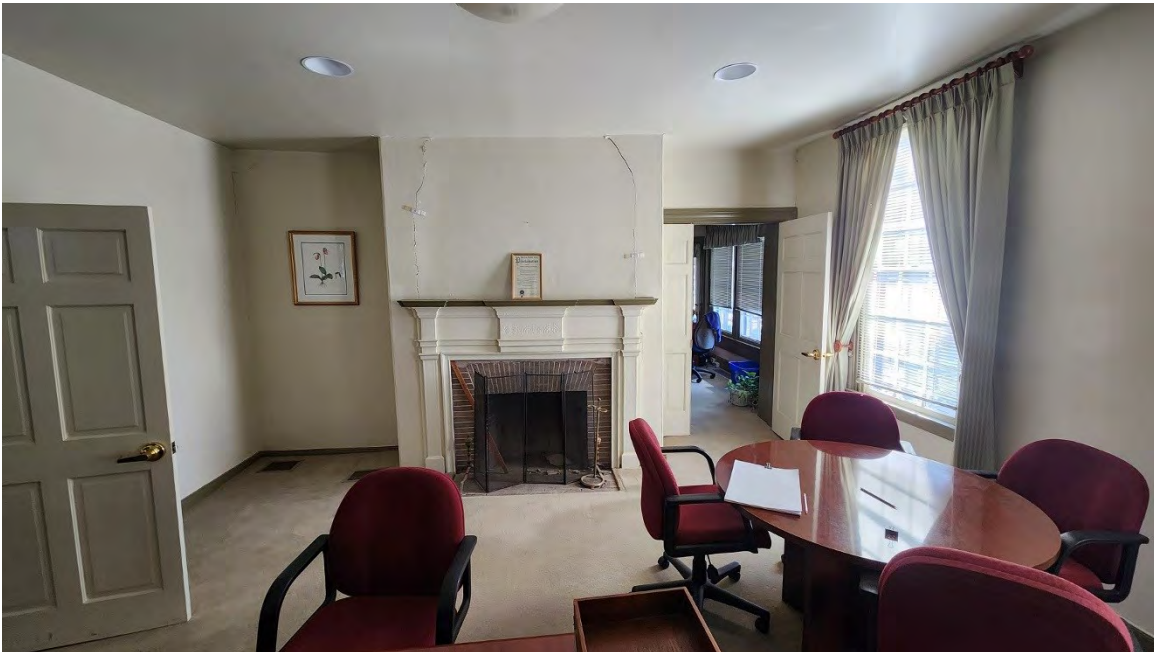
Photo I-12. View looking east at the southwest parlor. Note the cracking around the fireplace; there are other cracks along this entire wall and at the northeast corner of the space.

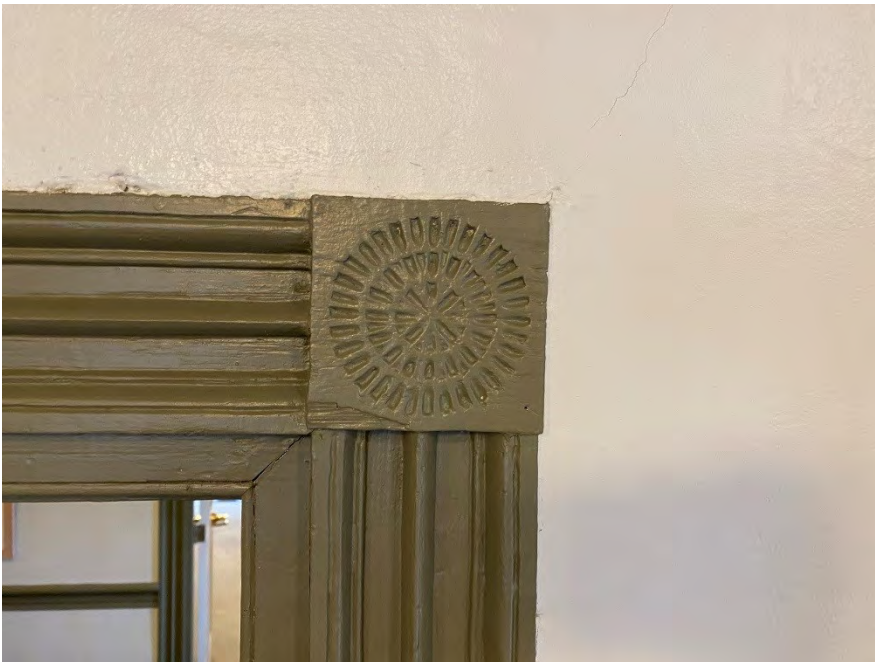
Photo I-14. Detailing of the corner blocks at the window and door surrounds in the western-most spaces.

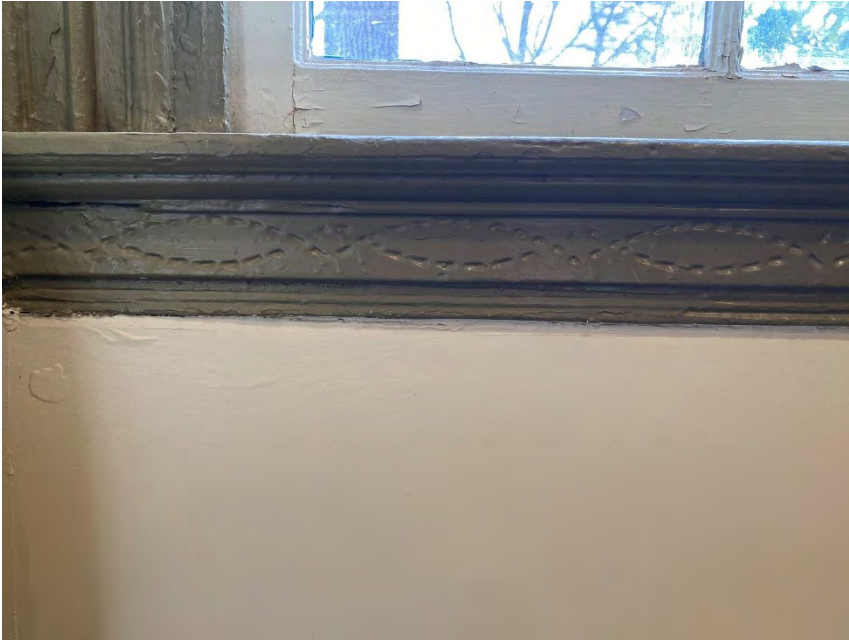
Photo I-15. Relief detail of the apron at the windows in the western-most spaces.

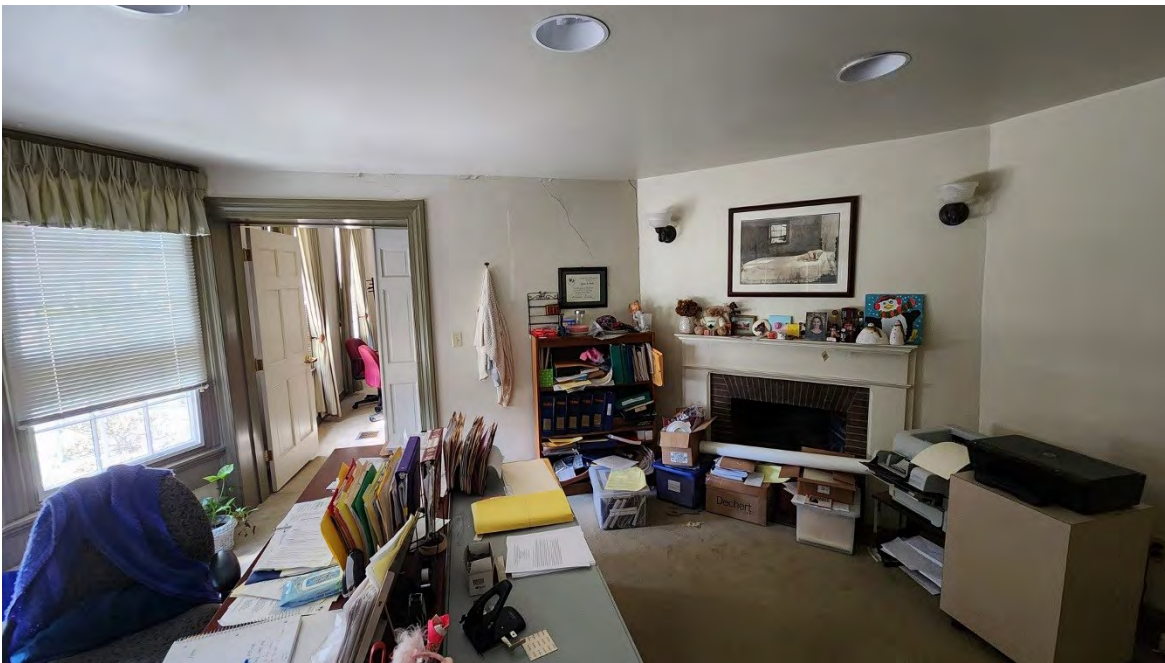
Photo I-16. View looking west at a first-floor office space and the corner fireplace, which would have been part of the first build of the Manor. The cracking adjacent to the corner fireplace is related to the issues with the fireplace in the southwest parlor.

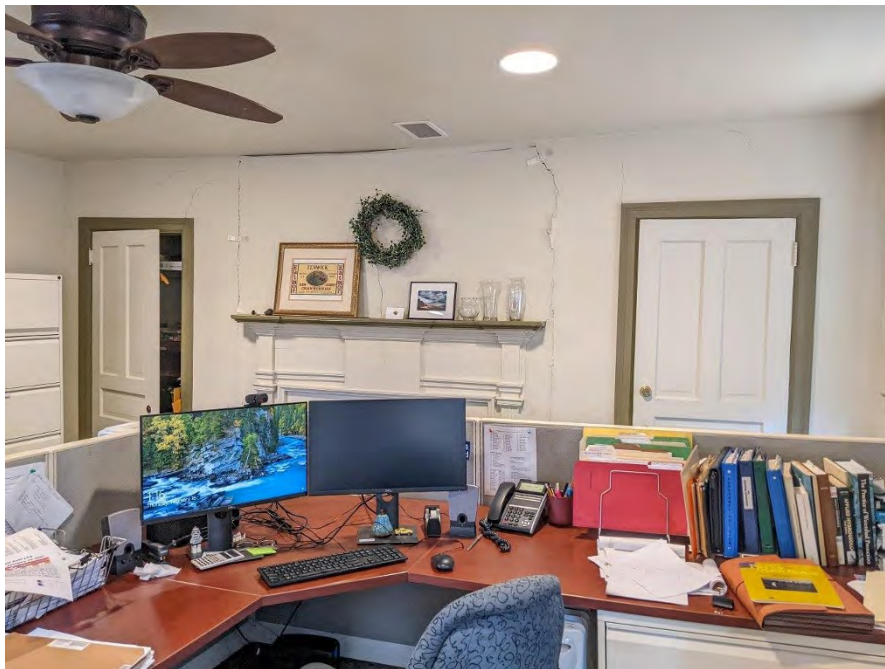
Photo I-22. View looking east within the former southwest bedroom. Note the cracking in the plaster around the fireplace.
