**N.J. PINELANDS COMMISSION
REQUEST FOR PROPOSAL (RFP)
RFP # 25-001
Cover Page**

HISTORIC FENWICK MANOR REHABILITATION

Historic Fenwick Manor Rehabilitation

HISTORIC PRESERVATION PLAN

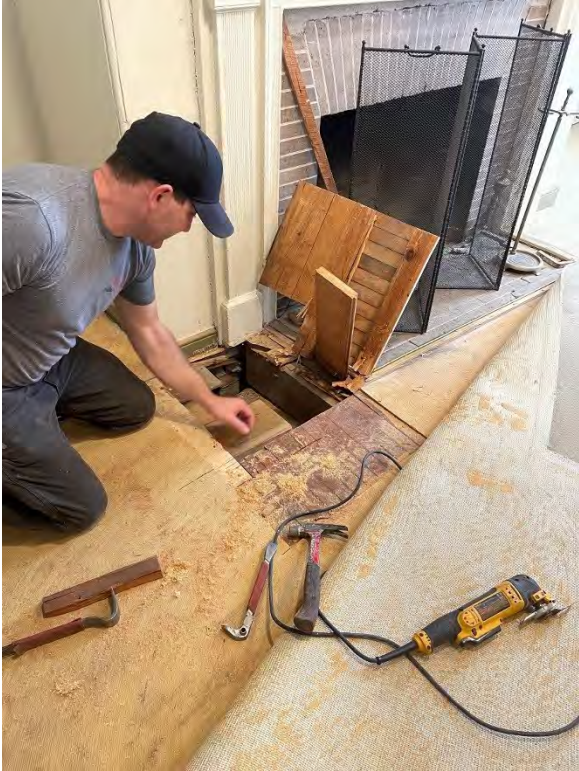
Photo I-29. Removal of flooring in southwest parlor to investigate the condition of the fireplace supports.

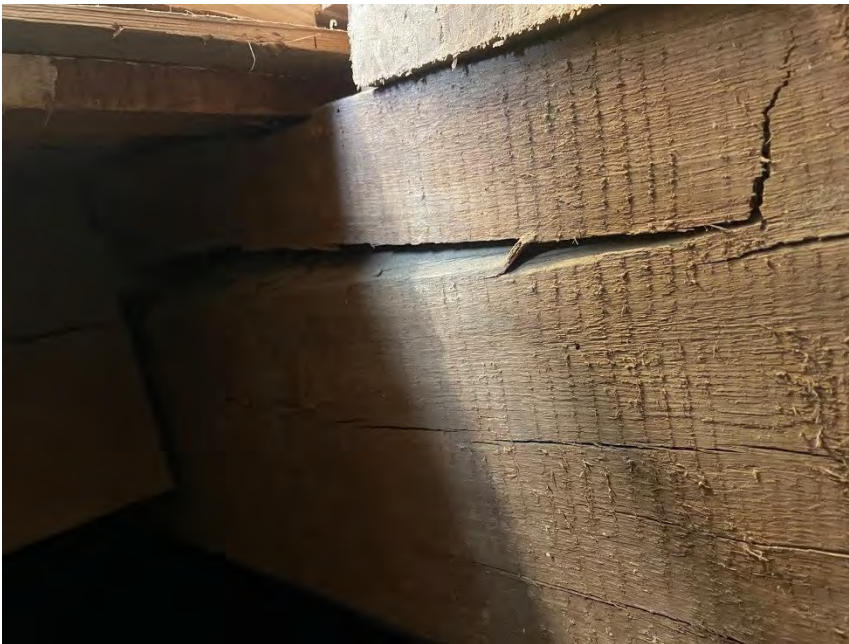
Photo I-30. View the cracked fireplace header, which supports three levels of brick masonry.

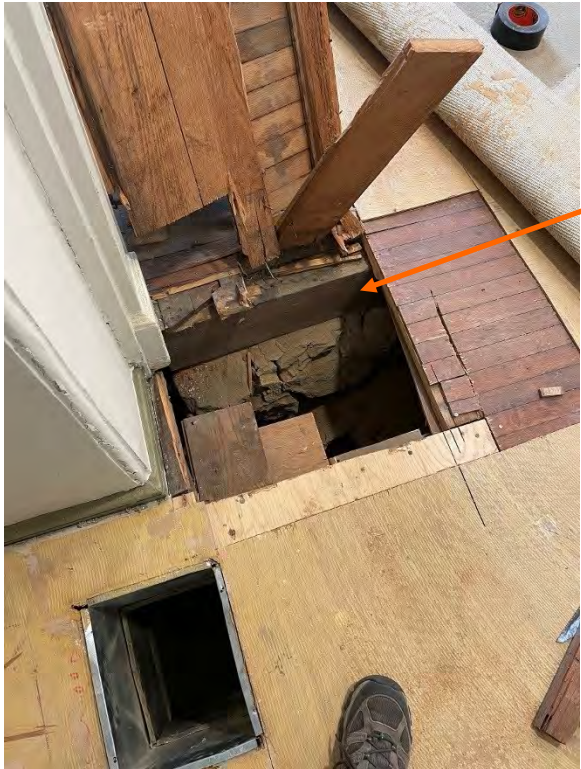
Multiple layers of flooring

Photo I-31. Detail view of floor removed showing portion of foundation wall, which has been undermined by the digging out of the crawlspace of the HVAC ducts. Note the various layers of flooring under the existing carpet.

When the HVAC system was installed in 2004, the contractors dug out the crawlspace in part in order to have the ductwork fit. Unfortunately, since the soil is sandy it lacks structure; it has a light and loose structure and, therefore, when cut into does not hold its form. Since 2004, the sandy soil, especially around the southwest parlor fireplace foundation, has shifted away and from under the foundation causing the fireplace above to put pressure on the hearth beam and significantly shift. Similar conditions are developing around the northwest parlor fireplace and at several of the piers located at the center of the north crawlspace.

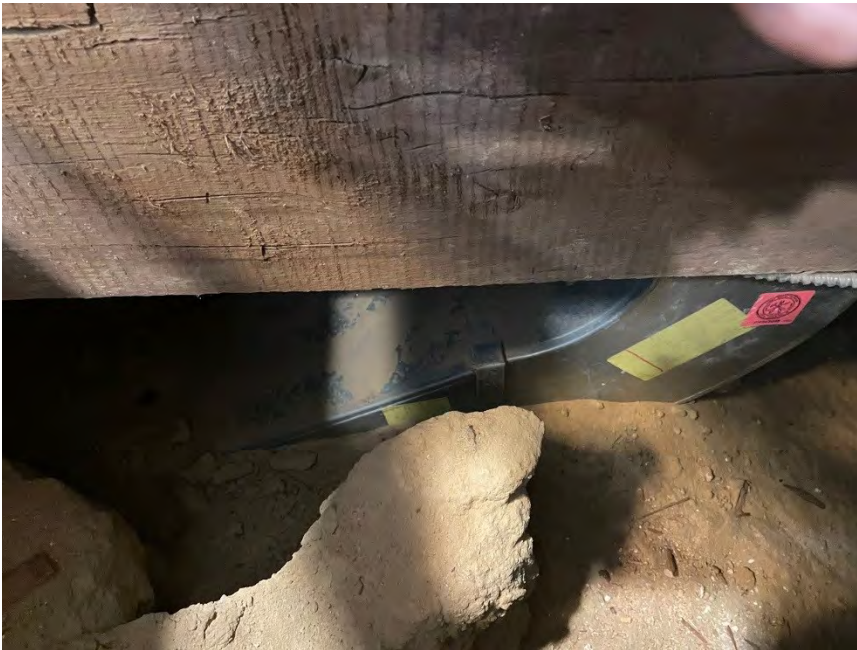
Photo I-32. View of the duct that sits close to the foundation mostly covered in sand. This sand came from underneath the fireplace supports.

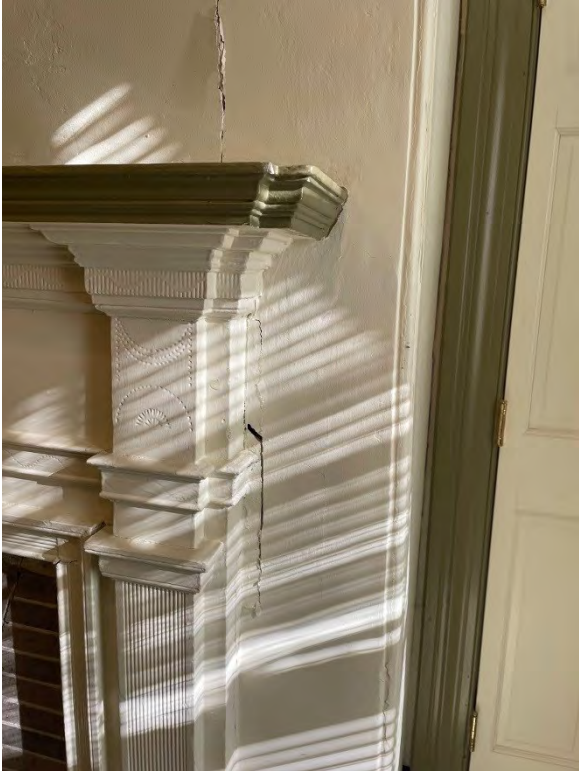
Photo I-33. Detail of the crack around the fireplace in the southwest parlor. Note also the detailing of the fireplace, which matches the treatment of the window and door surrounds.

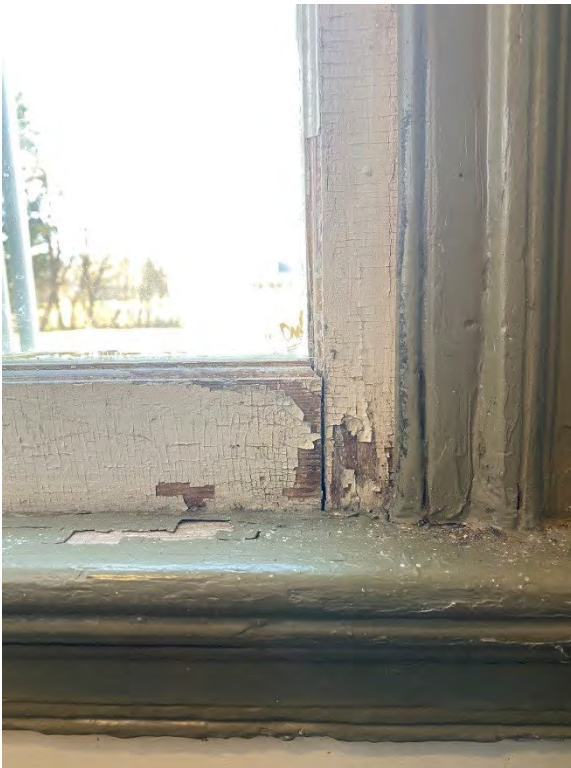
Photo I-34. Detail view of window sashes showing open joints, crazing paint on the sashes, and paint loss on the sills.

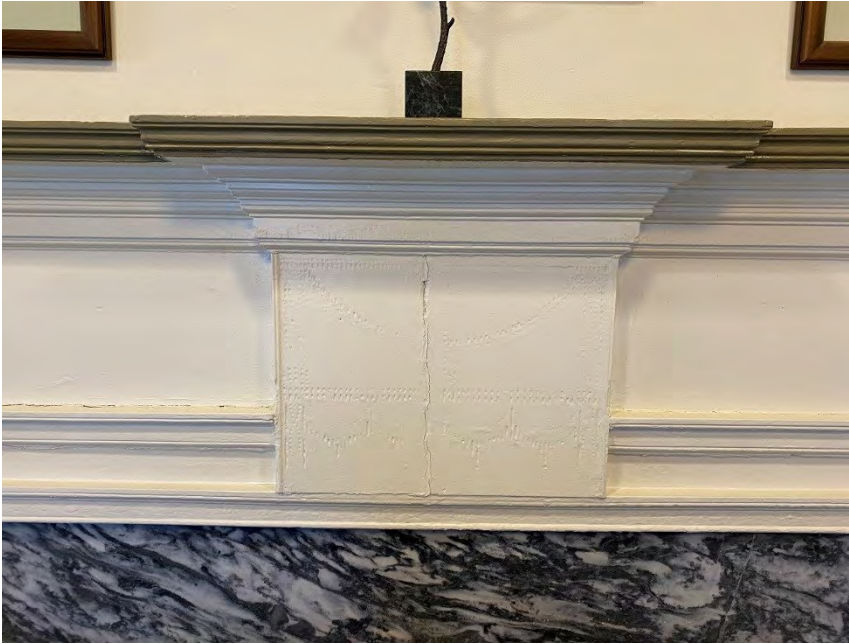
Photo I-35. Crack in the mantelpiece of the fireplace in the northwest parlor. There are conditions at this fireplace that indicate the supports here may also be undermined but not to the extent of the fireplace in the southwest parlor.

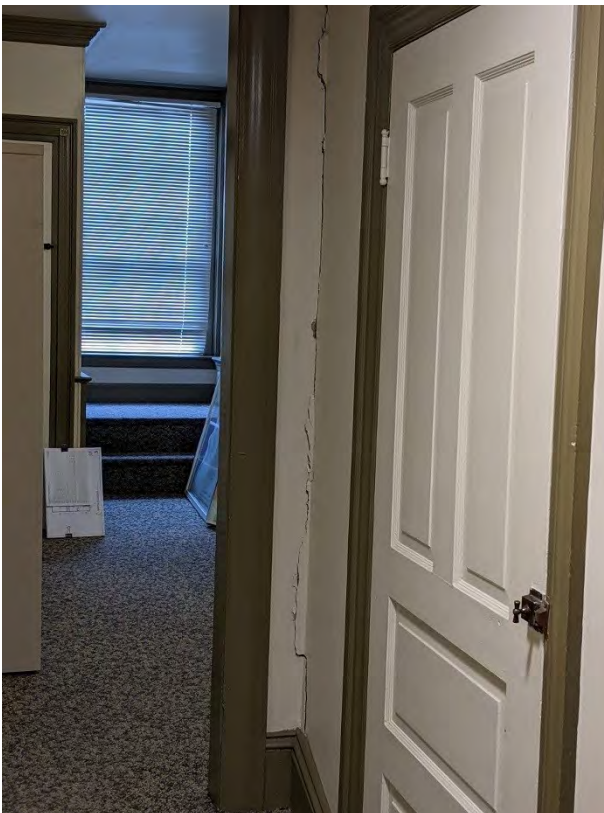
Photo I-36. Crack in the plaster at the second floor about center of the space but toward the south side. It is suspected this crack is caused by the foundation problems with the fireplace in the southwest parlor, which translate to the upper stories.

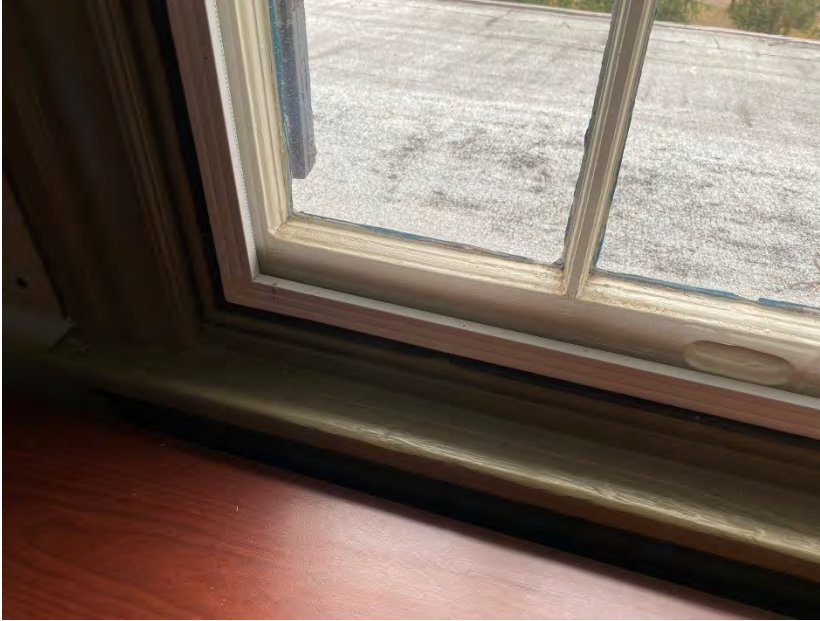
Photo I-37. View of a typical interior storm. Many of the storms were removed at the time of the condition assessment despite the cold weather. These storms are compression type with a plastic film stretched between the vinyl frame. Aluminum storms with operable glass sashes including screens may be a better option.

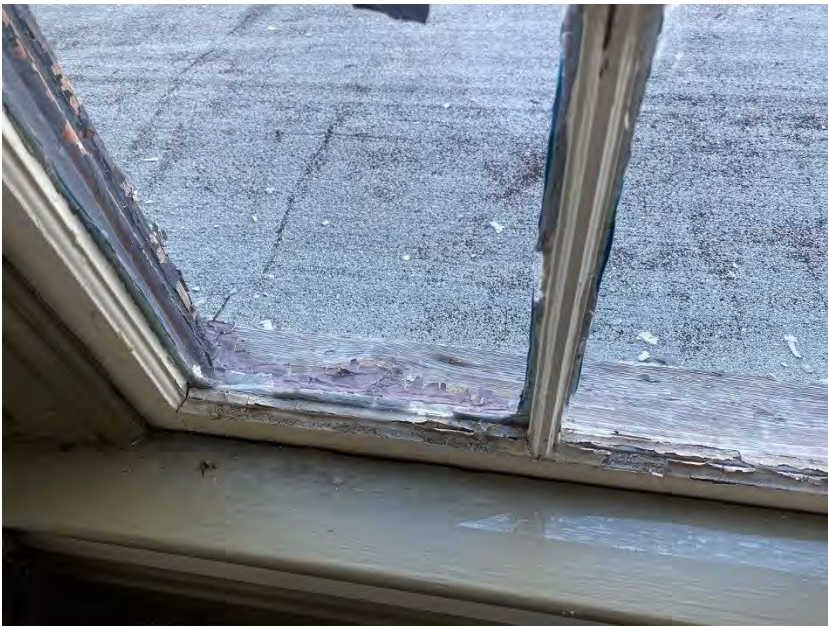
Photo I-38. View of a second floor window showing loss of paint at the exterior sills and the interior of the window sashes.
