Corrosion Protection

Release Detection Monitoring

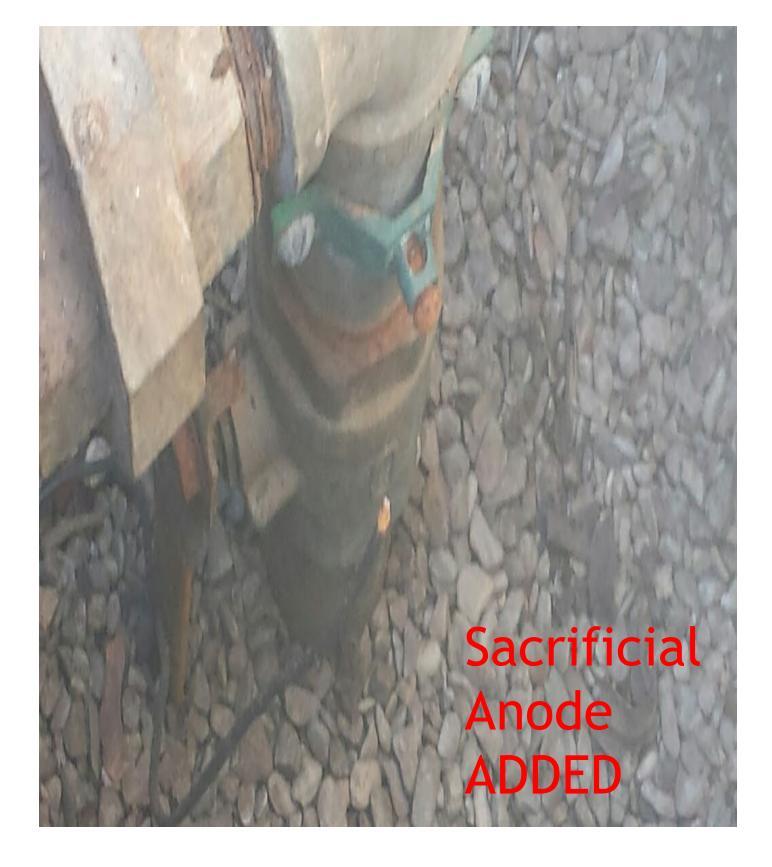
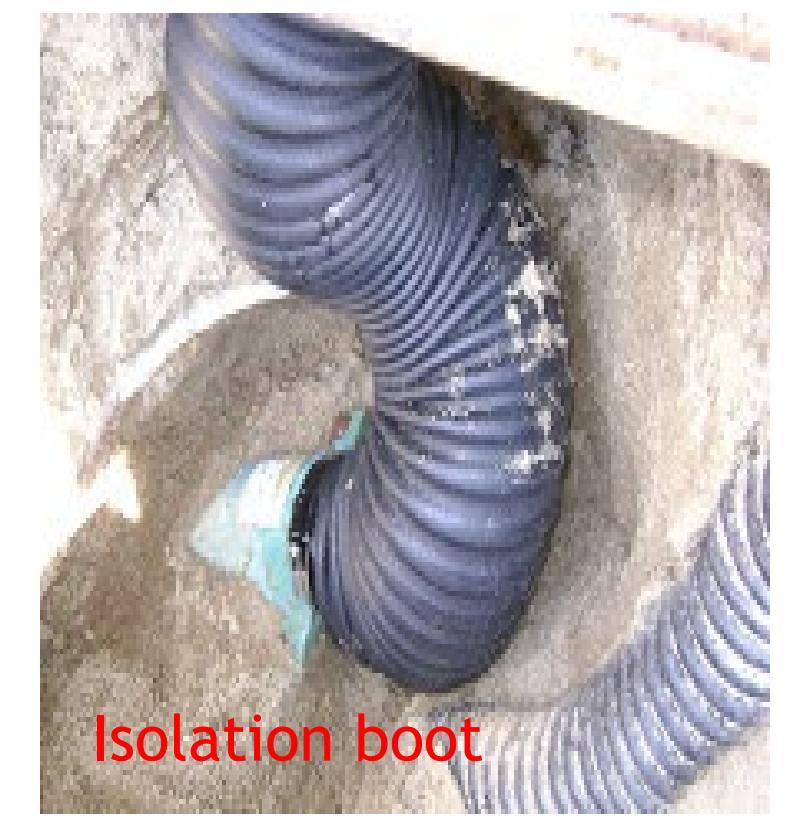
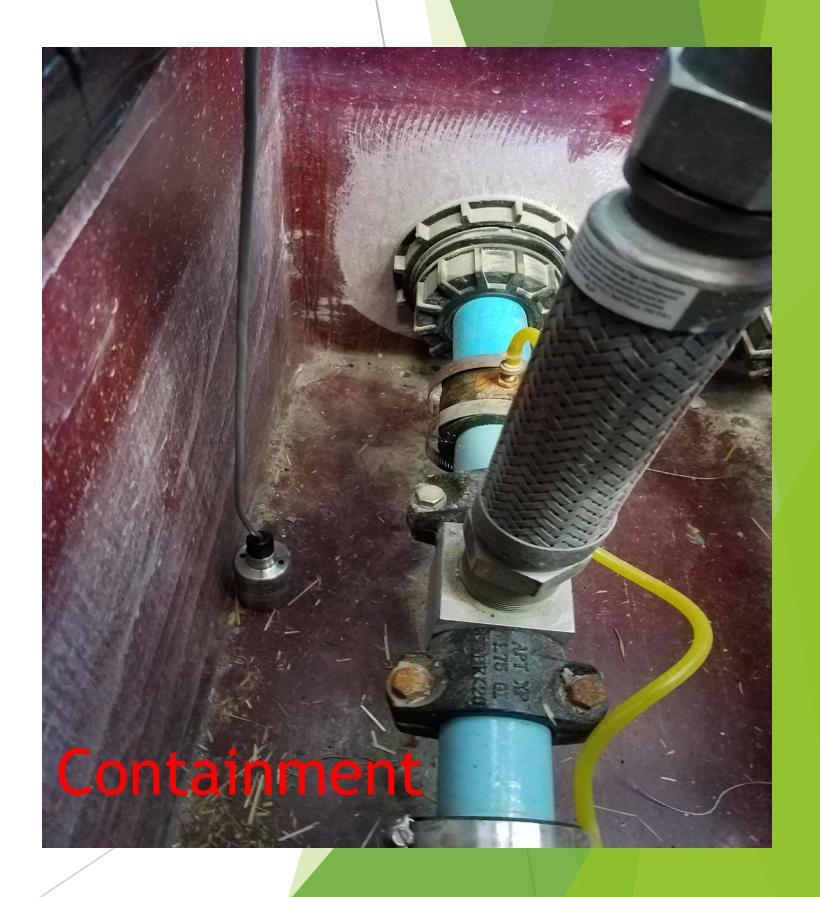
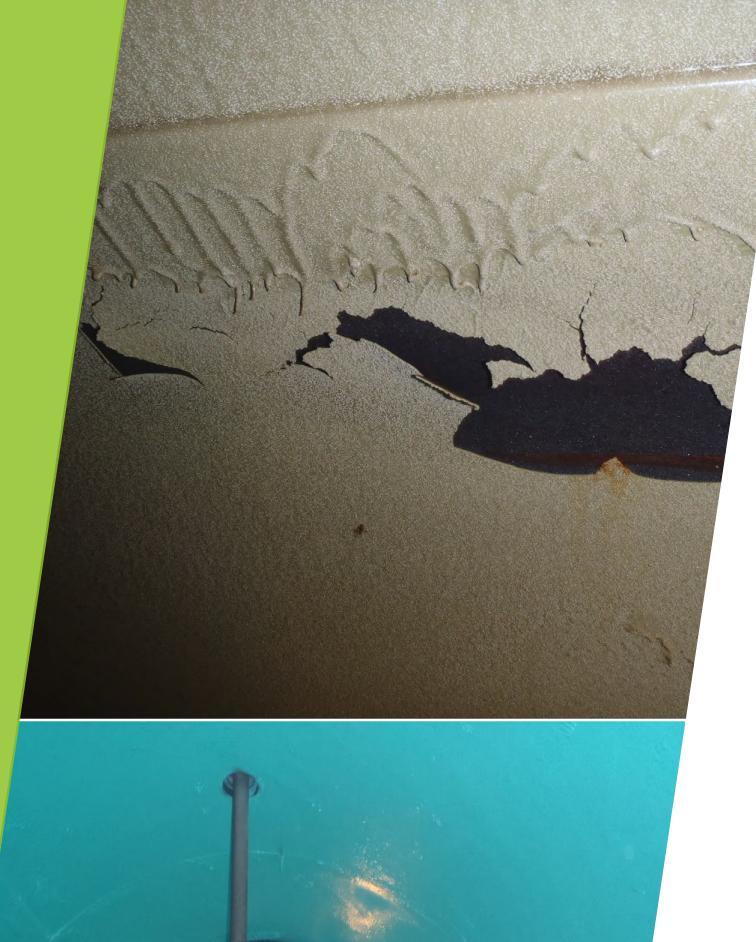
Transition Piping Protection

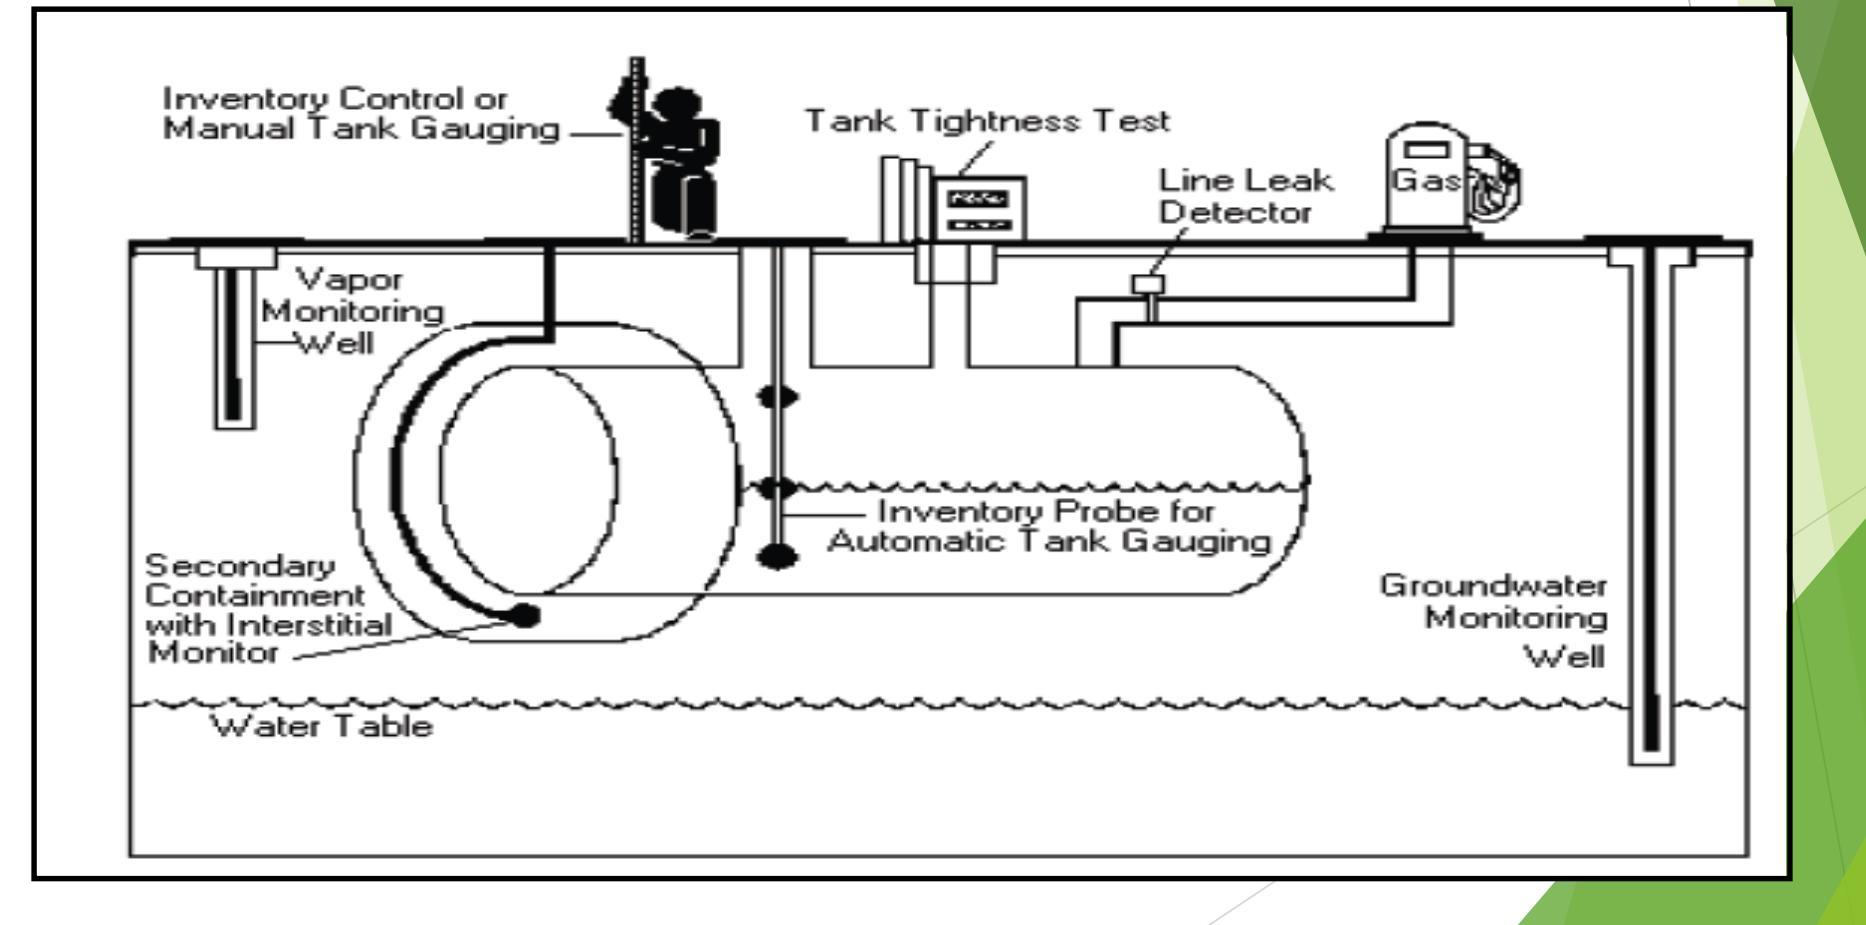
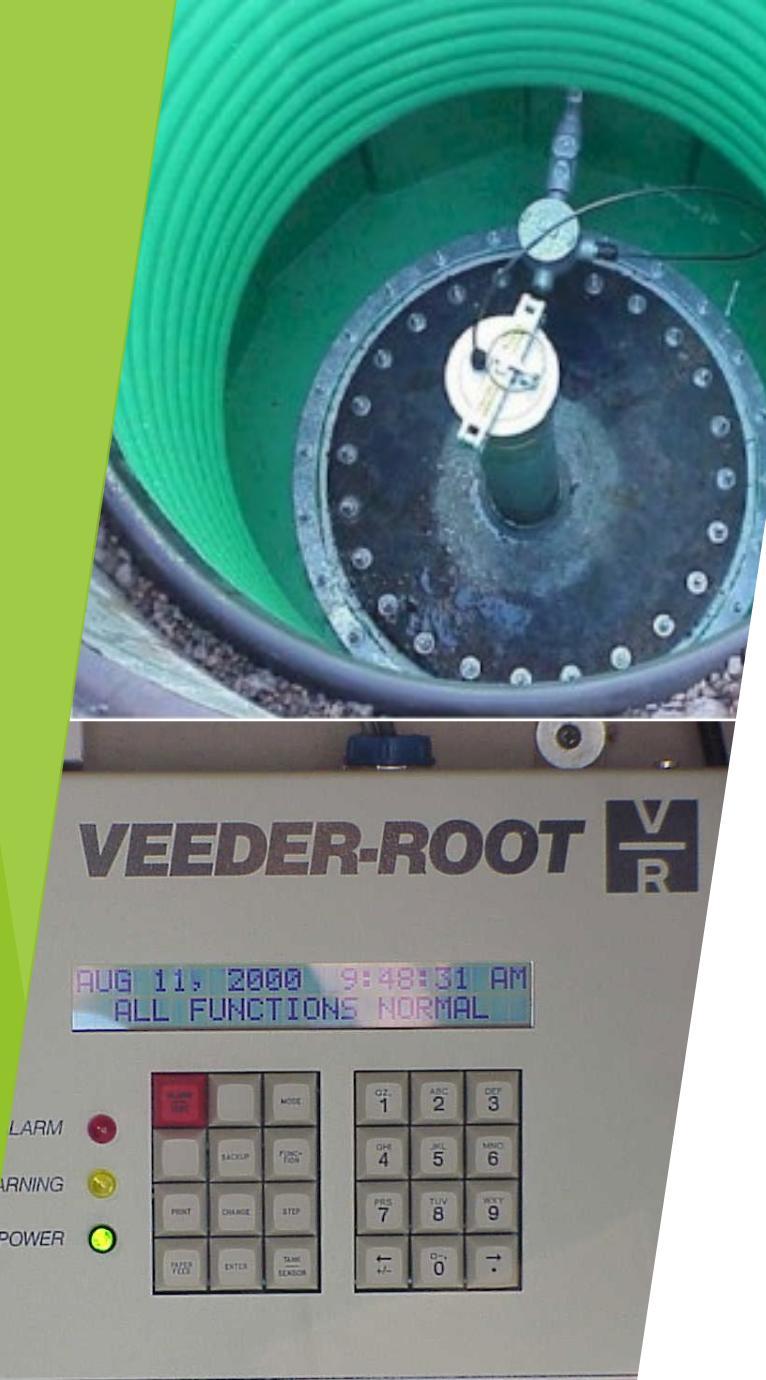
Release Detection Monitoring Automatic Tank Gauging (ATG)

- Most common for single wall tanks
- Can detect a <u>0.2 gph leak</u>
- Passing test every <u>30</u> days
- Certified annually
- Needs 2-4 hours downtime and 50% volume to complete a test
- ✓ CSLD/SCALD
 - ✓ Volume decrease to 10-15% volume
 - Less downtime "grabs" data and calculates result
- ATG certified every year
- Keep certifications and monthly pass 5 years
- IF ATG is not functioning = high level overfill alarm will NOT function

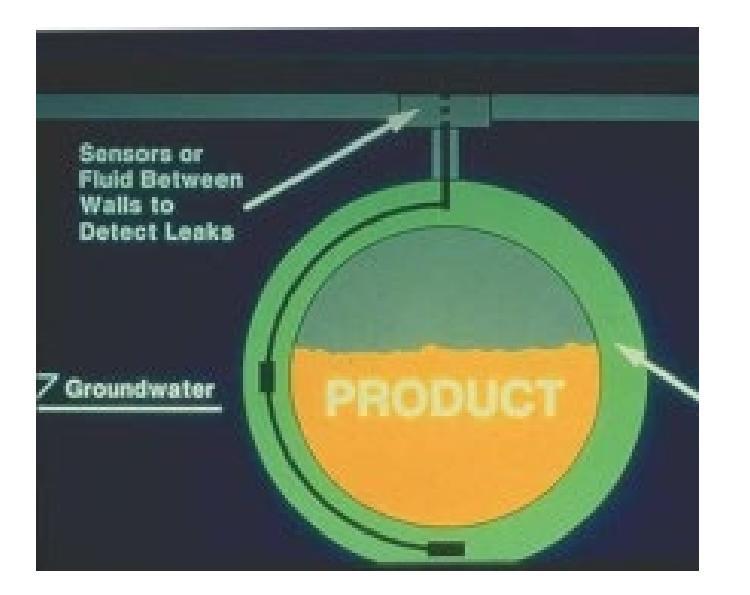
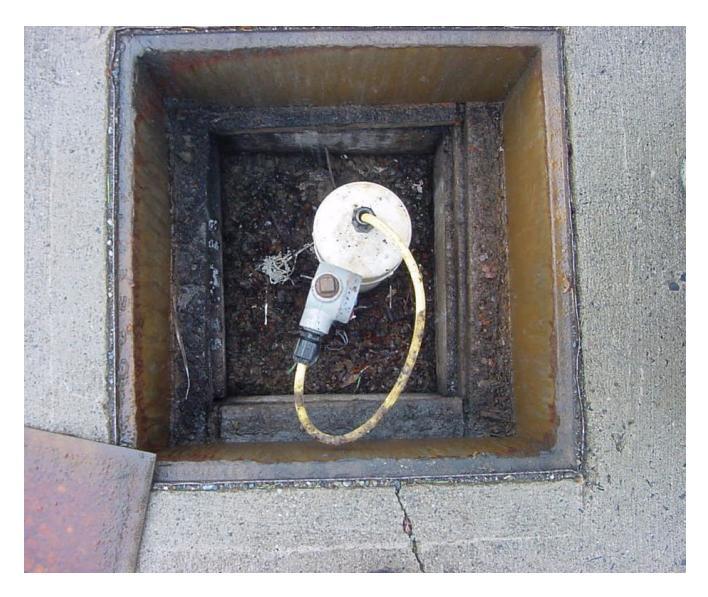
Proof of ATG monitoring

> Monitoring system can be programmed to auto print testing

- > System will print last attempted test
- > Look at the slip!
 - Did the test pass or fail?
 - Was the test done in the last 30 days?

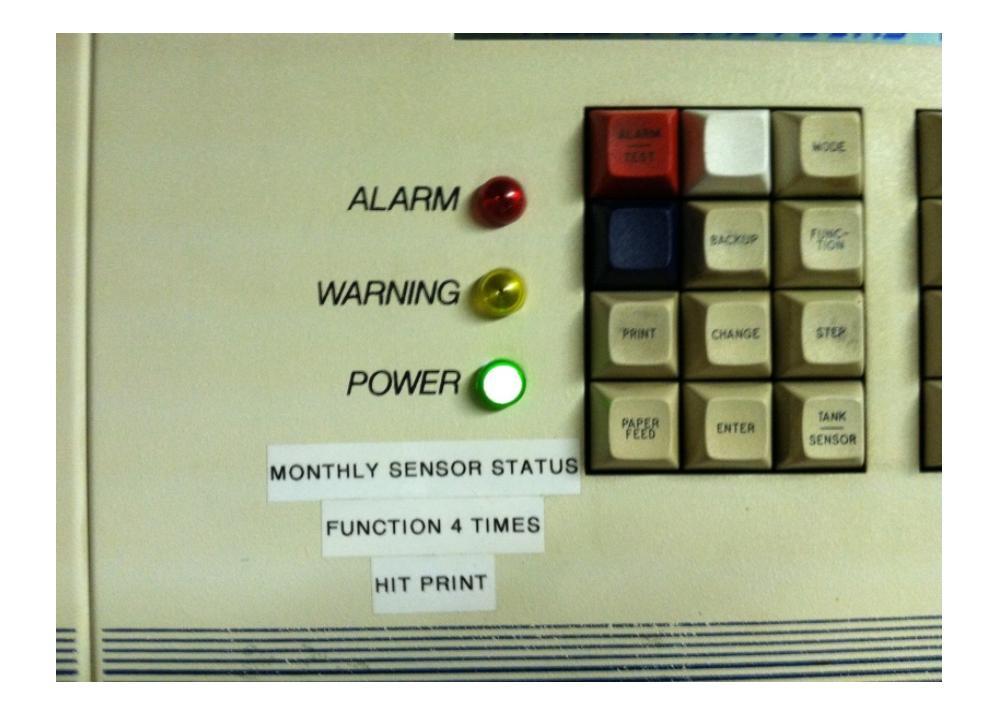
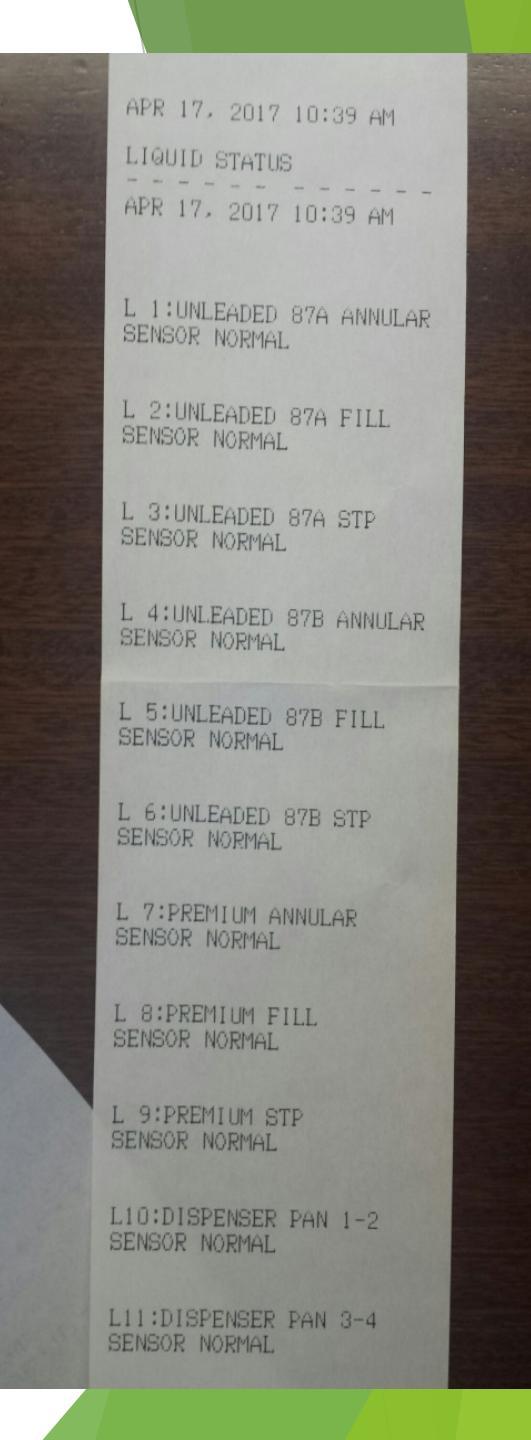
Proof Of Monitoring

- Systems do not automatically print this report!
- > At least 1 time a month, print and save sensor status printout
- Keep printouts for 5 years

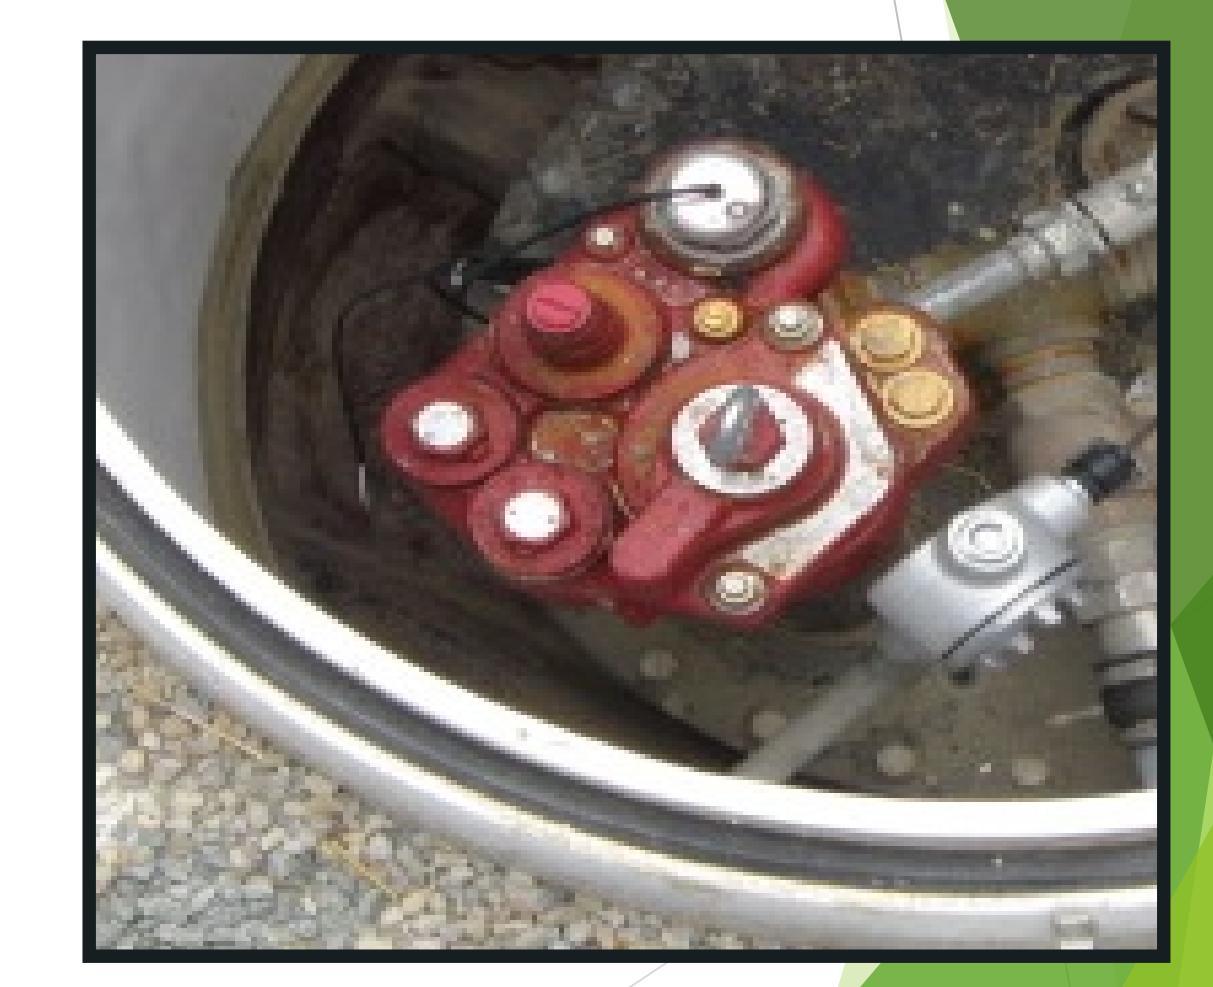
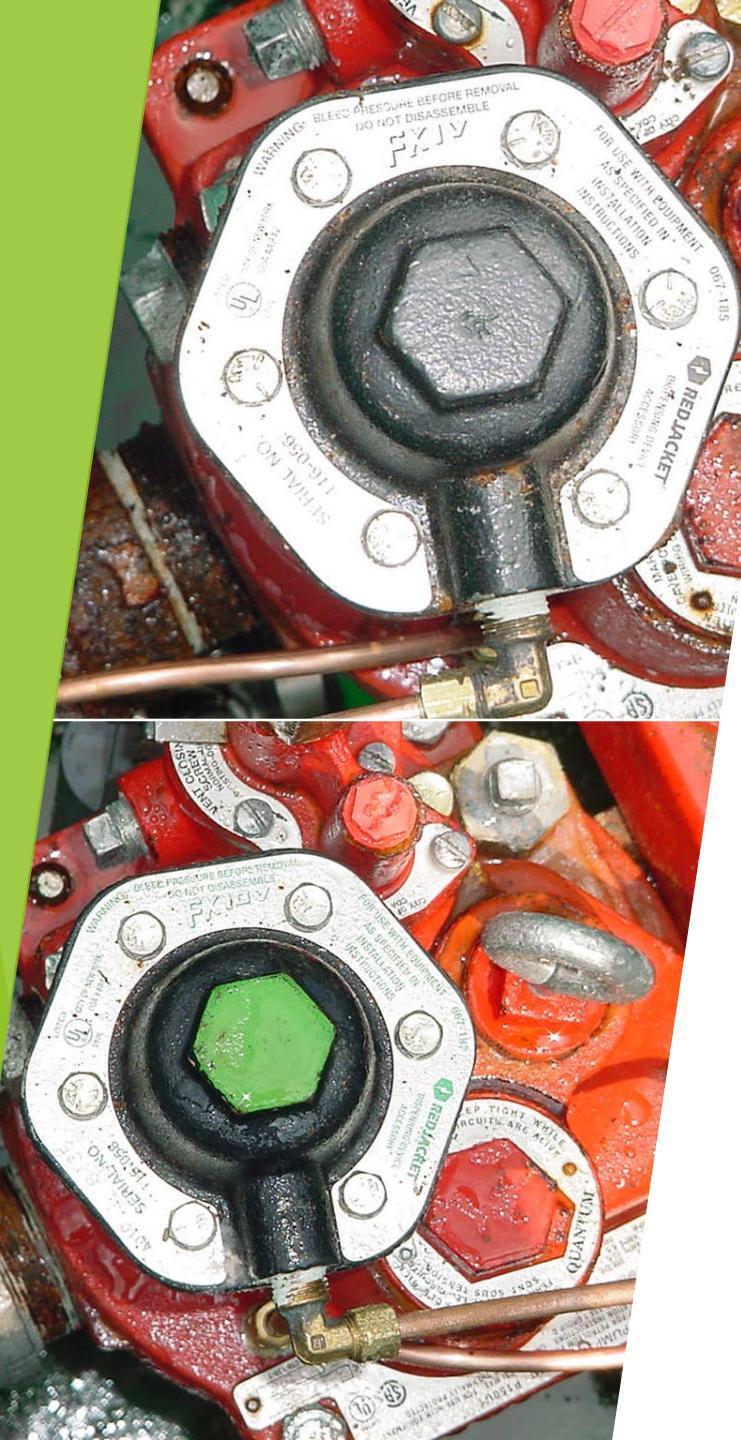
Pressurized Piping

- Turbine in sump pumps fuel to dispensers
- Faster fueling
- Always under pressure
- 2 forms of monitoring
 - Line Leak Detector
 - > 2nd form depends on construction

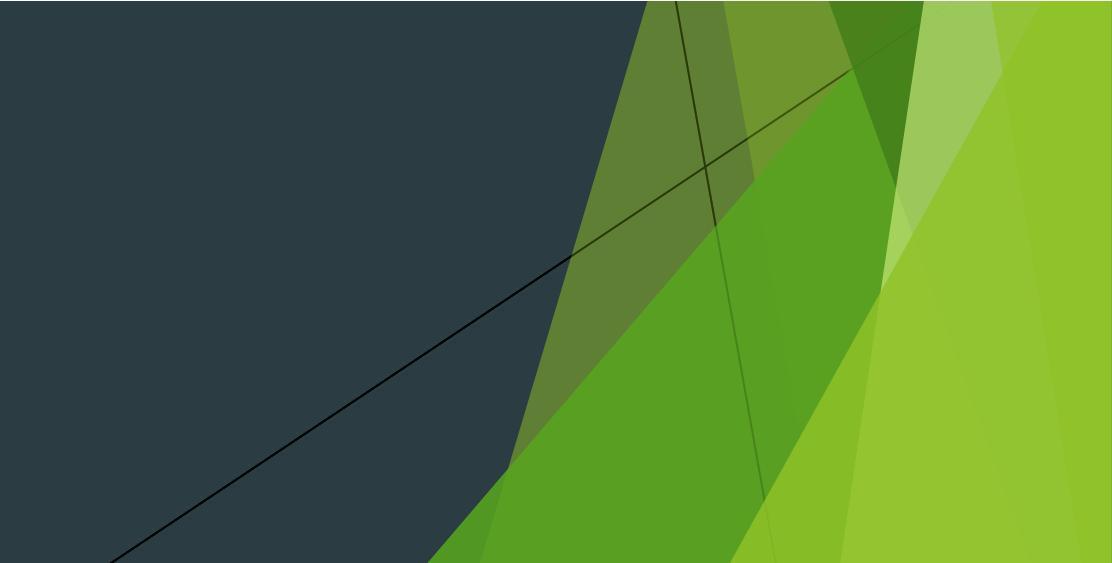
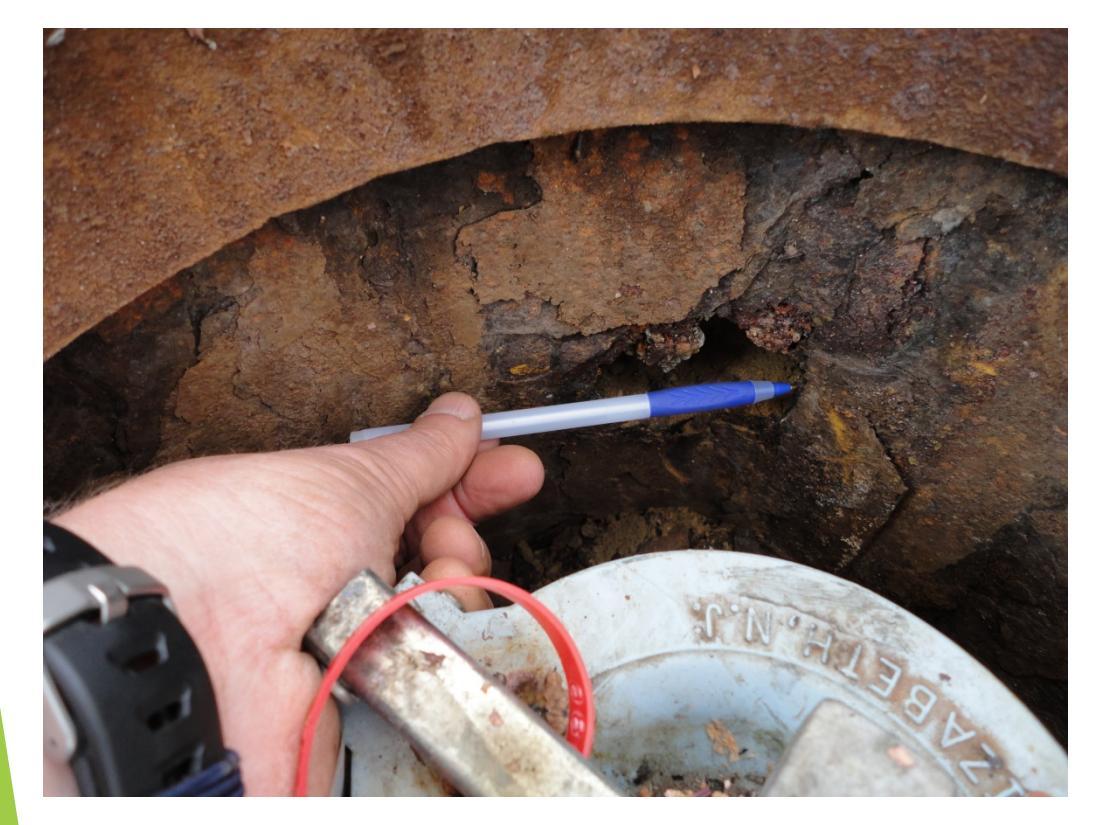
- Located at each fill port
- Inspected before/after each delivery OR once every 30 days (whichever is more often)
- Remove water/fuel/debris
- Integrity tested once every 3 years
 1st round was due by Oct. 13, 2018

Spill Prevention

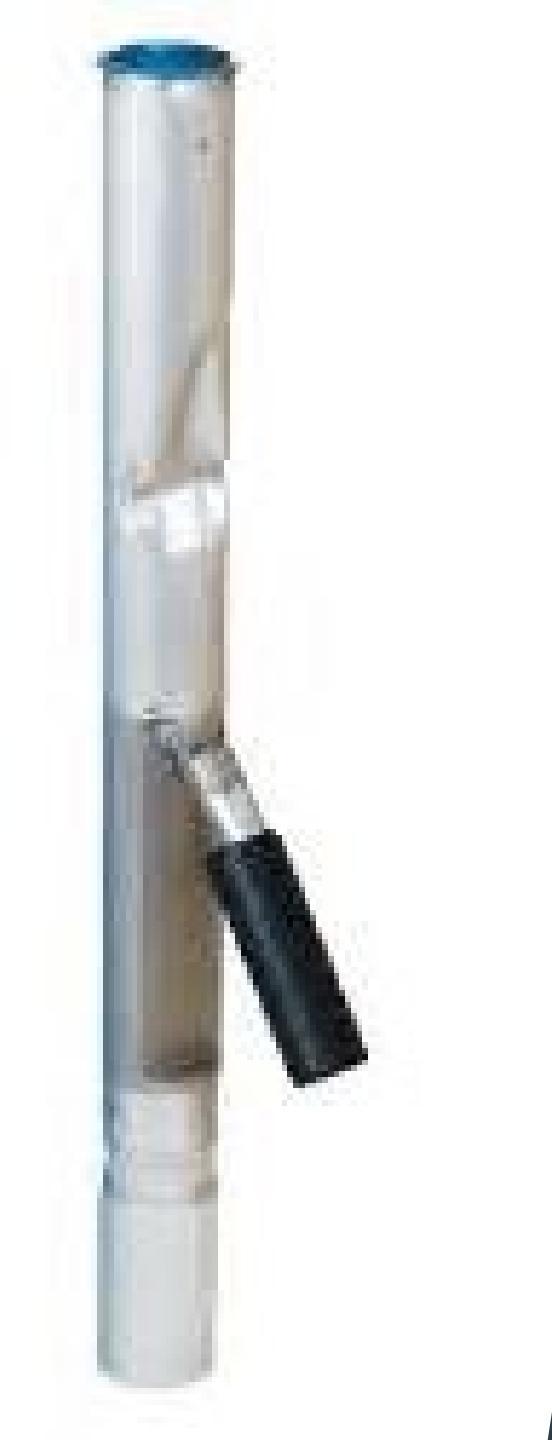
Overfill Prevention: High Level Alarm

- Gravity or Pressurized Deliveries
- Visible/Audible to delivery driver
- Activate at <u>90%</u> full
- Certified annually

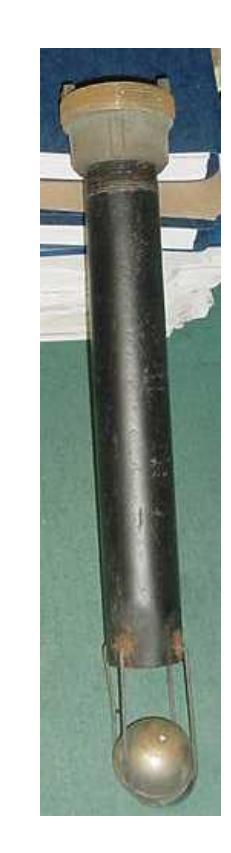
Overfill Prevention: Ball Floats

- Gravity Deliveries
 - No compatible with suction systems
- Set at **90%** full
- Certified every 3 years
 - 1st round was due Oct. 13, 2018
- Failing ball floats can not be repaired or replaced
 - Must install alternate overfill device
 - If installing shutoff flapper, entire cage must be removed (not just the float)
