Fatality Assessment & Control Evaluation Project

FACE 01-NJ-055-01

Tree Climber Crushed by Falling Tree Section

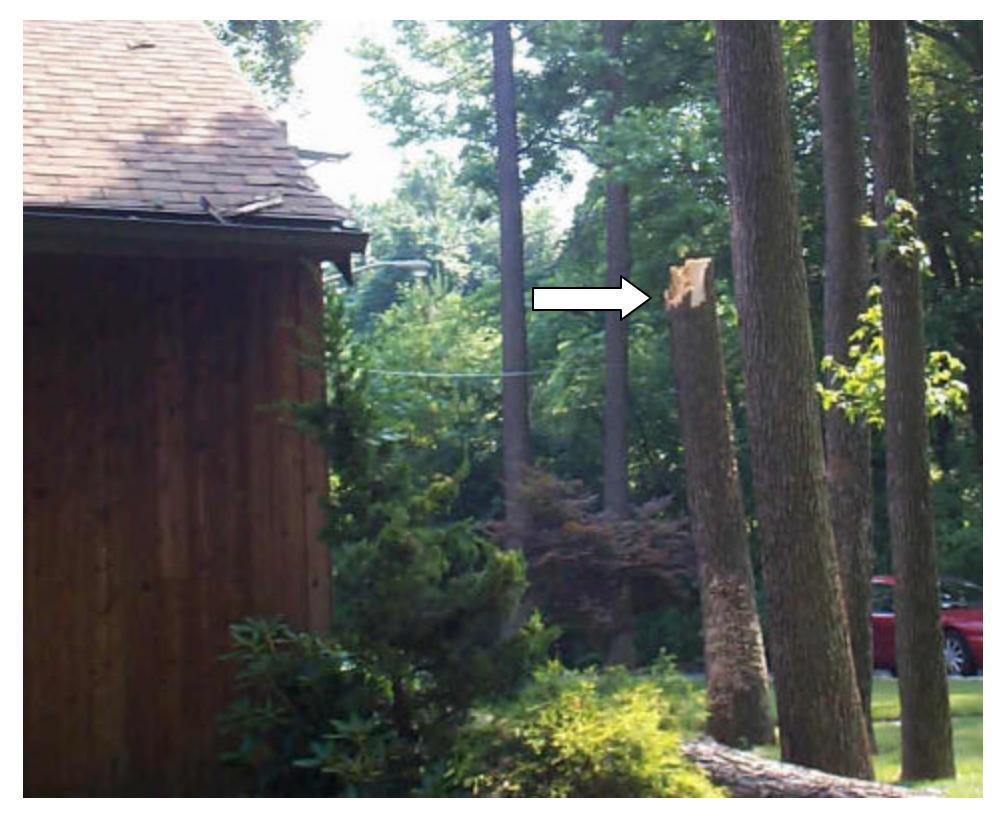
Fractured Tree #1

When the victim made the back cut, the top section of the tree fell away. The middle section of the tree then fractured 12 feet, 9 inches from the ground, at what may have been the driest and weakest section of the trunk. The break occurred below where the climber was tied (see pages 9 and 10). His co-workers heard a loud cracking sound and watched as he fell with the tree section. It landed on him and crushed him. They rushed to him and manually lifted the tree off of him. The company owner called for help by dialing 911. The victim was transported to the nearest hospital by emergency medical services where he was pronounced dead 25 minutes after the police received the call for assistance.

It is not known exactly what caused the fracture but there are two possible causes: First, instead of breaking free, the top section of the tree may have swung down and against the lower part of the trunk, as if on a hinge. The force of the cut section impacting with the standing trunk may have caused the tree to fracture. Or, second, when the climber made the back cut, the top section of the tree fell until the timber hitch caught and halted its descent. The stress of the force on the rope may have caused a kick back and the remaining portion of the tree trunk to fracture.

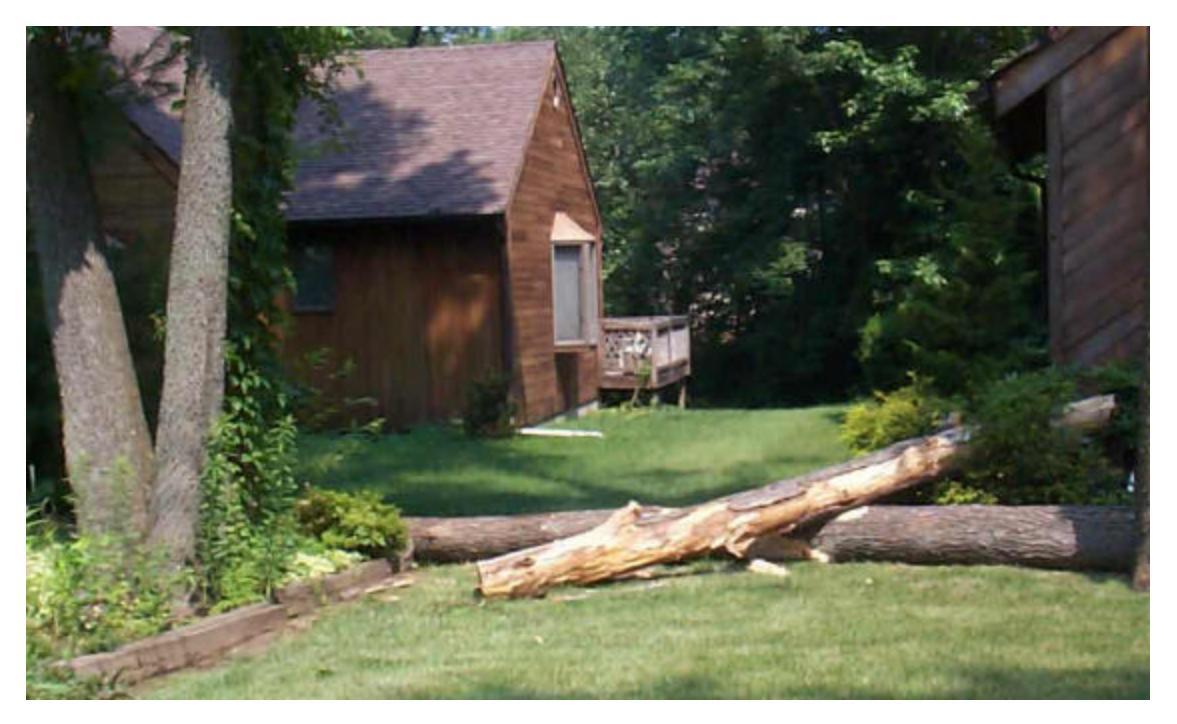
Fallen Tree Sections Showing Tree Decay

Hazardous trees: Signs of decay were visible in three of the trees; all of the trees were in a state of decline. Growth of fungi, peeling bark, and areas that visibly looked like tree rot all indicated

that the trees were unsafe to climb. If the first hazard of proximity to electrical lines could have been resolved (by the lines being deenergized), the company could have safely completed the job by having the employees work from an aerial lift. This would have eliminated the need to climb the trees. After designing a work plan to ensure appropriate communication and that employees would not be in the drop zone, the tree could have been taken down by cutting away sections of the top of the tree and allowing them to fall to the ground.

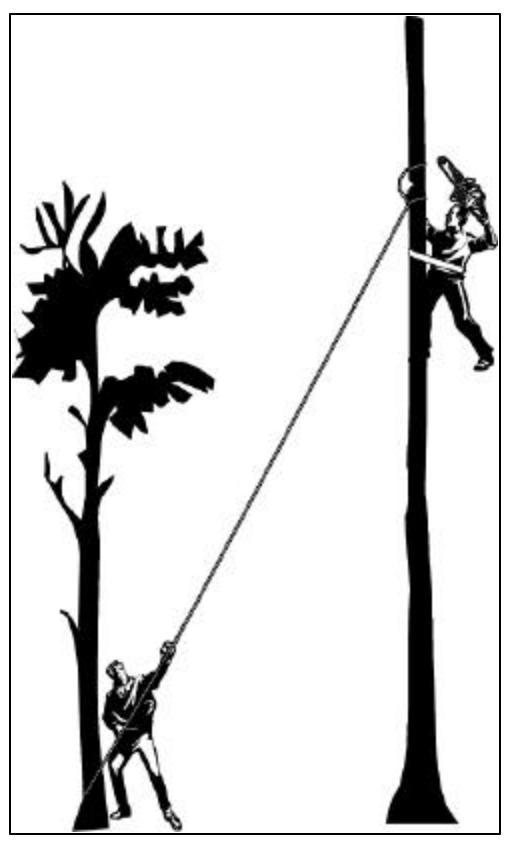
Tree trimmer in rotted tree, after making the first notch (face) cut into the tree trunk and applying the timber hitch knot.

The victim (the climber) used the ladder to ascend tree # 2 and then continued climbing, using his spurs. He looped a rope once around tree # 2. The ladder was removed and he then swung over to tree # 1, climbed it (spike marks started at 27 feet from the ground) and secured himself to the tree with his lanyard. He was approximately 44 feet above the ground. Using his chain saw, the climber made a notch cut into the tree trunk and instructed the groundsman to send up the pull line, or lowering line, used to lower limbs and parts of trees to the ground. The climber tied the pull line around the tree, using a timber hitch. He had no independent safety line although extra rope was available. The groundsman wrapped the opposite end of the pull line around the trunk of tree # 2 and held the line taut. He pulled on the line and watched the climber.

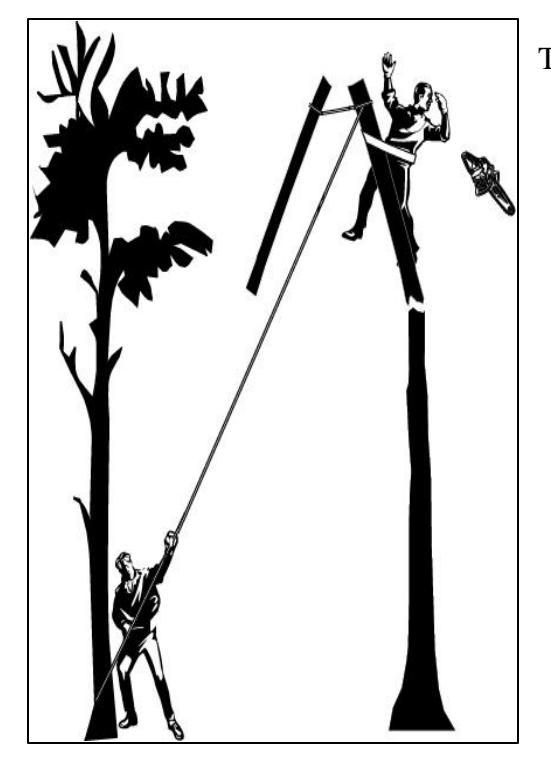
Tree trimmer after making the back cut into the tree trunk.
