New Jersey Department of Transportation **CONSTRUCTION ADVISORY**

| NUMBER: 36 | Scabbing | 07/18/2018 |
| CATEGORY: Pavement | | |

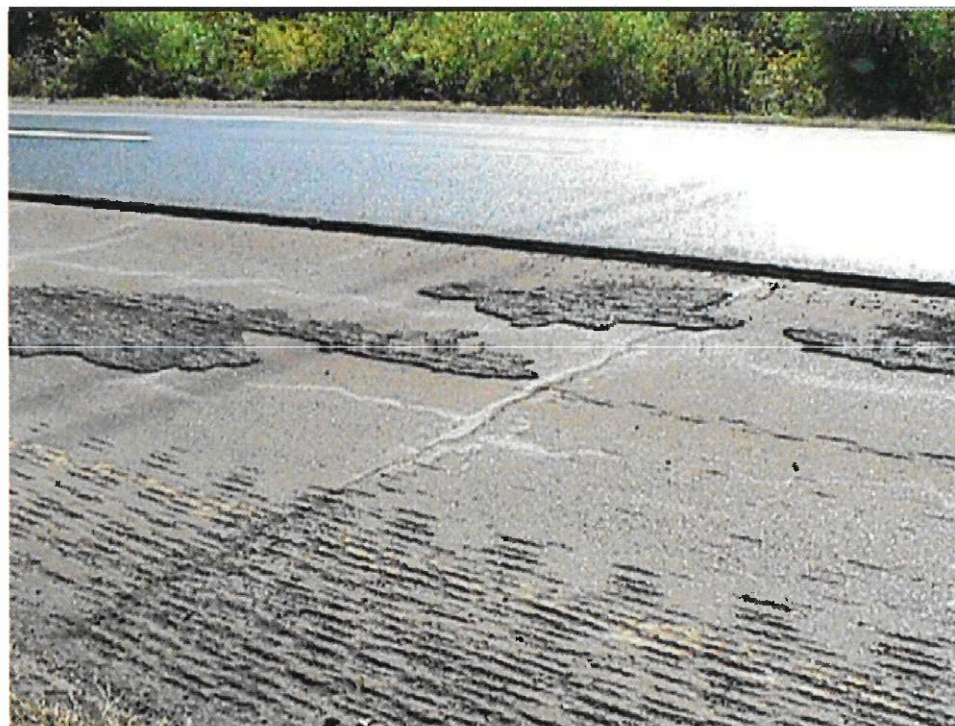
Scabbing occurs when an existing layer of pavement is not fully removed during the milling operation. The RE should discuss scabbing and how to address this issue during the pre-paving meeting so a plan is in place prior to starting the milling operation.

Scabbing happens most often when milling over concrete pavement. It can also happen when milling HMA, if the layer between previously paved HMA lifts is close to the depth of milling. The scabbing may contribute to a lower IRI and density issues due to differential compaction between the scabbing and non-scabbing areas.

Although the Contractor is required to clean the milled surface with a mechanical sweeper (vacuum or vacuum assisted), presumably removing poorly bonded materials, the bond between the scabbed area and the underlying pavement may not be strong enough to take the loads produced by traffic and the newly place HMA layer may debond. This may lead to premature distress and/or failure in the pavement.

To prevent these potential issues, the RE should monitor the milling depth (particularly over concrete pavement) to ensure scabbing does not occur. If scabbing occurs during the milling operation, the RE will direct the Contractor to lower the milling head to fully remove the scabbing or drop back and perform another pass to fully remove the scabbing. The Contractor can also opt to have an additional milling machine to follow the primary milling machine to keep production going.

The RE must be careful not to mill too much HMA because this will impact the placed HMA thickness and may result in multiple lifts of HMA based on the mix design and thickness.
